WATER TOWER ROAD SCREEN WALL INVESTIGATIONS

Water Tower Road
Longs, South Carolina

Stantec Project No. 171015900

March 31, 2025

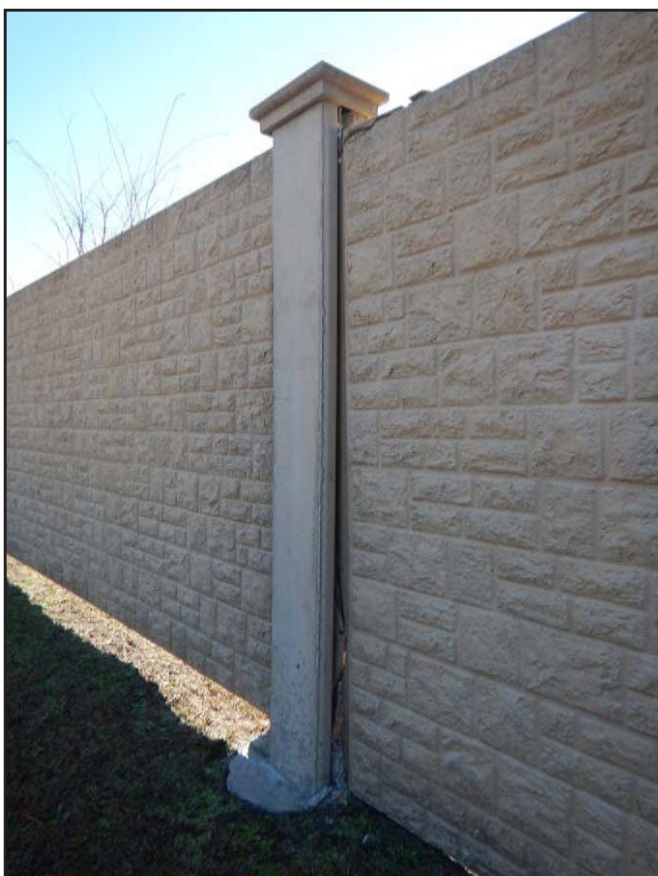
NO. 1 - DROPPED PRECAST WALL PANEL AT 3512 CLUB COURSE DRIVE, BETWEEN COLUMNS 13NM AND 14NM, AS VIEWED FROM WATER TOWER ROAD

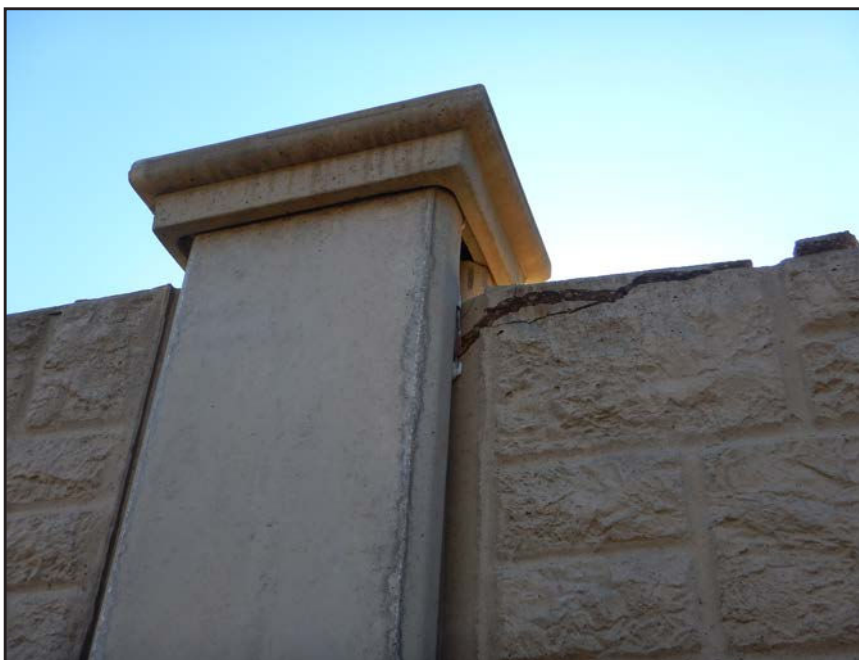
NO. 2 - COLUMN 13NM - DROPPED PRECAST PANEL WITH A CRACKED AND SPALLED TOP

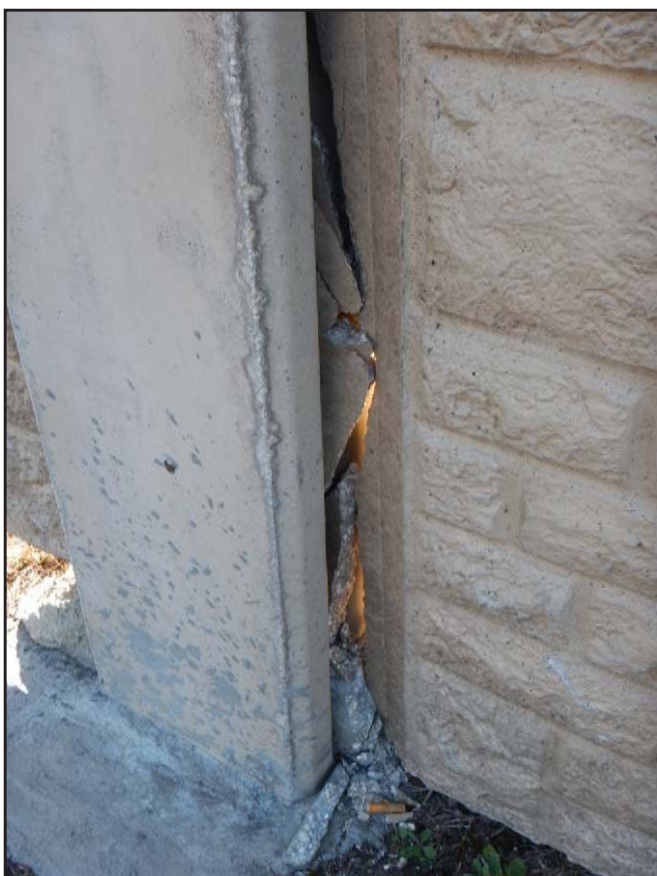
NO. 3 - COLUMN 13NM -
DROPPED PRECAST PANEL WITH
A CRACKED AND SPALLED TOP

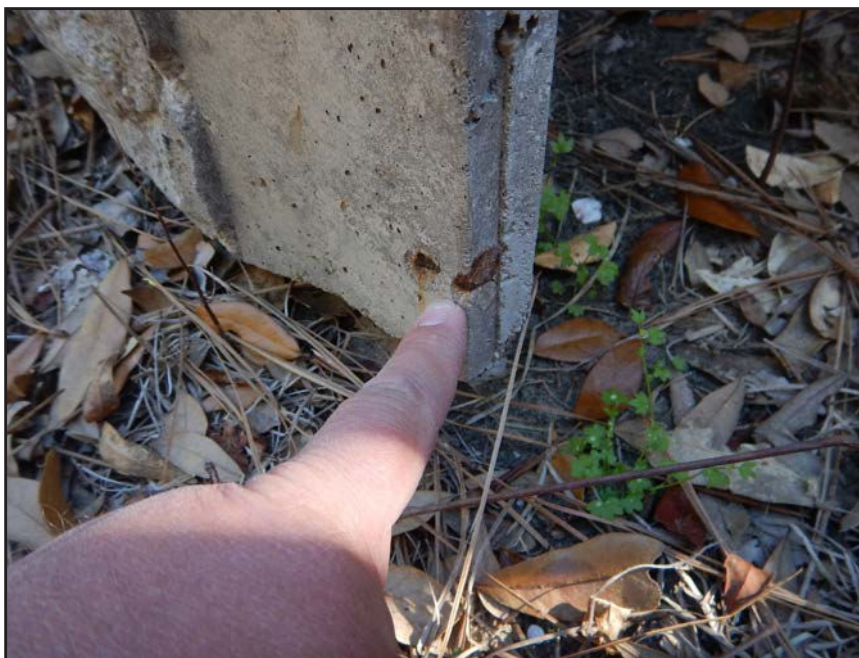
As shown in attached excerpts from the 2018 International Building Code and ACI 318-14, Table 20.6.1.3.3 in ACI 318-14 requires at least 3/4" of concrete cover for all No. 11 and smaller reinforcing bars in precast concrete, when exposed to weather. Therefore, any reinforcing steel in the subject screen wall which is exposed to the elements or has less than 3/4" of concrete cover is in violation of the 2018 International Building Code.

NO. 37 - STORED EXCESS WALL
PANEL - TONGUE REINFORCING
STEEL WITH INADEQUATE
CONCRETE COVER

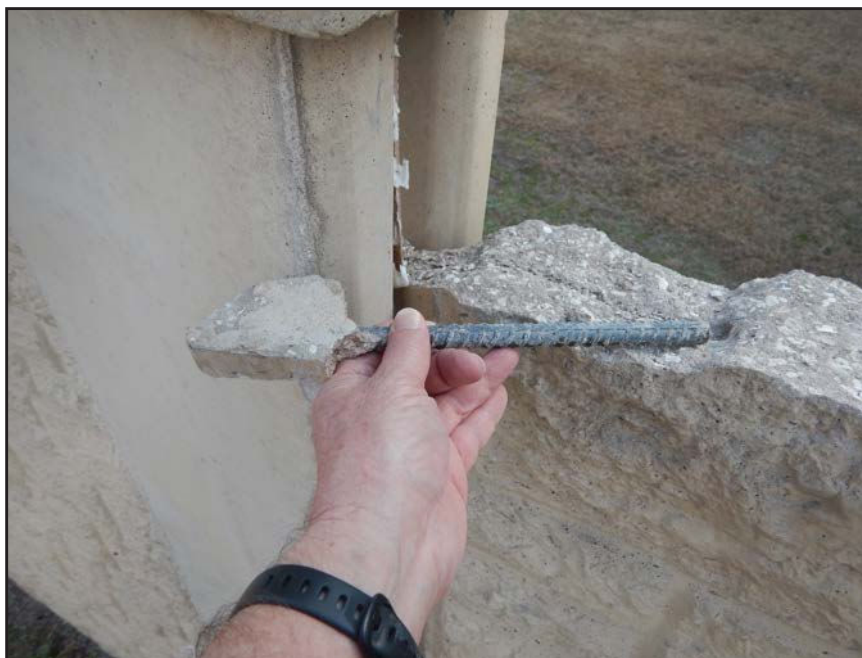
NO. 55 - SPALLED WALL
PANEL ON THE SOUTH SIDE
OF COLUMN 13NM - TONGUE
REINFORCING DOWEL WITH
INADEQUATE CONCRETE
COVER

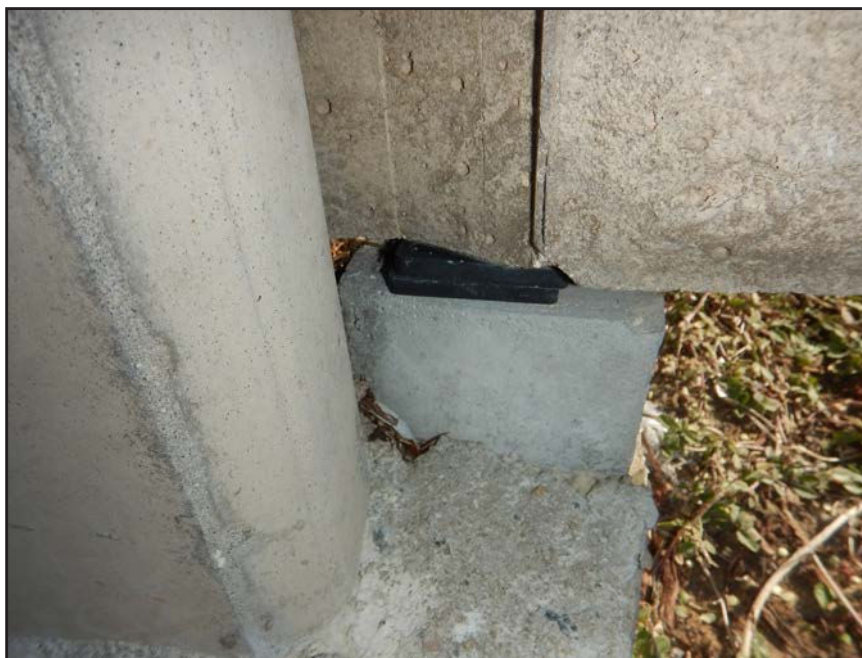
- 13C) Numerous precast wall panels are inadequately supported on 2" x 2" neoprene bearing pads, as shown in example photographs No. 63 through No. 105.

NO. 64 - COLUMN 2N -
INADEQUATE BEARING OF A
PRECAST WALL PANEL ON A
2" x 2" NEOPRENE BEARING
PAD

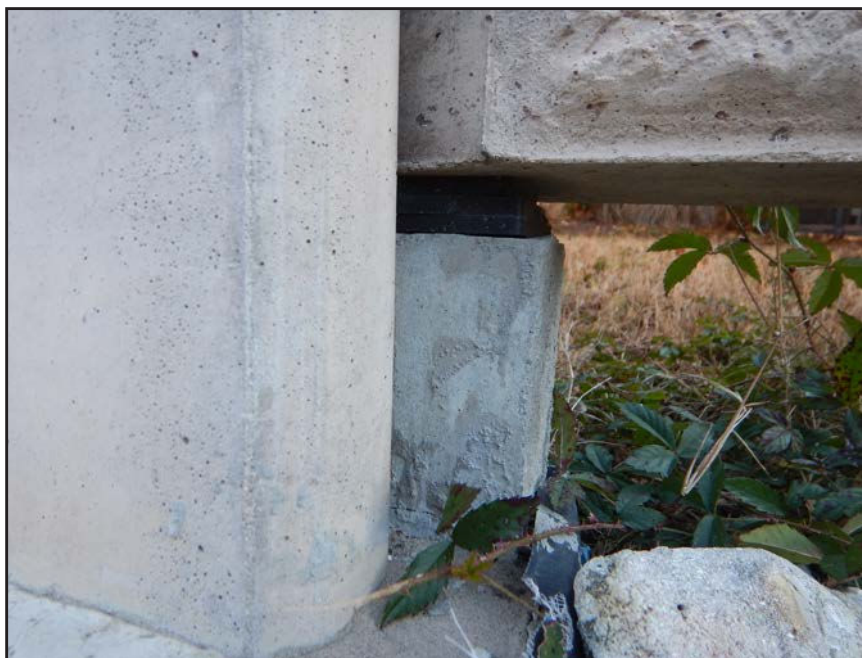
NO. 67 - COLUMN 11N -
INADEQUATE BEARING OF A
PRECAST WALL PANEL ON A
2" x 2" NEOPRENE BEARING
PAD

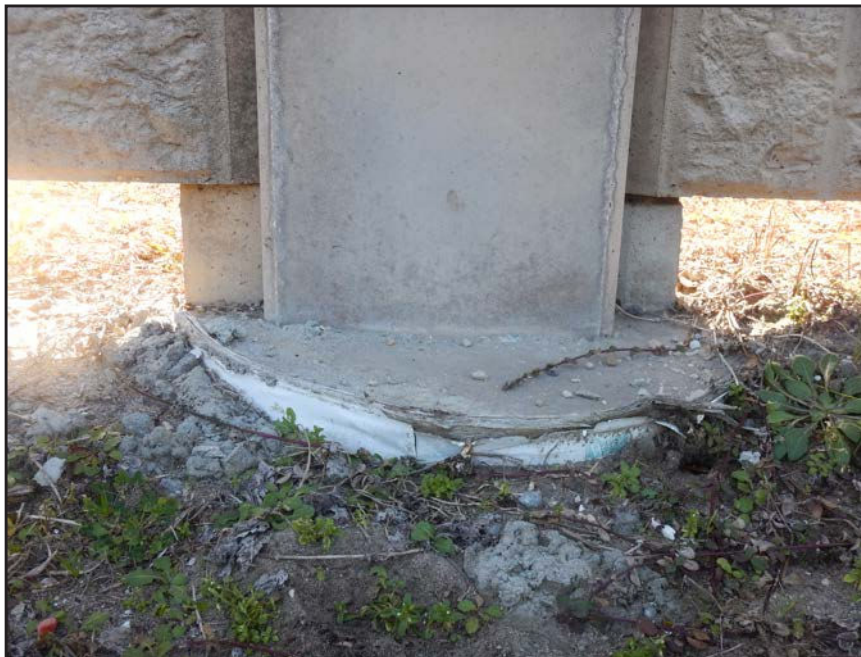
NO. 68 - COLUMN 11N -
INADEQUATE BEARING OF A
PRECAST WALL PANEL ON A
2" x 2" NEOPRENE BEARING
PAD

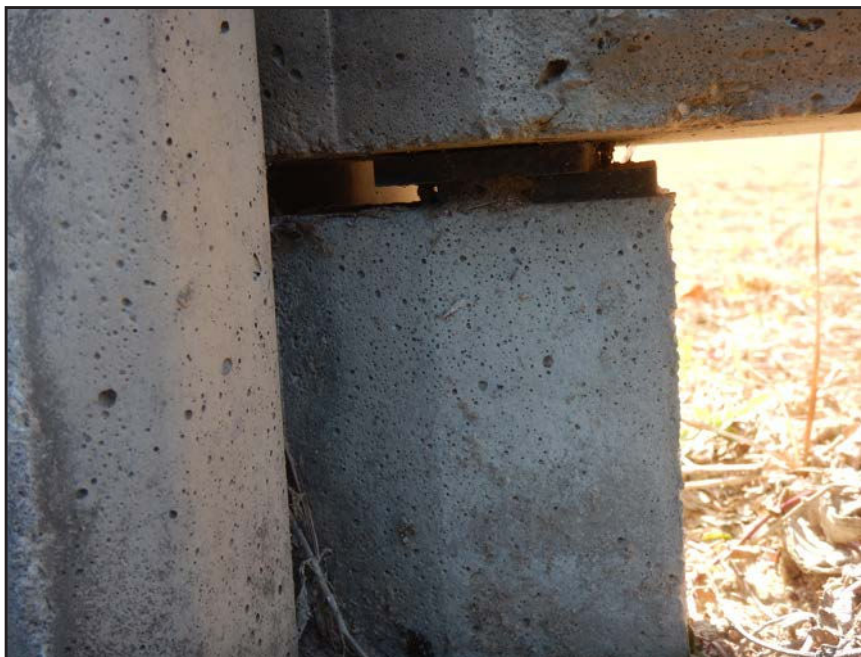
NO. 69 - COLUMN 52N -
INADEQUATE BEARING OF A
PRECAST WALL PANEL ON A
2" x 2" NEOPRENE BEARING
PAD

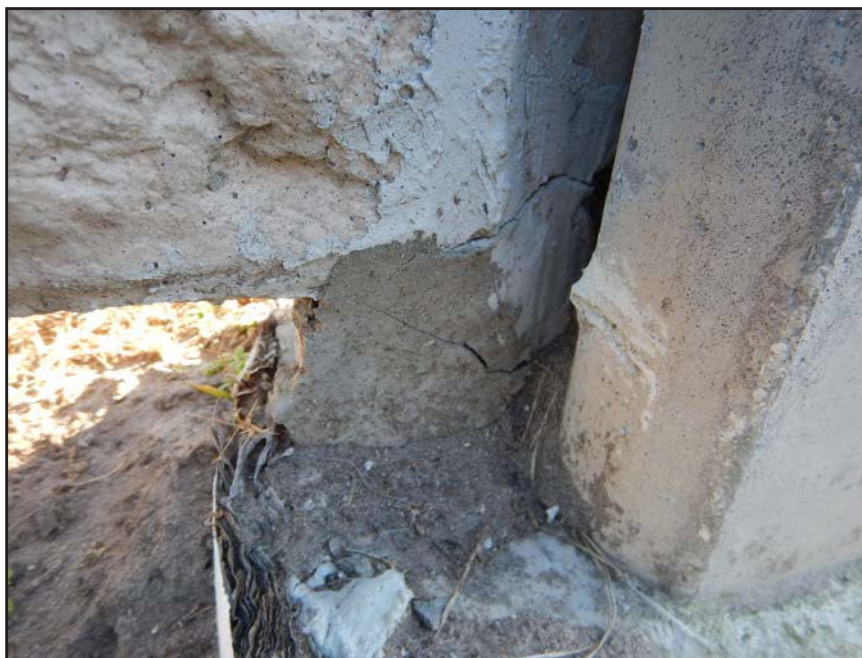
- 14C) Numerous precast wall panels supported on grout pedestals have failed, with cracked and spalled pedestals and/or cracked and spalled panels, as shown in example photographs No. 106 through No. 182.

NO. 107 - COLUMN 10N -
INADEQUATE BEARING OF A
PRECAST WALL PANEL ON A
FAILED GROUT PEDESTAL OR A
FAILED PRECAST TONGUE

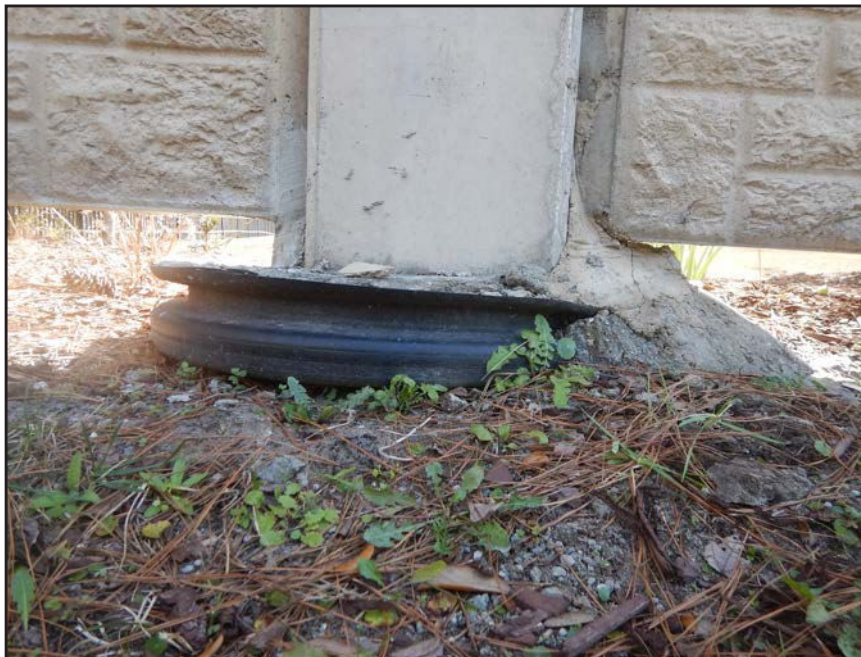
NO. 120 - COLUMN 25SM -
INADEQUATE BEARING OF A
PRECAST WALL PANEL ON A
FAILED GROUT PEDESTAL OR A
FAILED PRECAST TONGUE

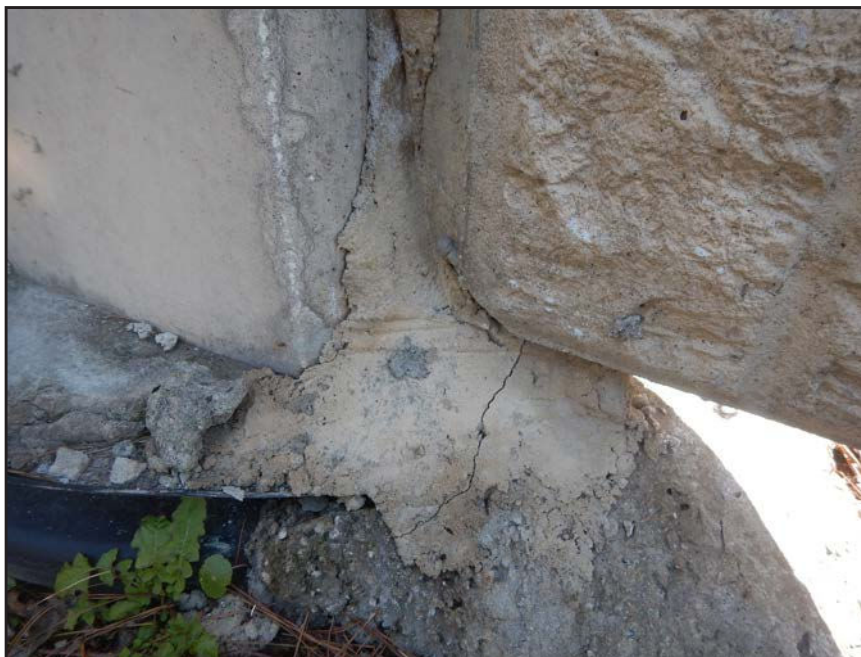
NO. 121 - COLUMN 2S -
INADEQUATE BEARING OF A
PRECAST WALL PANEL ON A
FAILED GROUT PEDESTAL OR A
FAILED PRECAST TONGUE

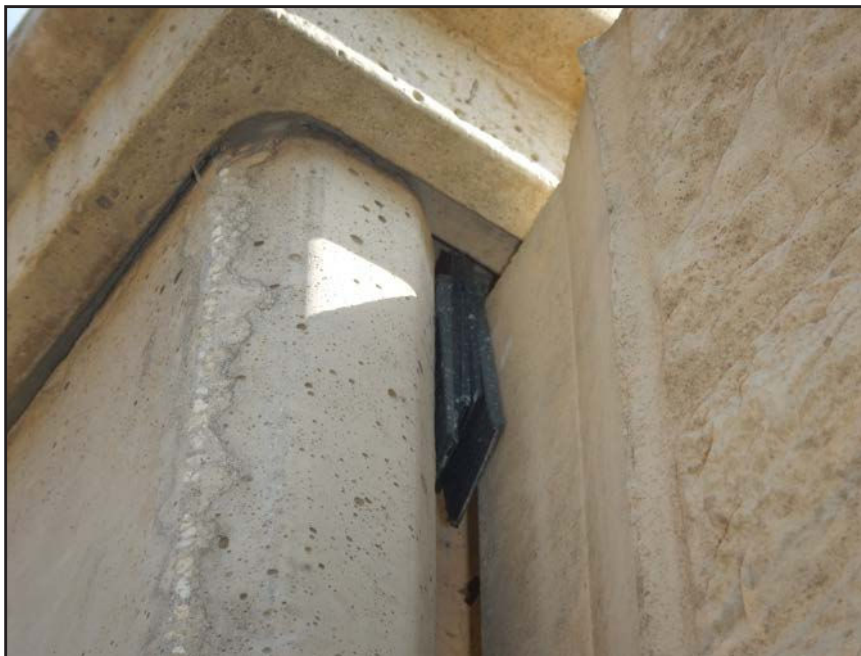
- 16C) Numerous wall panel to column connections are inadequately stabilized with loose shims, as shown in example photographs No. 262 through No. 286.

NO. 271 - COLUMN 26SM -
INADEQUATE SHIMS STABILIZING
A WALL PANEL TO COLUMN
CONNECTION AT EXCESSIVE
PLAY BETWEEN ADJACENT
MEMBERS

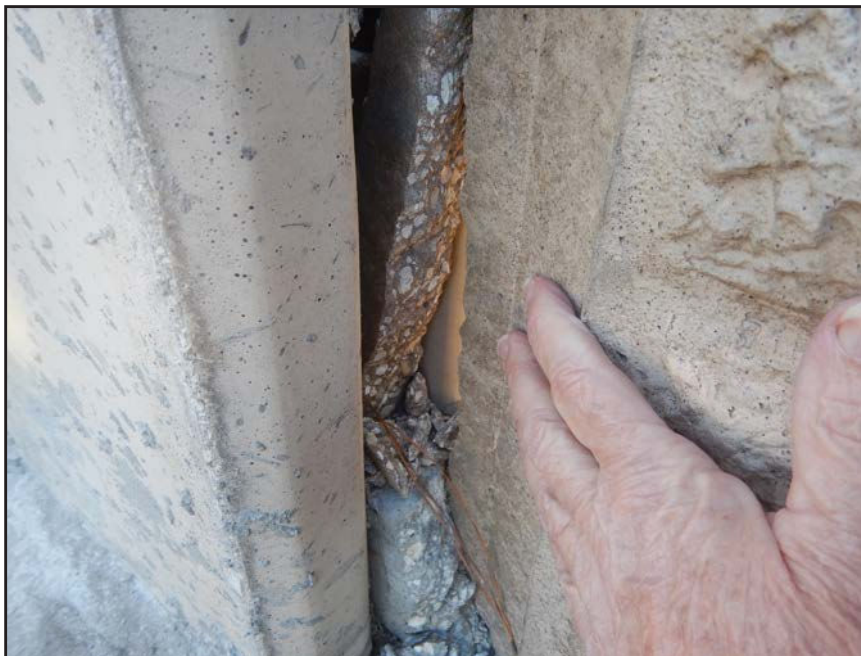
- 17C) Numerous wall panel "tongues" are cracked and spalled at "H" column connections, as shown in example photographs No. 287 through No. 400.
- 18C) Several deficient wall panel to column connections have been inadequately repaired with aesthetically displeasing and non-code-compliant clip angles, as shown in example photographs No. 401 through No. 458.

NO. 312 - COLUMN 13NM -
CRACKED AND FAILED
TONGUE OF A PRECAST WALL
PANEL IN A PRECAST COLUMN

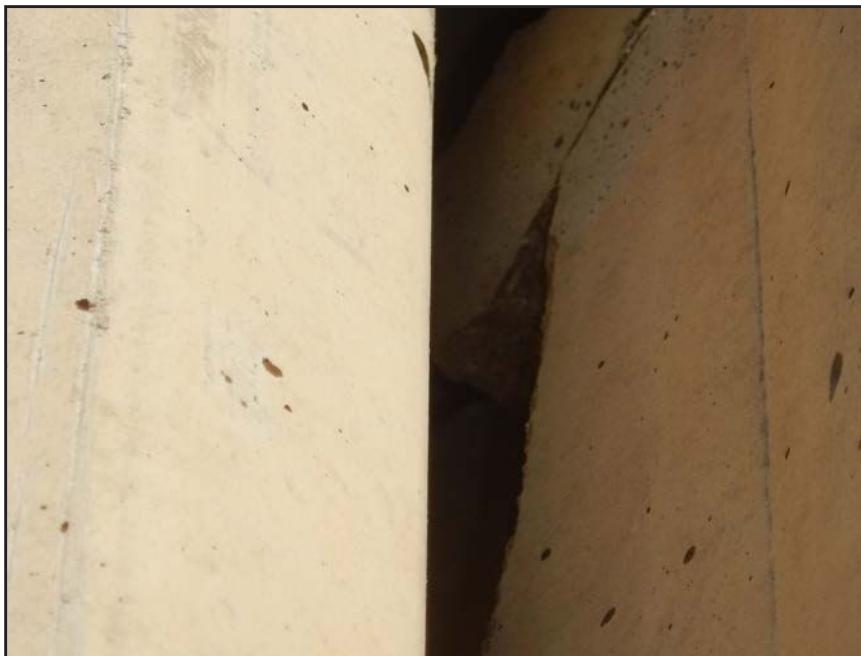
NO. 345 - COLUMN 8SS -
CRACKED AND FAILED
TONGUE OF A PRECAST WALL
PANEL IN A PRECAST COLUMN

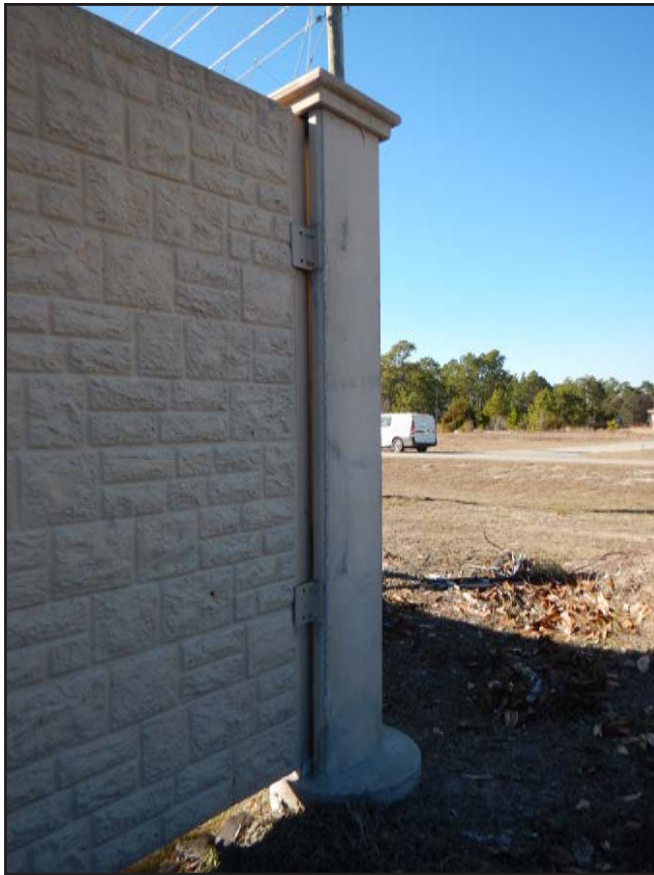
As shown in attached Sheet AB1, precast column flange thicknesses are 3." As specified in the attached "Added Brackets For Columns" details by JBM&R Engineering dated October 19, 2021, 1/2" diameter Red Head Concrete Wedge Type Bolts are specified at each clip angle. According to the attached ICC-ES Evaluation Report ESR-2251, the minimum required edge distance for a 1/2" diameter ITW Red Head Trubolt Wedge Anchor is 3 3/4." Therefore, each wedge anchor in each added clip angle is in violation of the Manufacturer's International Code Council Evaluation Report.

NO. 401 - COLUMN 1NE - INADEQUATE ADDED
CLIP ANGLE CONNECTION AT A DEFICIENT
WALL PANEL TO COLUMN CONNECTION

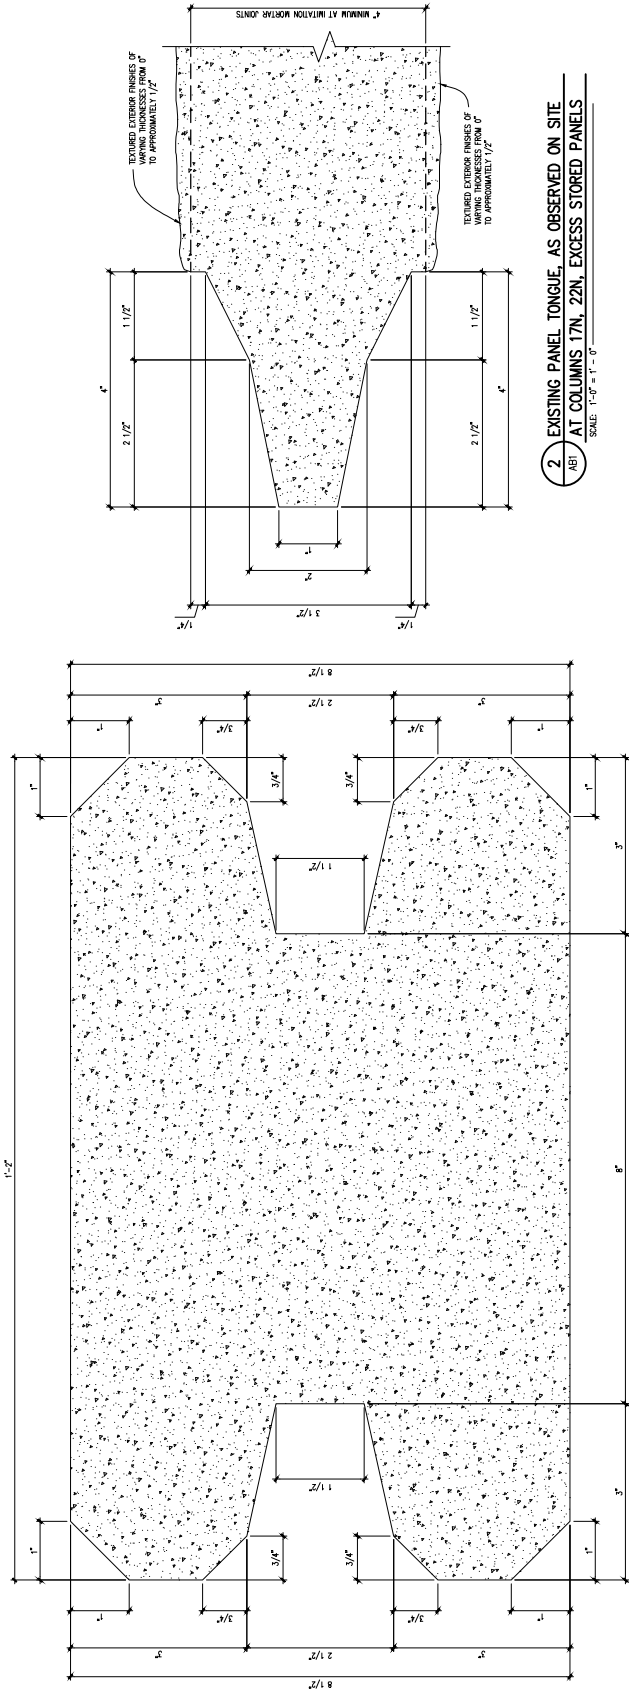
1 EXISTING COLUMN, AS OBSERVED ON SITE AT COLUMNS 17N, 22N, AND EXCESS STORED PANELS
SCALE: 1'-0" = 1'-0"

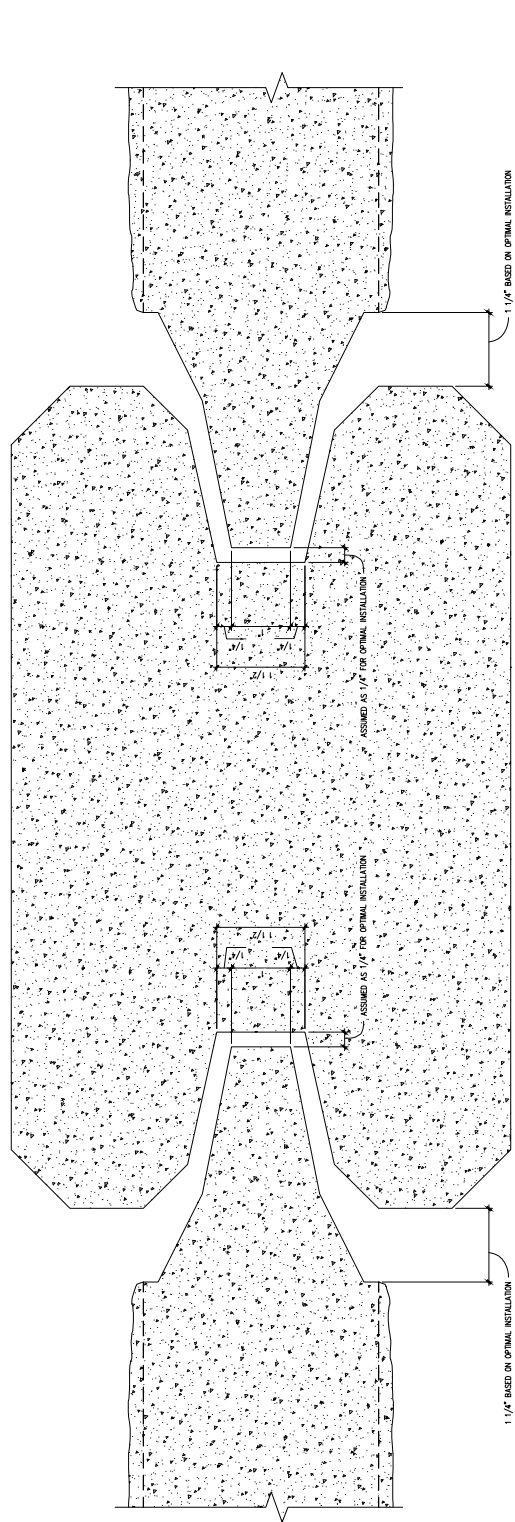
2 EXISTING COLUMN / PANEL CONNECTIONS, BASED ON DIMENSIONS AT COLUMNS 17N, 22N, AND EXCESS STORED PANELS
SCALE: 1'-0" = 1'-0"
