Date: 8/11/25 **Job No.:** 171015900
Project: Water Tower Road
Screen Wall Investigations
Location: Longs, South Carolina
Contractor: Glasstec, Inc.
Owner: _____
Present at site: Not Applicable

FIELD REPORT

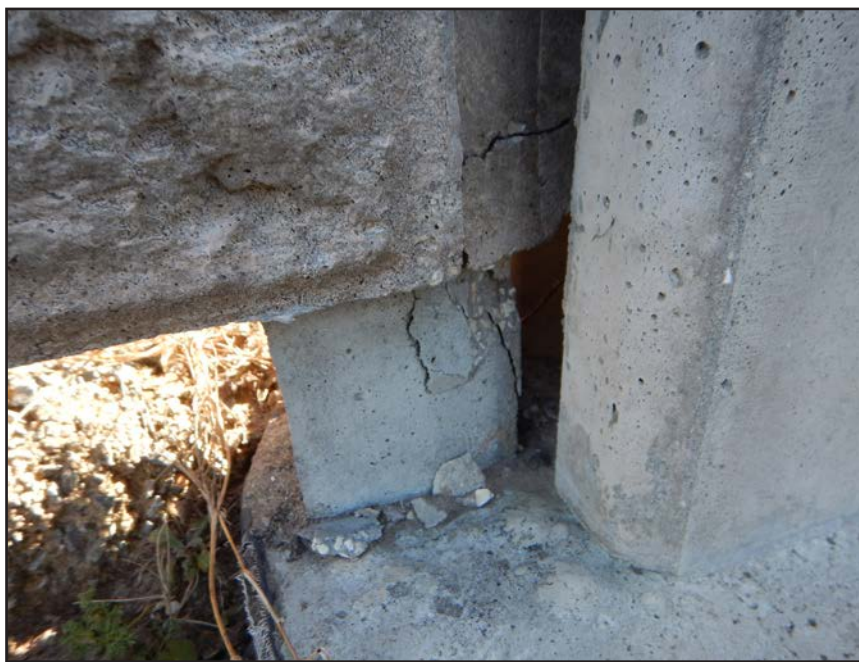
NO. 172 - ECP SITE VISIT ON
1/16/25 - COLUMN 10N

Water Tower Road - Screen Wall Investigations									
Specific Repair Recommendations as of August 11, 2025									
Panel as Viewed From Water Tower Road		Defect Requiring Repairs					Photographs		Stantec Recommendations Until Permanent Repairs are Implemented
Left Column	Right Column	Failed Grout at Bearing	Inadequate Bearing Pads	Exposed Panel Tongues of 2" or Greater	Inadequate Added Clip Angles by Others	Cracked and/or Spalled Concrete	Site Visit	Numbers	
1N	2N					Crack at top of 1N	1/16/25	85	Monitor the Panel Monthly ²
3N	4N			2.5" Left			1/16/25	109	Provide Immediate Temporary Repair ¹
6N	7N			2.75" Bottom Left, 2.5" Top Left	Left		1/16/25	127, 135, 136	Provide Immediate Temporary Repair ¹
7N	8N	Right					1/16/25	147	Monitor the Panel Monthly ²
8N	9N			3" Right Bottom, 2.5" Right Top	Right	Right, by clip angles	1/16/25	154, 157, 158, 161-163	Provide Immediate Temporary Repair ¹
9N	10N	Right				Bottom Right at bearing	1/16/25	172	Monitor the Panel Monthly ²

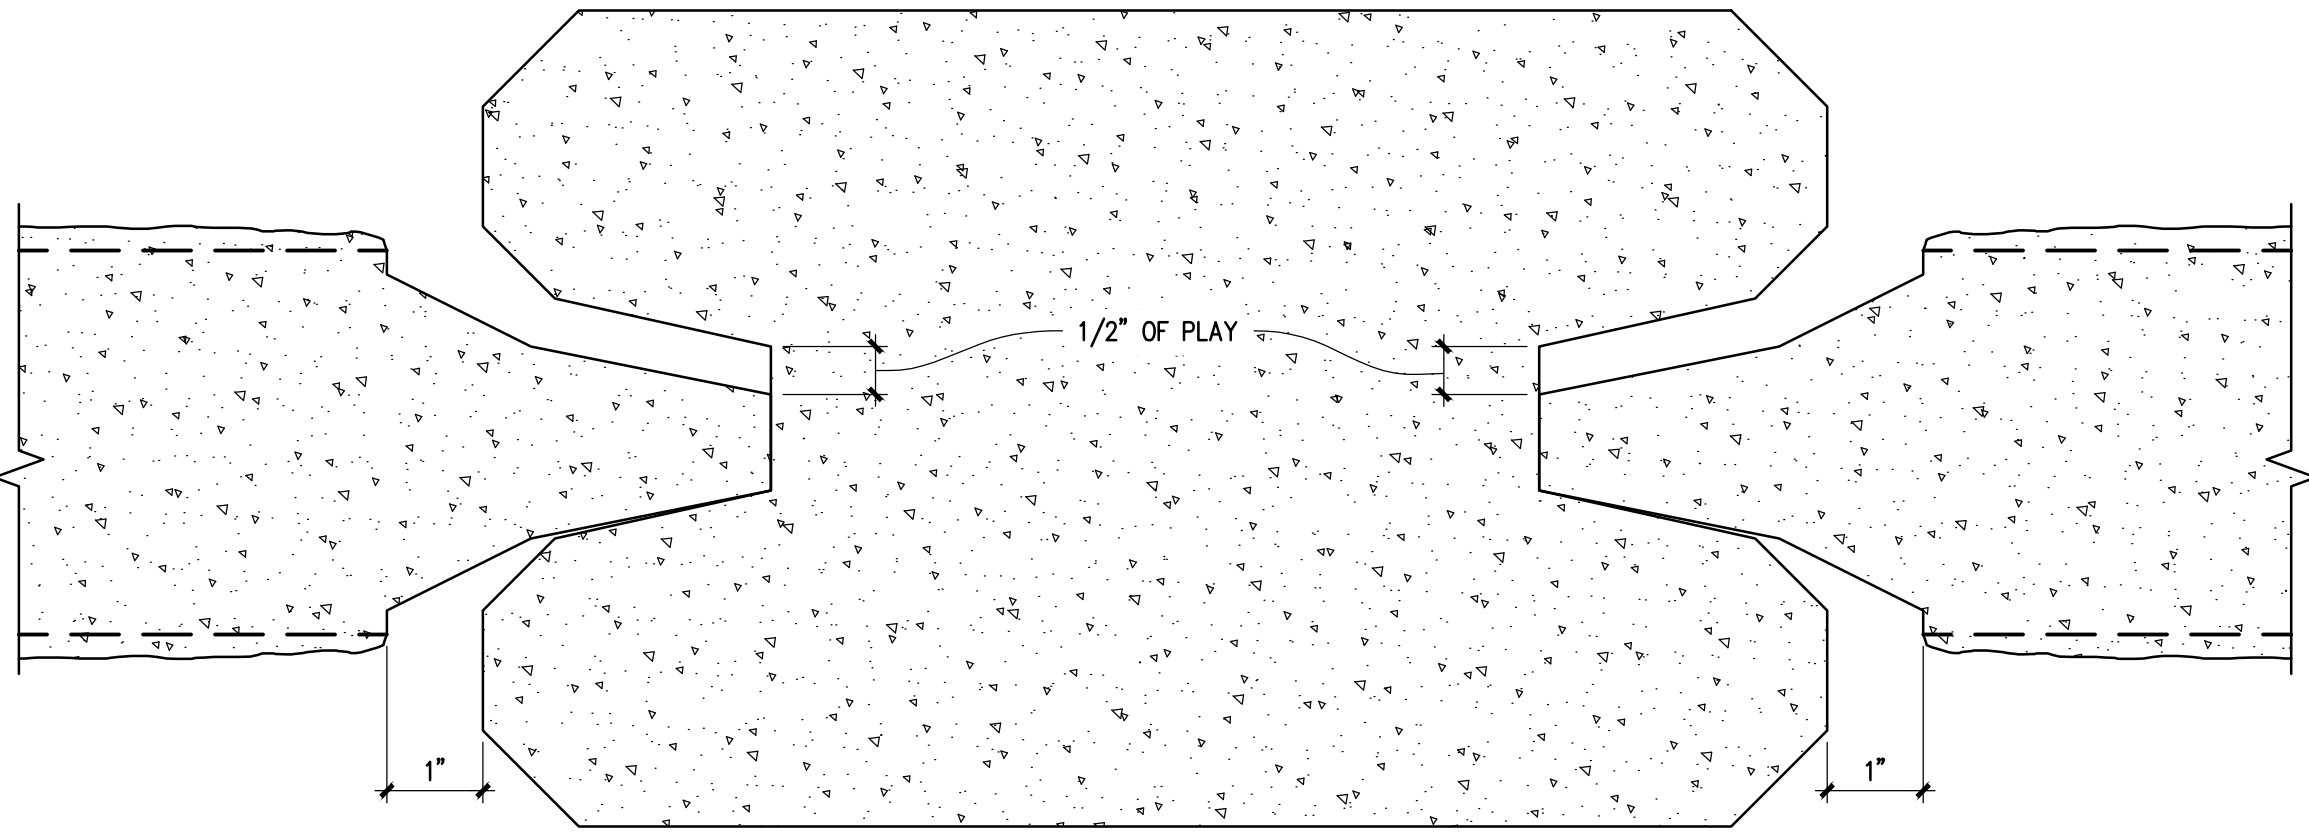
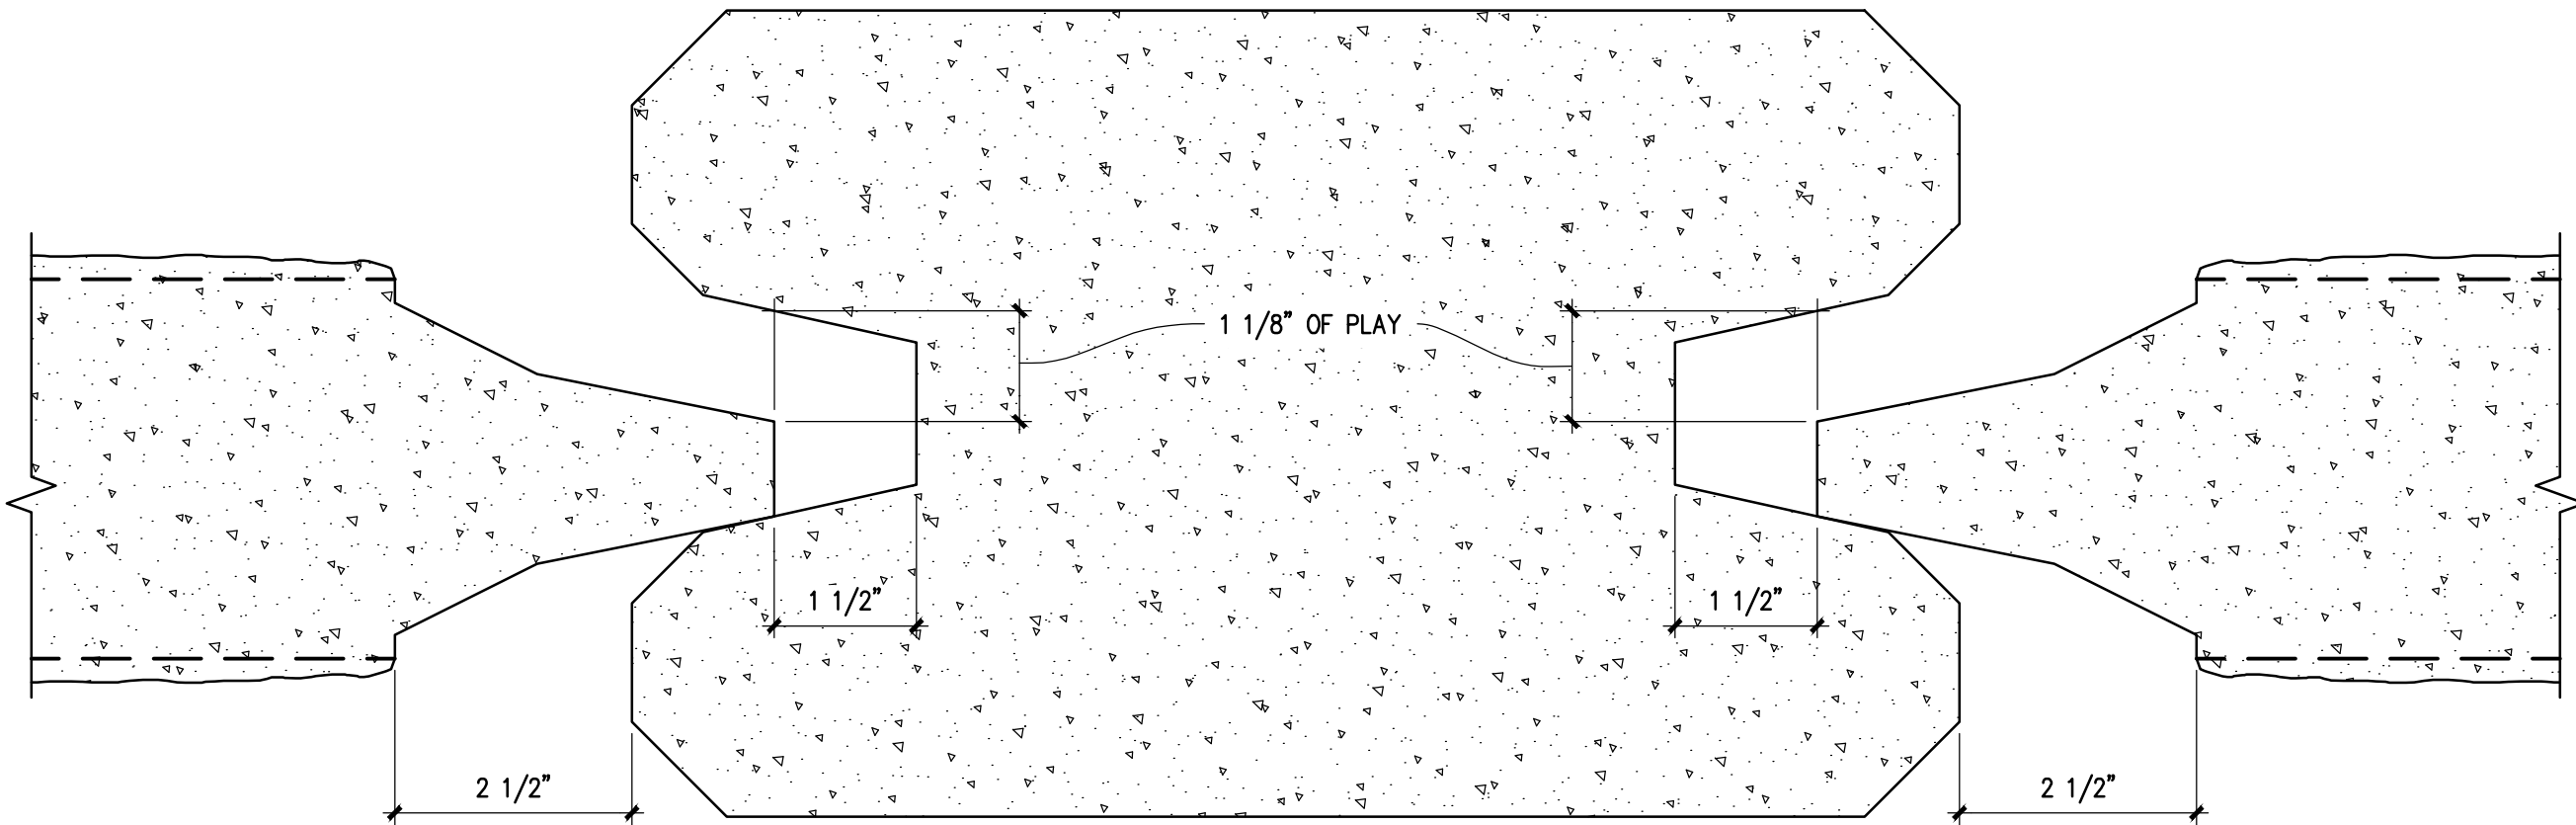
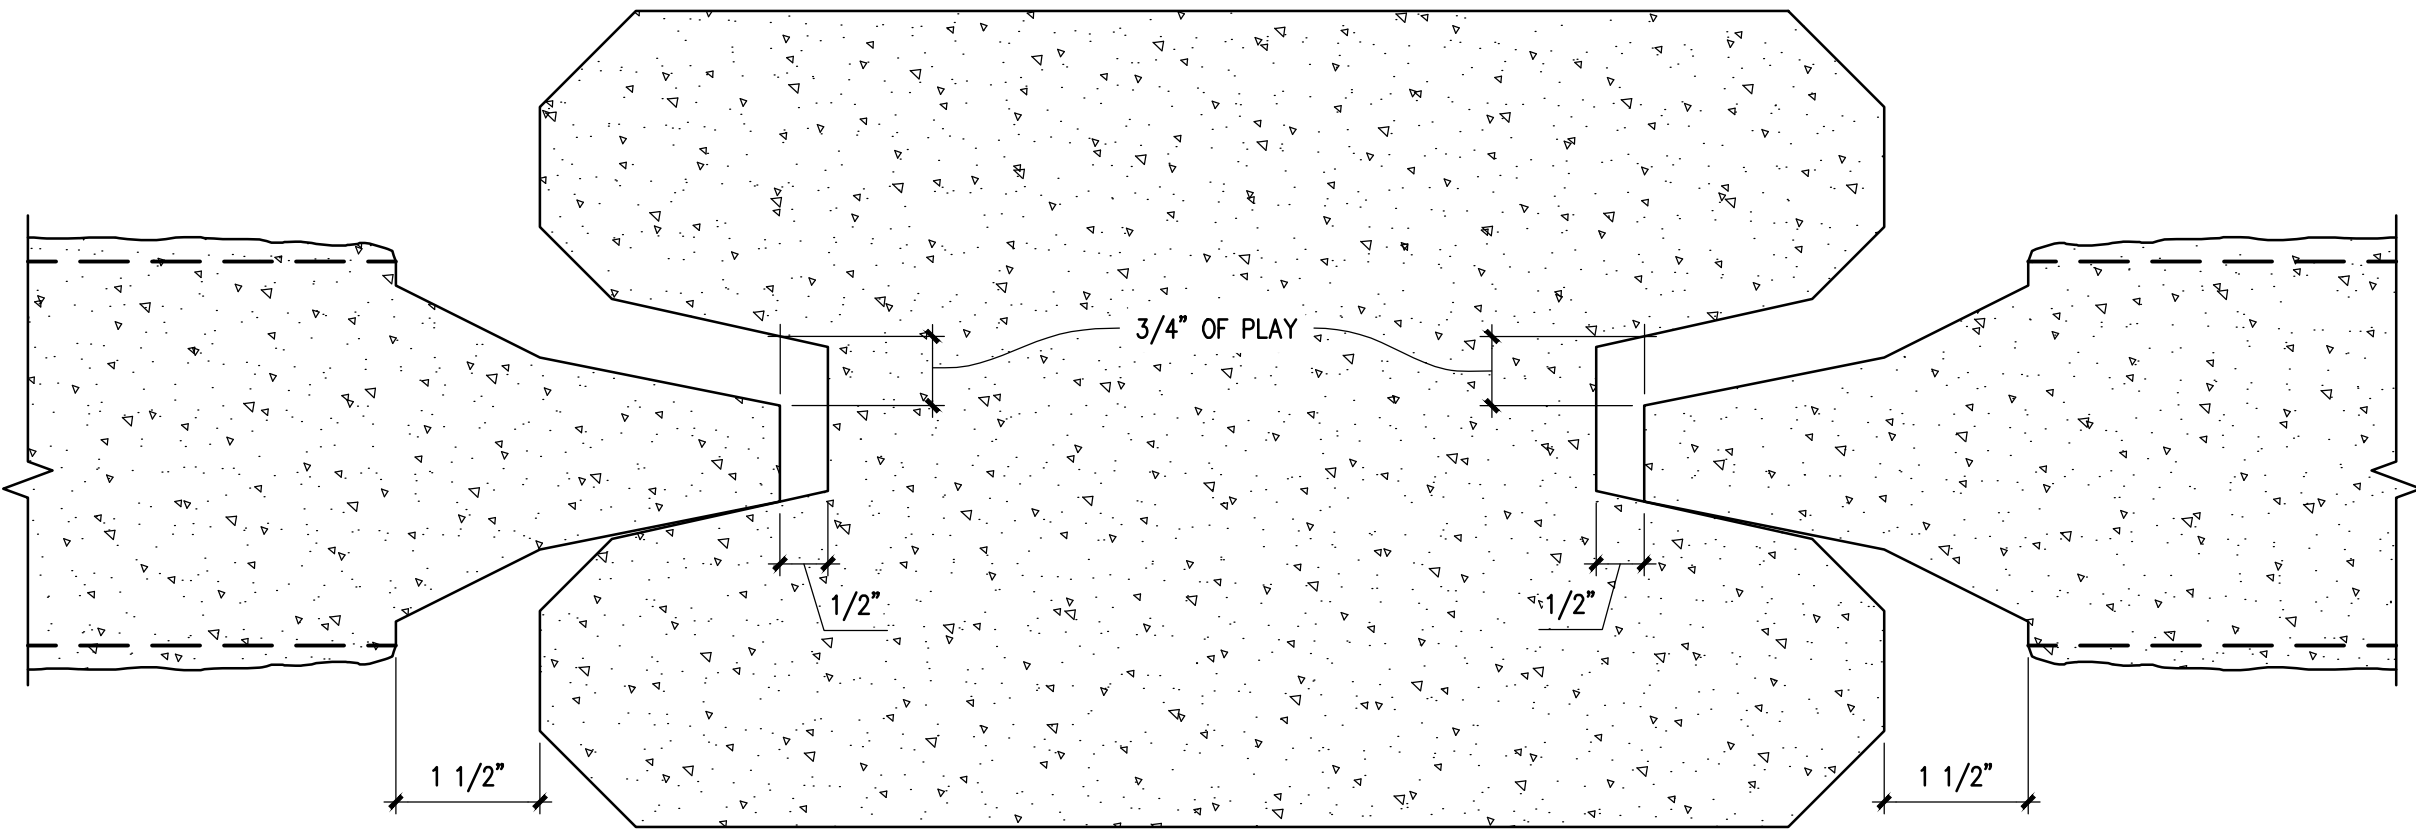
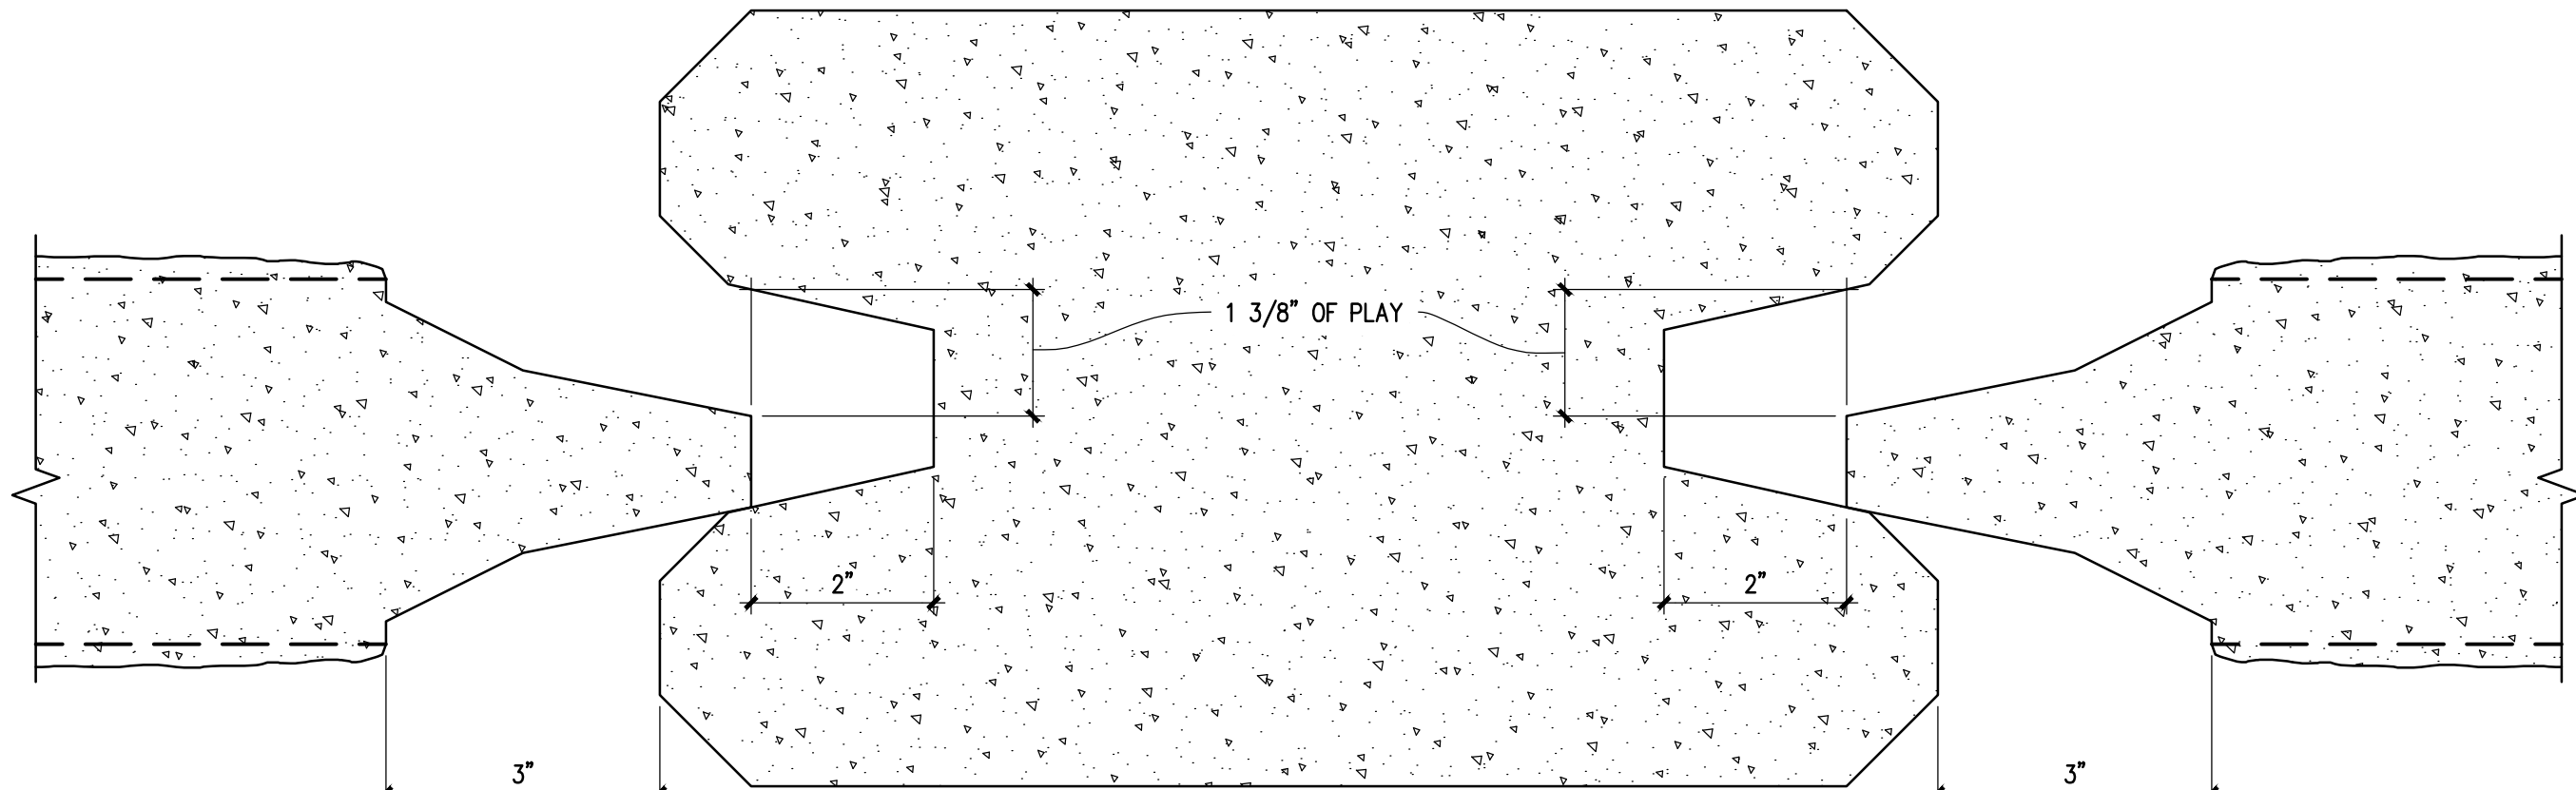
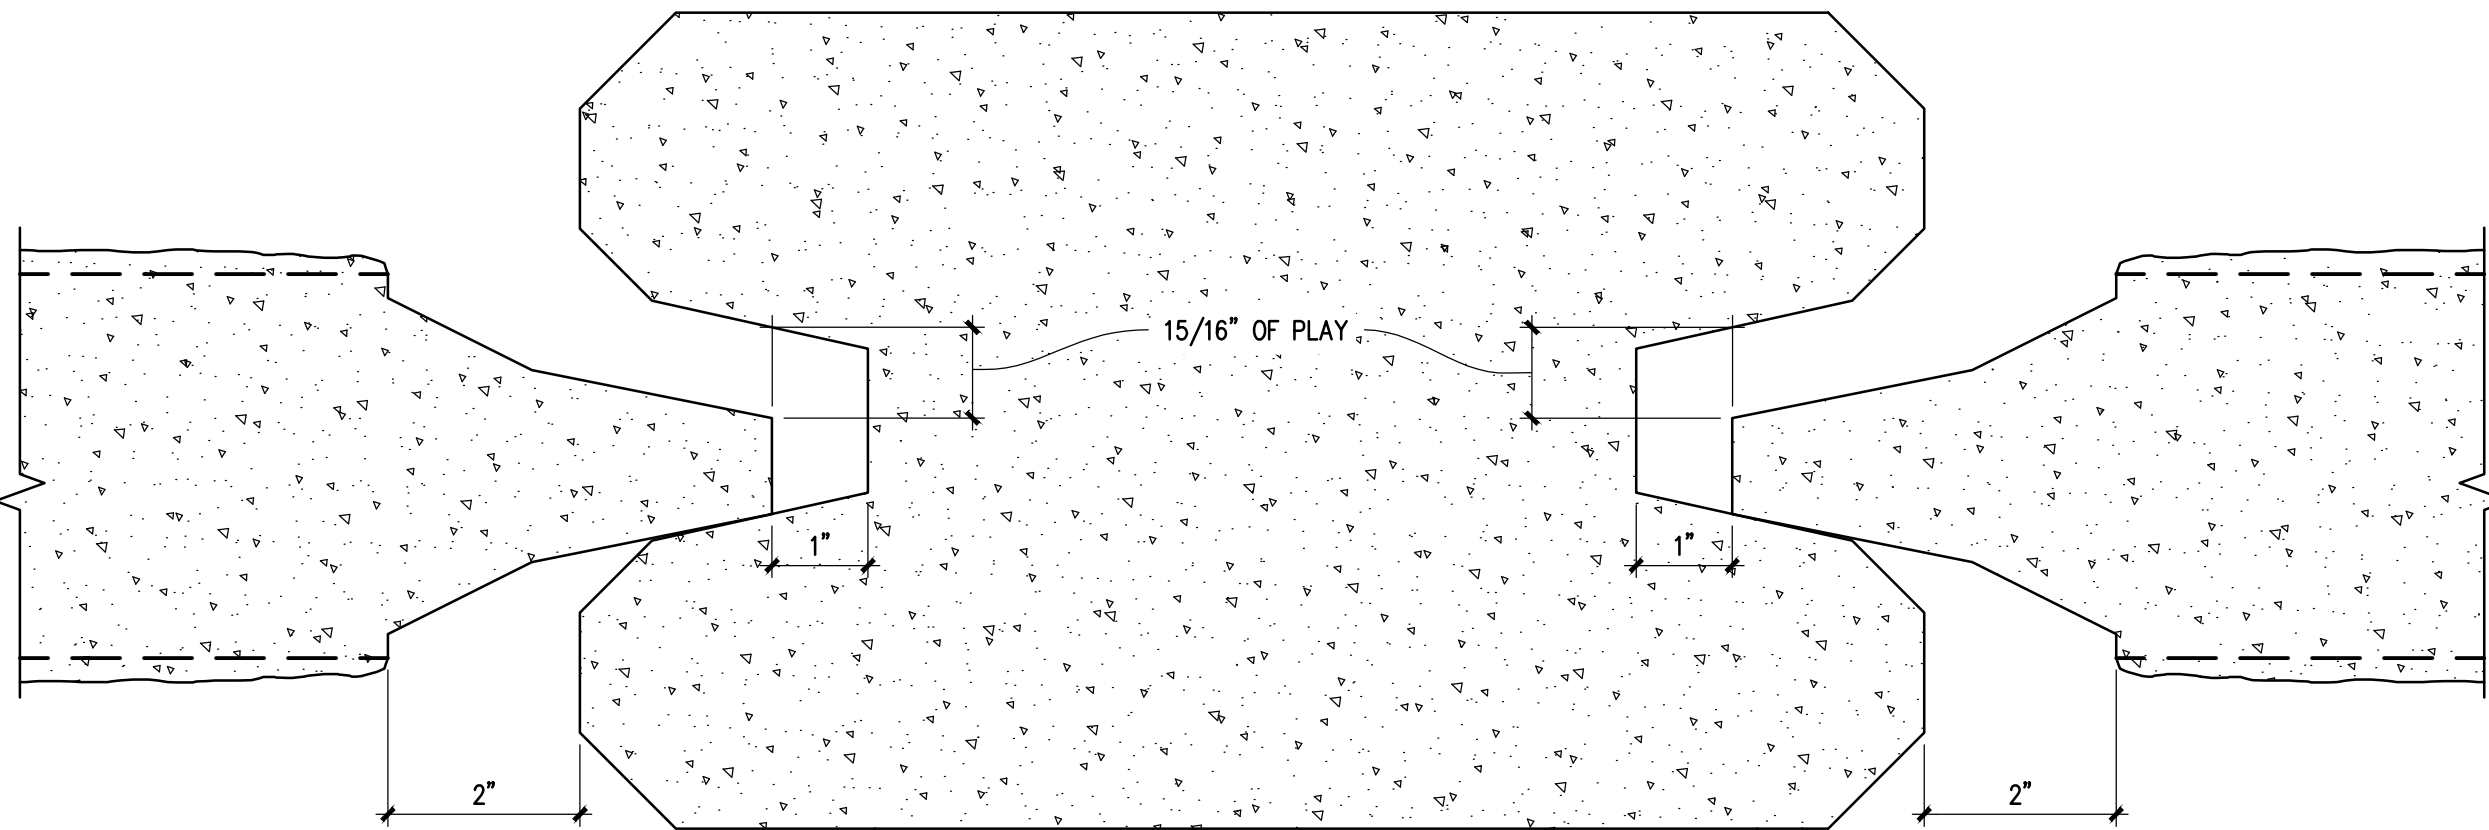
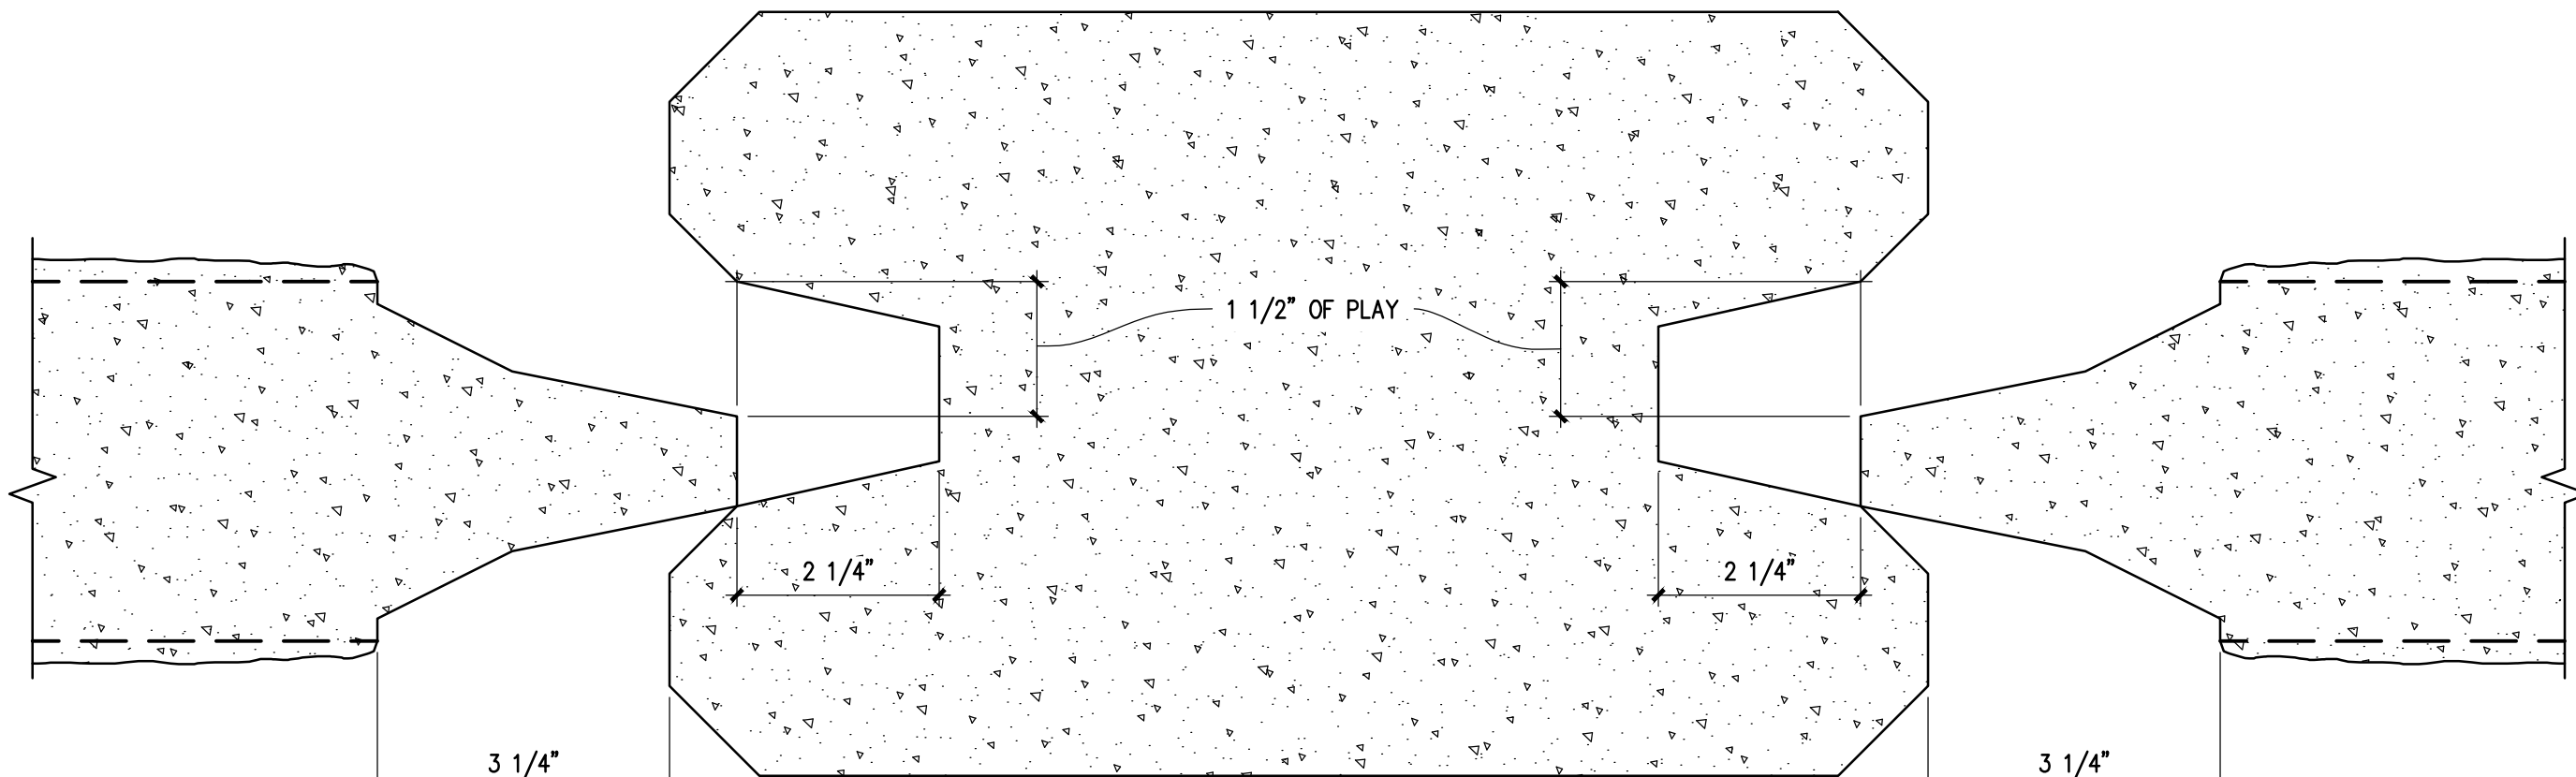
Varying Play between Columns
and Panels, as Observed on Site

Panels flagged for "Immediate Temporary Repair" include panel tongues exceeding 2.25" of exposure (as shown on attached Sheet AB3), failed grout at panel bearing, inadequate added clip angle connections, and/or severely cracked and spalled concrete. Repairs per attached Sheet S1B are referred to as "temporary," because Sheet S1B repairs will not repair existing cracked "tongues," spalled "tongues," or reinforcing steel with inadequate concrete cover. Each existing "tongue" at each end of each existing panel will deteriorate over time, due to corrosion and expansion of existing reinforcing steel with inadequate concrete cover. Any future cracks or spalls which extend to within 3" of new stainless steel through-bolts shall be brought to the immediate attention of Stantec for review and analysis. Ultimately, each individual wall panel will have to be removed and replaced with a new wall panel, with code-compliant reinforcing steel.

1 EXISTING PLAY AT COLUMN / PANEL CONNECTIONS WITH
1" BETWEEN THE COLUMN AND PANEL TEXTURED FINISHES
SCALE: 6" = 1' - 0"

4 EXISTING PLAY AT COLUMN / PANEL CONNECTIONS WITH
2 1/2" BETWEEN THE COLUMN AND PANEL TEXTURED FINISHES
SCALE: 6" = 1' - 0"

2 EXISTING PLAY AT COLUMN / PANEL CONNECTIONS WITH
1 1/2" BETWEEN THE COLUMN AND PANEL TEXTURED FINISHES
SCALE: 6" = 1' - 0"

5 EXISTING PLAY AT COLUMN / PANEL CONNECTIONS WITH
3" BETWEEN THE COLUMN AND PANEL TEXTURED FINISHES
SCALE: 6" = 1' - 0"

3 EXISTING PLAY AT COLUMN / PANEL CONNECTIONS WITH
2" BETWEEN THE COLUMN AND PANEL TEXTURED FINISHES
SCALE: 6" = 1' - 0"

6 EXISTING PLAY AT COLUMN / PANEL CONNECTIONS WITH
3 1/4" BETWEEN THE COLUMN AND PANEL TEXTURED FINISHES
SCALE: 6" = 1' - 0"
