WATER TOWER ROAD SCREEN WALL INVESTIGATIONS

Water Tower Road
Longs, South Carolina

Stantec Project No. 171015900

March 31, 2025

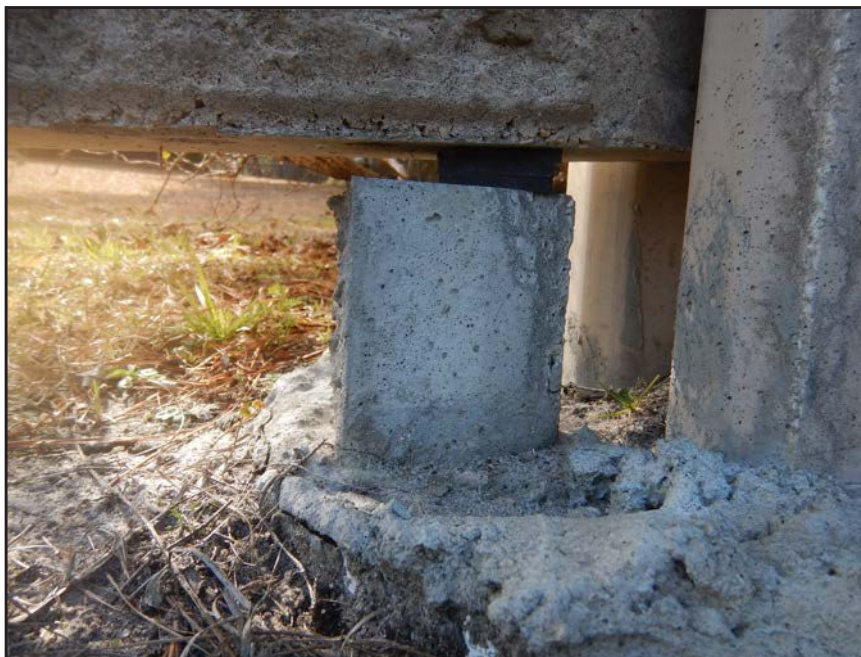
NO. 74 - COLUMN 14NM -
INADEQUATE BEARING OF A
PRECAST WALL PANEL ON A
2" x 2" NEOPRENE BEARING
PAD
