Date: 8/11/25 **Job No.:** 171015900
Project: Water Tower Road
Screen Wall Investigations
Location: Longs, South Carolina
Contractor: Glasstec, Inc.
Owner: _____
Present at site: Not Applicable

FIELD REPORT

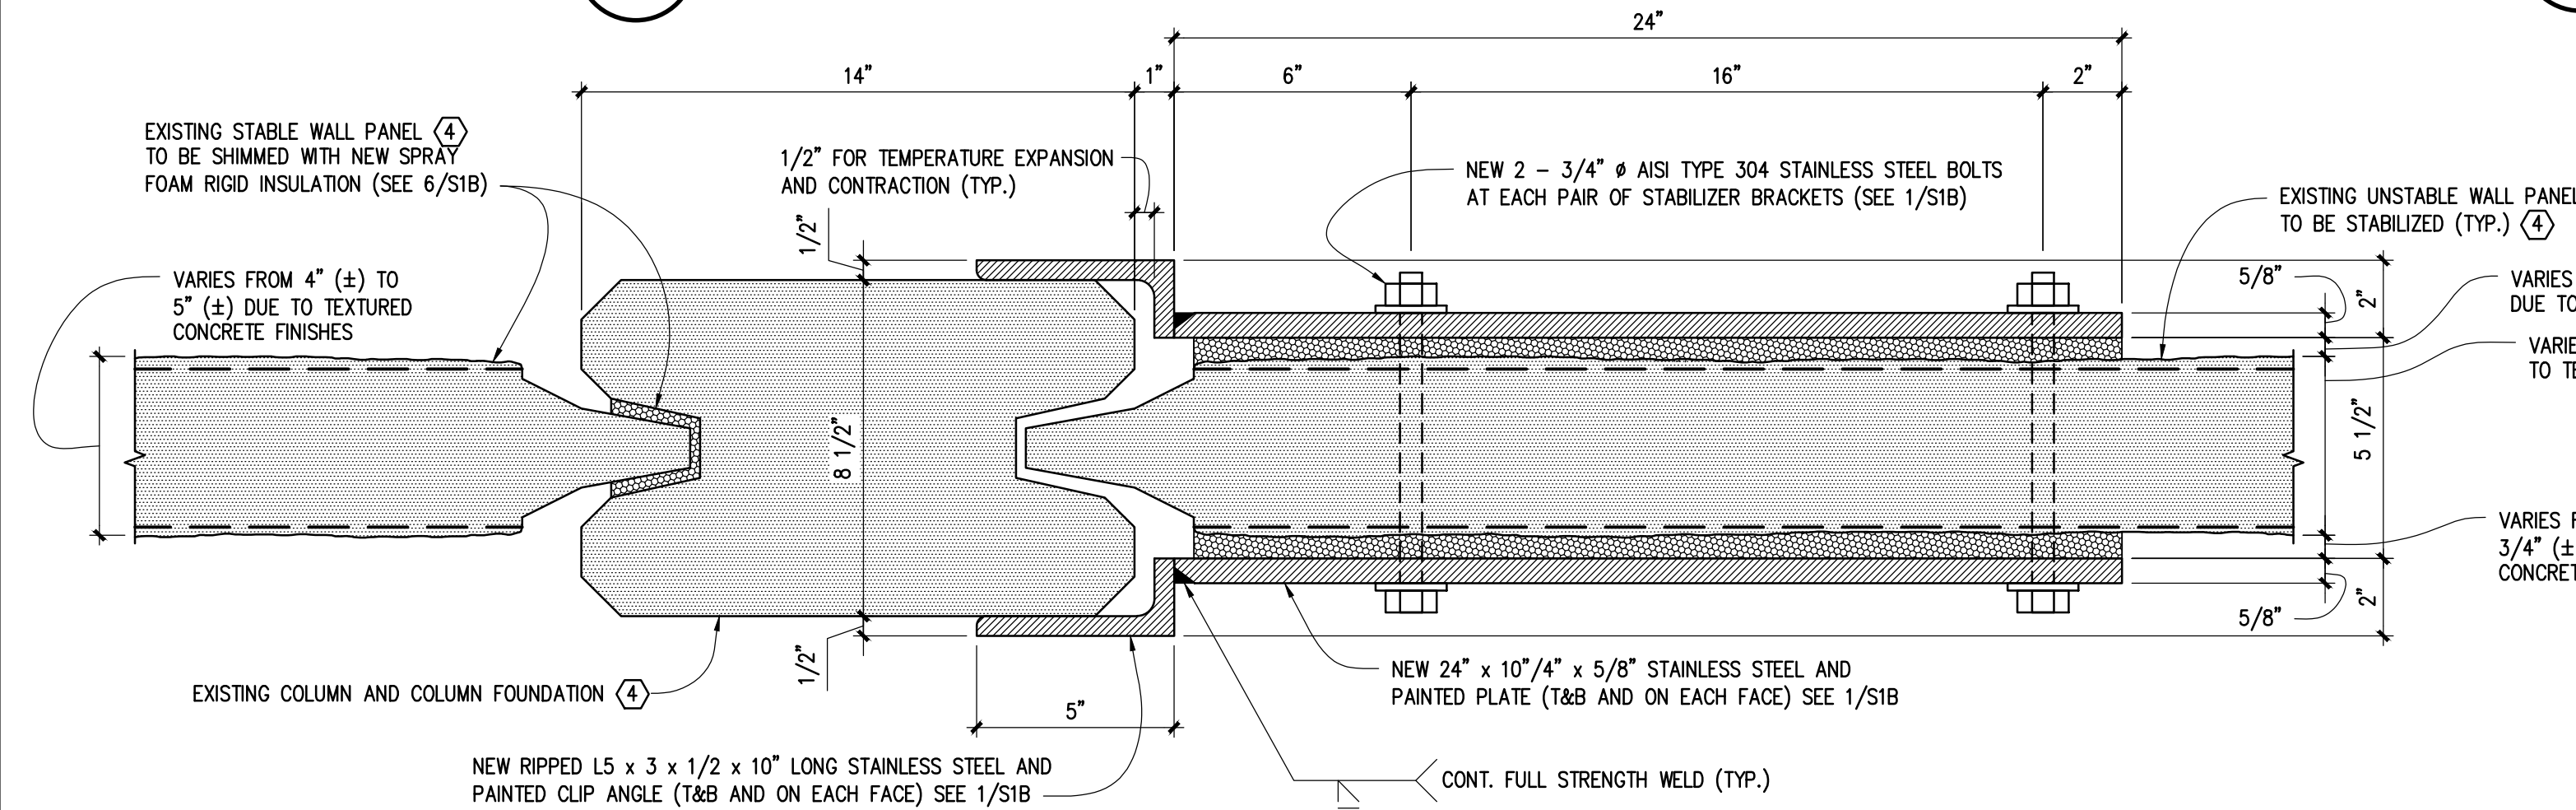
2 PARTIAL PLAN AT A STABILIZED WALL PANEL
SCALE: 3" = 1' - 0"

- Each existing wall panel contains inadequately designed "tongues" at each end of each panel, with non-code-compliant reinforcing steel with inadequate concrete cover. The Owner is advised that repair designs on Stantec Sheet SIB will stabilize each wall panel to existing precast concrete columns, and stabilize each wall panel on new footing foundations. However, Sheet SIB repair designs will not repair existing cracked tongues, spalled tongues, or reinforcing steel with inadequate concrete cover. Each tongue at each end of each existing wall panel will deteriorate over time, due to corrosion and expansion of existing reinforcing steel with inadequate concrete cover. Any future cracks or spalls which extend to within 3" of new stainless steel through-bolts shall be brought to the attention of Stantec for review and analysis. Ultimately, each individual wall panel will have to be removed and replaced with a new wall panel, with code-compliant reinforcing steel.

- Securing each referenced wall panel with four (4) new pairs of stainless steel and painted stabilizer brackets, in accordance with Details 1/SIB through 5/SIB,
