WATER TOWER ROAD SCREEN WALL INVESTIGATIONS

Water Tower Road
Longs, South Carolina

Stantec Project No. 171015900

March 31, 2025

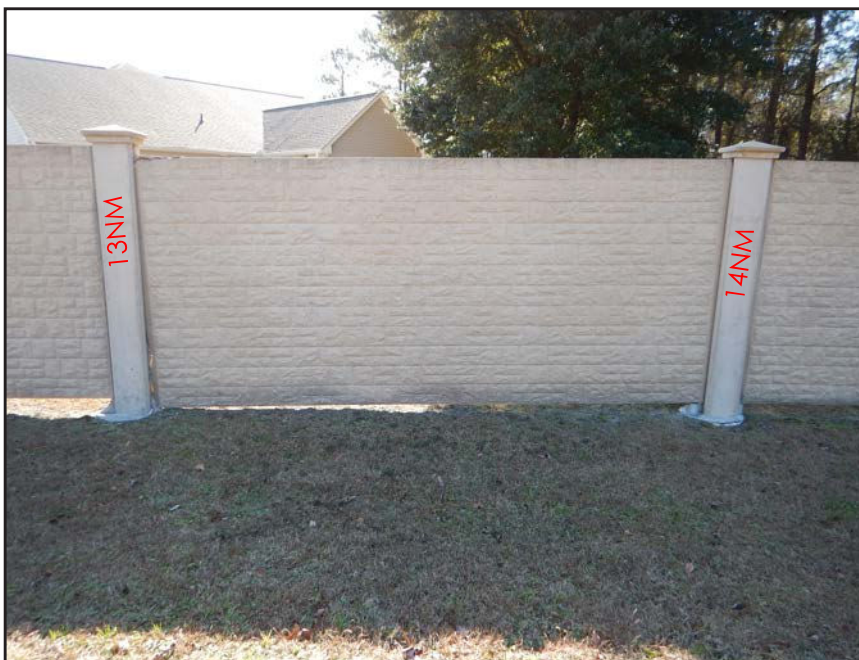
- 2C) In response to the attached email dated January 21, 2025, Stantec investigated one severely displaced wall panel at 3512 Club Course Drive, as shown in example photographs No. 1 through No. 11, and provided emergency repair recommendations as documented in previous Stantec Field Reports dated January 30, 2025 and March 11, 2025.

NO. 1 - DROPPED PRECAST WALL PANEL AT 3512 CLUB COURSE DRIVE, BETWEEN COLUMNS 13NM AND 14NM, AS VIEWED FROM WATER TOWER ROAD

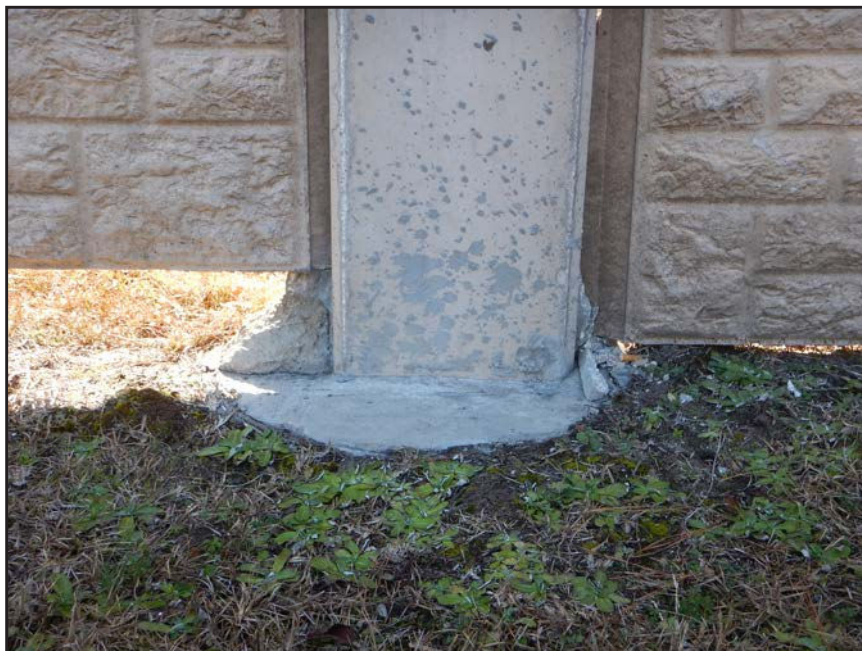
NO. 5 - COLUMN 13NM -
DROPPED PRECAST SOUTH
PANEL AND ELEVATED PRECAST
NORTH PANEL

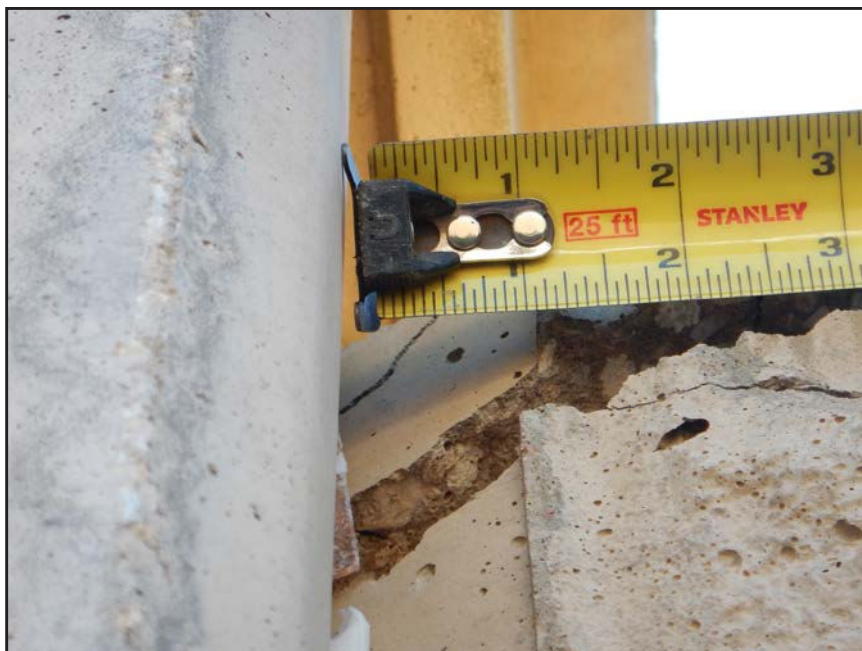
NO. 6 - COLUMN 13NM -
DROPPED PRECAST PANEL WITH
A 1" GAP AT THE TOP AND A
2 7/8" GAP AT THE BOTTOM

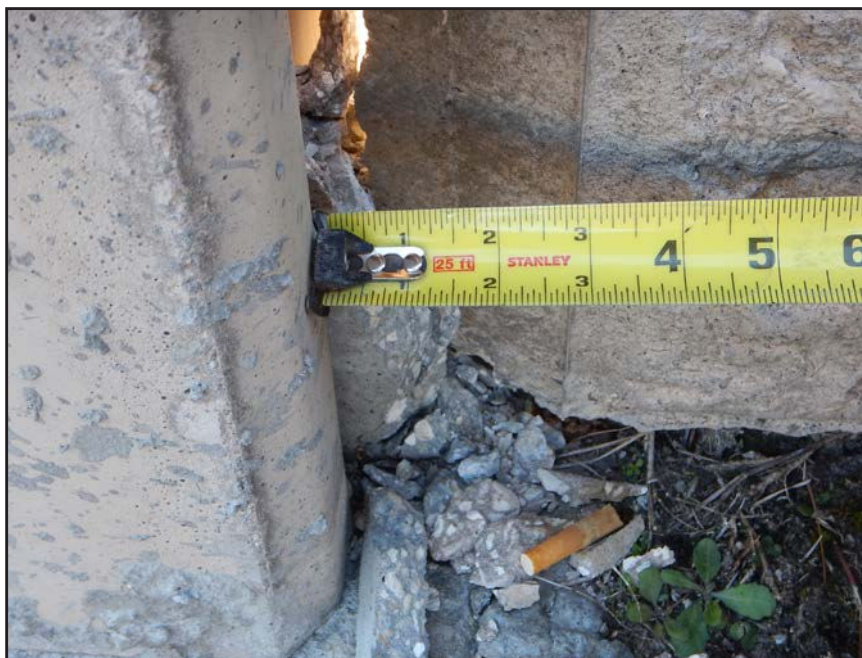
NO. 7 - COLUMN 13NM -
DROPPED PRECAST PANEL WITH
A 1" GAP AT THE TOP AND A
2 7/8" GAP AT THE BOTTOM

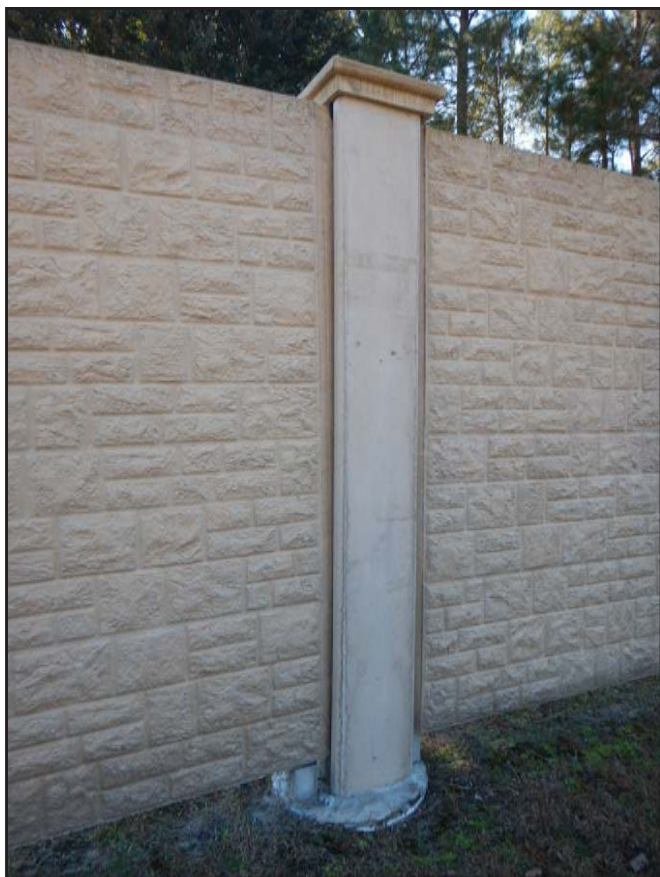
NO. 8 - COLUMN 14NM, AS VIEWED FROM
WATER TOWER ROAD

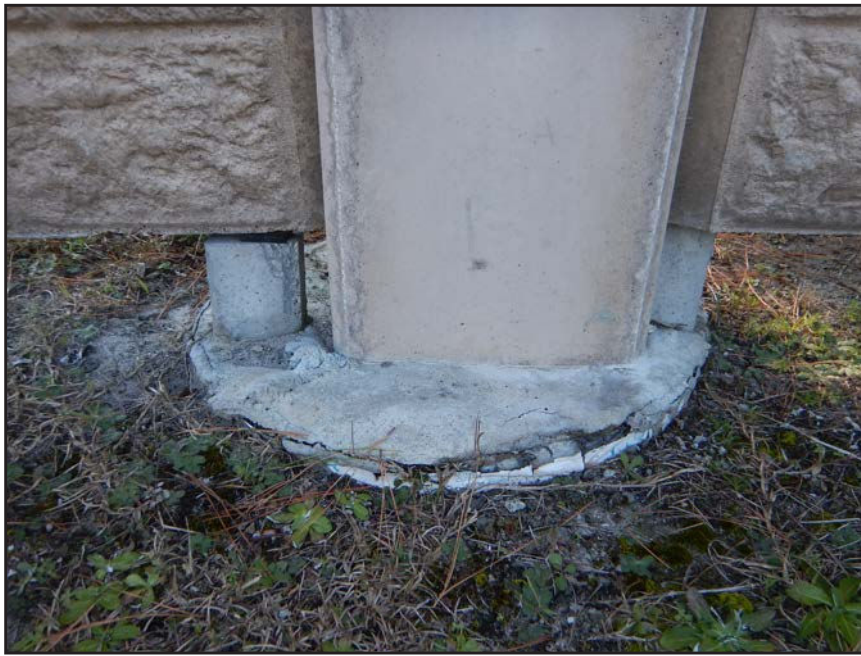
NO. 9 - COLUMN 14NM - BASE
OF ADJACENT PRECAST WALL
PANELS

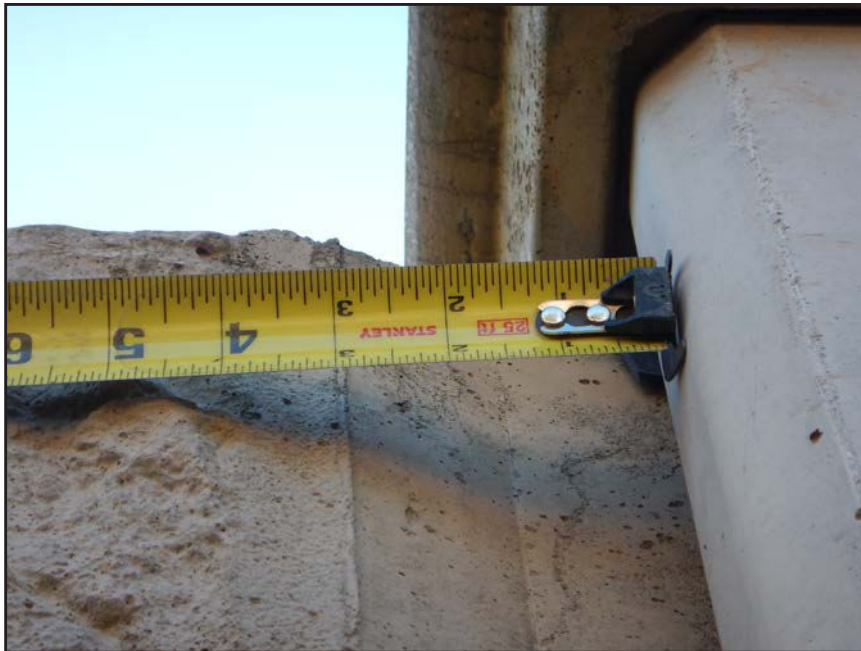
NO. 10 - COLUMN 14NM -
DROPPED PRECAST PANEL WITH
A 2 7/8" GAP AT THE TOP AND
A 1" GAP AT THE BOTTOM

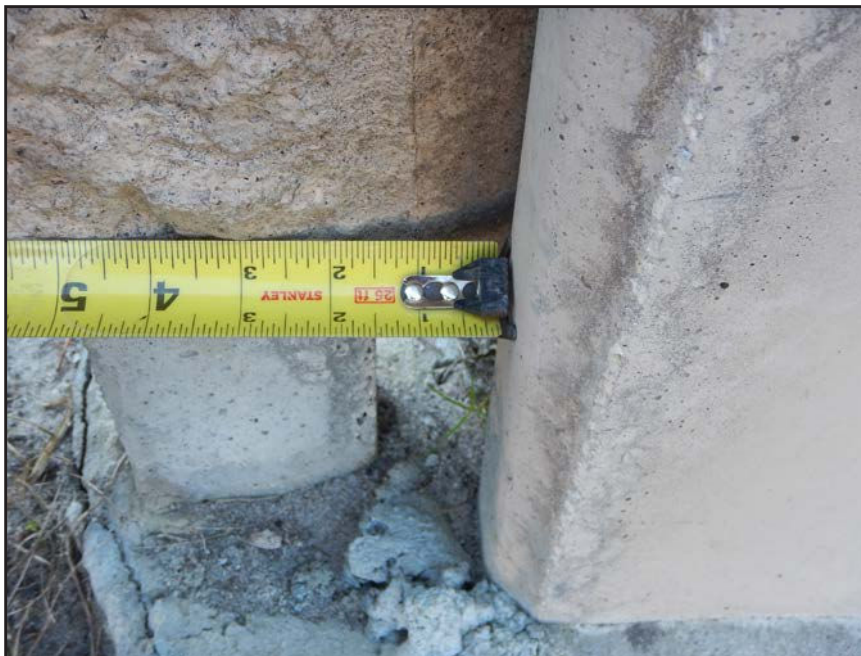
NO. 11 - COLUMN 14NM -
DROPPED PRECAST PANEL WITH
A 2 7/8" GAP AT THE TOP AND
A 1" GAP AT THE BOTTOM

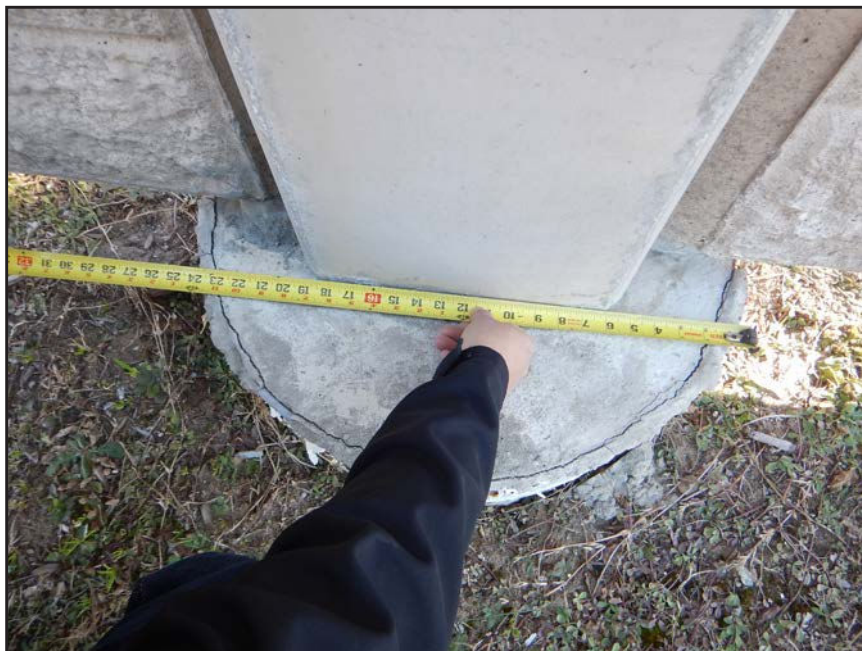
- 3C) Precast "H" shaped columns are supported in 24" diameter x 6'-4" deep, cast-in-place concrete foundations, as shown in example photographs No. 12 through No. 14 and Sheet S3 of the attached Construction Plans and Specifications by Elias Runar Johannsson, P.E. dated January 21, 2021.

NO. 12 - COLUMN 3N -
TYPICAL PRECAST COLUMN
FOUNDATION

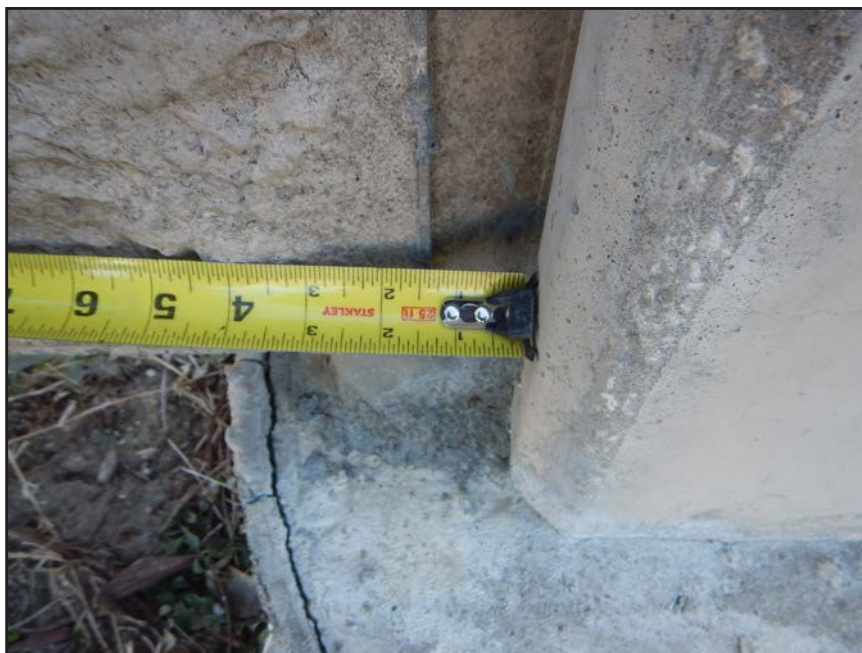
NO. 13 - COLUMN 3N -
TYPICAL PRECAST COLUMN
FOUNDATION

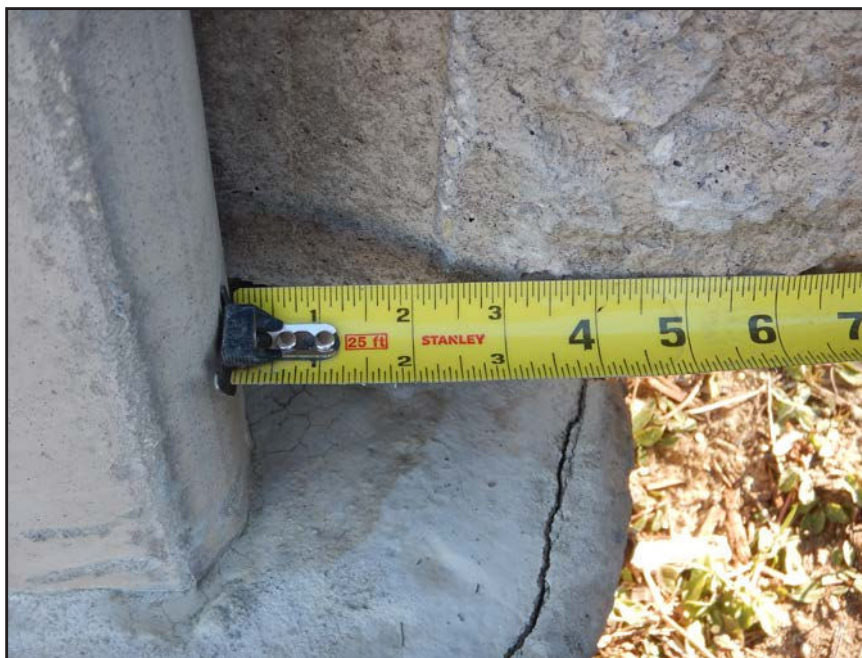
NO. 14 - COLUMN 3N -
TYPICAL PRECAST COLUMN
FOUNDATION

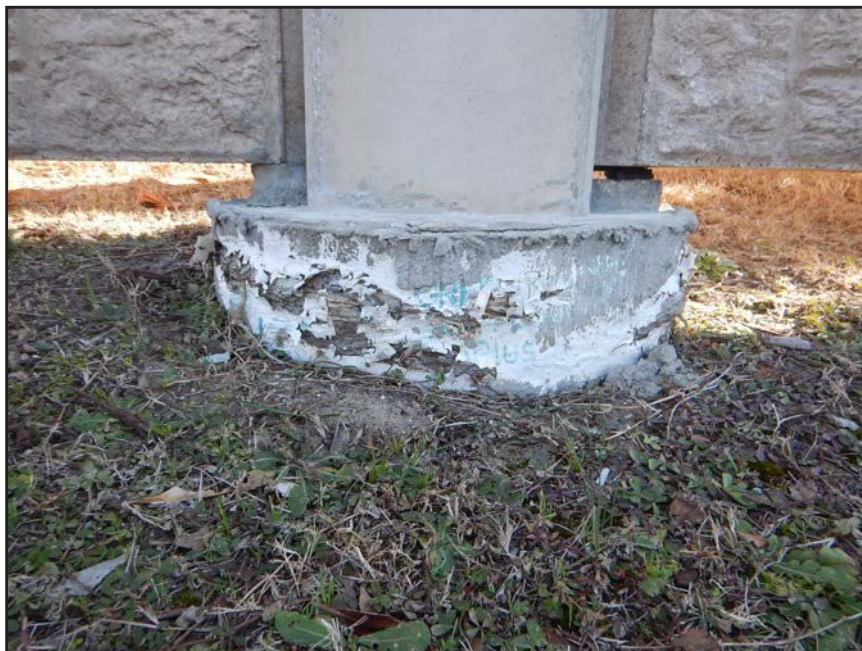
- 4C) Although no wall panel bearing conditions are specified on the Construction Plans and Specifications by Mr. Johannsson, some wall panels are supported on grout pedestals, while other panels are supported on grout pedestals with 2" x 2" neoprene bearing pads, as shown in example photographs No. 15 through No. 17.

NO. 15 - COLUMN 3N -
TYPICAL WALL PANEL BEARING
CONDITIONS AT A GROUT
PEDESTAL, AND AT A GROUT
PEDESTAL WITH 2" x 2"
NEOPRENE BEARING PADS

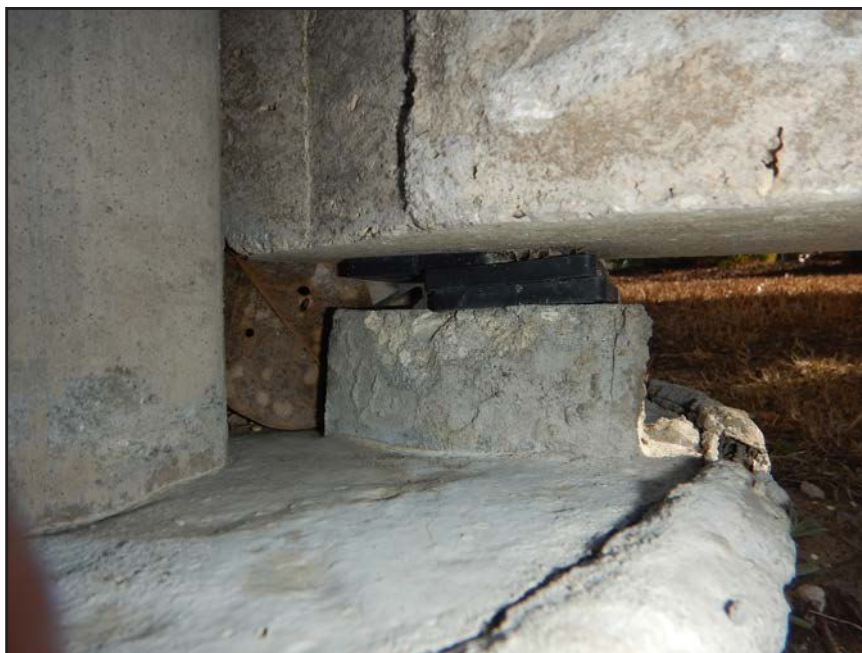
NO. 16 - COLUMN 3N -
TYPICAL WALL PANEL
BEARING CONDITION AT A
GROUT PEDESTAL WITH 2" x 2"
NEOPRENE BEARING PADS

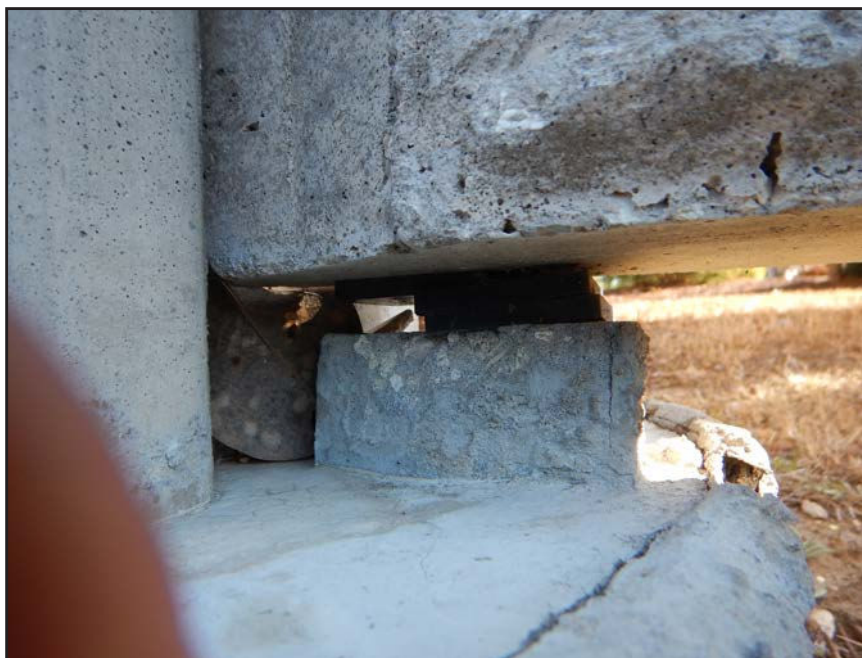
NO. 17 - COLUMN 3N -
TYPICAL WALL PANEL
BEARING CONDITION AT A
GROUT PEDESTAL WITH 2" x 2"
NEOPRENE BEARING PADS

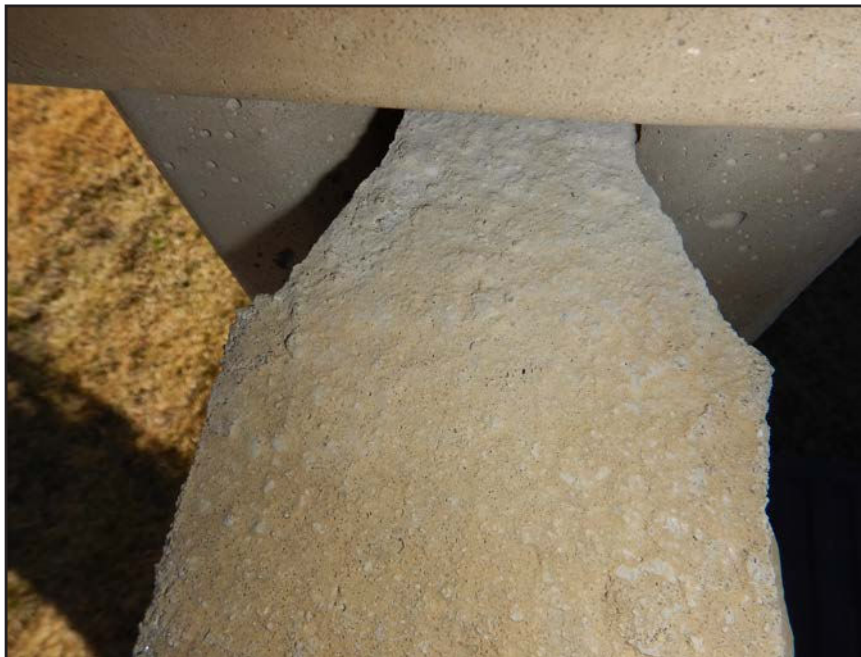
NO. 18 - COLUMN 17N - FIELD
MEASURED COLUMN AND
WALL PANEL TONGUE

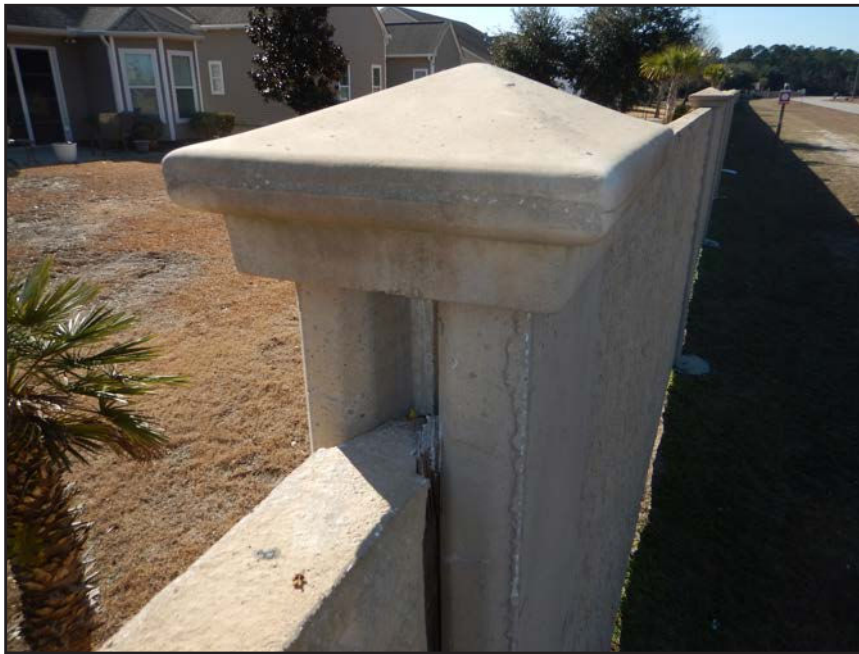
NO. 20 - COLUMN 22N - FIELD
MEASURED COLUMN AND
WALL PANEL TONGUE

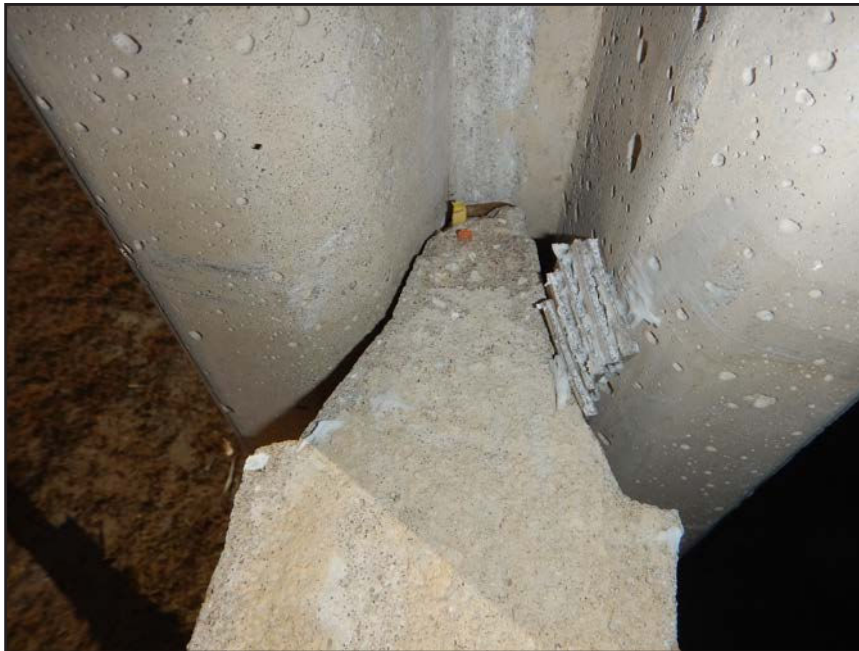
NO. 21 - COLUMN 22N - FIELD
MEASURED COLUMN AND
WALL PANEL TONGUE

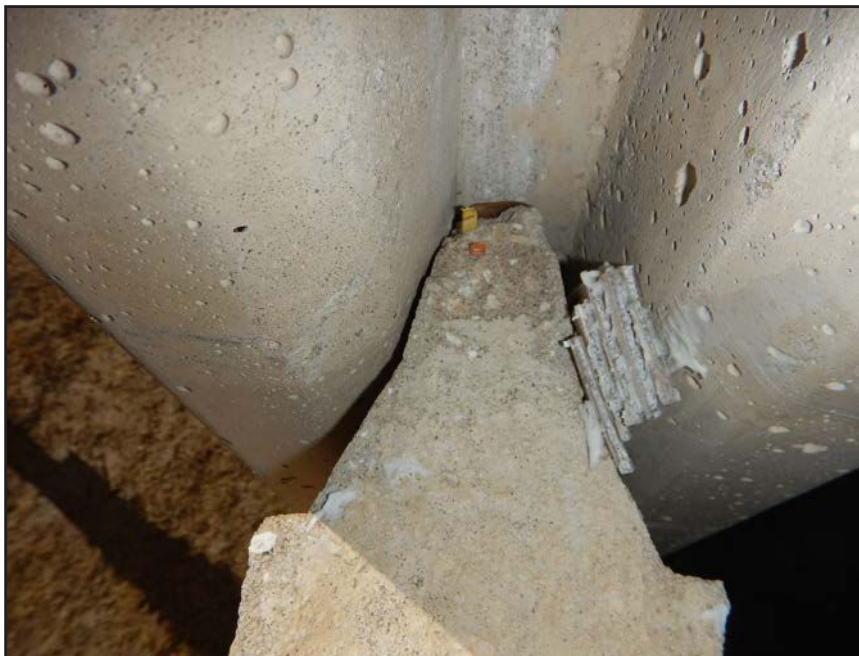
NO. 22 - COLUMN 22N - FIELD
MEASURED COLUMN AND
WALL PANEL TONGUE

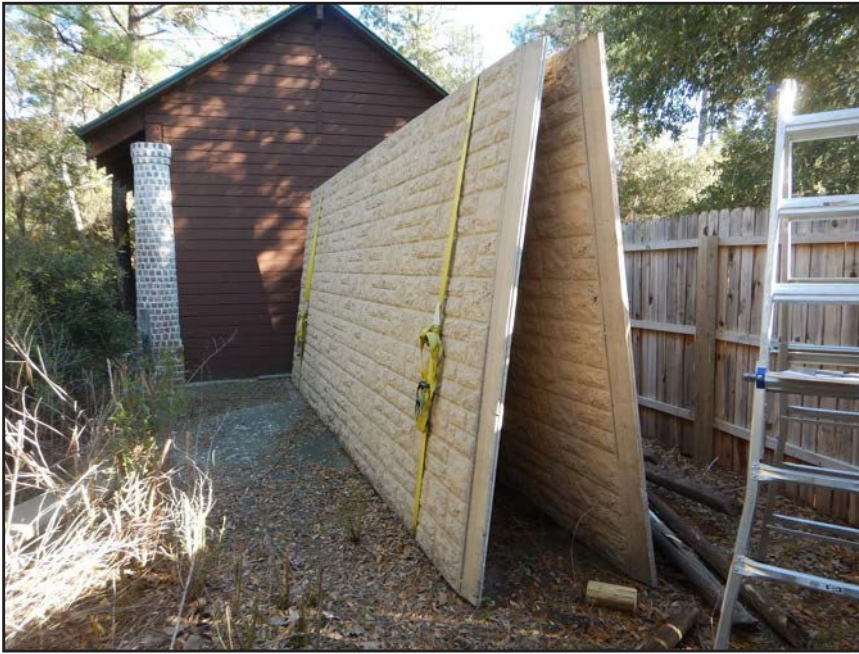
NO. 23 - STORED EXCESS WALL
PANELS

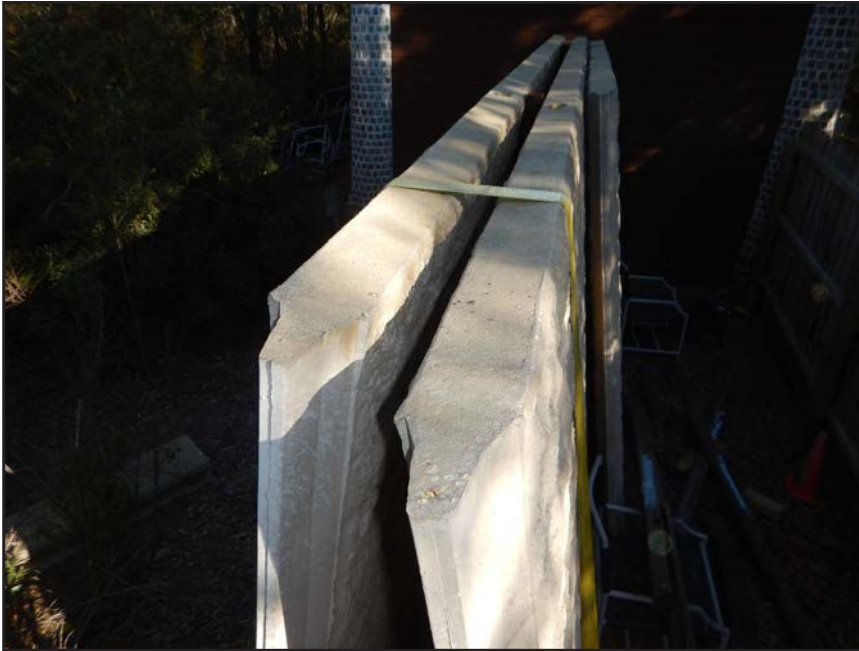
NO. 24 - STORED EXCESS WALL
PANELS

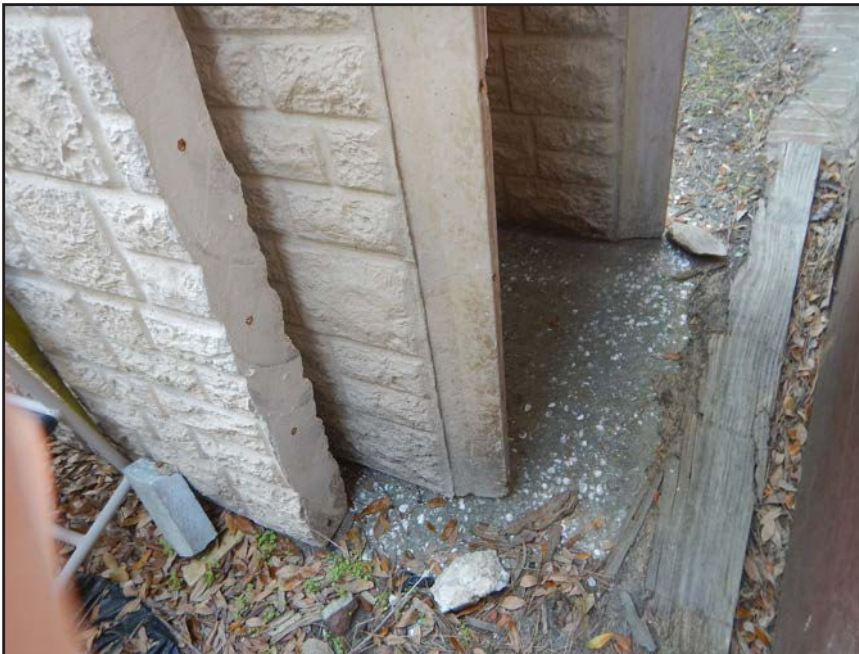
NO. 25 - STORED EXCESS WALL
PANELS

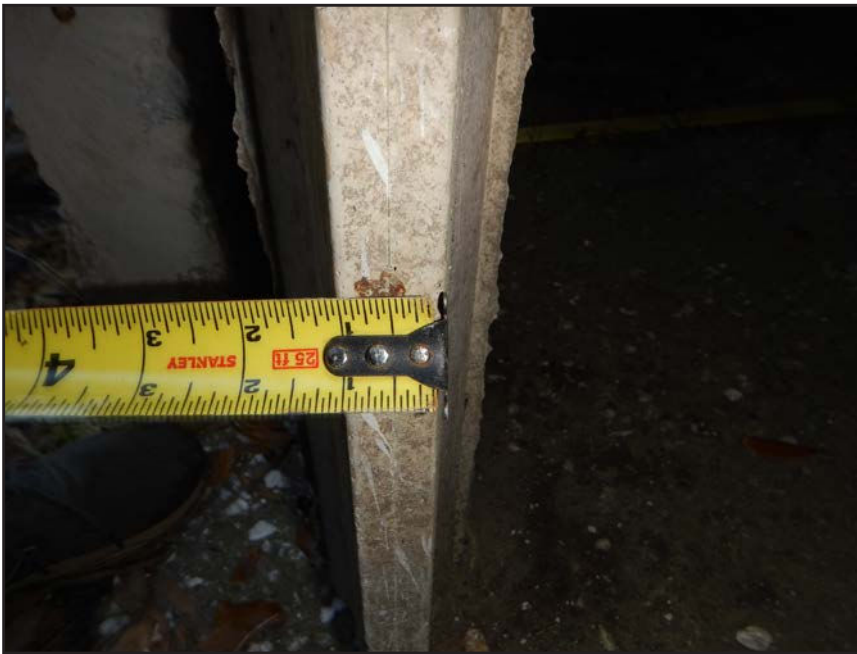
NO. 27 - STORED EXCESS WALL
PANELS - TYPICAL TONGUE
DIMENSIONS

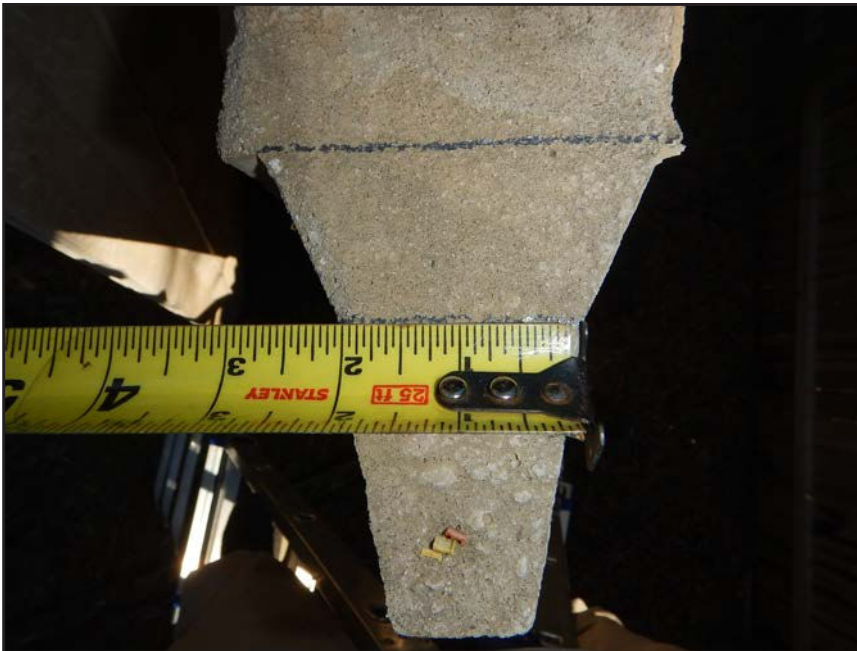
NO. 28 - STORED EXCESS WALL
PANELS - TYPICAL TONGUE
DIMENSIONS

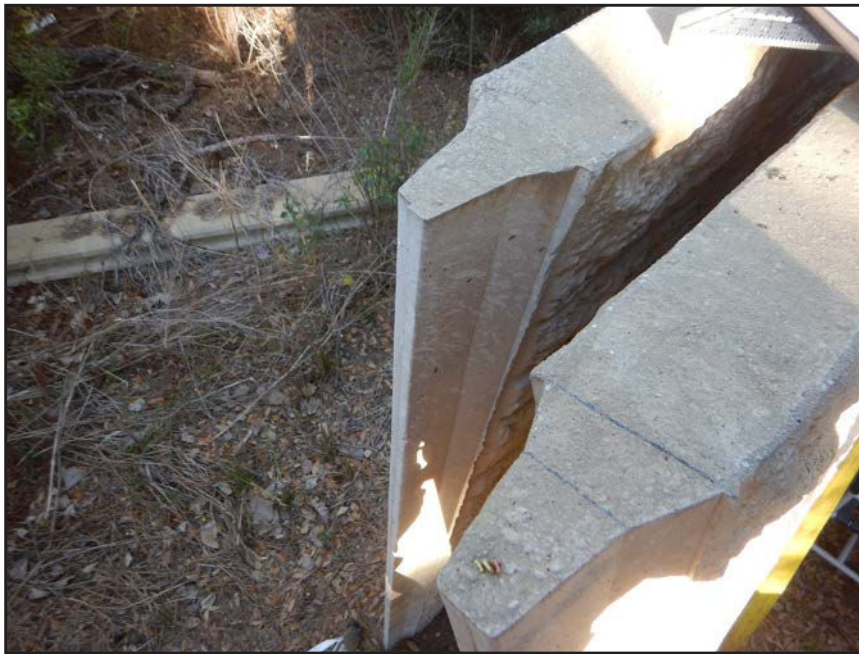
NO. 29 - STORED EXCESS WALL
PANELS - TYPICAL TONGUE
DIMENSIONS

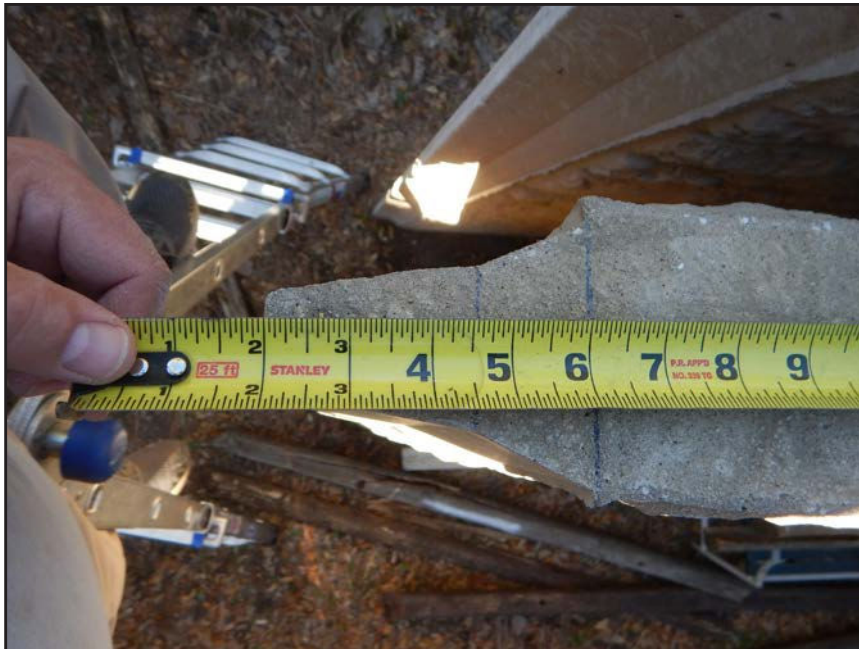
NO. 30 - STORED EXCESS WALL
PANELS - TYPICAL TONGUE
DIMENSIONS

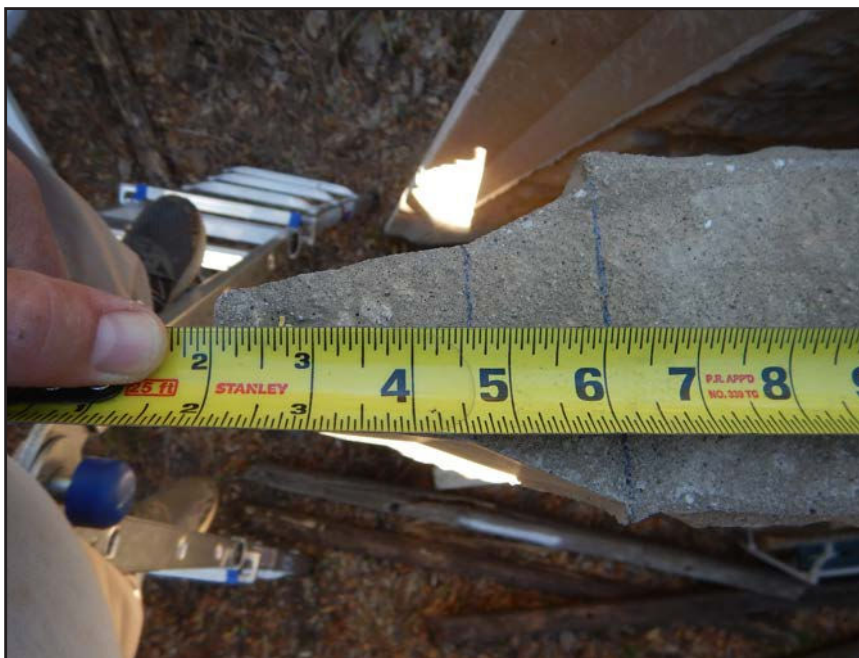
NO. 31 - STORED EXCESS WALL
PANELS - TYPICAL TONGUE
DIMENSIONS

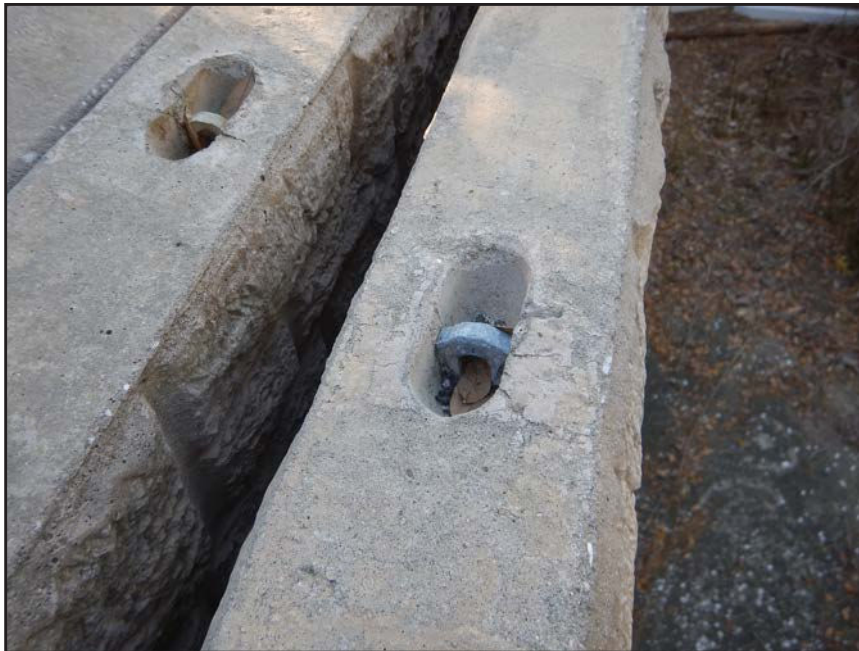
NO. 33 - STORED EXCESS WALL
PANELS - TYPICAL LIFTING EYES

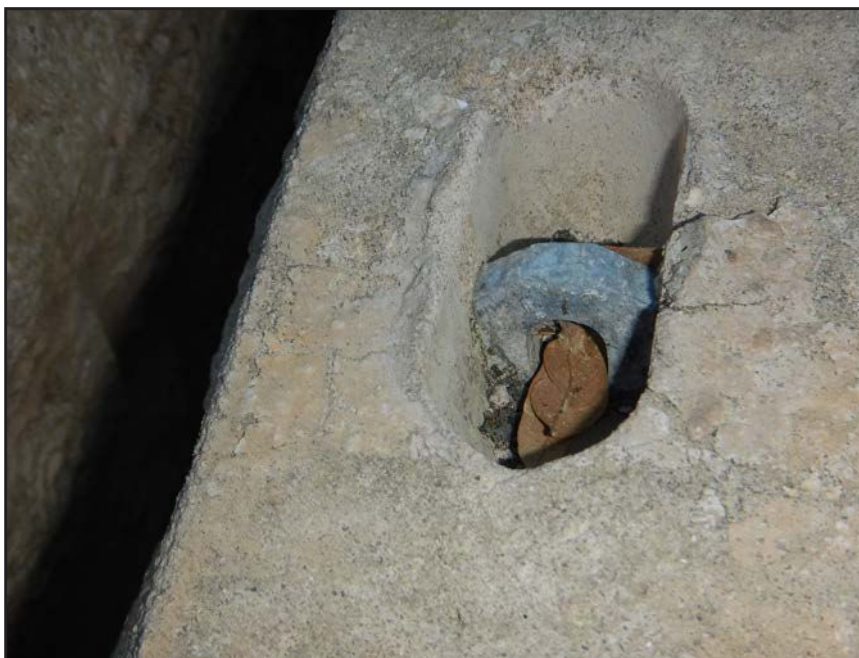
NO. 34 - STORED EXCESS WALL
PANELS - TYPICAL LIFTING EYE

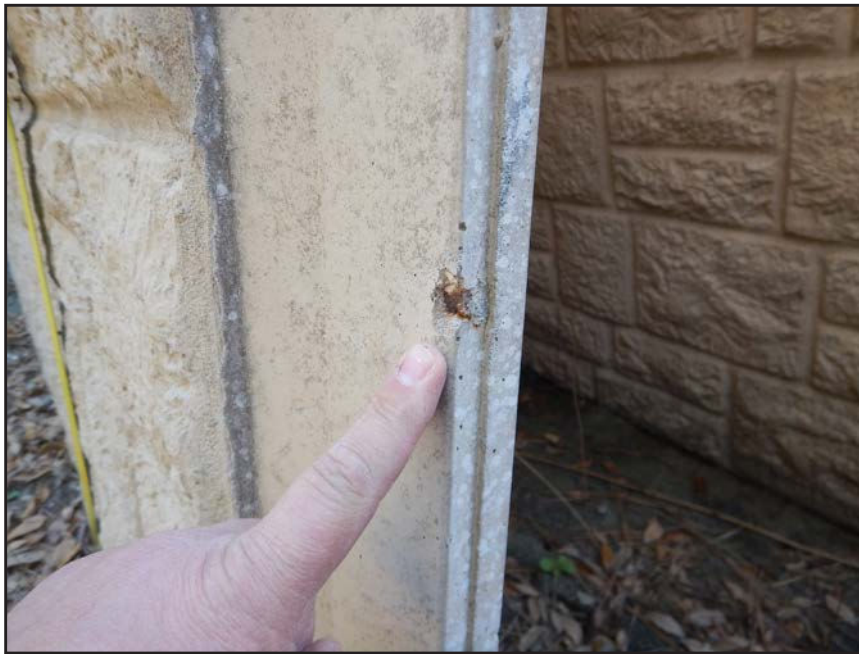
NO. 36 - STORED EXCESS WALL
PANEL - TONGUE REINFORCING
STEEL WITH INADEQUATE
CONCRETE COVER

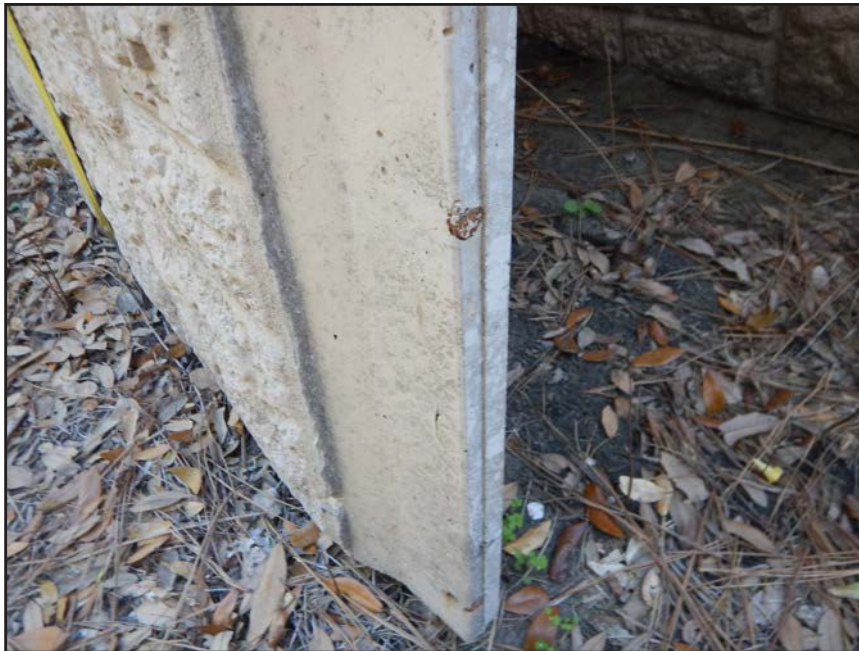
NO. 37 - STORED EXCESS WALL
PANEL - TONGUE REINFORCING
STEEL WITH INADEQUATE
CONCRETE COVER

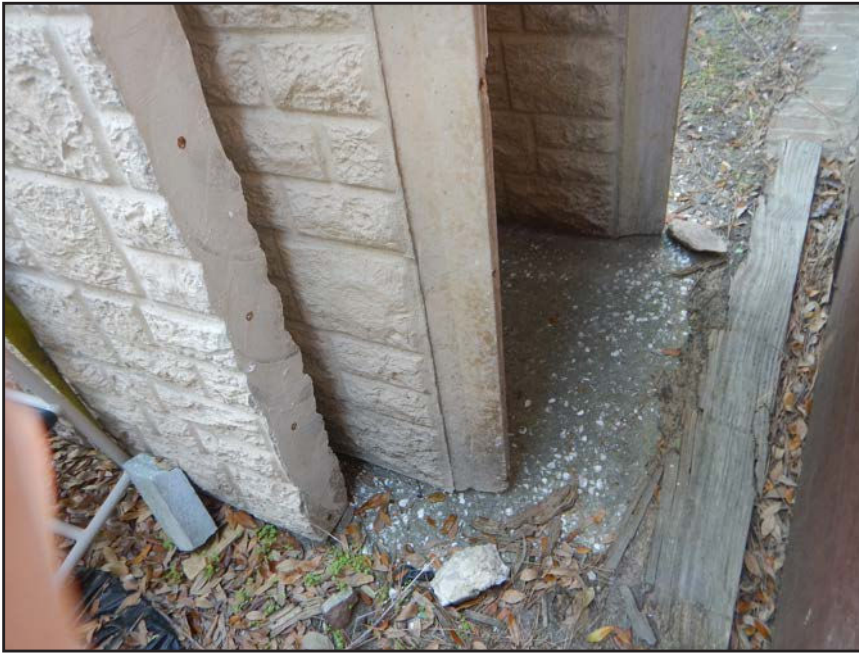
NO. 39 - STORED EXCESS WALL
PANELS

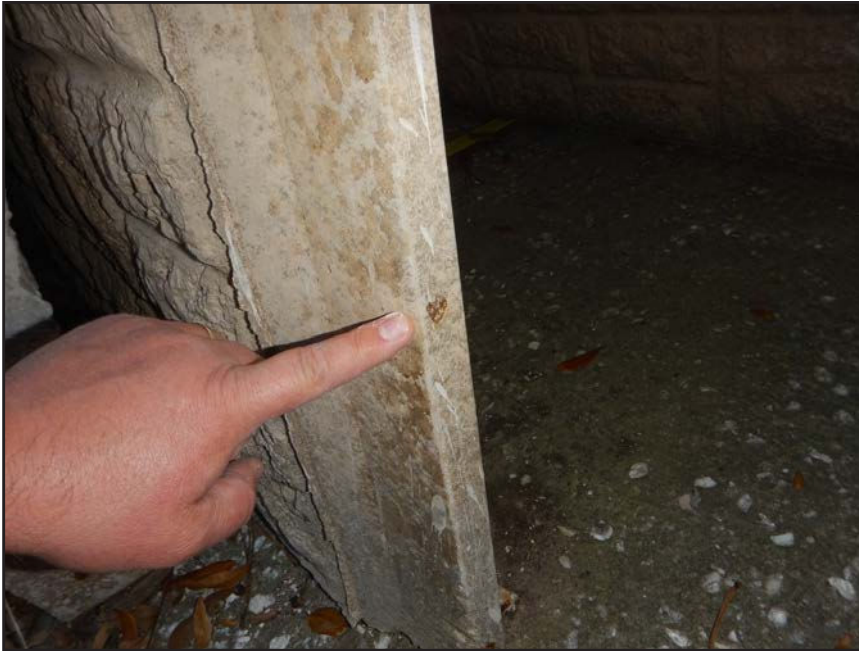
NO. 40 - STORED EXCESS WALL
PANEL - TONGUE REINFORCING
STEEL WITH INADEQUATE
CONCRETE COVER

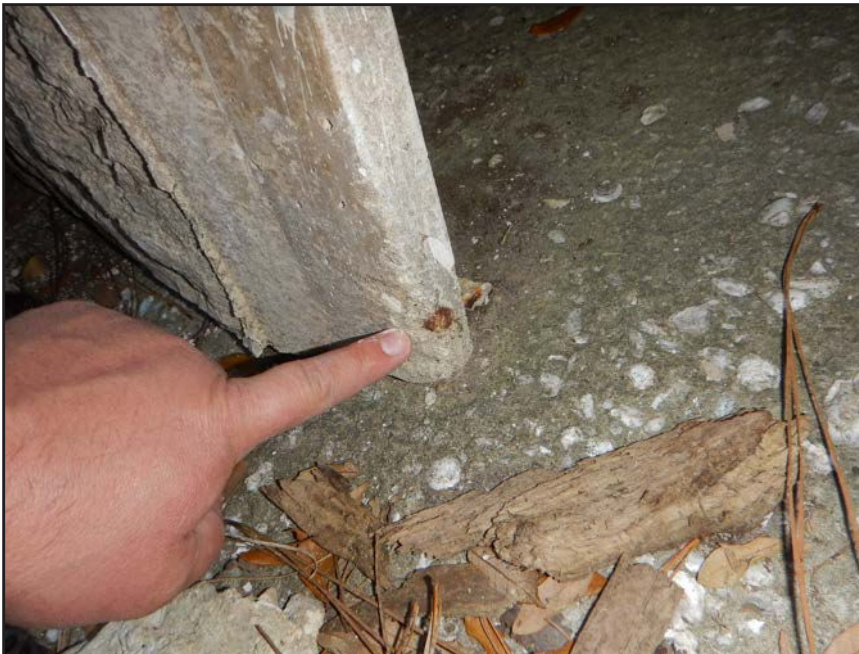
NO. 41 - STORED EXCESS WALL
PANEL - TONGUE REINFORCING
STEEL WITH INADEQUATE
CONCRETE COVER

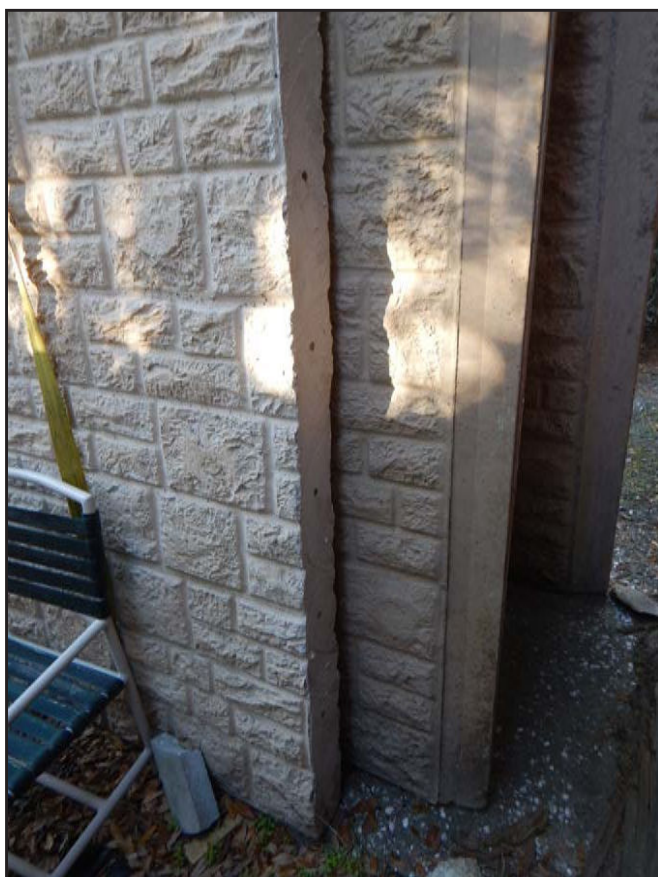
NO. 42 - SAW CUT STORED EXCESS WALL
PANEL - TYPICAL HORIZONTAL REINFORCING
BARS

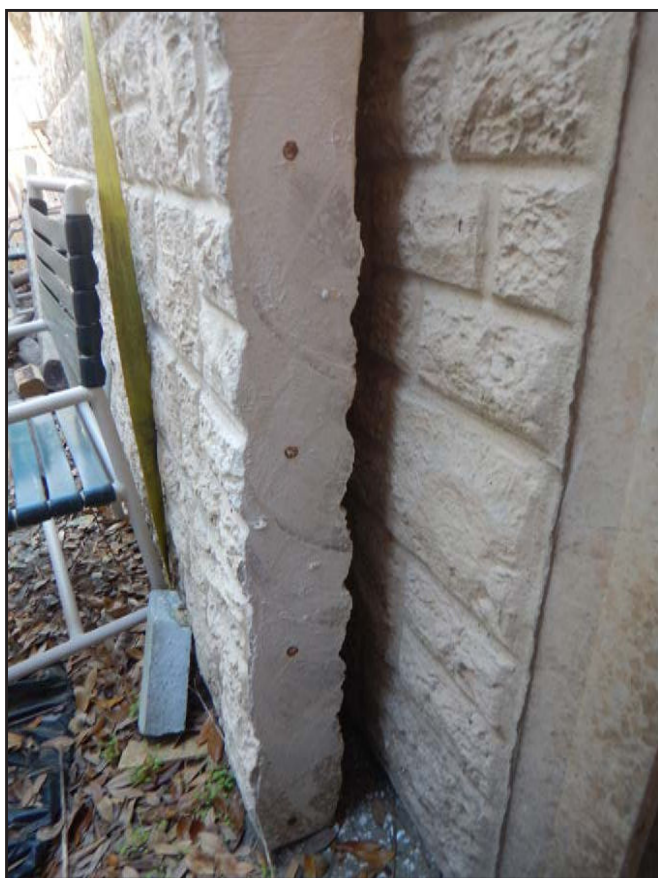
NO. 43 - SAW CUT STORED EXCESS WALL
PANEL - TYPICAL HORIZONTAL REINFORCING
BARS

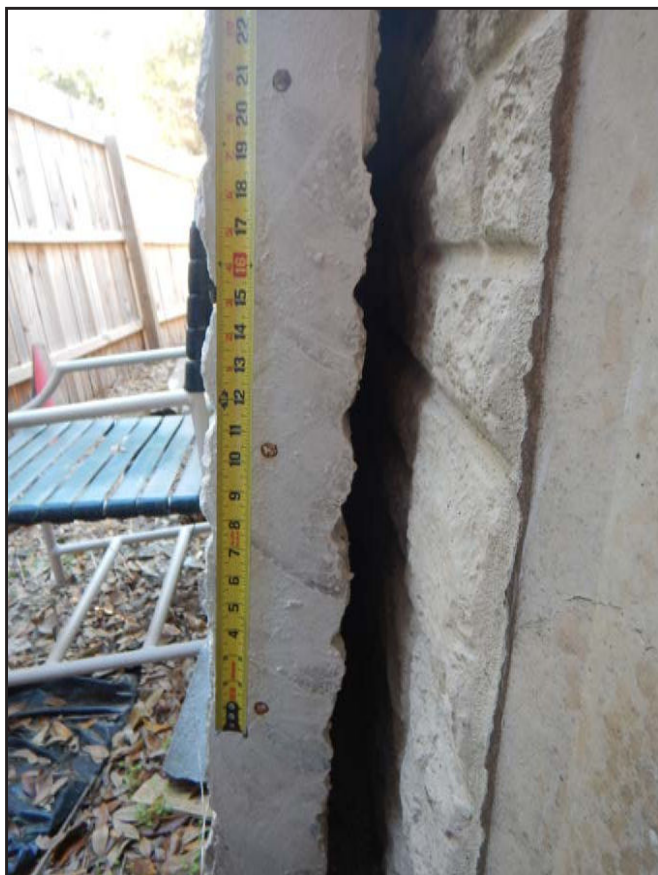
NO. 44 - SAW CUT STORED EXCESS WALL
PANEL - TYPICAL HORIZONTAL REINFORCING
BARS

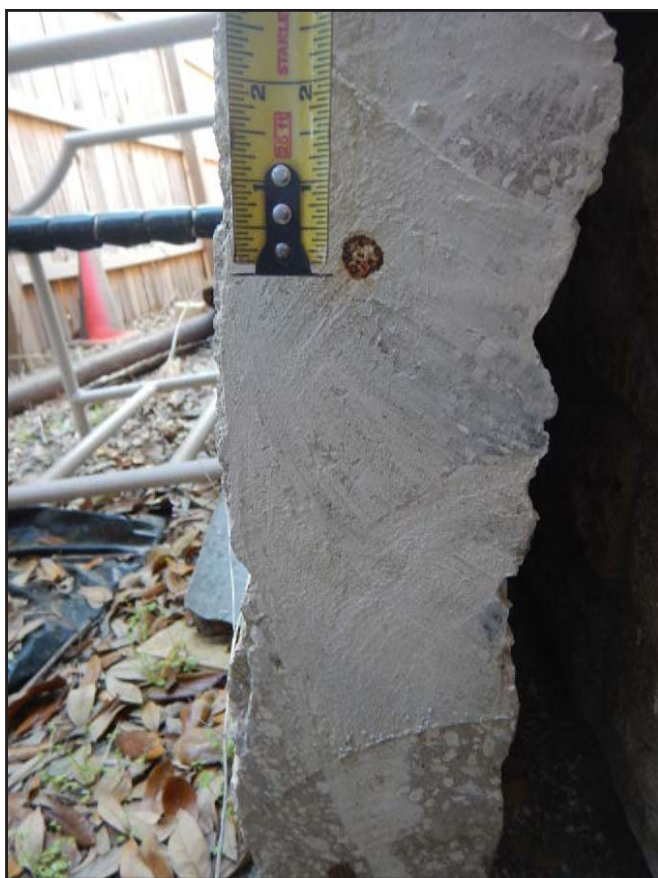
NO. 45 - SAW CUT STORED EXCESS WALL
PANEL - TYPICAL HORIZONTAL REINFORCING
BARS

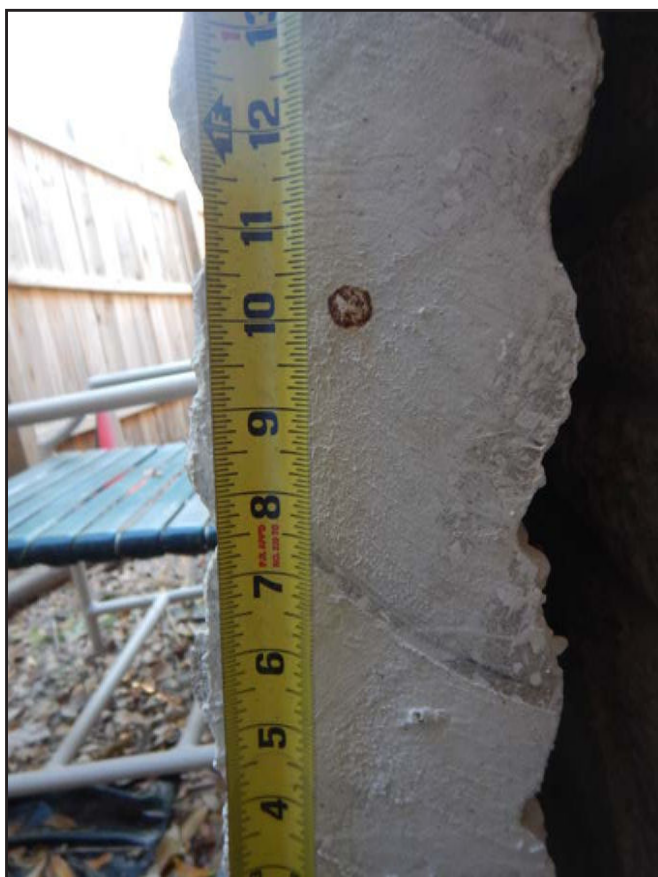
NO. 46 - SAW CUT STORED EXCESS WALL
PANEL - TYPICAL HORIZONTAL REINFORCING
BARS

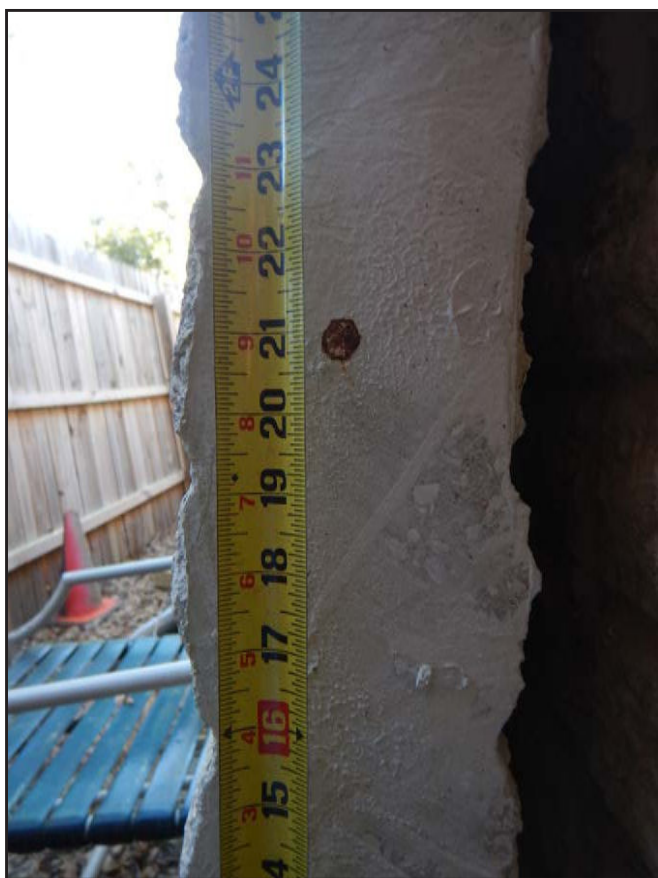
NO. 47 - SAW CUT STORED EXCESS WALL
PANEL - TYPICAL HORIZONTAL REINFORCING
BARS
