WATER TOWER ROAD SCREEN WALL INVESTIGATIONS

Water Tower Road
Longs, South Carolina

Stantec Project No. 171015900

March 31, 2025

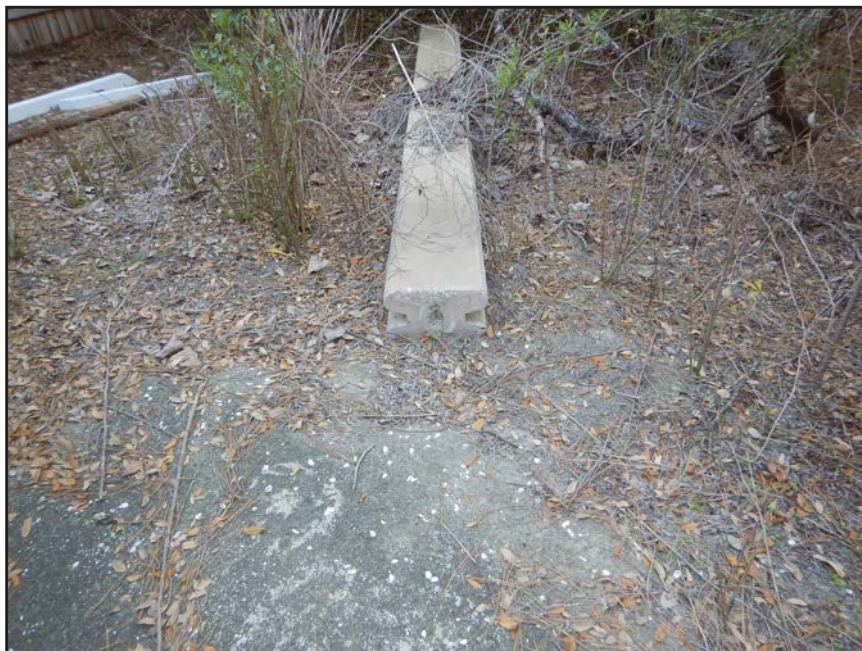
NO. 48 - STORED EXCESS
PRECAST COLUMN

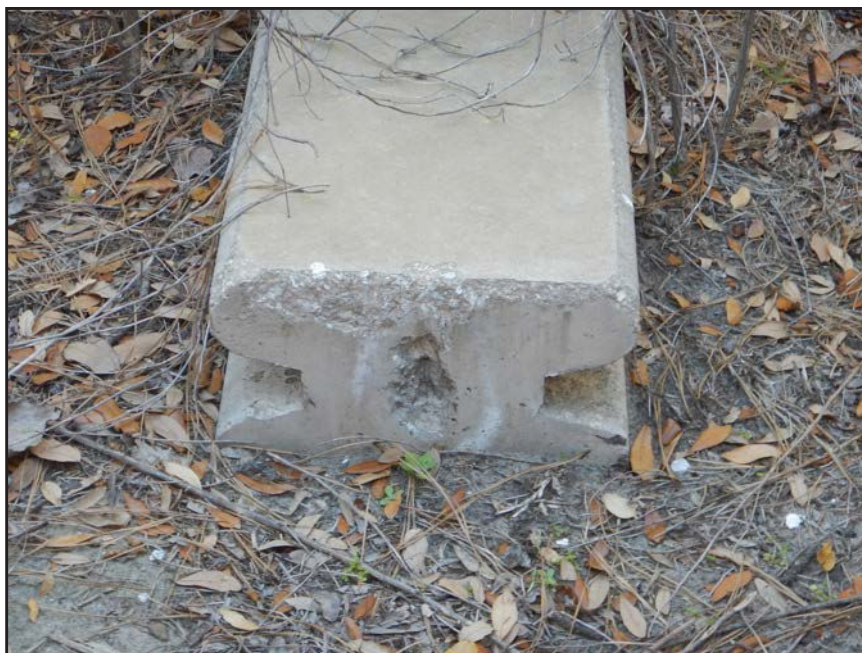
NO. 49 - STORED EXCESS
PRECAST COLUMN

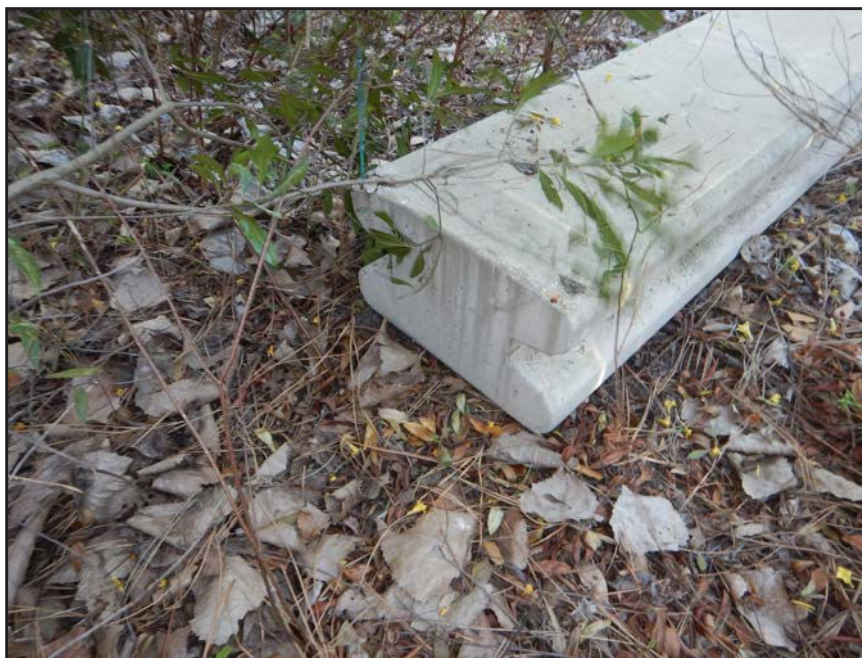
NO. 50 - STORED EXCESS
PRECAST COLUMN

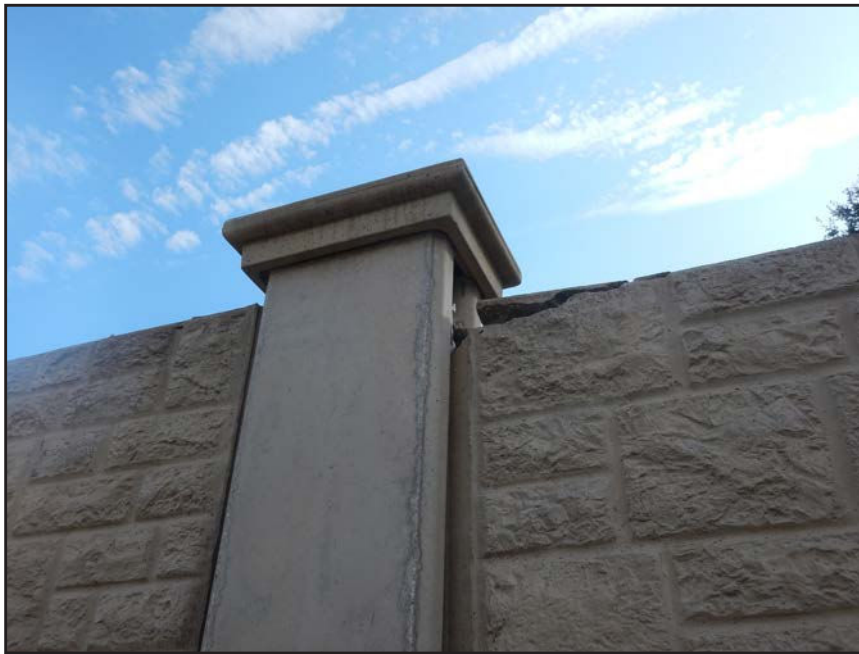
NO. 51 - SPALLED WALL
PANEL ON THE SOUTH SIDE OF
COLUMN 13NM

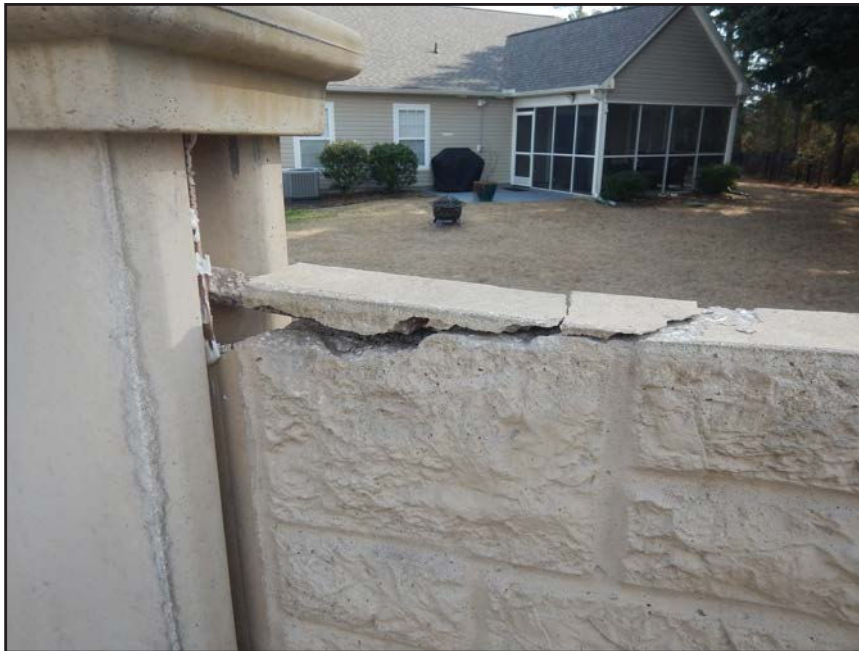
NO. 52 - SPALLED WALL
PANEL ON THE SOUTH SIDE OF
COLUMN 13NM

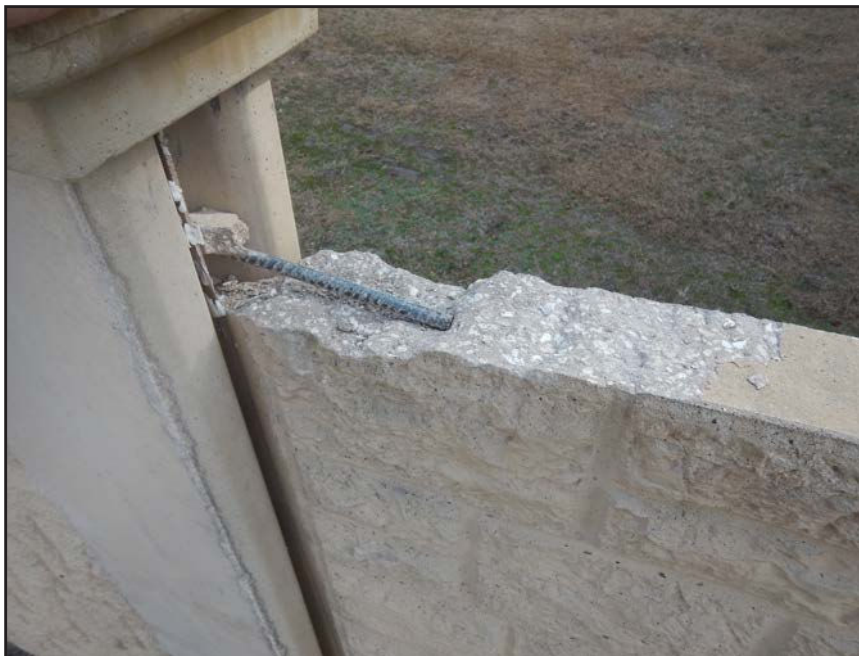
NO. 53 - SPALLED WALL
PANEL ON THE SOUTH SIDE
OF COLUMN 13NM - TONGUE
REINFORCING DOWEL WITH
INADEQUATE CONCRETE
COVER

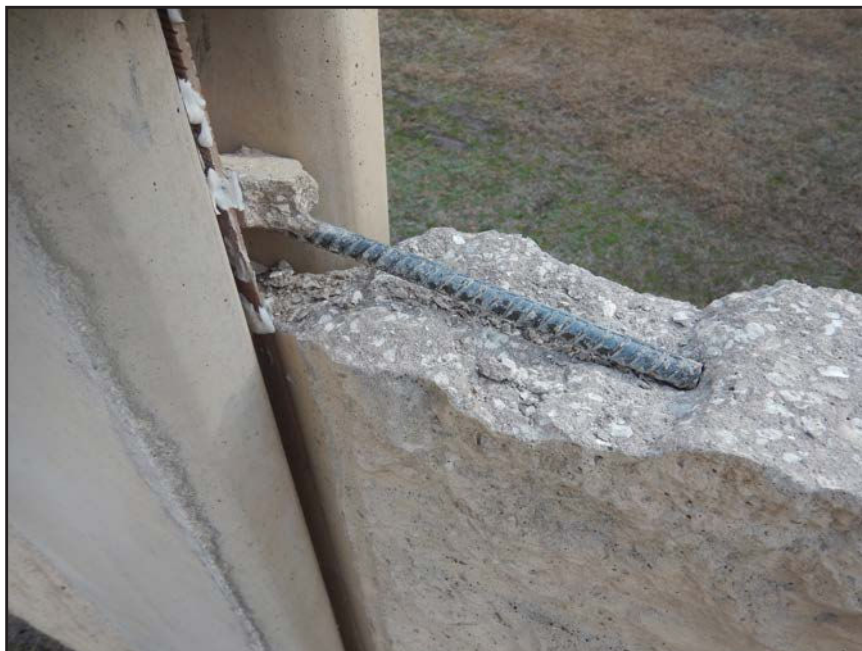
NO. 54 - SPALLED WALL
PANEL ON THE SOUTH SIDE
OF COLUMN 13NM - TONGUE
REINFORCING DOWEL WITH
INADEQUATE CONCRETE
COVER

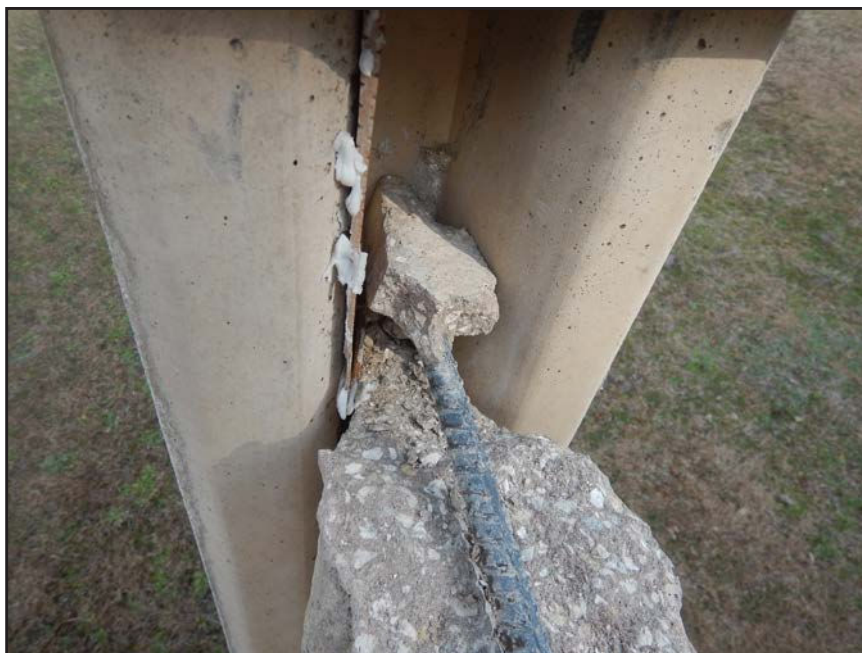
NO. 55 - SPALLED WALL
PANEL ON THE SOUTH SIDE
OF COLUMN 13NM - TONGUE
REINFORCING DOWEL WITH
INADEQUATE CONCRETE
COVER

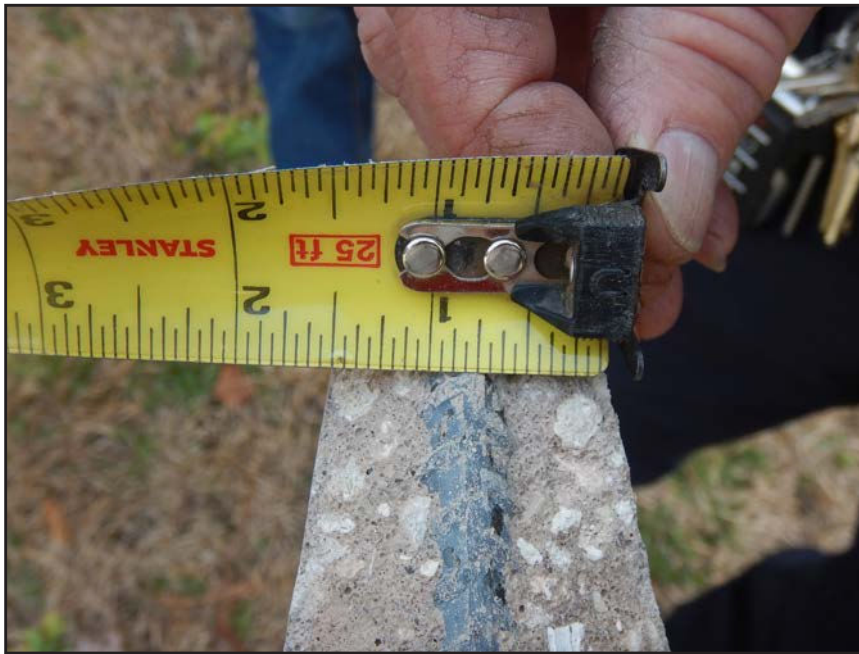
NO. 57 - SPALLED WALL
PANEL ON THE SOUTH SIDE
OF COLUMN 13NM - TONGUE
REINFORCING DOWEL WITH
INADEQUATE CONCRETE
COVER

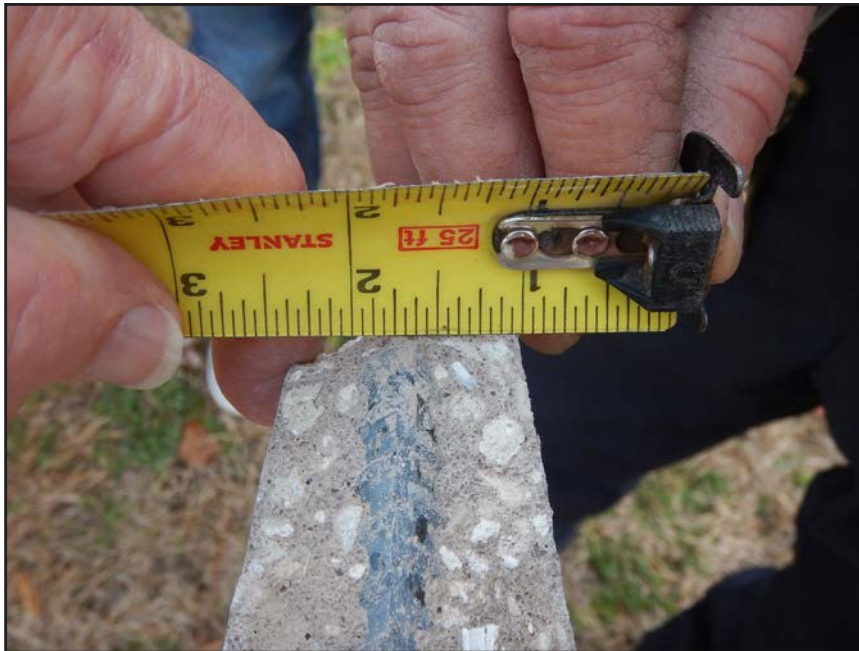
NO. 58 - SPALLED WALL
PANEL ON THE SOUTH SIDE
OF COLUMN 13NM - TONGUE
REINFORCING DOWEL WITH
INADEQUATE CONCRETE
COVER

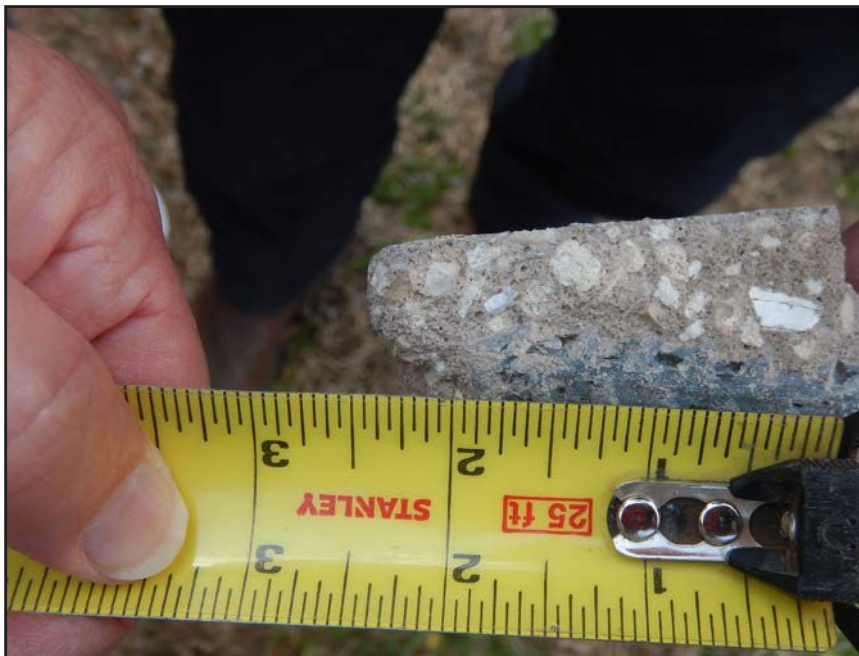
NO. 59 - SPALLED WALL
PANEL ON THE SOUTH SIDE
OF COLUMN 13NM - TONGUE
REINFORCING DOWEL WITH
INADEQUATE CONCRETE
COVER

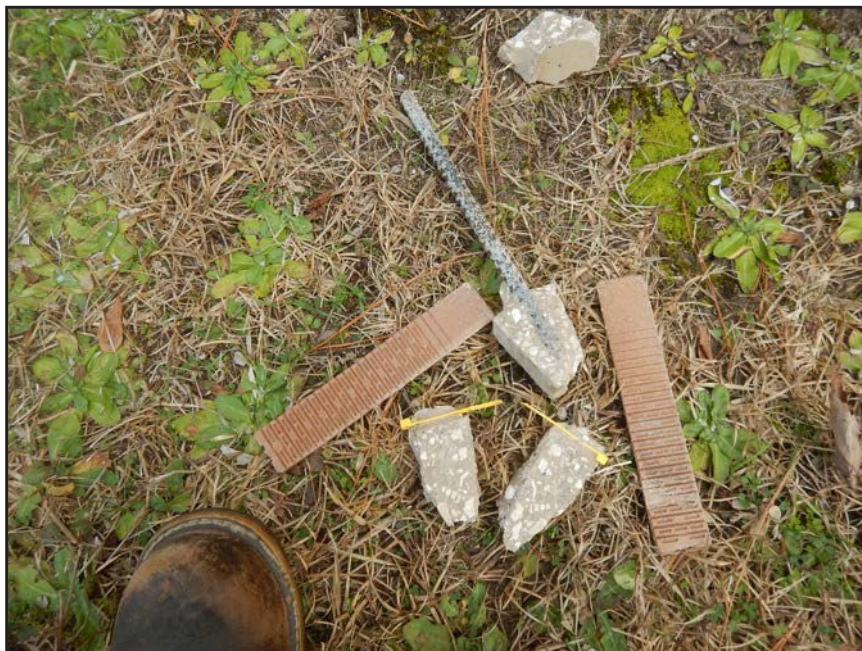
NO. 60 - SPALLED WALL
PANEL ON THE SOUTH SIDE
OF COLUMN 13NM - TONGUE
REINFORCING DOWEL WITH
INADEQUATE CONCRETE
COVER

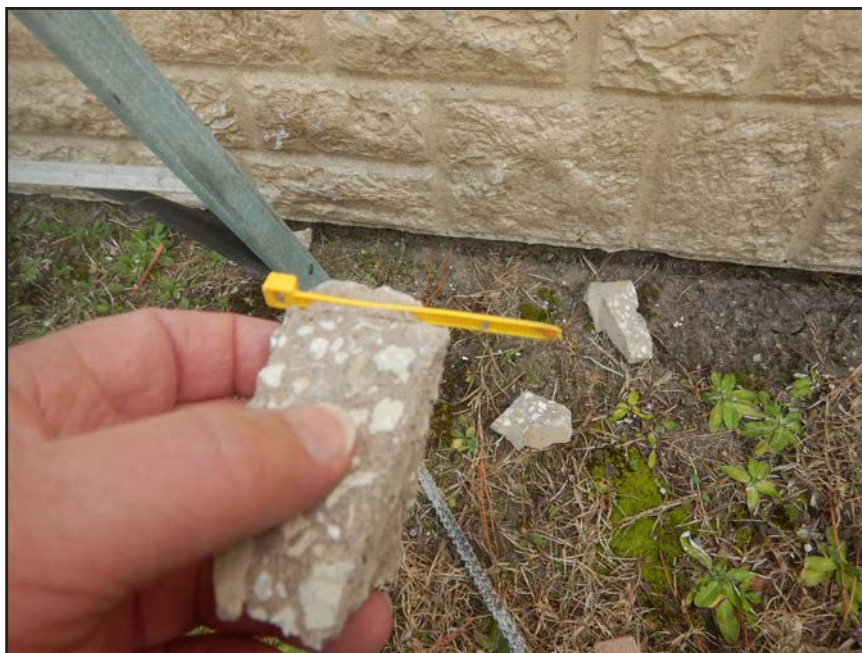
NO. 61 - SPALLED WALL
PANEL ON THE SOUTH SIDE OF
COLUMN 13NM - EMBEDDED
ZIP TIES

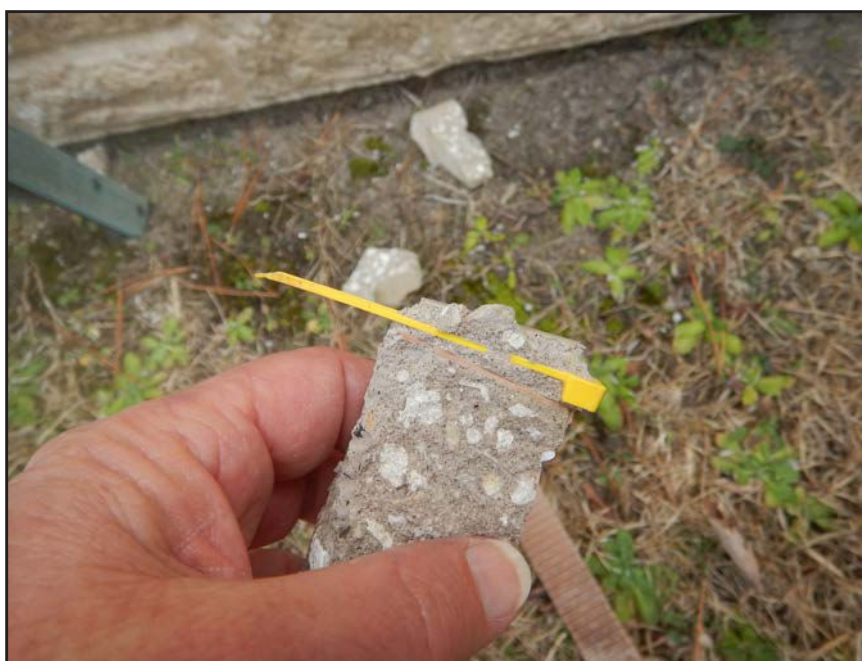
NO. 62 - SPALLED WALL
PANEL ON THE SOUTH SIDE OF
COLUMN 13NM - EMBEDDED
ZIP TIES

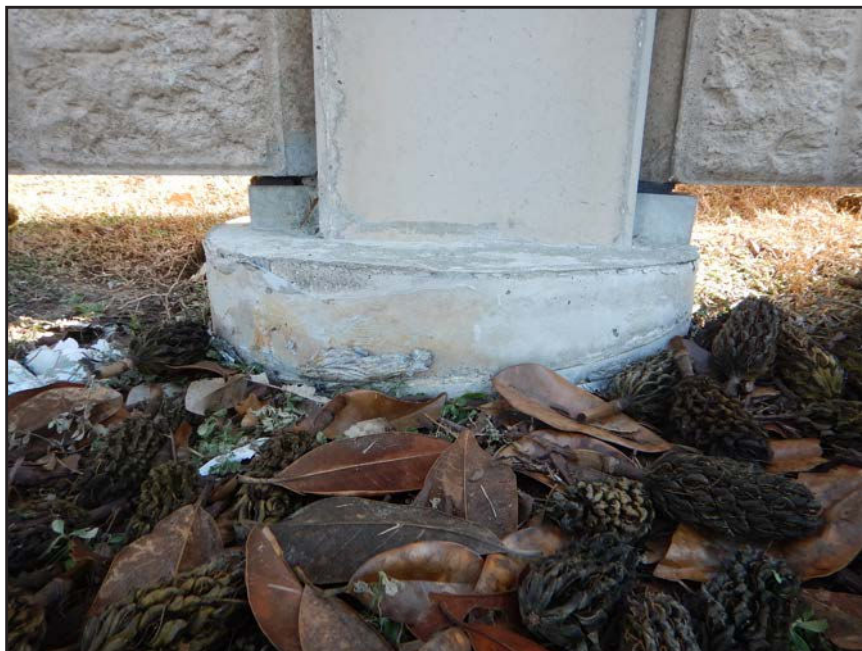
NO. 63 - COLUMN 2N -
INADEQUATE BEARING OF A
PRECAST WALL PANEL ON A
2" x 2" NEOPRENE BEARING
PAD

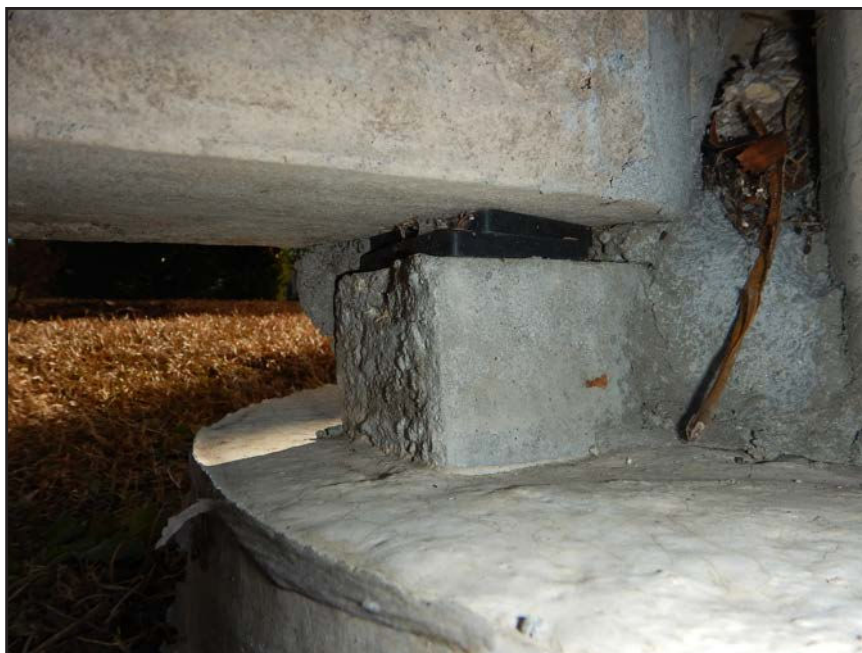
NO. 64 - COLUMN 2N -
INADEQUATE BEARING OF A
PRECAST WALL PANEL ON A
2" x 2" NEOPRENE BEARING
PAD

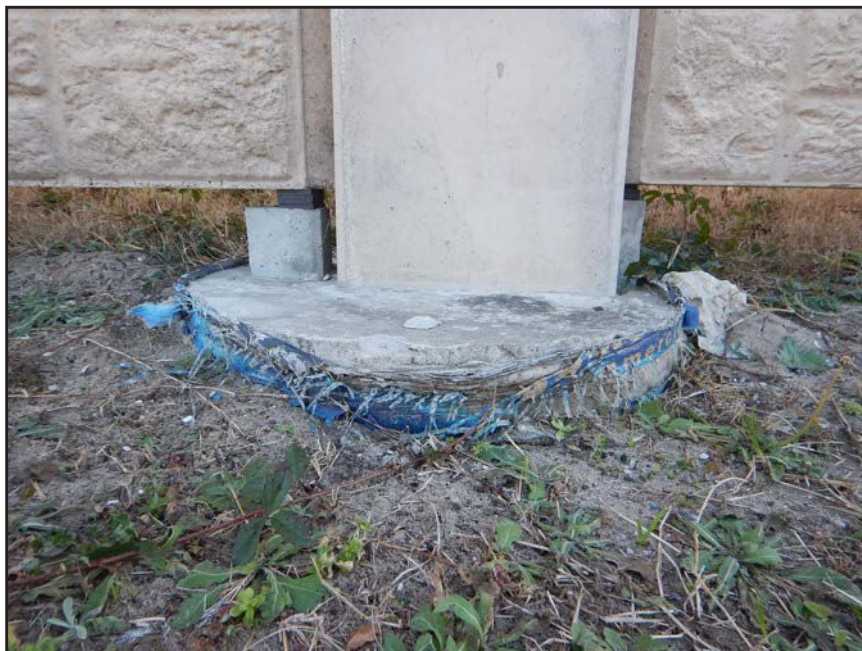
NO. 66 - COLUMN 11N -
INADEQUATE BEARING OF A
PRECAST WALL PANEL ON A
2" x 2" NEOPRENE BEARING
PAD

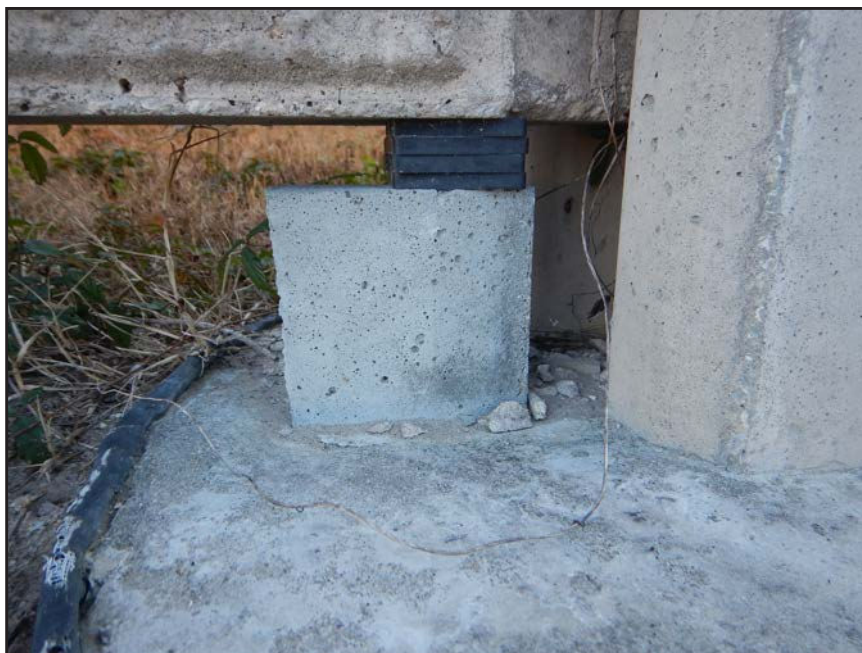
NO. 67 - COLUMN 11N -
INADEQUATE BEARING OF A
PRECAST WALL PANEL ON A
2" x 2" NEOPRENE BEARING
PAD

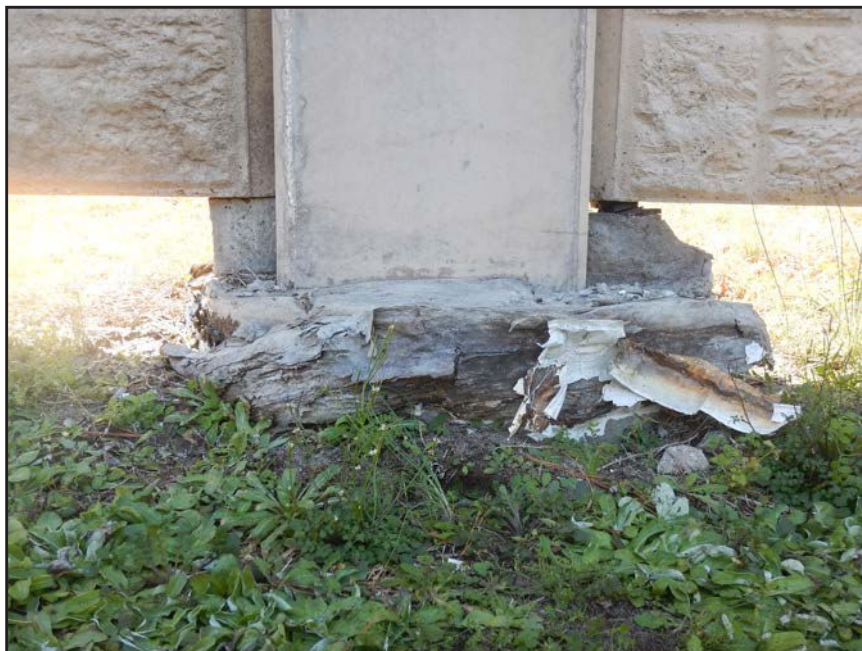
NO. 71 - COLUMN 10NM -
INADEQUATE BEARING OF A
PRECAST WALL PANEL ON A
2" x 2" NEOPRENE BEARING
PAD

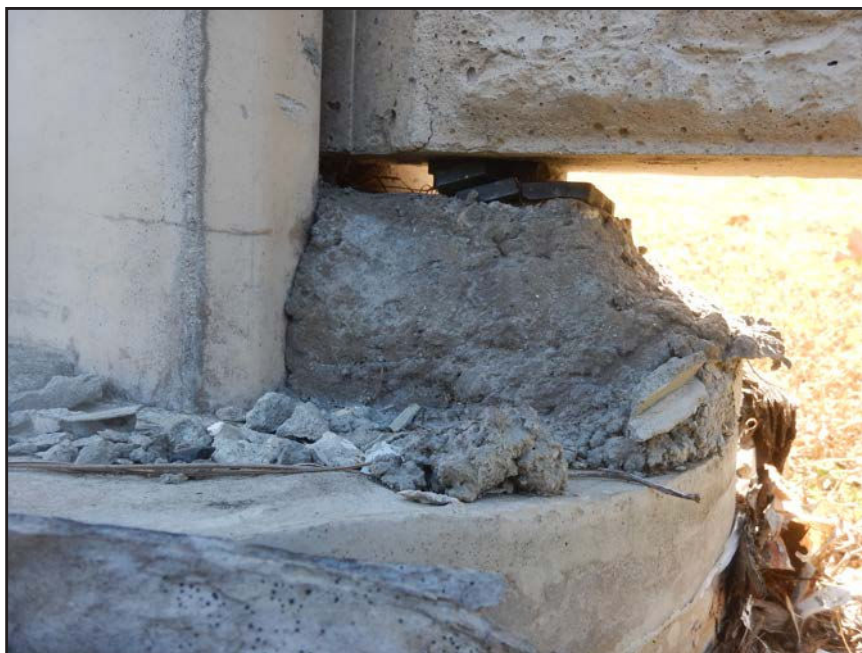
NO. 72 - COLUMN 10NM -
INADEQUATE BEARING OF A
PRECAST WALL PANEL ON A
2" x 2" NEOPRENE BEARING
PAD

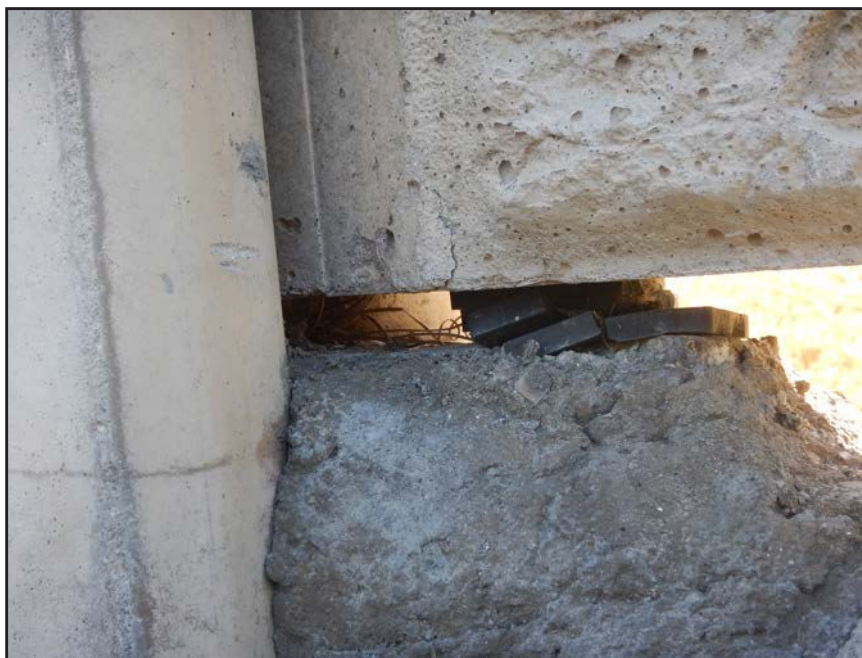
NO. 73 - COLUMN 10NM -
INADEQUATE BEARING OF A
PRECAST WALL PANEL ON A
2" x 2" NEOPRENE BEARING
PAD

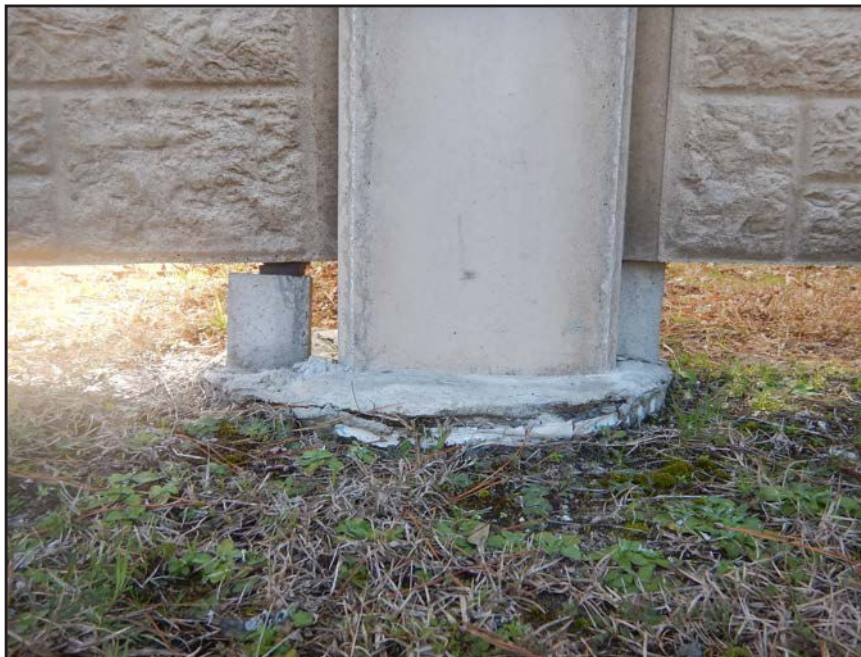
NO. 74 - COLUMN 14NM -
INADEQUATE BEARING OF A
PRECAST WALL PANEL ON A
2" x 2" NEOPRENE BEARING
PAD

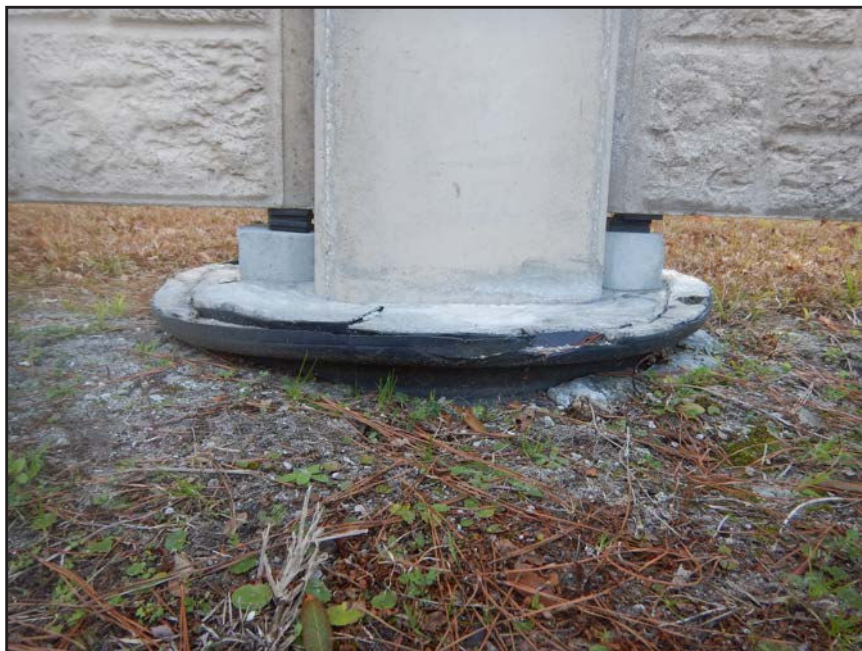
NO. 75 - COLUMN 14NM -
INADEQUATE BEARING OF A
PRECAST WALL PANEL ON A
2" x 2" NEOPRENE BEARING
PAD

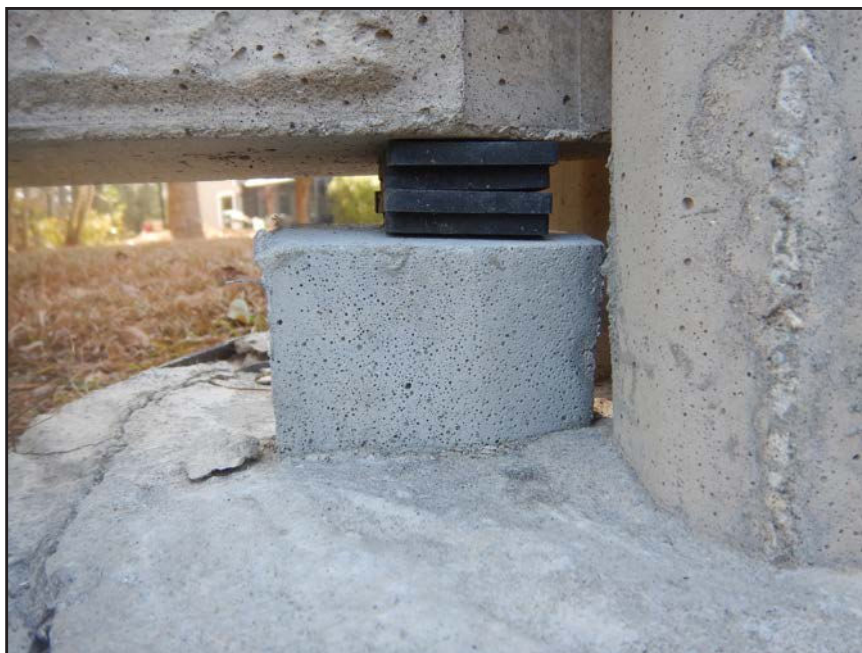
NO. 76 - COLUMN 2SM -
INADEQUATE BEARING OF A
PRECAST WALL PANEL ON A
2" x 2" NEOPRENE BEARING
PAD

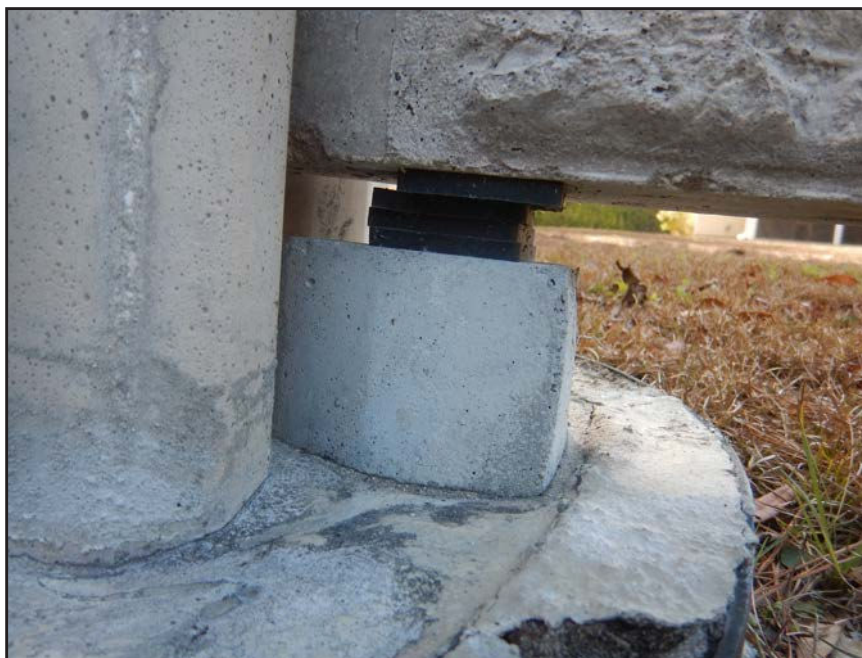
NO. 77 - COLUMN 2SM -
INADEQUATE BEARING OF A
PRECAST WALL PANEL ON A
2" x 2" NEOPRENE BEARING
PAD

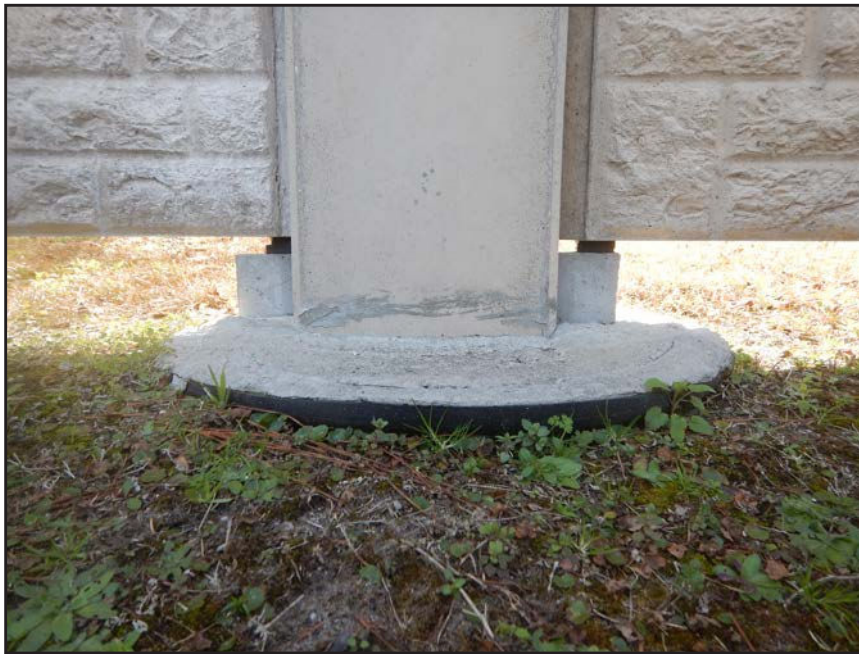
NO. 78 - COLUMN 2SM -
INADEQUATE BEARING OF A
PRECAST WALL PANEL ON A
2" x 2" NEOPRENE BEARING
PAD

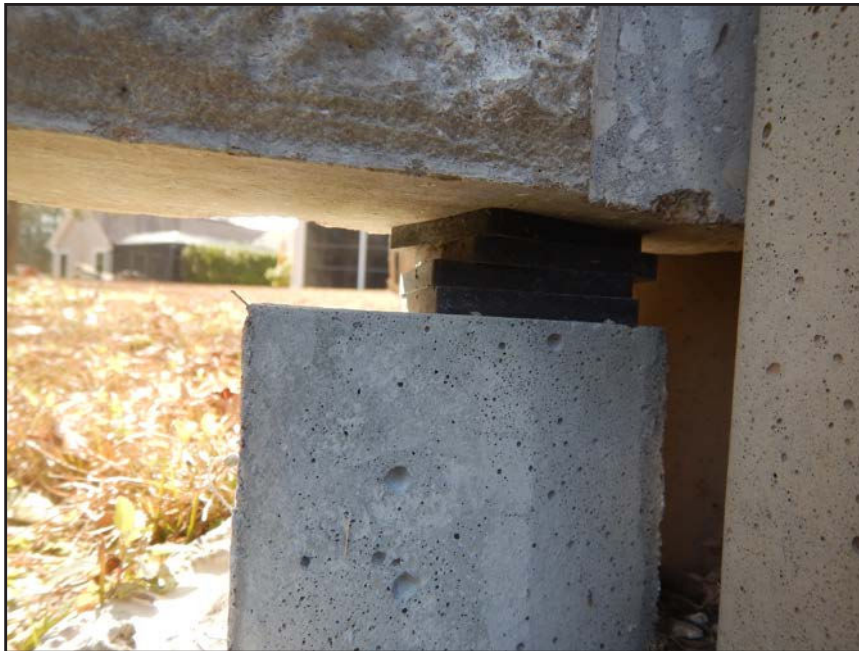
NO. 79 - COLUMN 3SM -
INADEQUATE BEARING OF A
PRECAST WALL PANEL ON A
2" x 2" NEOPRENE BEARING
PAD

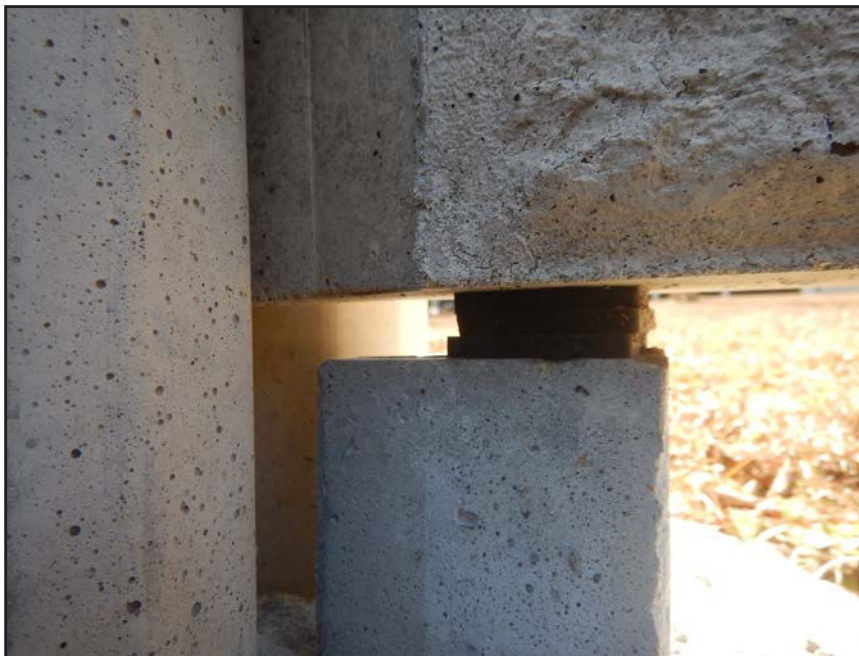
NO. 80 - COLUMN 3SM -
INADEQUATE BEARING OF A
PRECAST WALL PANEL ON A
2" x 2" NEOPRENE BEARING
PAD

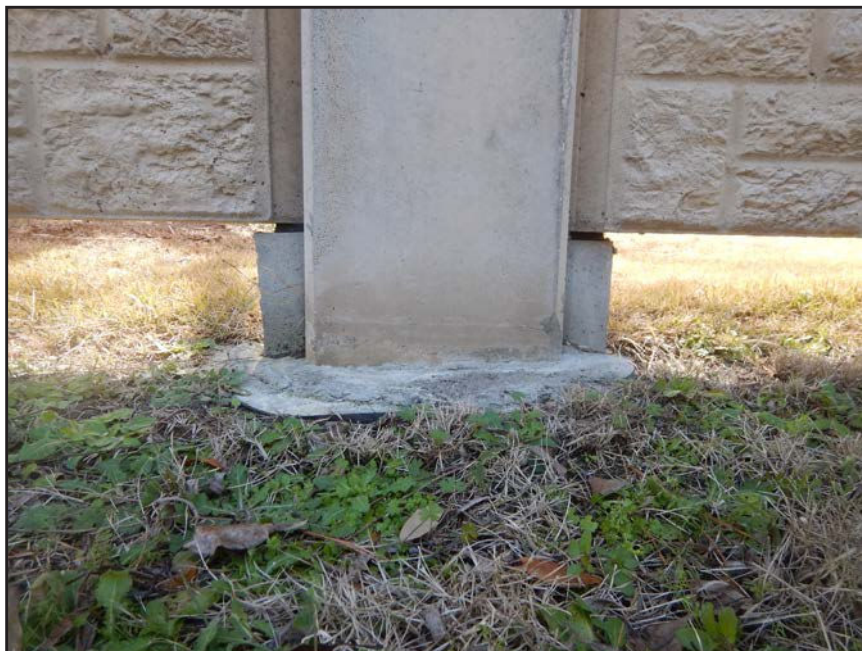
NO. 81 - COLUMN 3SM -
INADEQUATE BEARING OF A
PRECAST WALL PANEL ON A
2" x 2" NEOPRENE BEARING
PAD

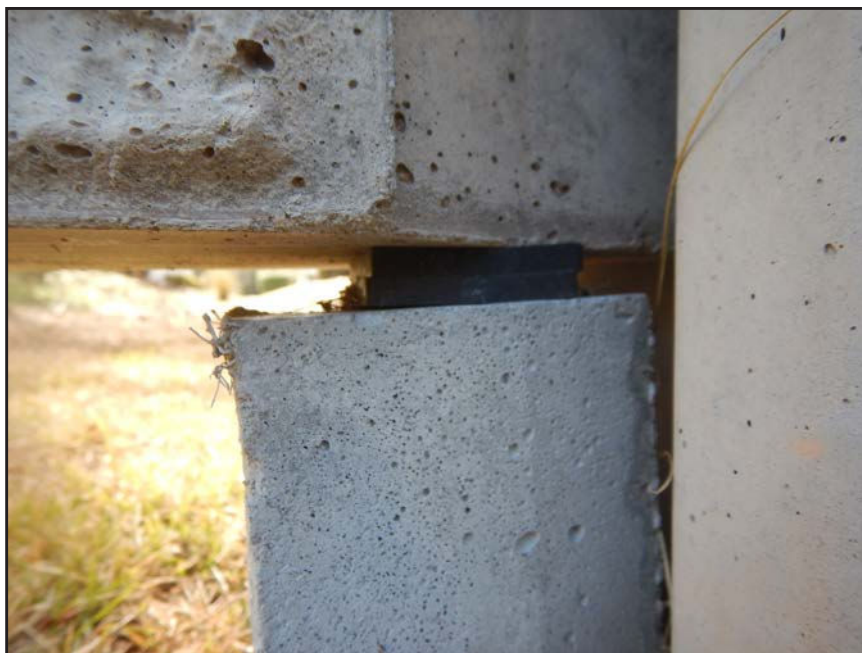
NO. 82 - COLUMN 15SM -
INADEQUATE BEARING OF A
PRECAST WALL PANEL ON A
2" x 2" NEOPRENE BEARING
PAD

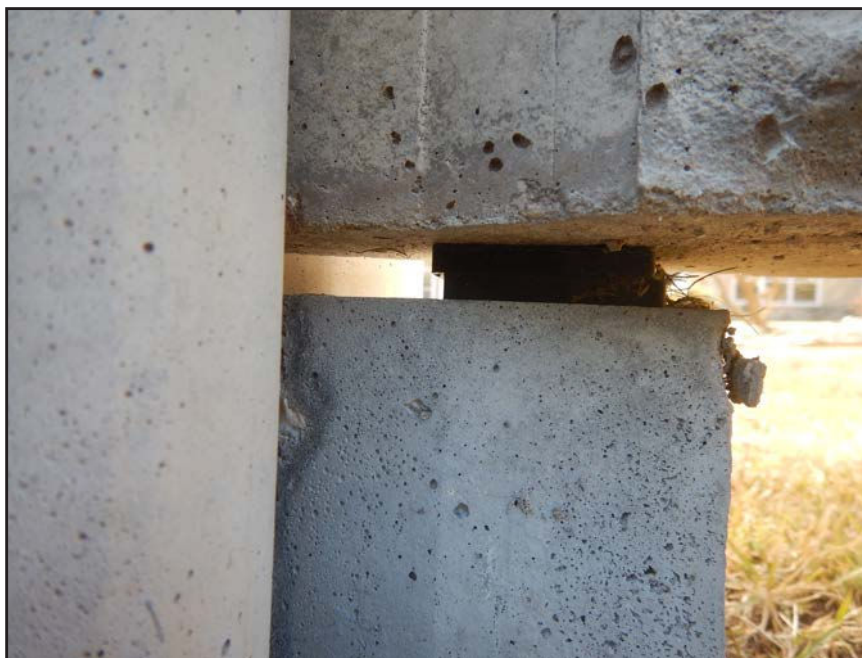
NO. 83 - COLUMN 15SM -
INADEQUATE BEARING OF A
PRECAST WALL PANEL ON A
2" x 2" NEOPRENE BEARING
PAD

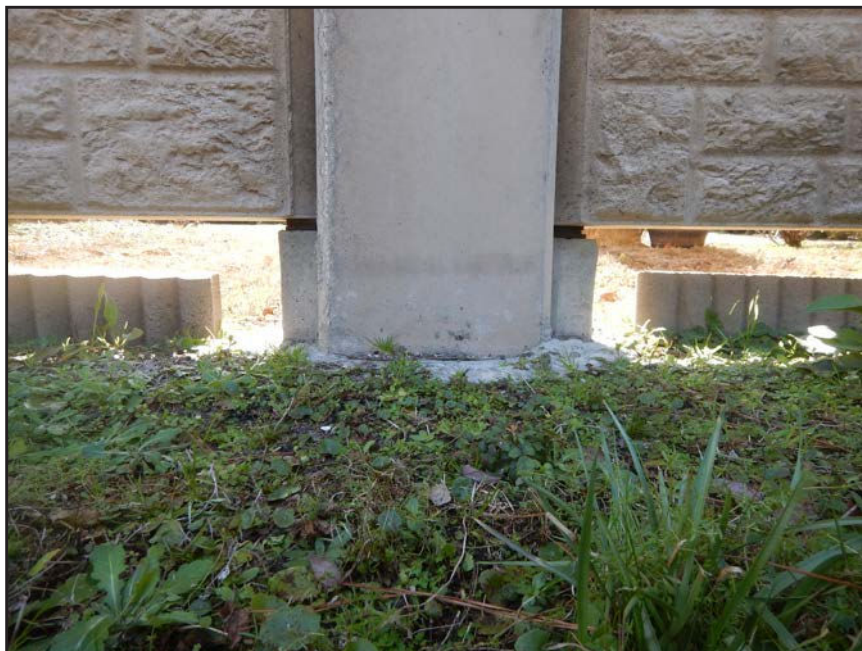
NO. 84 - COLUMN 15SM -
INADEQUATE BEARING OF A
PRECAST WALL PANEL ON A
2" x 2" NEOPRENE BEARING
PAD

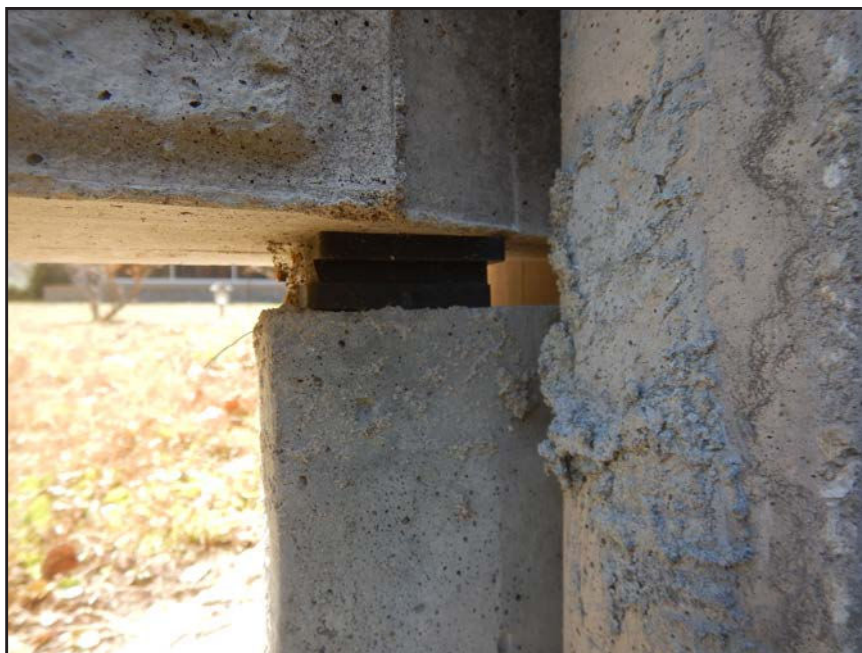
NO. 85 - COLUMN 22SM -
INADEQUATE BEARING OF A
PRECAST WALL PANEL ON A
2" x 2" NEOPRENE BEARING
PAD

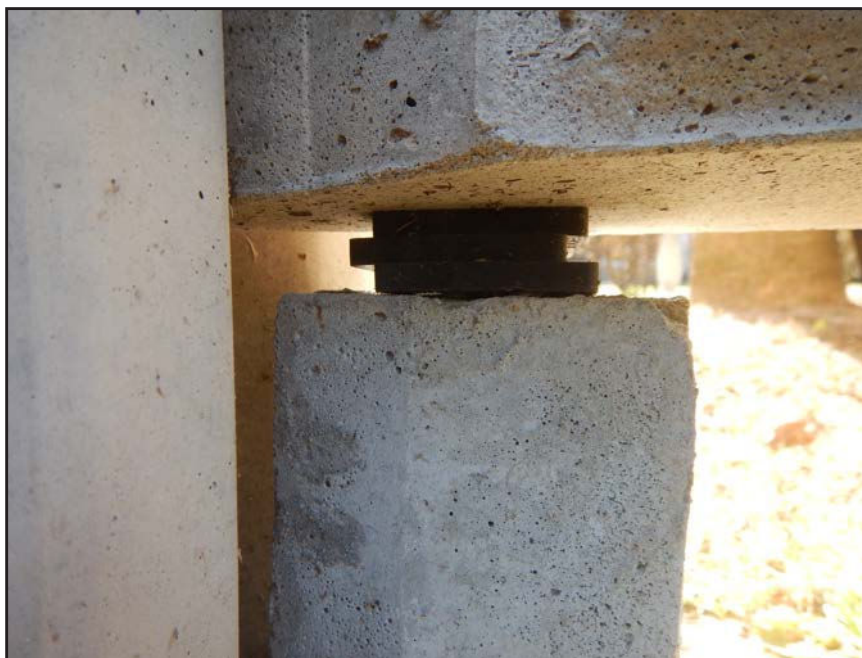
NO. 86 - COLUMN 22SM -
INADEQUATE BEARING OF A
PRECAST WALL PANEL ON A
2" x 2" NEOPRENE BEARING
PAD

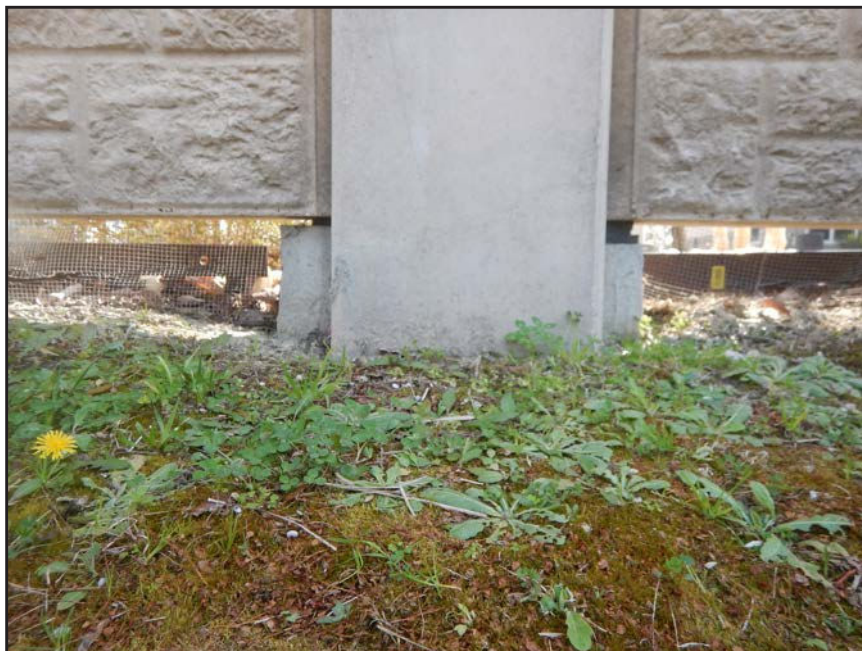
NO. 87 - COLUMN 22SM -
INADEQUATE BEARING OF A
PRECAST WALL PANEL ON A
2" x 2" NEOPRENE BEARING
PAD

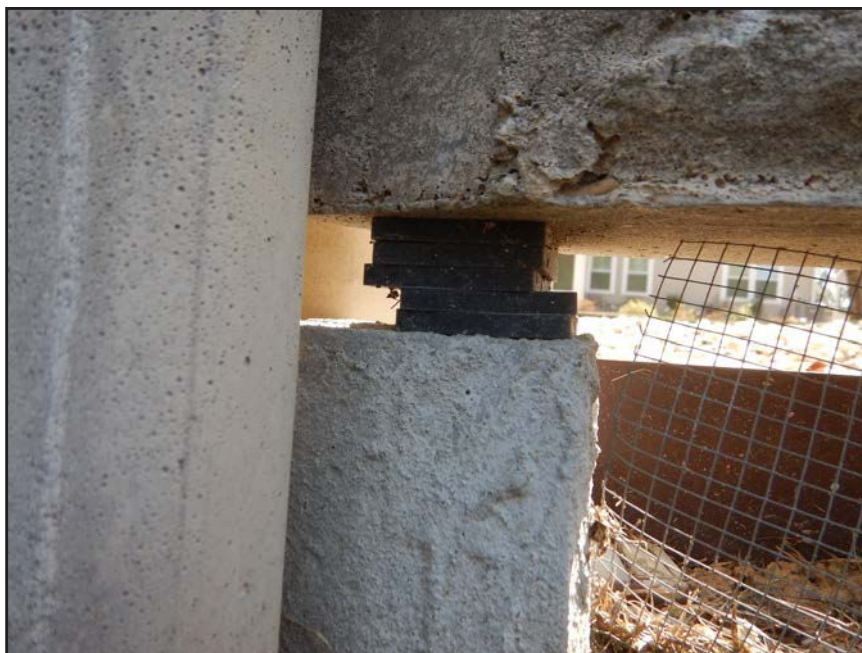
NO. 88 - COLUMN 8S -
INADEQUATE BEARING OF A
PRECAST WALL PANEL ON A
2" x 2" NEOPRENE BEARING
PAD

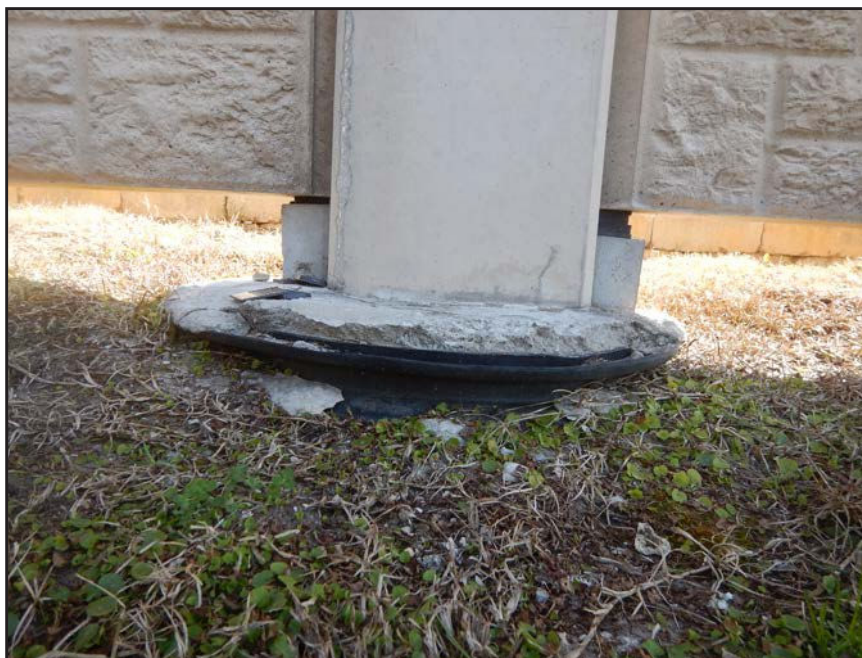
NO. 89 - COLUMN 8S -
INADEQUATE BEARING OF A
PRECAST WALL PANEL ON A
2" x 2" NEOPRENE BEARING
PAD

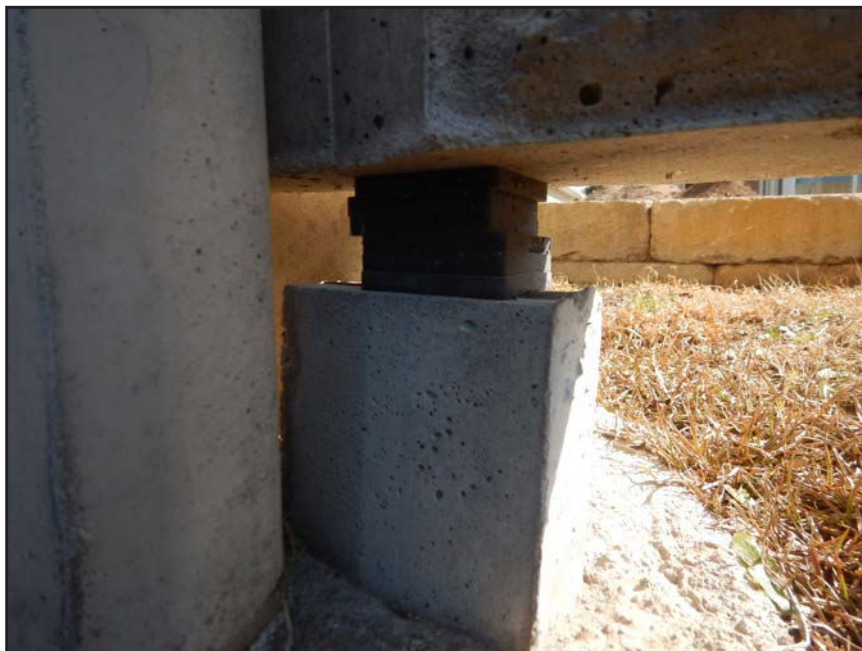
NO. 90 - COLUMN 33S -
INADEQUATE BEARING OF A
PRECAST WALL PANEL ON A
2" x 2" NEOPRENE BEARING
PAD

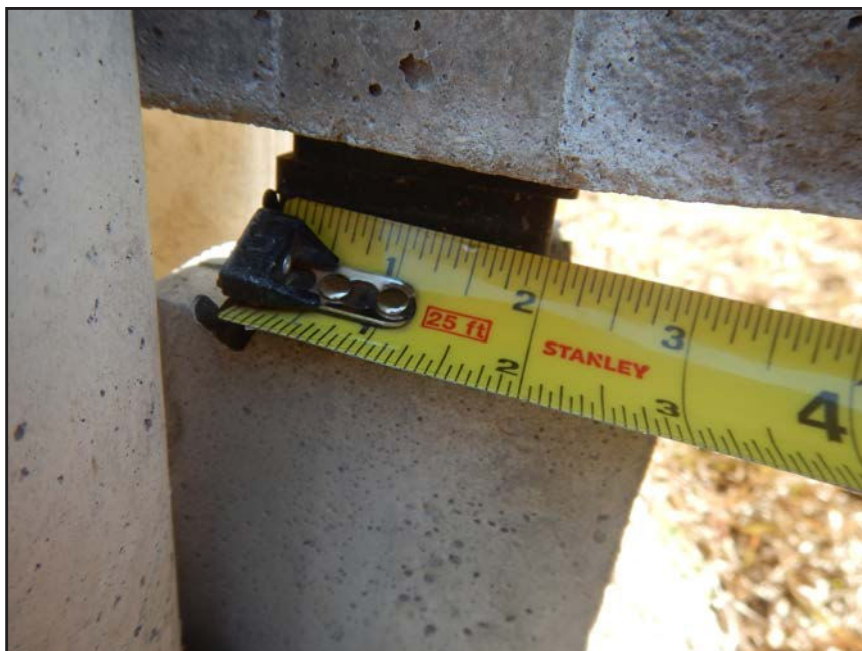
NO. 91 - COLUMN 33S -
INADEQUATE BEARING OF A
PRECAST WALL PANEL ON A
2" x 2" NEOPRENE BEARING
PAD
