WATER TOWER ROAD SCREEN WALL INVESTIGATIONS

Water Tower Road
Longs, South Carolina

Stantec Project No. 171015900

March 31, 2025

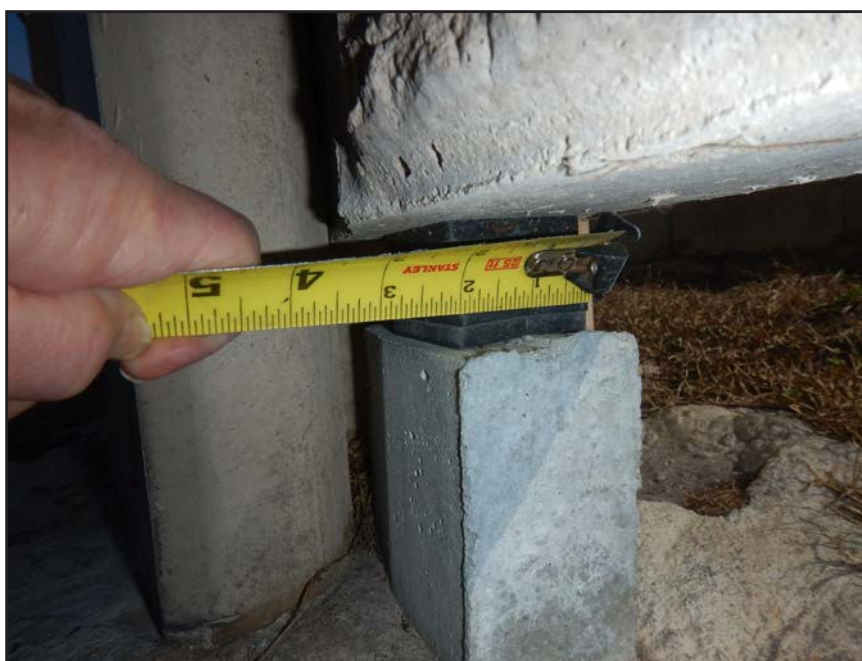
NO. 92 - COLUMN 33S -
INADEQUATE BEARING OF A
PRECAST WALL PANEL ON A
2" x 2" NEOPRENE BEARING
PAD

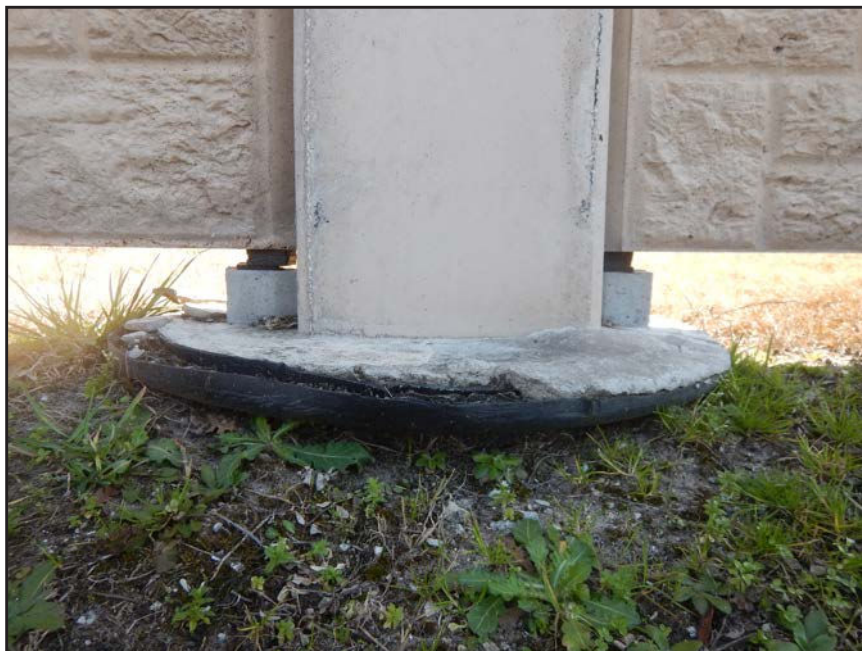
NO. 93 - COLUMN 33S -
INADEQUATE BEARING OF A
PRECAST WALL PANEL ON A
2" x 2" NEOPRENE BEARING
PAD

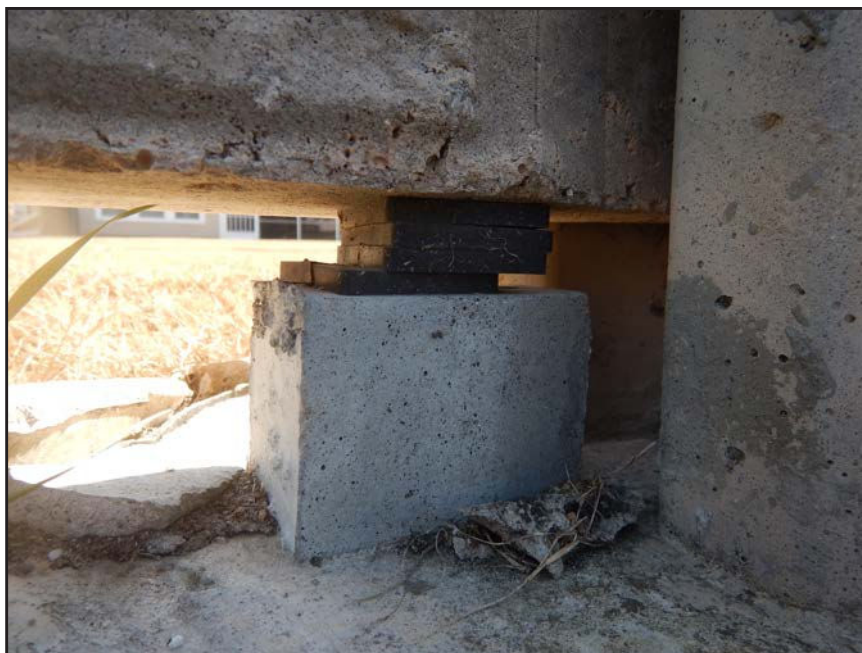
NO. 94 - COLUMN 46S -
INADEQUATE BEARING OF A
PRECAST WALL PANEL ON A
2" x 2" NEOPRENE BEARING
PAD

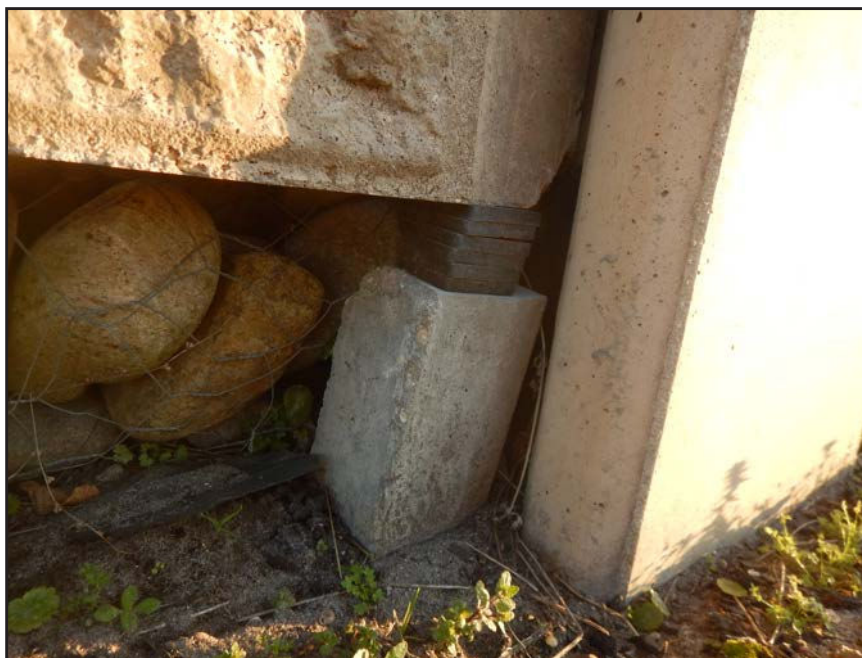
NO. 95 - COLUMN 46S -
INADEQUATE BEARING OF A
PRECAST WALL PANEL ON A
2" x 2" NEOPRENE BEARING
PAD

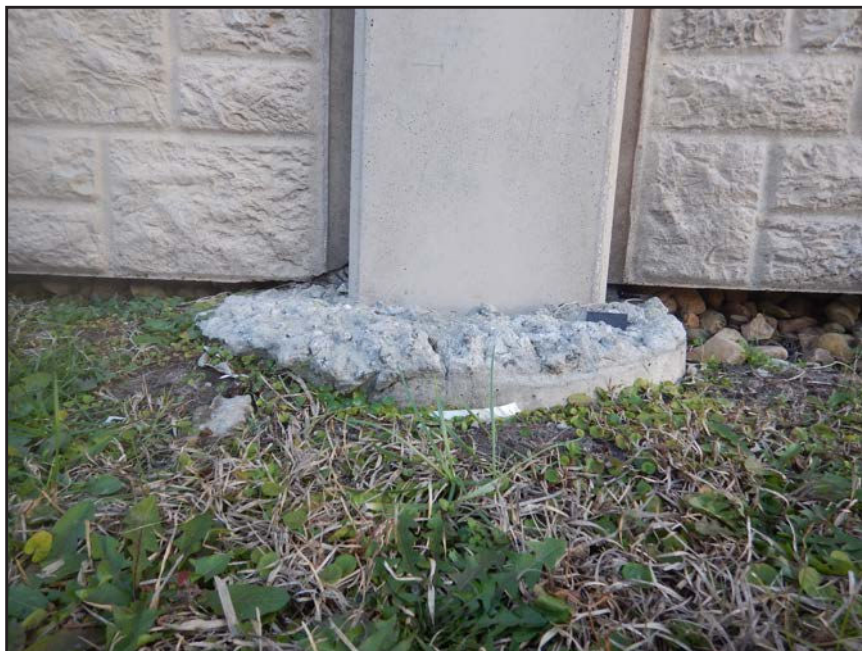
NO. 96 - COLUMN 51SS -
INADEQUATE BEARING OF A
PRECAST WALL PANEL ON A
2" x 2" NEOPRENE BEARING
PAD

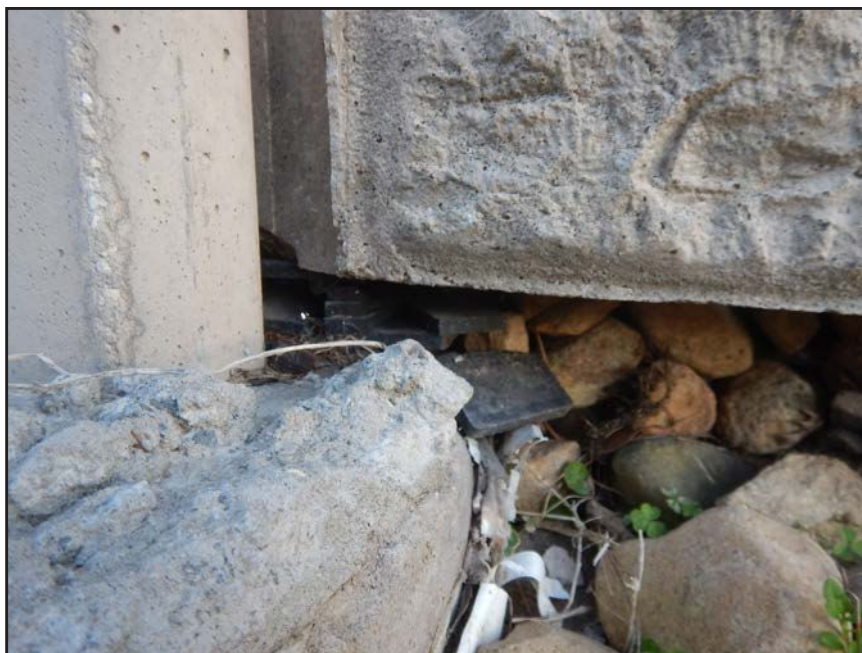
NO. 97 - COLUMN 64SS -
INADEQUATE BEARING OF A
PRECAST WALL PANEL ON A
2" x 2" NEOPRENE BEARING
PAD

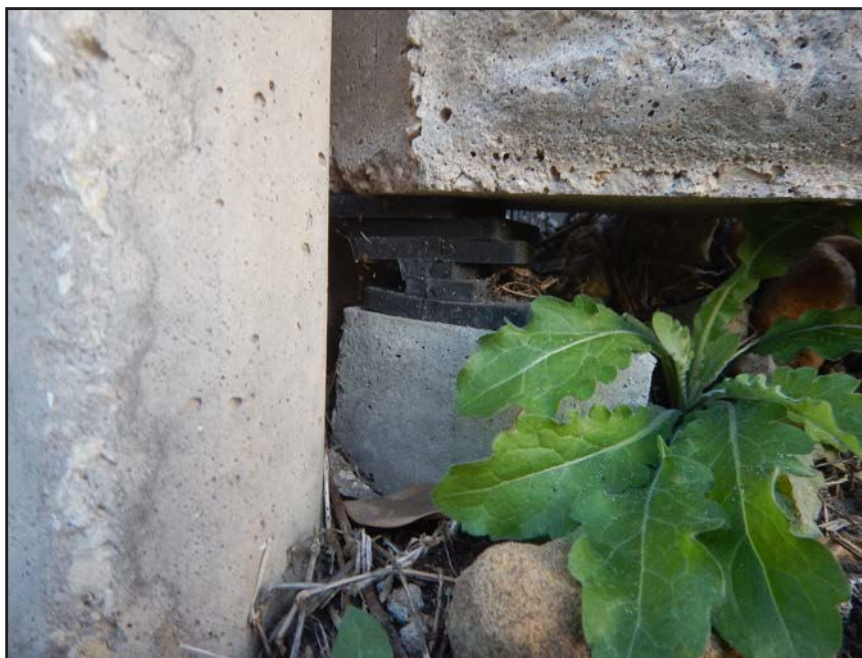
NO. 98 - COLUMN 64SS -
INADEQUATE BEARING OF A
PRECAST WALL PANEL ON A
2" x 2" NEOPRENE BEARING
PAD

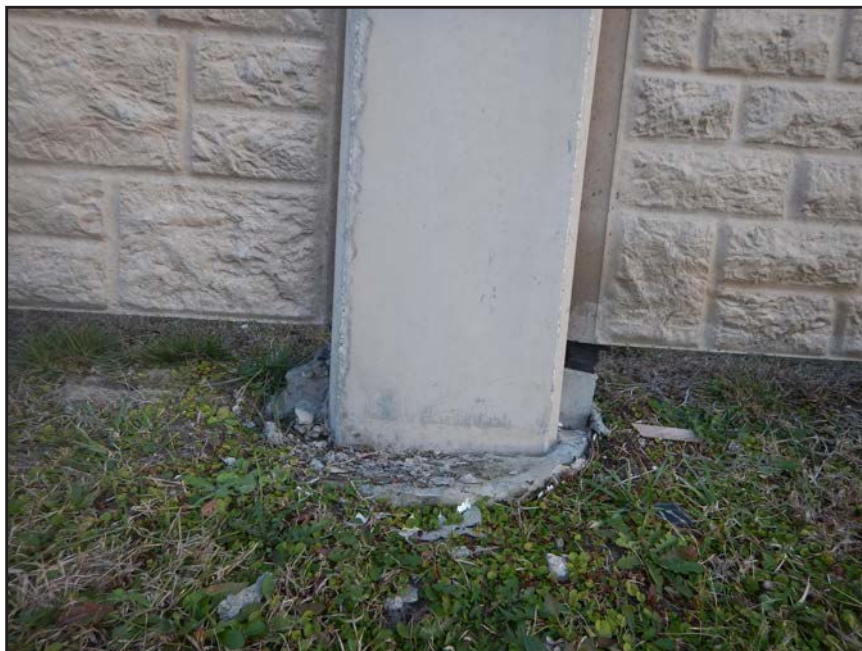
NO. 99 - COLUMN 66S -
INADEQUATE BEARING OF A
PRECAST WALL PANEL ON A
2" x 2" NEOPRENE BEARING
PAD

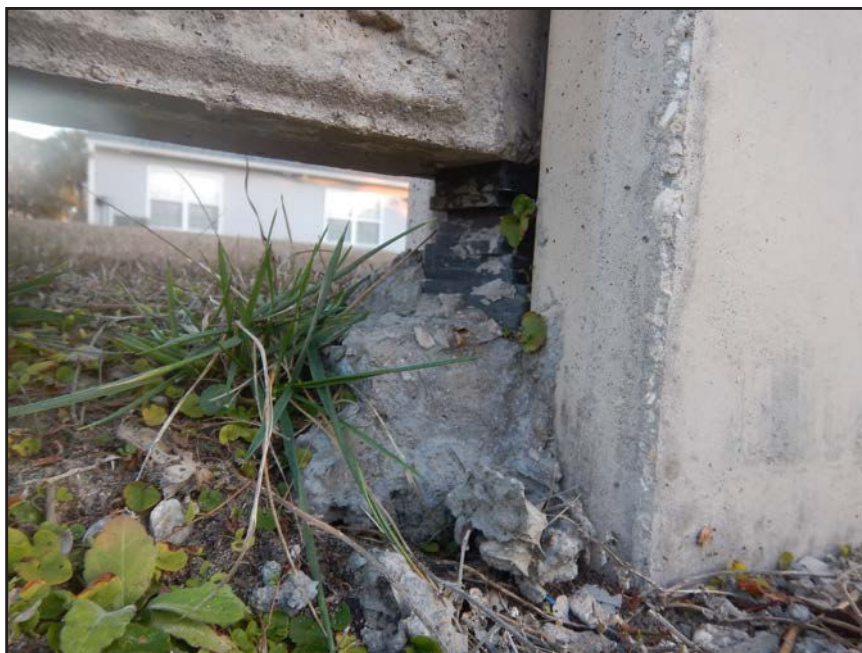
NO. 100 - COLUMN 67SS -
INADEQUATE BEARING OF A
PRECAST WALL PANEL ON A
2" x 2" NEOPRENE BEARING
PAD

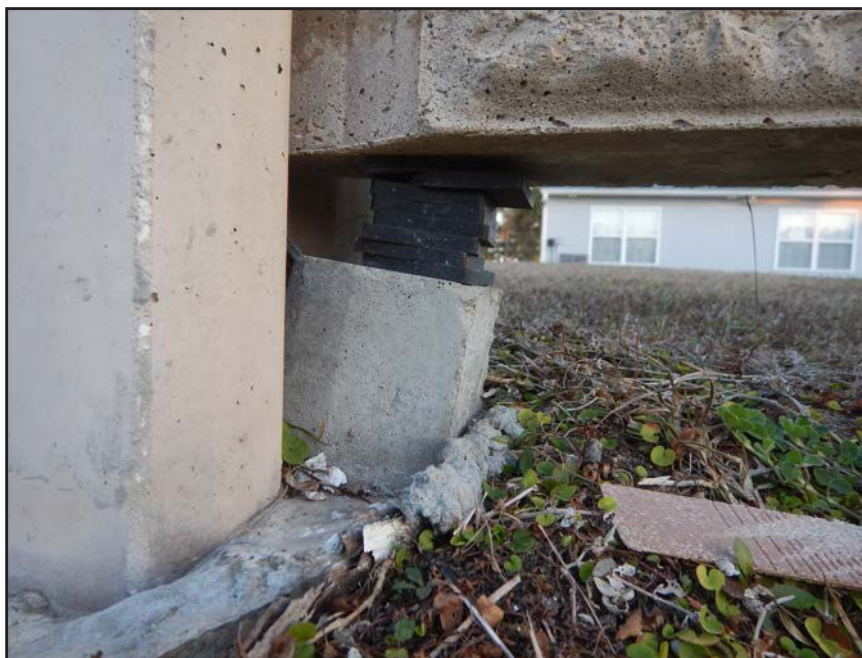
NO. 101 - COLUMN 67SS -
INADEQUATE BEARING OF A
PRECAST WALL PANEL ON A
2" x 2" NEOPRENE BEARING
PAD

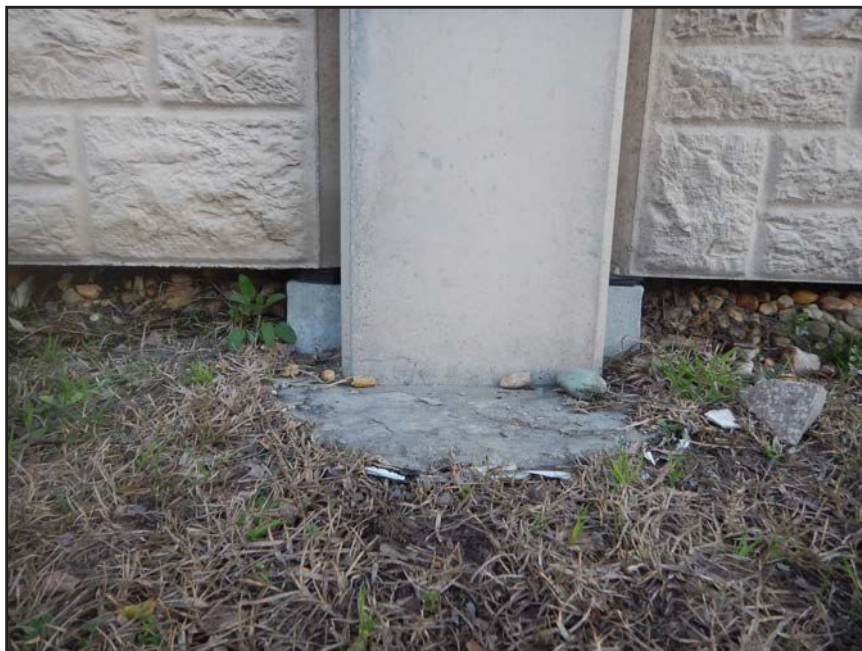
NO. 102 - COLUMN 67SS -
INADEQUATE BEARING OF A
PRECAST WALL PANEL ON A
2" x 2" NEOPRENE BEARING
PAD

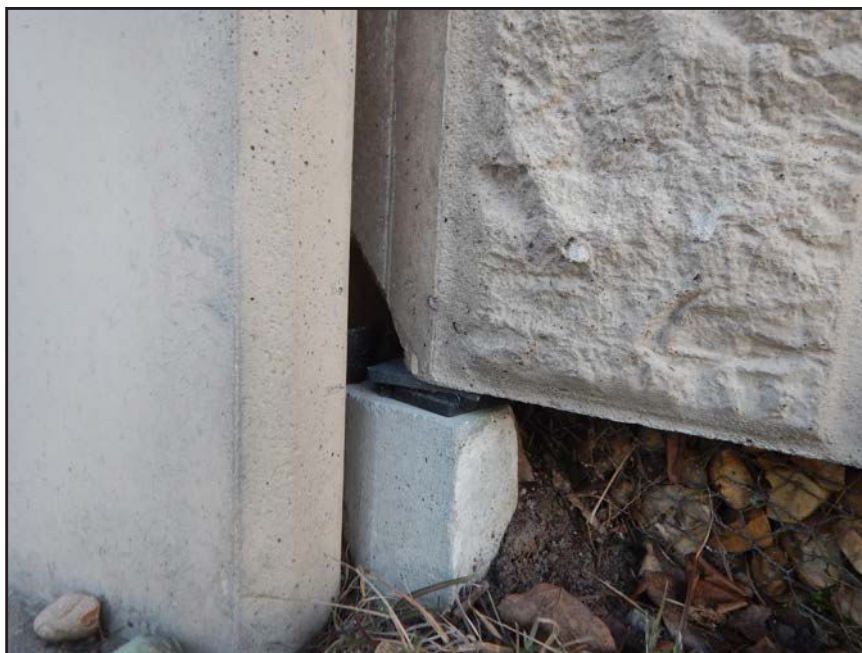
NO. 103 - COLUMN 78SS -
INADEQUATE BEARING OF A
PRECAST WALL PANEL ON A
2" x 2" NEOPRENE BEARING
PAD

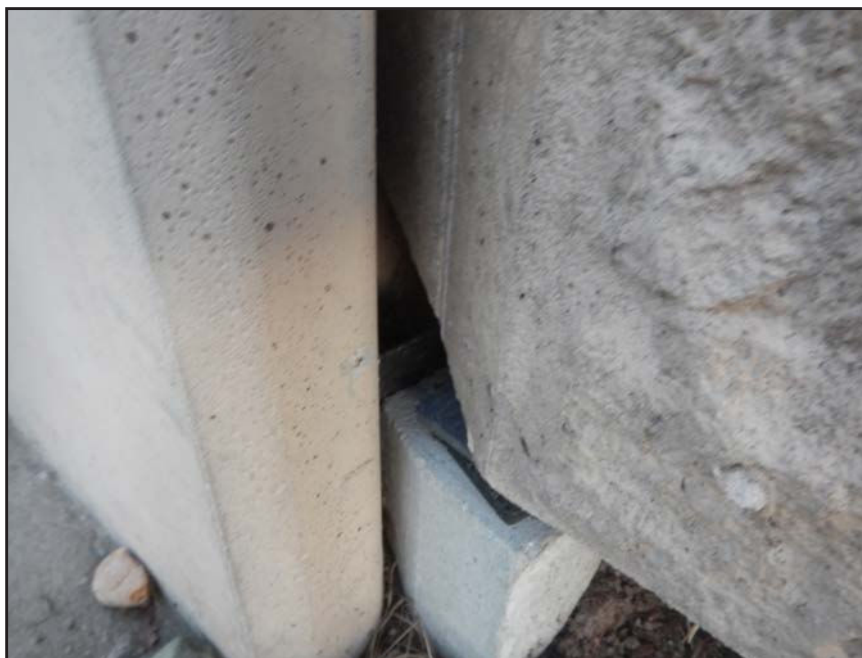
NO. 104 - COLUMN 78SS -
INADEQUATE BEARING OF A
PRECAST WALL PANEL ON A
2" x 2" NEOPRENE BEARING
PAD

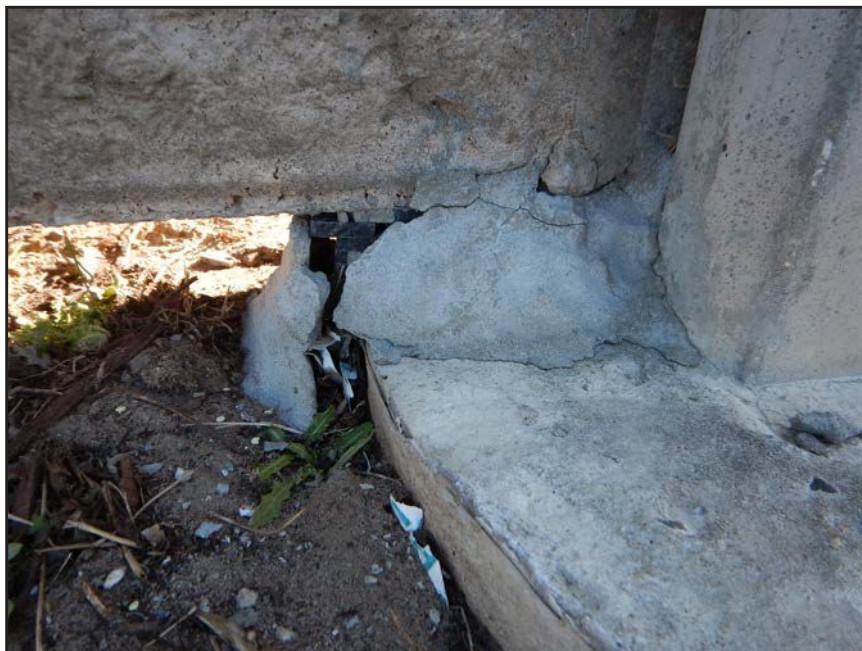
NO. 105 - COLUMN 78SS -
INADEQUATE BEARING OF A
PRECAST WALL PANEL ON A
2" x 2" NEOPRENE BEARING
PAD

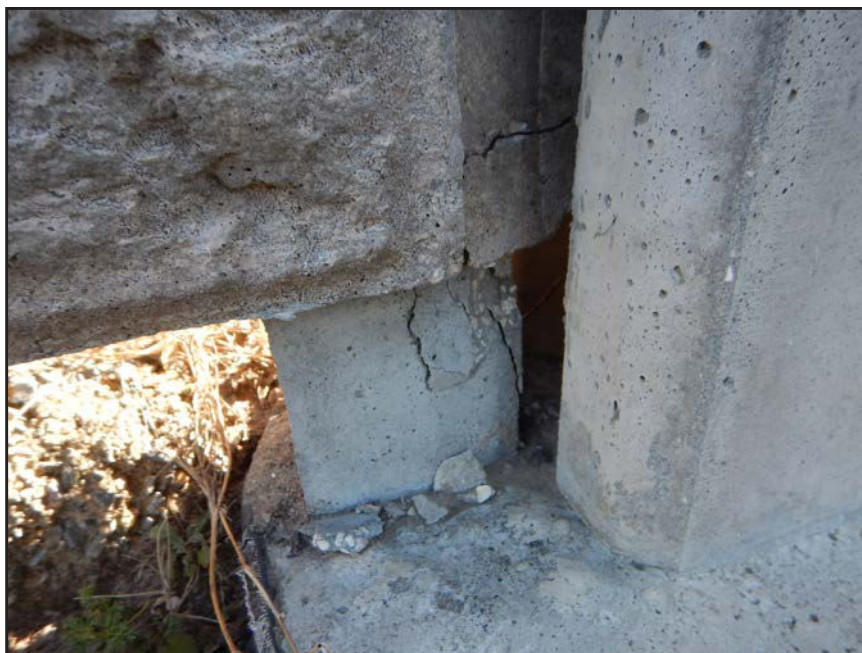
NO. 106 - COLUMN 8N -
INADEQUATE BEARING OF A
PRECAST WALL PANEL ON A
FAILED GROUT PEDESTAL OR A
FAILED PRECAST TONGUE

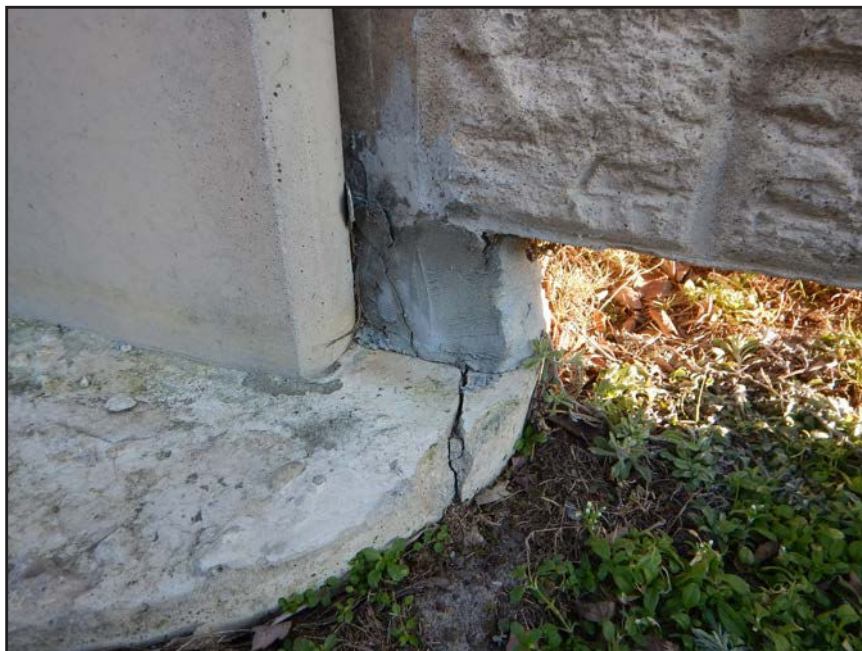
NO. 108 - COLUMN 25N -
INADEQUATE BEARING OF A
PRECAST WALL PANEL ON A
FAILED GROUT PEDESTAL OR A
FAILED PRECAST TONGUE

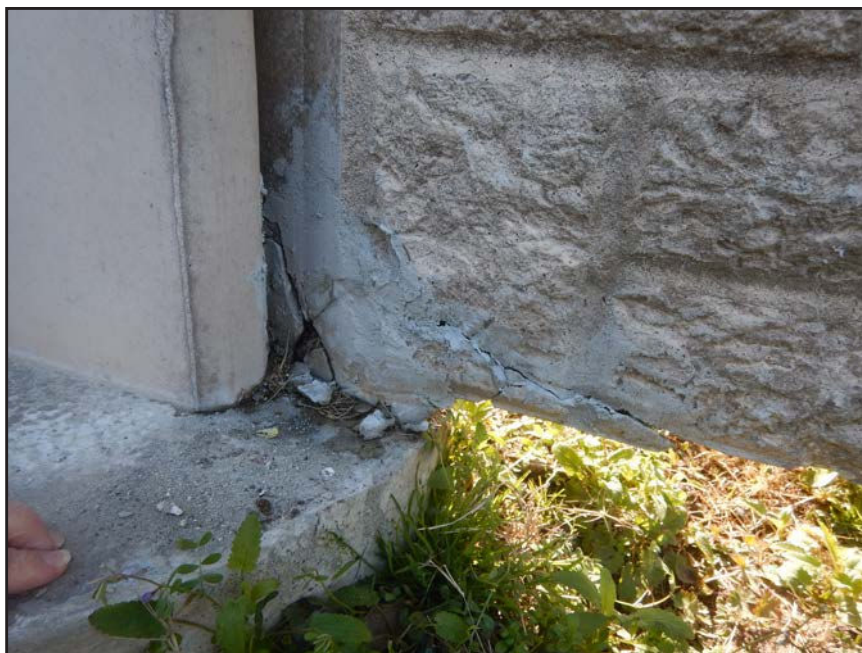
NO. 109 - COLUMN 41N -
INADEQUATE BEARING OF A
PRECAST WALL PANEL ON A
FAILED GROUT PEDESTAL OR A
FAILED PRECAST TONGUE

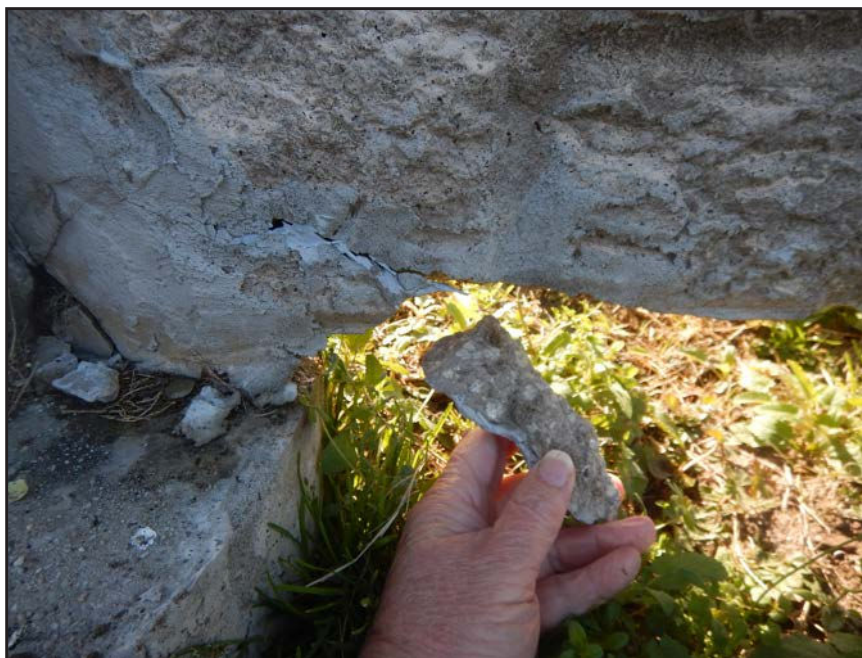
NO. 110 - COLUMN 43N -
INADEQUATE BEARING OF A
PRECAST WALL PANEL ON A
FAILED GROUT PEDESTAL OR A
FAILED PRECAST TONGUE

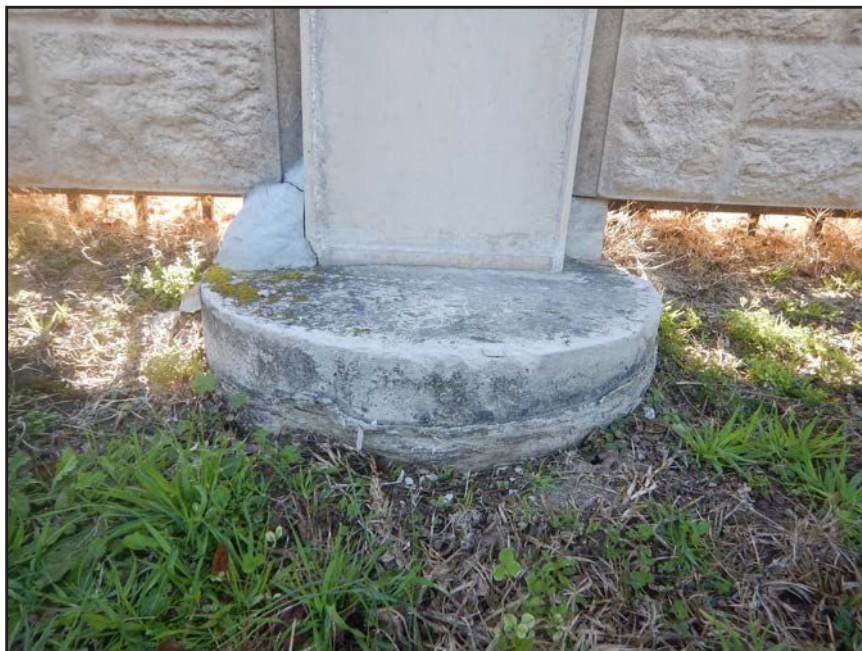
NO. 111 - COLUMN 43N -
INADEQUATE BEARING OF A
PRECAST WALL PANEL ON A
FAILED GROUT PEDESTAL OR A
FAILED PRECAST TONGUE

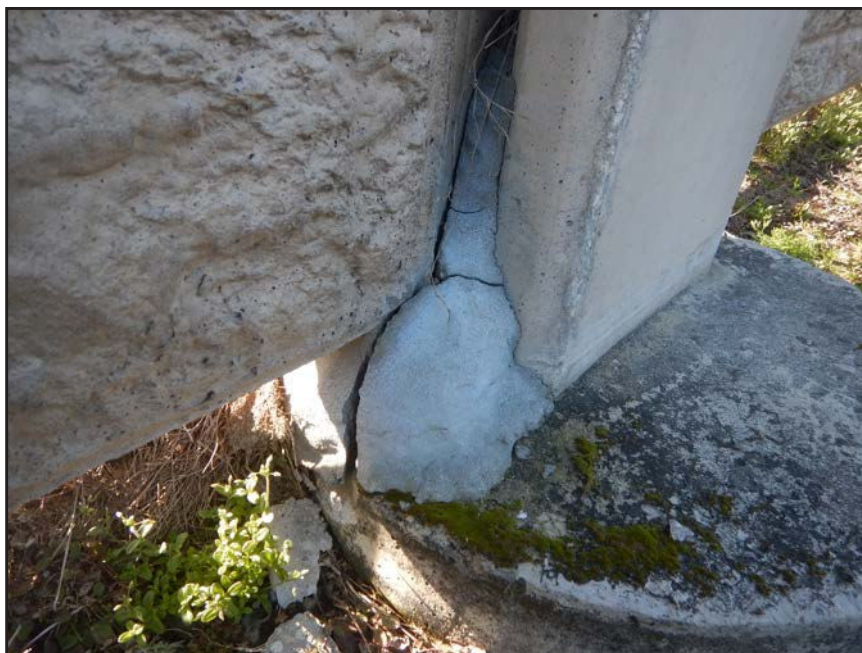
NO. 112 - COLUMN 45N -
INADEQUATE BEARING OF A
PRECAST WALL PANEL ON A
FAILED GROUT PEDESTAL OR A
FAILED PRECAST TONGUE

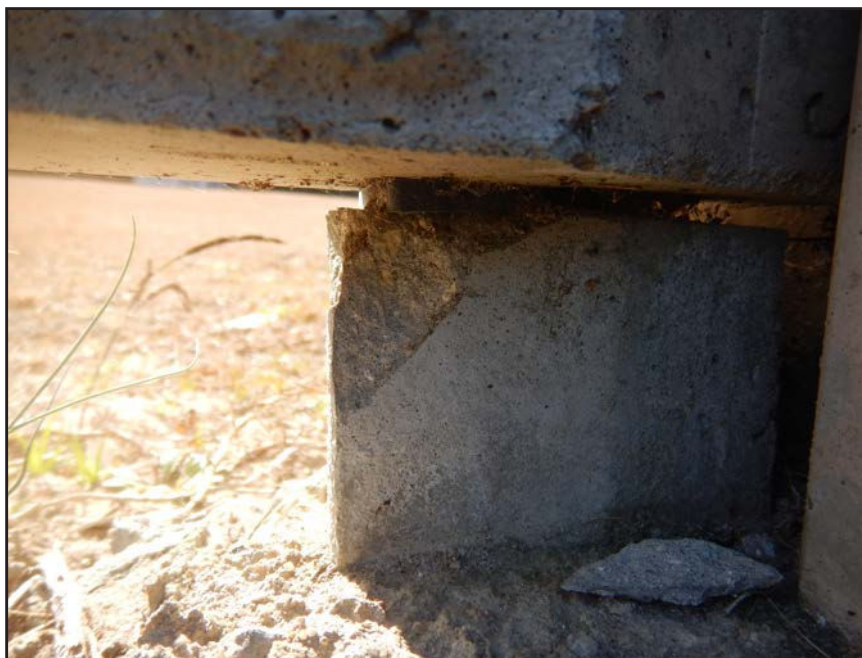
NO. 113 - COLUMN 45N -
INADEQUATE BEARING OF A
PRECAST WALL PANEL ON A
FAILED GROUT PEDESTAL OR A
FAILED PRECAST TONGUE

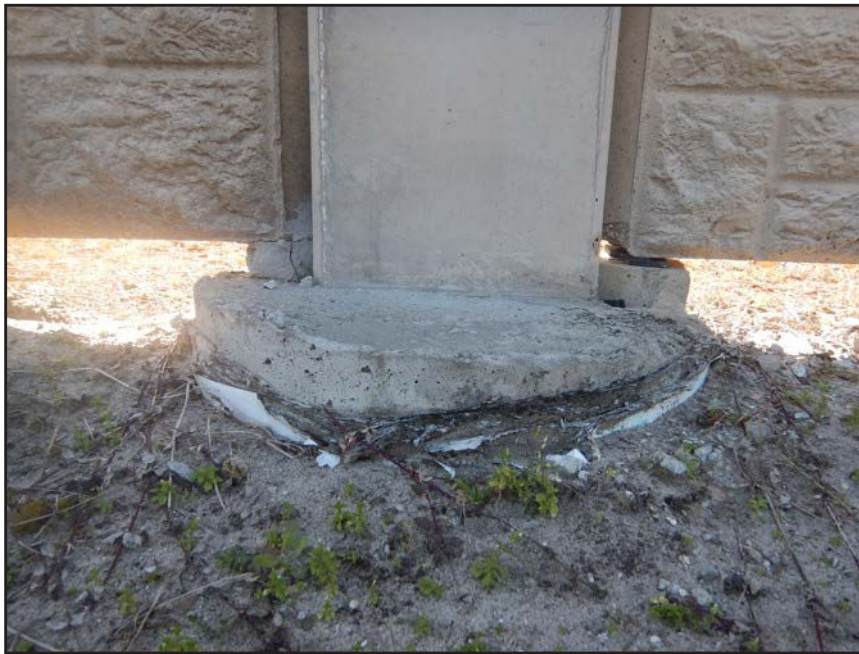
NO. 114 - COLUMN 53N -
INADEQUATE BEARING OF A
PRECAST WALL PANEL ON A
FAILED GROUT PEDESTAL OR A
FAILED PRECAST TONGUE

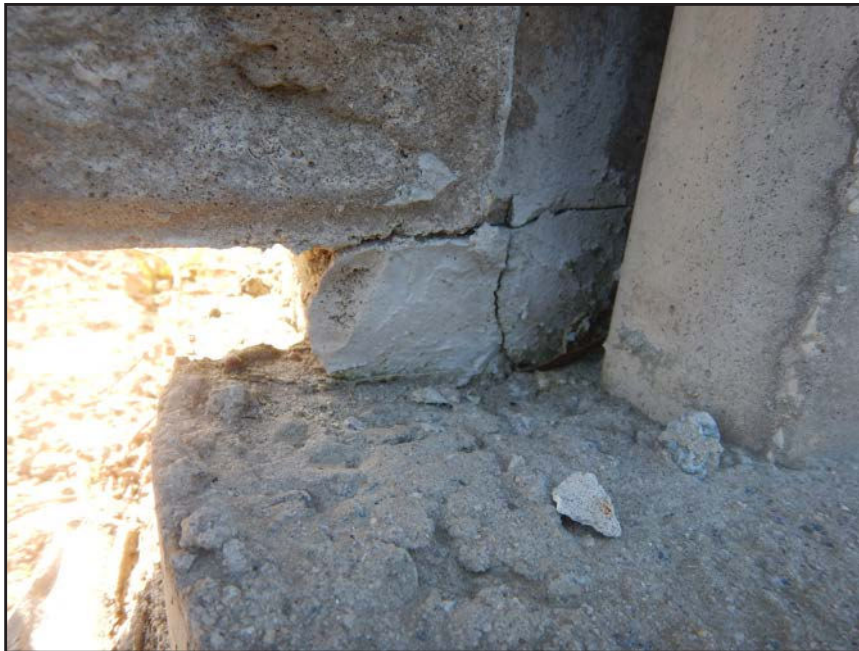
NO. 115 - COLUMN 55N -
INADEQUATE BEARING OF A
PRECAST WALL PANEL ON A
FAILED GROUT PEDESTAL OR A
FAILED PRECAST TONGUE

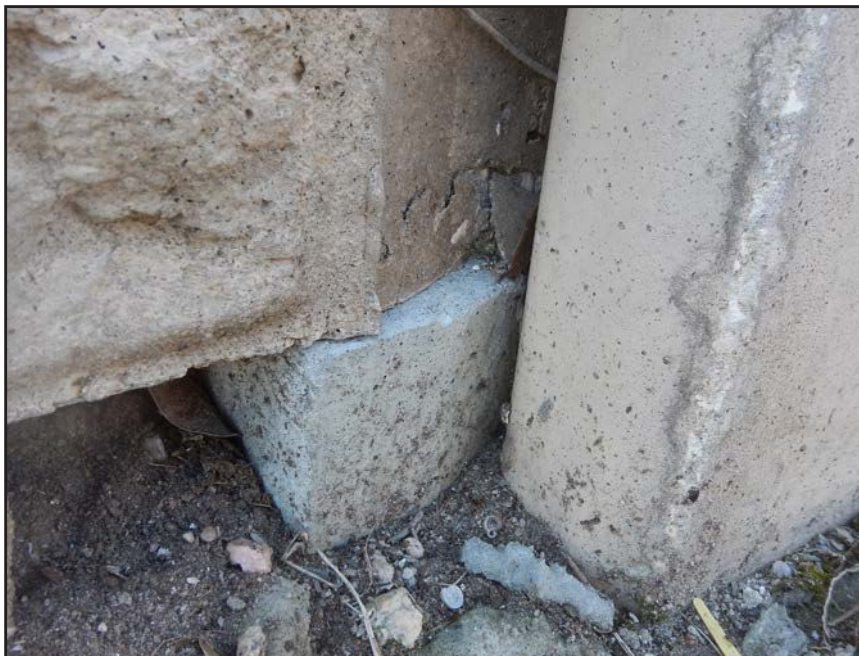
NO. 116 - COLUMN 55N -
INADEQUATE BEARING OF A
PRECAST WALL PANEL ON A
FAILED GROUT PEDESTAL OR A
FAILED PRECAST TONGUE

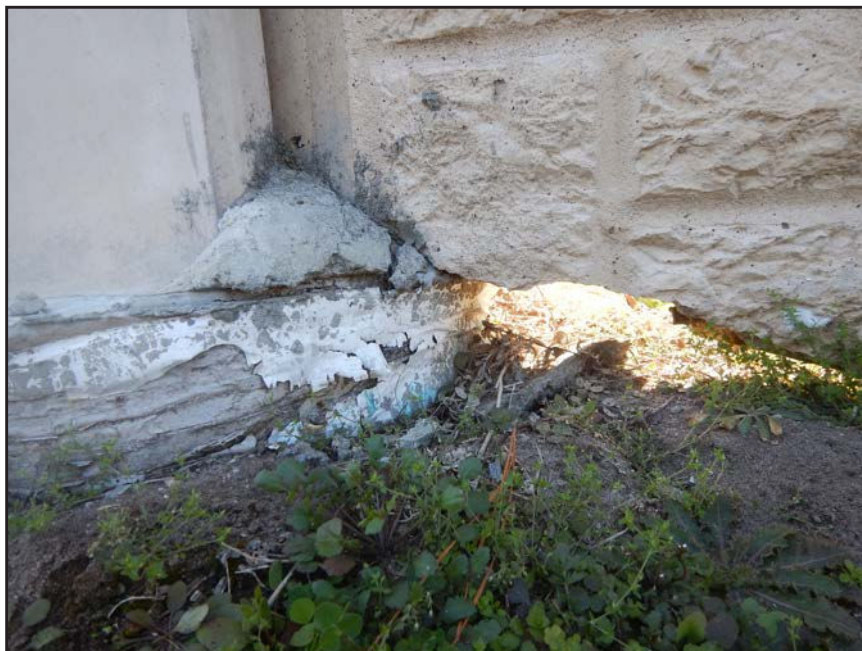
NO. 117 - COLUMN 5NM -
INADEQUATE BEARING OF A
PRECAST WALL PANEL ON A
FAILED GROUT PEDESTAL OR A
FAILED PRECAST TONGUE

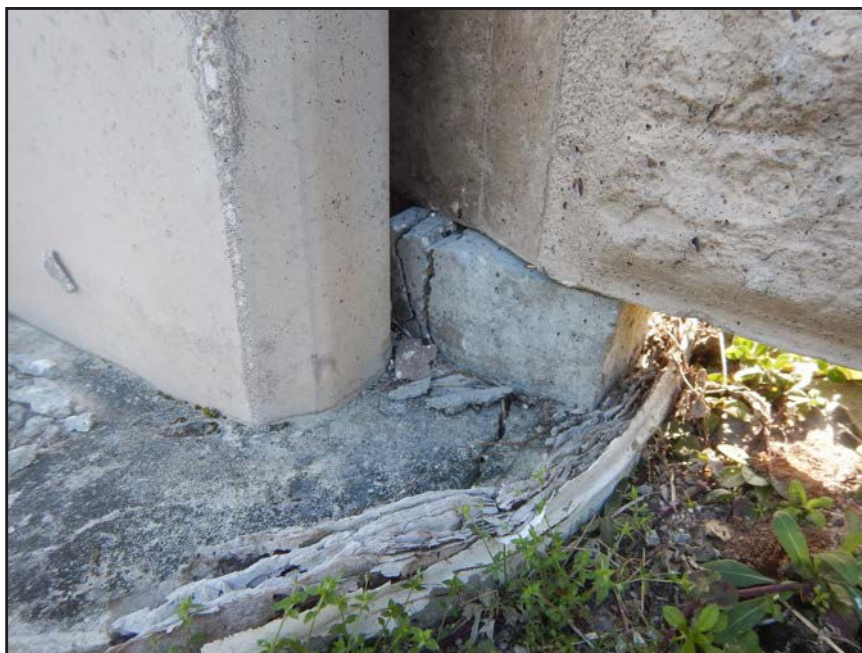
NO. 118 - COLUMN 11NM -
INADEQUATE BEARING OF A
PRECAST WALL PANEL ON A
FAILED GROUT PEDESTAL OR A
FAILED PRECAST TONGUE

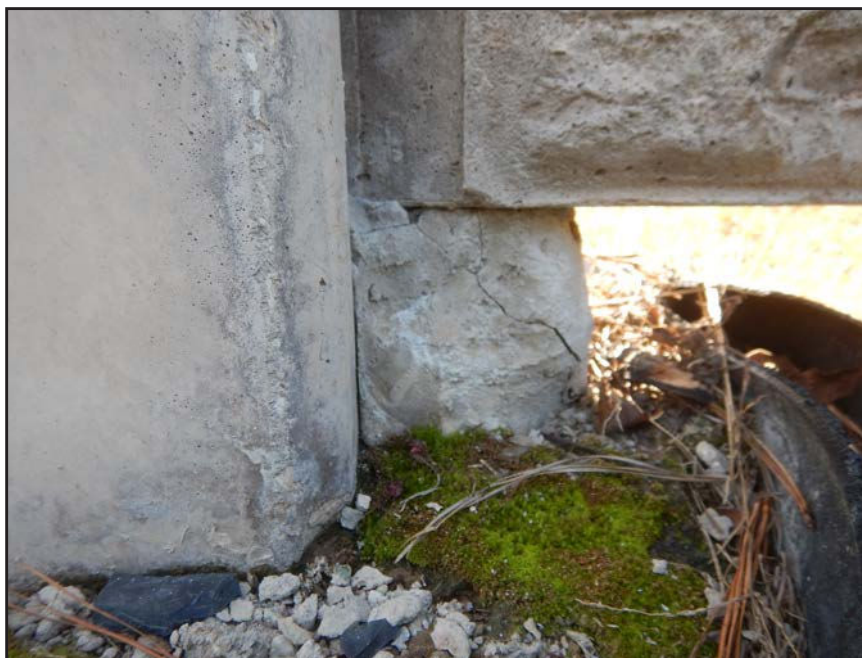
NO. 119 - COLUMN 12NM -
INADEQUATE BEARING OF A
PRECAST WALL PANEL ON A
FAILED GROUT PEDESTAL OR A
FAILED PRECAST TONGUE

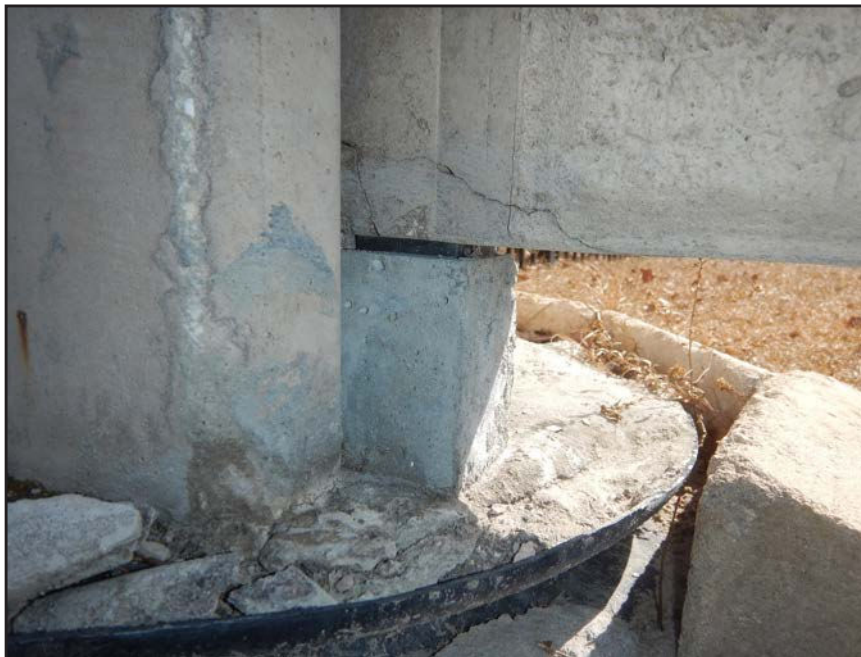
NO. 122 - COLUMN 2S -
INADEQUATE BEARING OF A
PRECAST WALL PANEL ON A
FAILED GROUT PEDESTAL OR A
FAILED PRECAST TONGUE

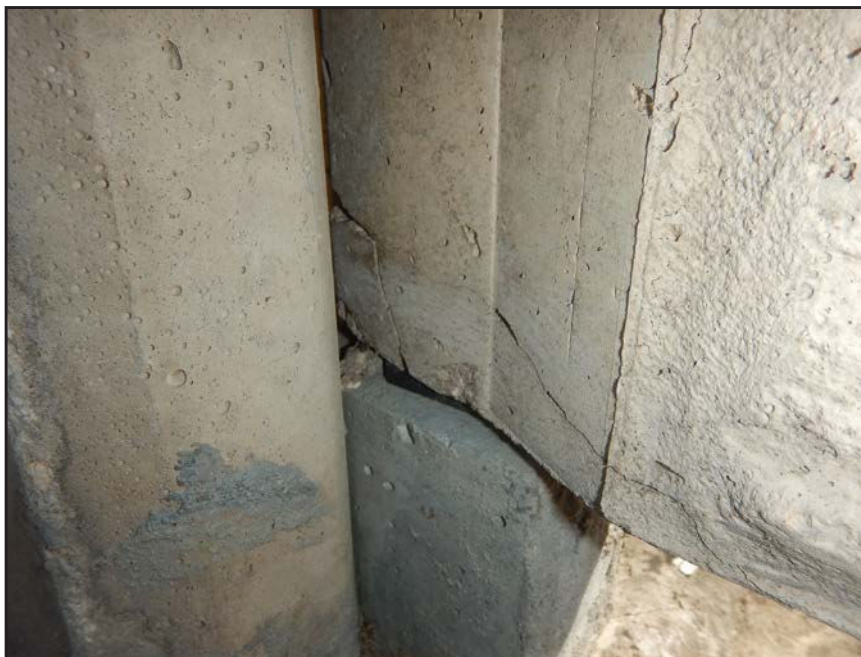
NO. 123 - COLUMN 4S -
INADEQUATE BEARING OF A
PRECAST WALL PANEL ON A
FAILED GROUT PEDESTAL OR A
FAILED PRECAST TONGUE

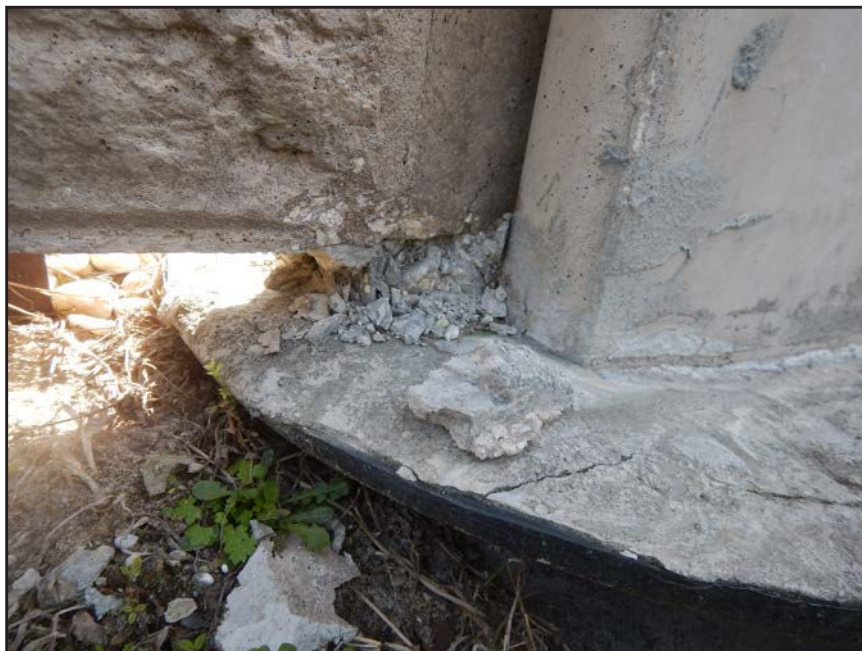
NO. 124 - COLUMN 4S -
INADEQUATE BEARING OF A
PRECAST WALL PANEL ON A
FAILED GROUT PEDESTAL OR A
FAILED PRECAST TONGUE

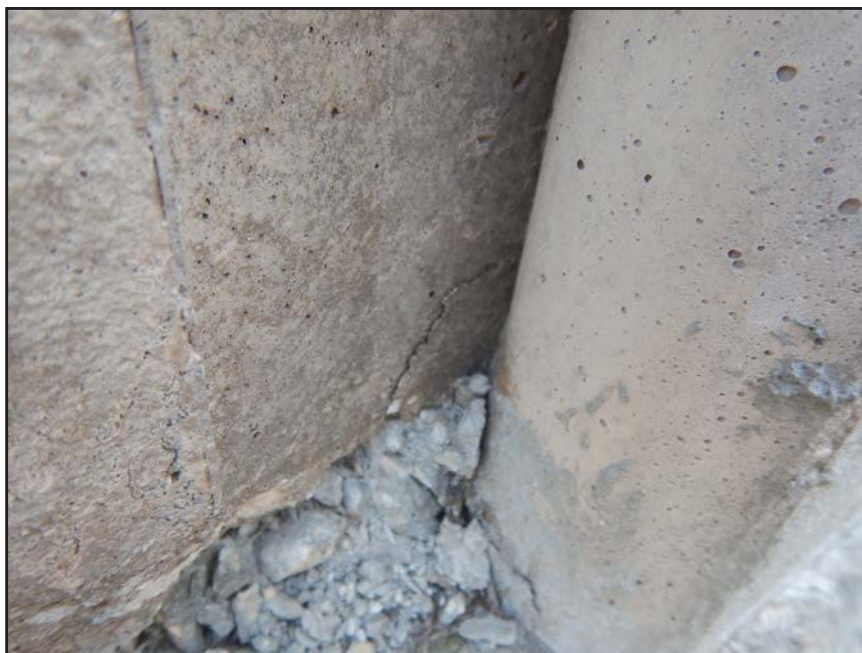
NO. 125 - COLUMN 12S -
INADEQUATE BEARING OF A
PRECAST WALL PANEL ON A
FAILED GROUT PEDESTAL OR A
FAILED PRECAST TONGUE

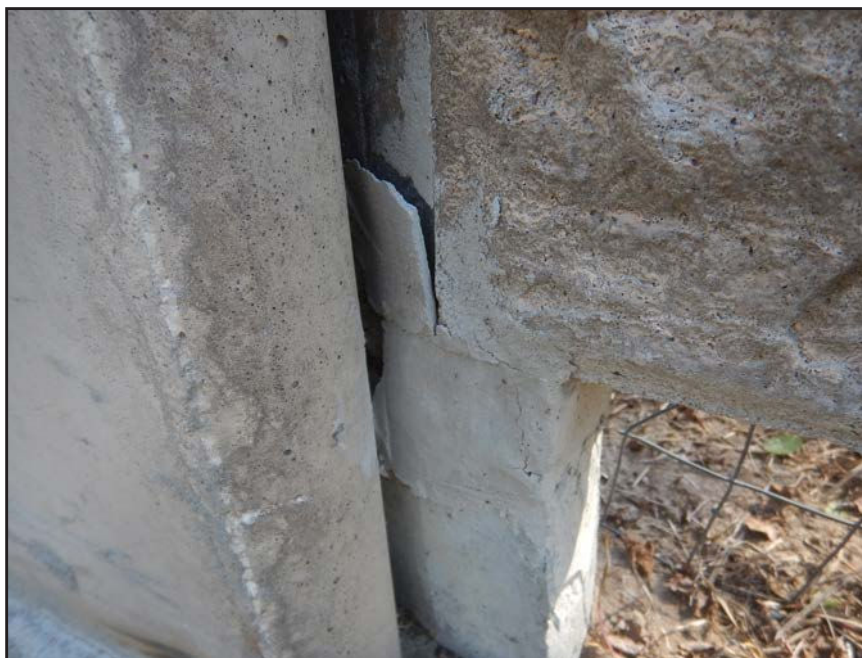
NO. 126 - COLUMN 12S -
INADEQUATE BEARING OF A
PRECAST WALL PANEL ON A
FAILED GROUT PEDESTAL OR A
FAILED PRECAST TONGUE

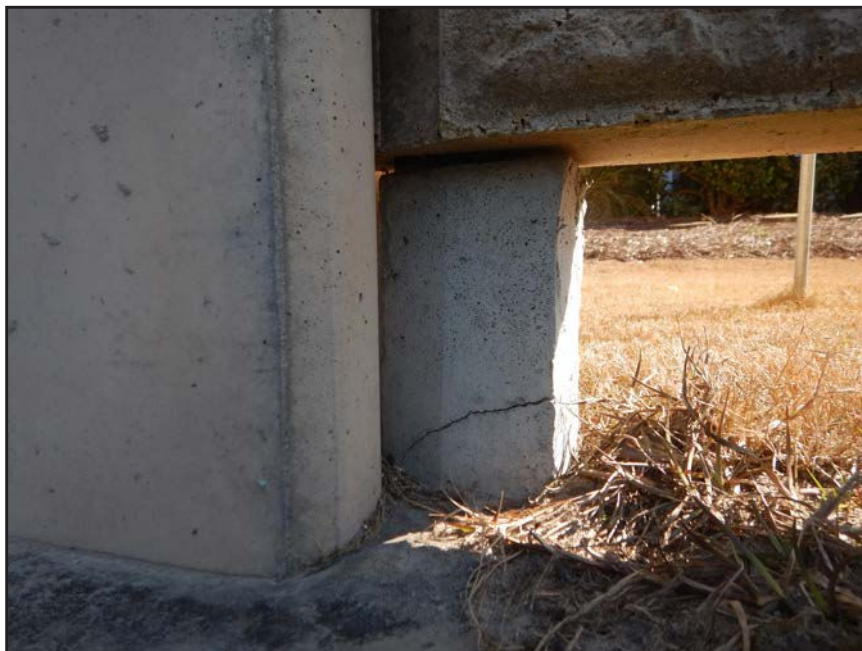
NO. 127 - COLUMN 20S -
INADEQUATE BEARING OF A
PRECAST WALL PANEL ON A
FAILED GROUT PEDESTAL OR A
FAILED PRECAST TONGUE

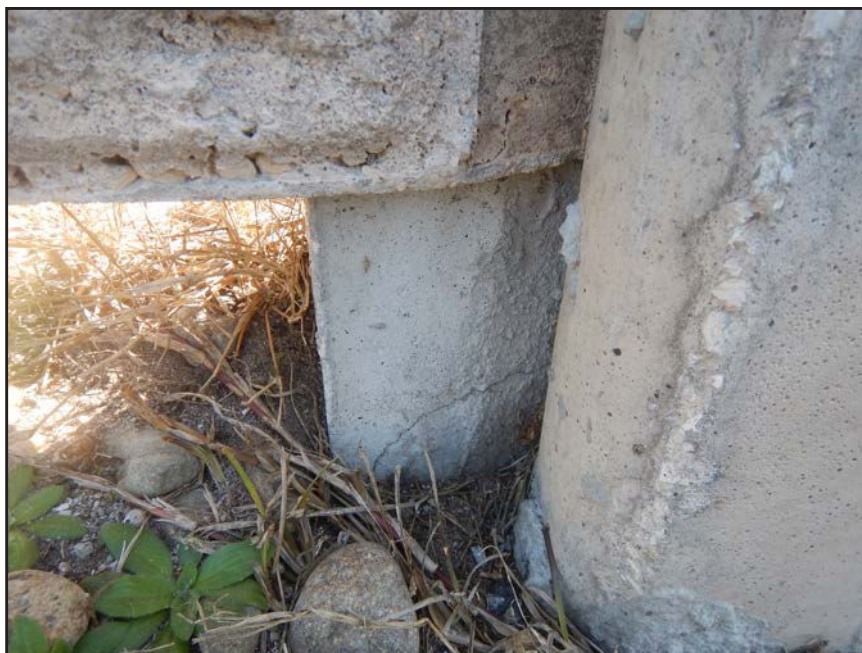
NO. 128 - COLUMN 28S -
INADEQUATE BEARING OF A
PRECAST WALL PANEL ON A
FAILED GROUT PEDESTAL OR A
FAILED PRECAST TONGUE

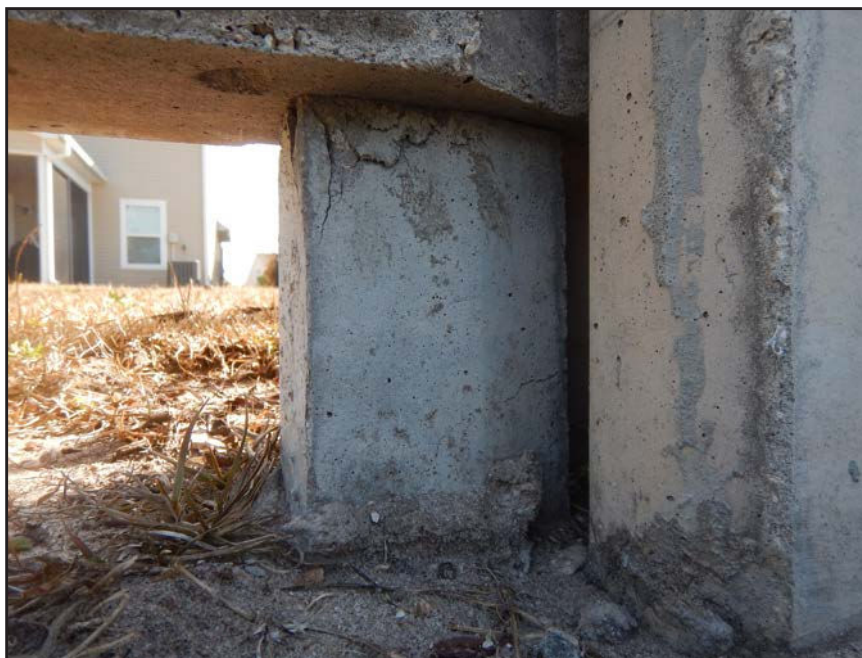
NO. 129 - COLUMN 37S -
INADEQUATE BEARING OF A
PRECAST WALL PANEL ON A
FAILED GROUT PEDESTAL OR A
FAILED PRECAST TONGUE

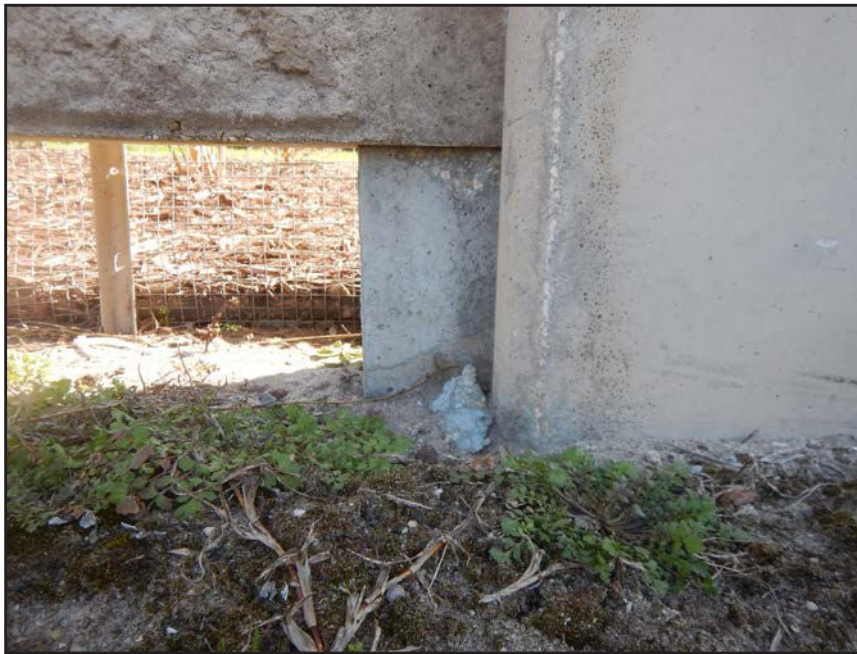
NO. 130 - COLUMN 40S -
INADEQUATE BEARING OF A
PRECAST WALL PANEL ON A
FAILED GROUT PEDESTAL OR A
FAILED PRECAST TONGUE

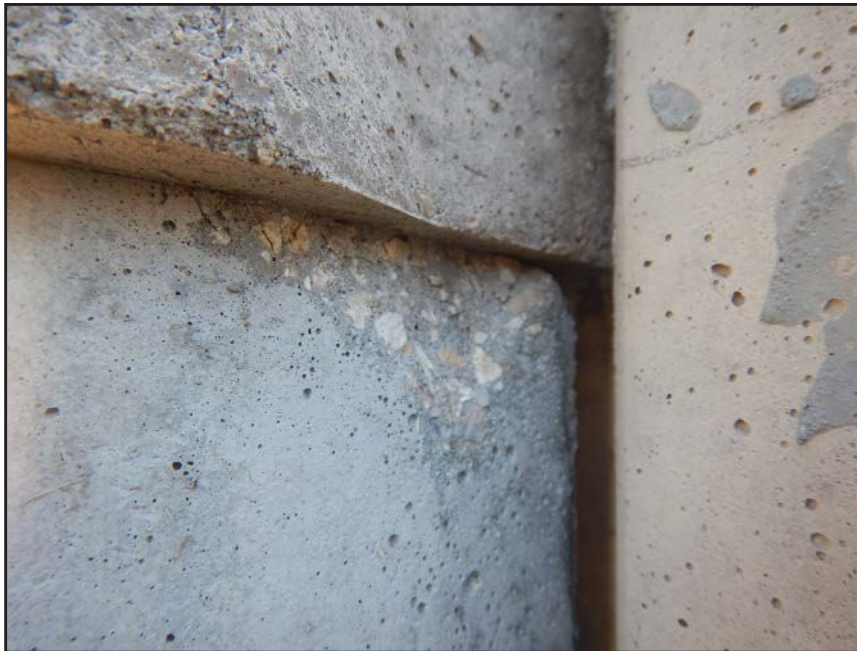
NO. 131 - COLUMN 42S -
INADEQUATE BEARING OF A
PRECAST WALL PANEL ON A
FAILED GROUT PEDESTAL OR A
FAILED PRECAST TONGUE

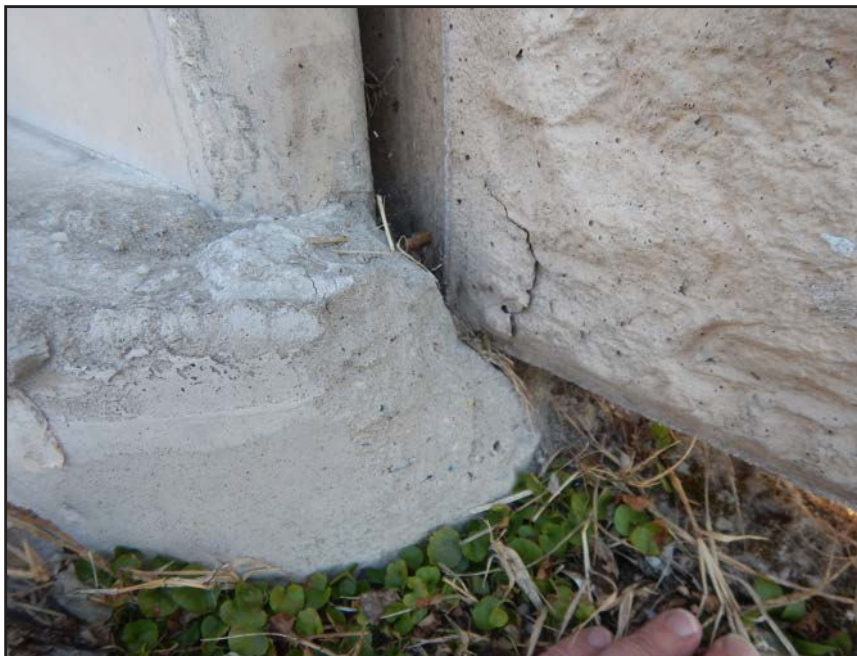
NO. 132 - COLUMN 42S -
INADEQUATE BEARING OF A
PRECAST WALL PANEL ON A
FAILED GROUT PEDESTAL OR A
FAILED PRECAST TONGUE

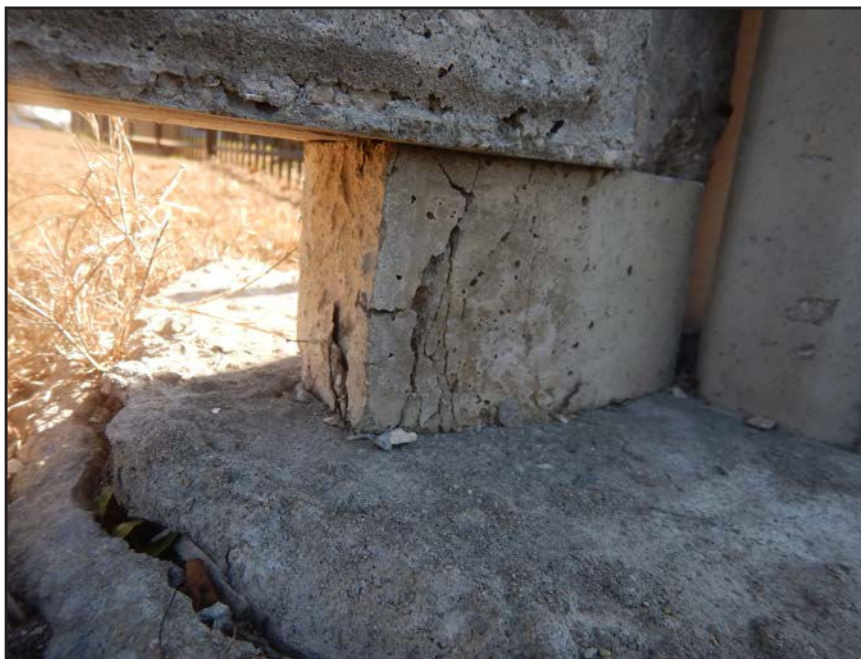
NO. 133 - COLUMN 53S -
INADEQUATE BEARING OF A
PRECAST WALL PANEL ON A
FAILED GROUT PEDESTAL OR A
FAILED PRECAST TONGUE
