WATER TOWER ROAD SCREEN WALL INVESTIGATIONS

Water Tower Road
Longs, South Carolina

Stantec Project No. 171015900

March 31, 2025

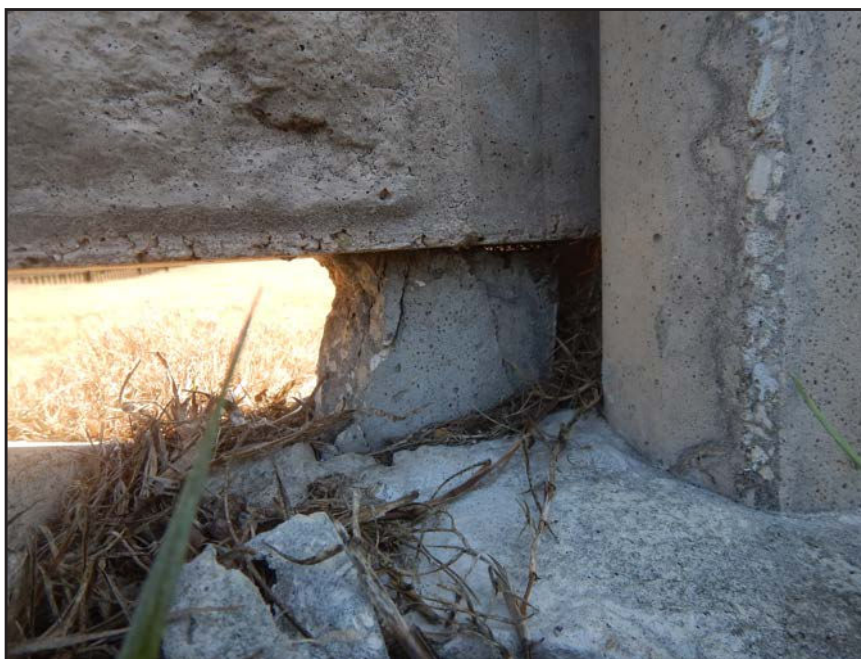
NO. 134 - COLUMN 55S -
INADEQUATE BEARING OF A
PRECAST WALL PANEL ON A
FAILED GROUT PEDESTAL OR A
FAILED PRECAST TONGUE

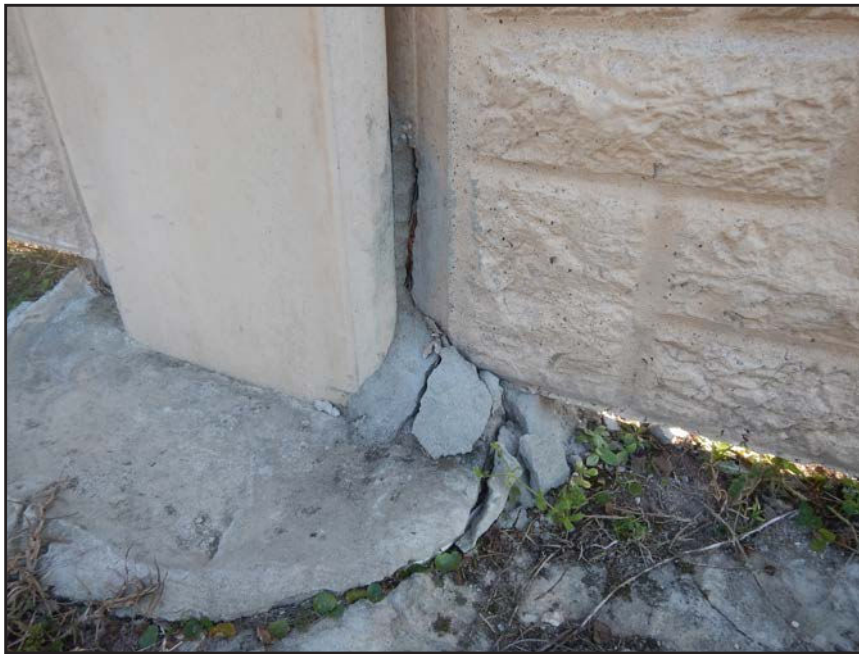
NO. 135 - COLUMN 58S -
INADEQUATE BEARING OF A
PRECAST WALL PANEL ON A
FAILED GROUT PEDESTAL OR A
FAILED PRECAST TONGUE

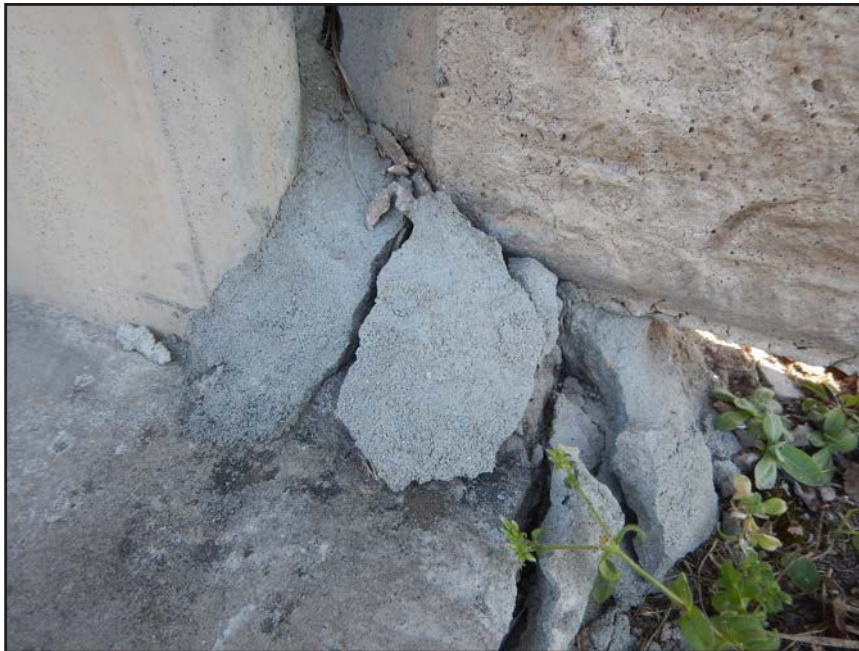
NO. 136 - COLUMN 61S -
INADEQUATE BEARING OF A
PRECAST WALL PANEL ON A
FAILED GROUT PEDESTAL OR A
FAILED PRECAST TONGUE

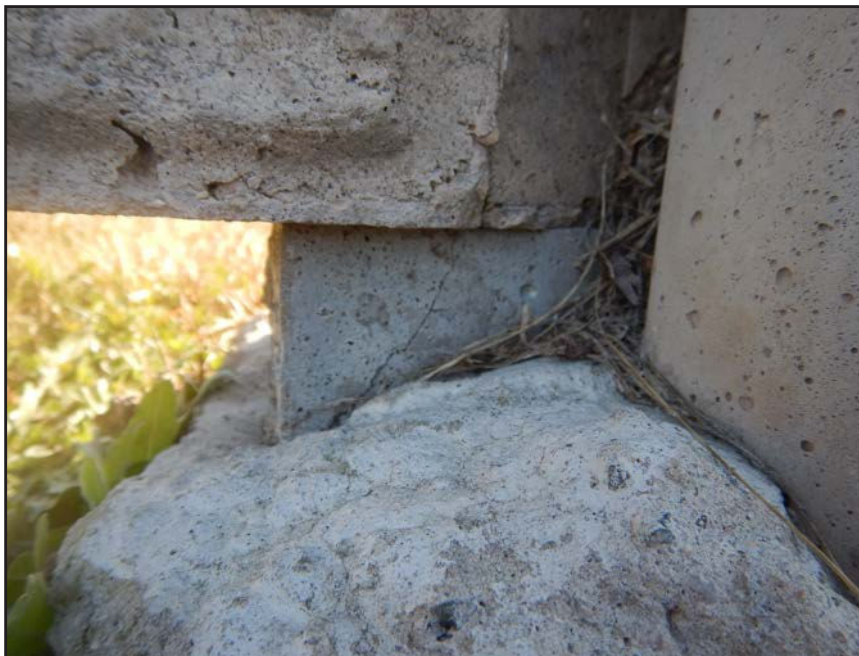
NO. 137 - COLUMN 61S -
INADEQUATE BEARING OF A
PRECAST WALL PANEL ON A
FAILED GROUT PEDESTAL OR A
FAILED PRECAST TONGUE

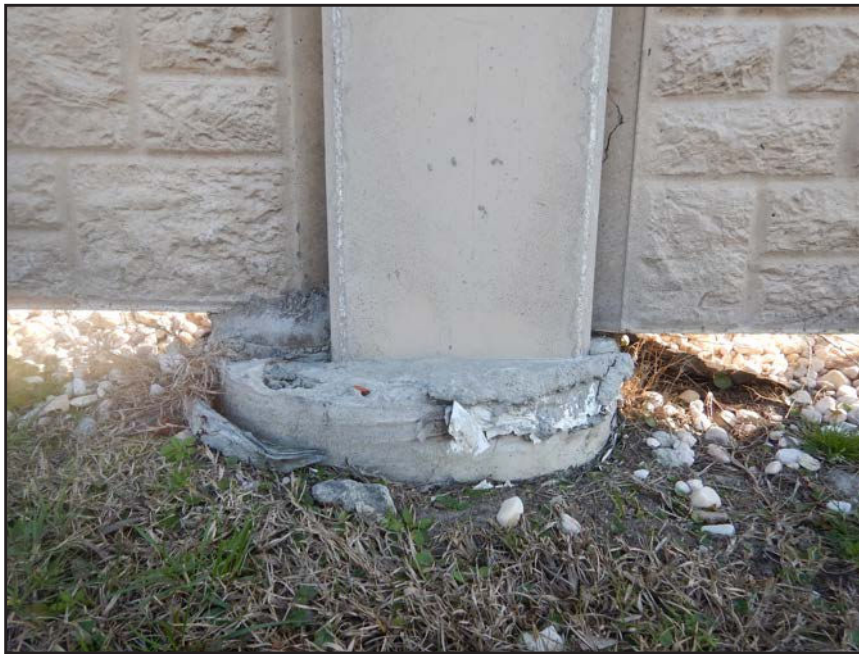
NO. 138 - COLUMN 62S -
INADEQUATE BEARING OF A
PRECAST WALL PANEL ON A
FAILED GROUT PEDESTAL OR A
FAILED PRECAST TONGUE

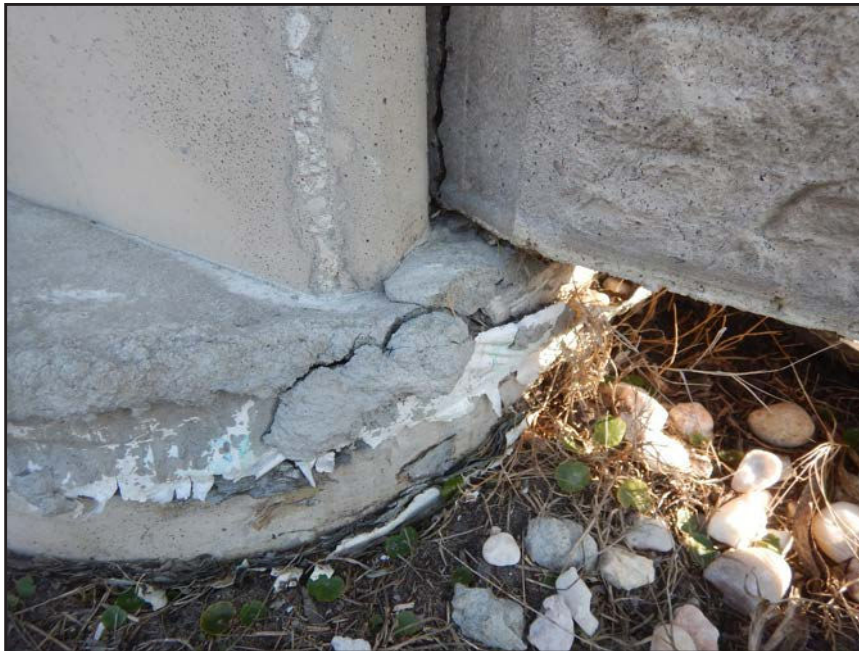
NO. 139 - COLUMN 67S -
INADEQUATE BEARING OF A
PRECAST WALL PANEL ON A
FAILED GROUT PEDESTAL OR A
FAILED PRECAST TONGUE

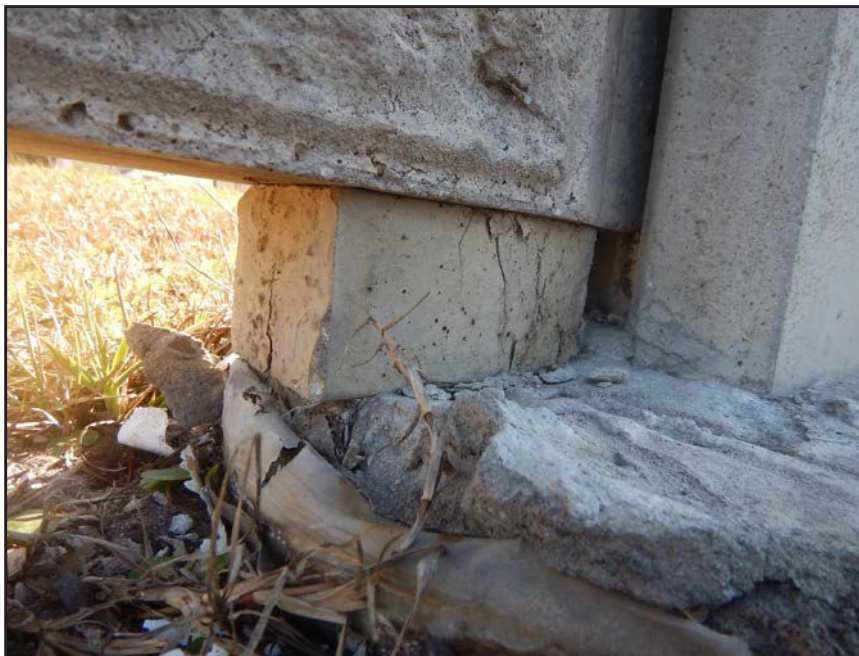
NO. 140 - COLUMN 67S -
INADEQUATE BEARING OF A
PRECAST WALL PANEL ON A
FAILED GROUT PEDESTAL OR A
FAILED PRECAST TONGUE

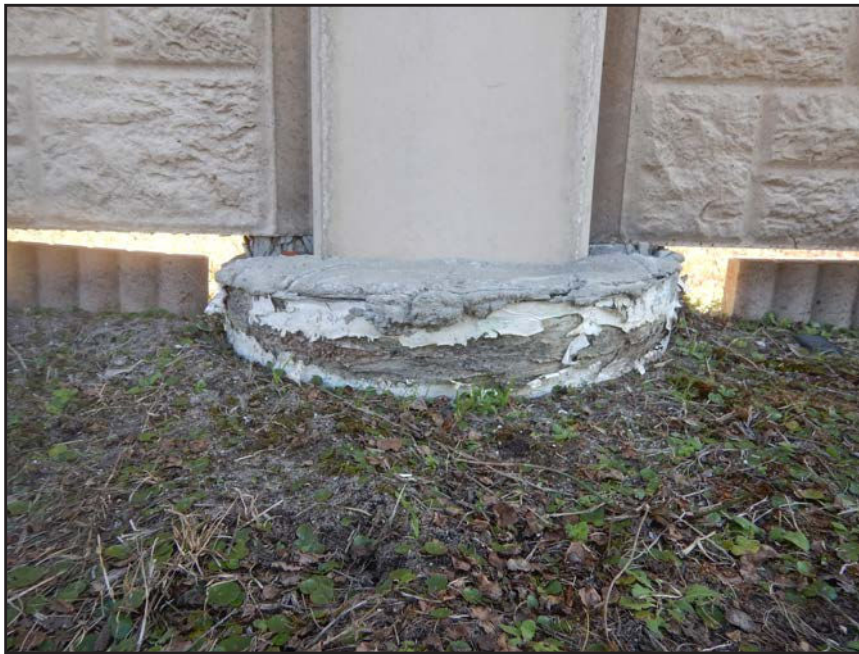
NO. 141 - COLUMN 69S -
INADEQUATE BEARING OF A
PRECAST WALL PANEL ON A
FAILED GROUT PEDESTAL OR A
FAILED PRECAST TONGUE

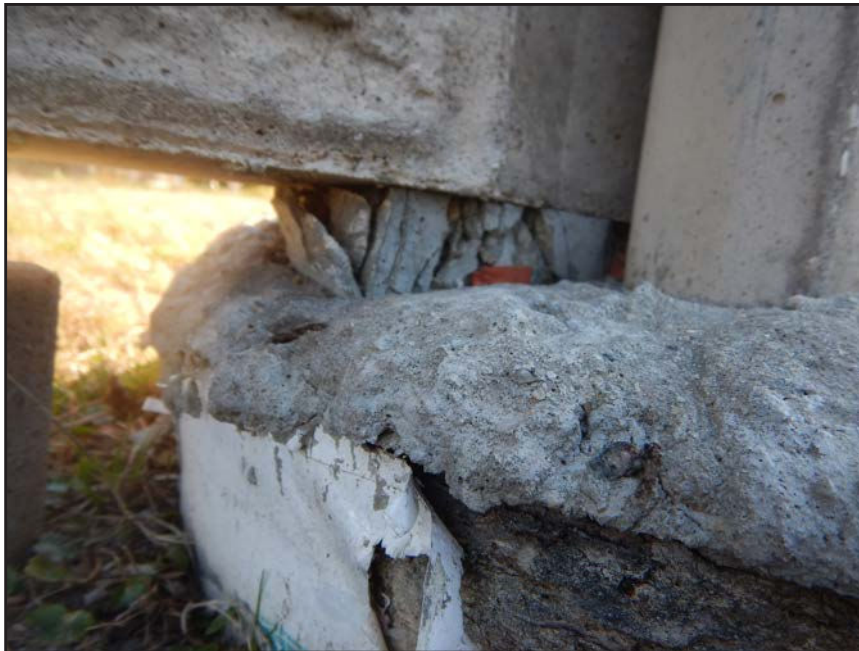
NO. 142 - COLUMN 73S -
INADEQUATE BEARING OF A
PRECAST WALL PANEL ON A
FAILED GROUT PEDESTAL OR A
FAILED PRECAST TONGUE

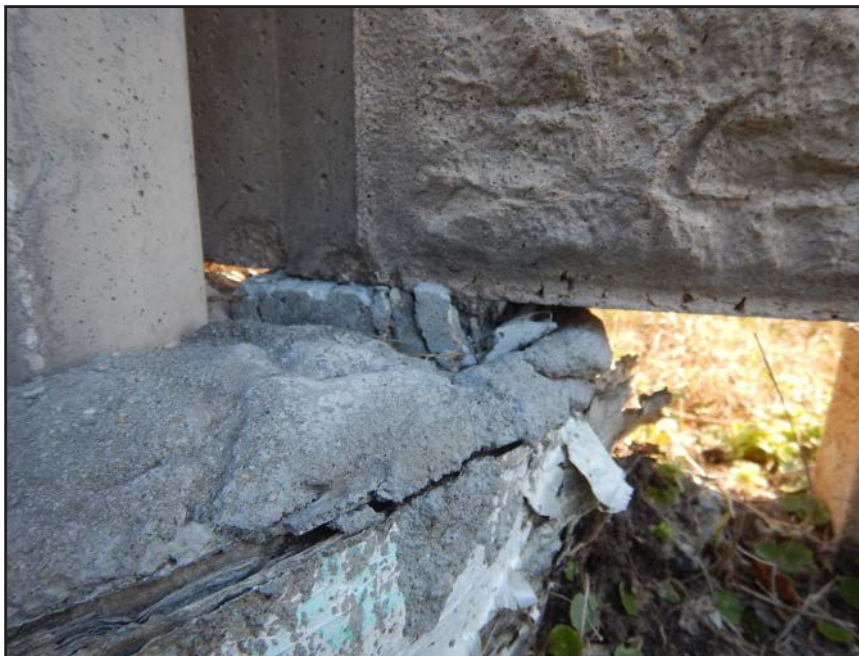
NO. 143 - COLUMN 73S -
INADEQUATE BEARING OF A
PRECAST WALL PANEL ON A
FAILED GROUT PEDESTAL OR A
FAILED PRECAST TONGUE

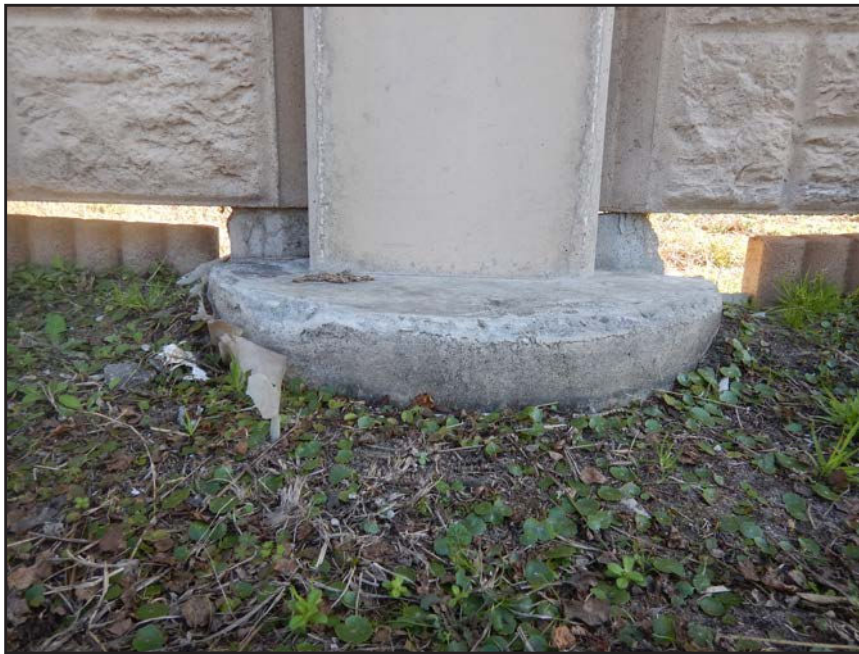
NO. 144 - COLUMN 73S -
INADEQUATE BEARING OF A
PRECAST WALL PANEL ON A
FAILED GROUT PEDESTAL OR A
FAILED PRECAST TONGUE

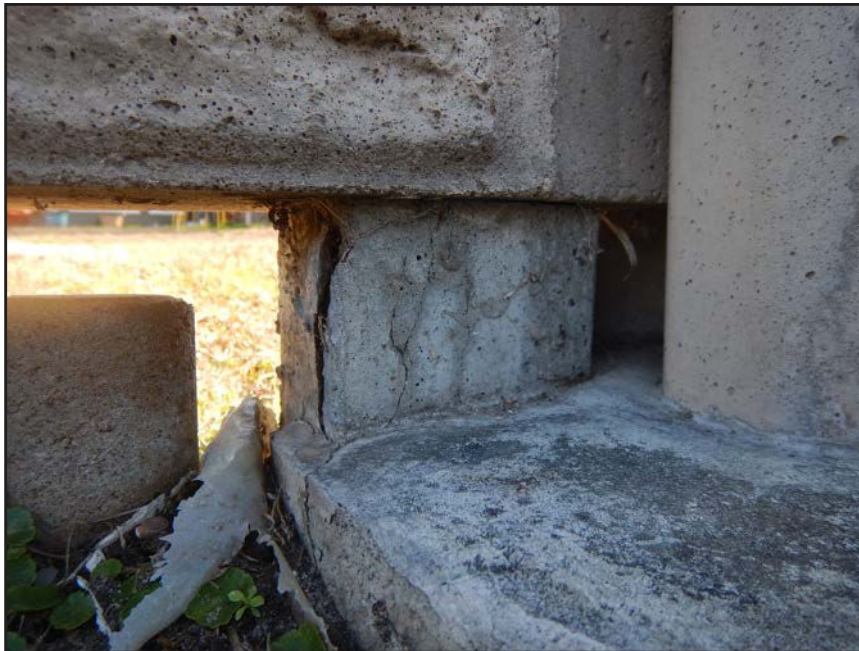
NO. 145 - COLUMN 75S -
INADEQUATE BEARING OF A
PRECAST WALL PANEL ON A
FAILED GROUT PEDESTAL OR A
FAILED PRECAST TONGUE

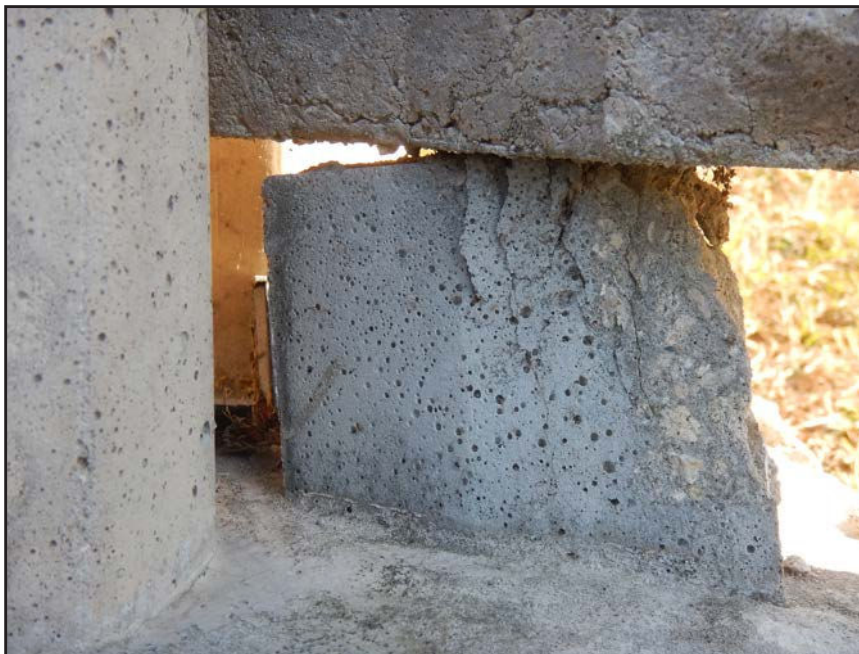
NO. 146 - COLUMN 75S -
INADEQUATE BEARING OF A
PRECAST WALL PANEL ON A
FAILED GROUT PEDESTAL OR A
FAILED PRECAST TONGUE

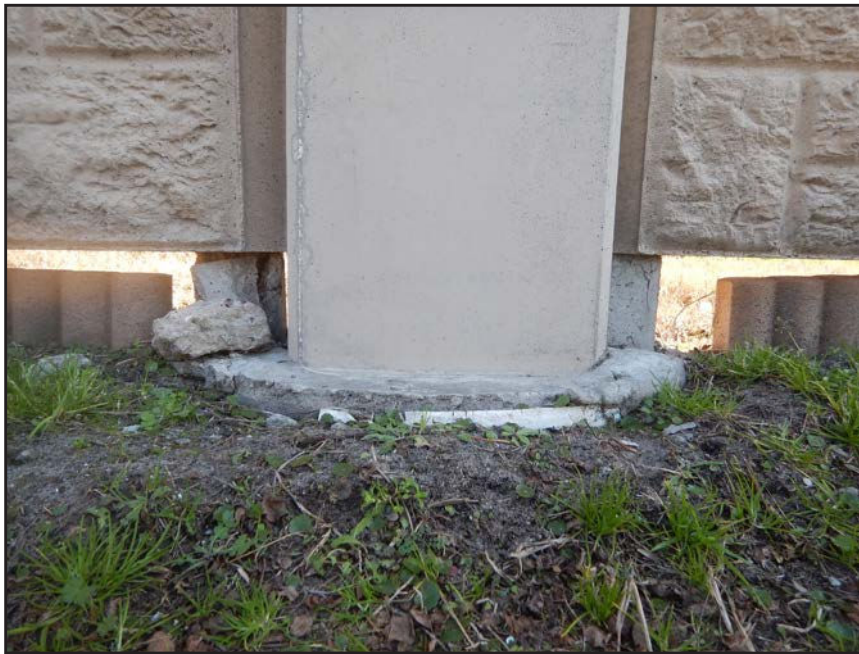
NO. 147 - COLUMN 75S -
INADEQUATE BEARING OF A
PRECAST WALL PANEL ON A
FAILED GROUT PEDESTAL OR A
FAILED PRECAST TONGUE

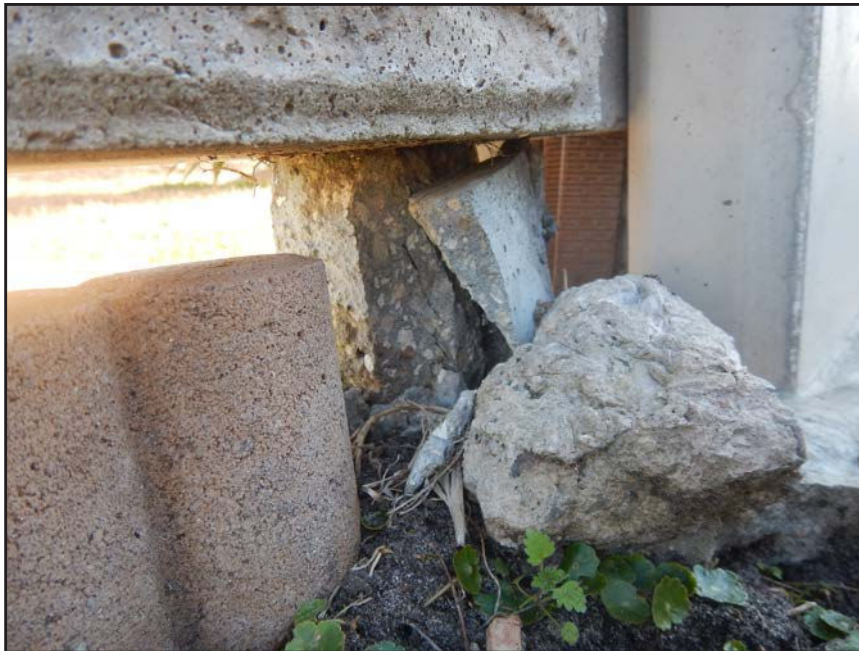
NO. 148 - COLUMN 76S -
INADEQUATE BEARING OF A
PRECAST WALL PANEL ON A
FAILED GROUT PEDESTAL OR A
FAILED PRECAST TONGUE

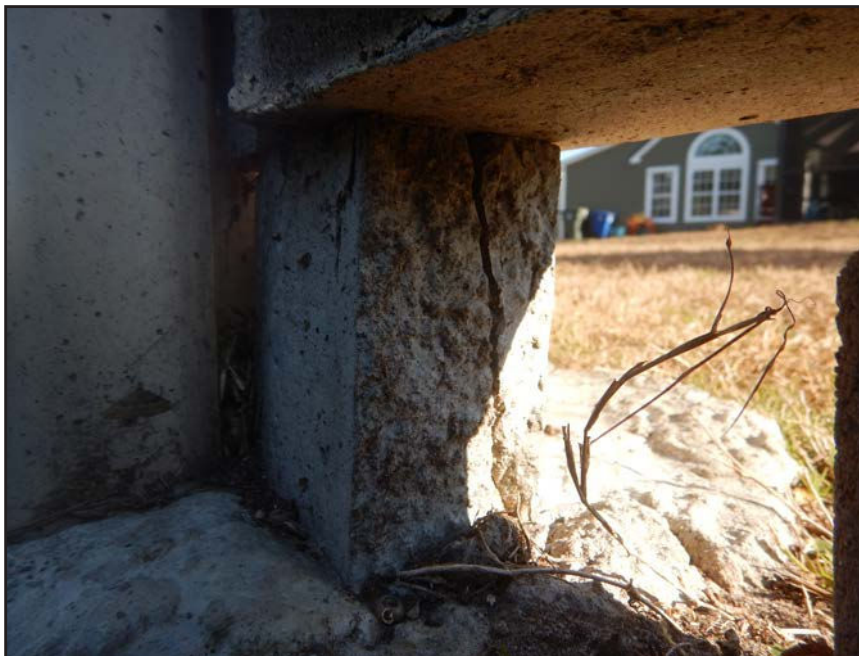
NO. 149 - COLUMN 76S -
INADEQUATE BEARING OF A
PRECAST WALL PANEL ON A
FAILED GROUT PEDESTAL OR A
FAILED PRECAST TONGUE

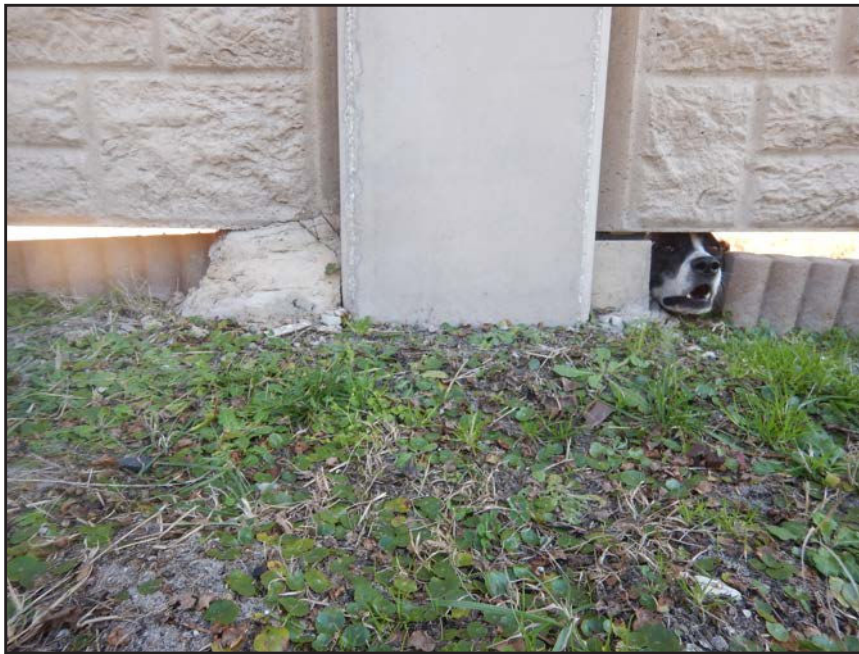
NO. 150 - COLUMN 76S -
INADEQUATE BEARING OF A
PRECAST WALL PANEL ON A
FAILED GROUT PEDESTAL OR A
FAILED PRECAST TONGUE

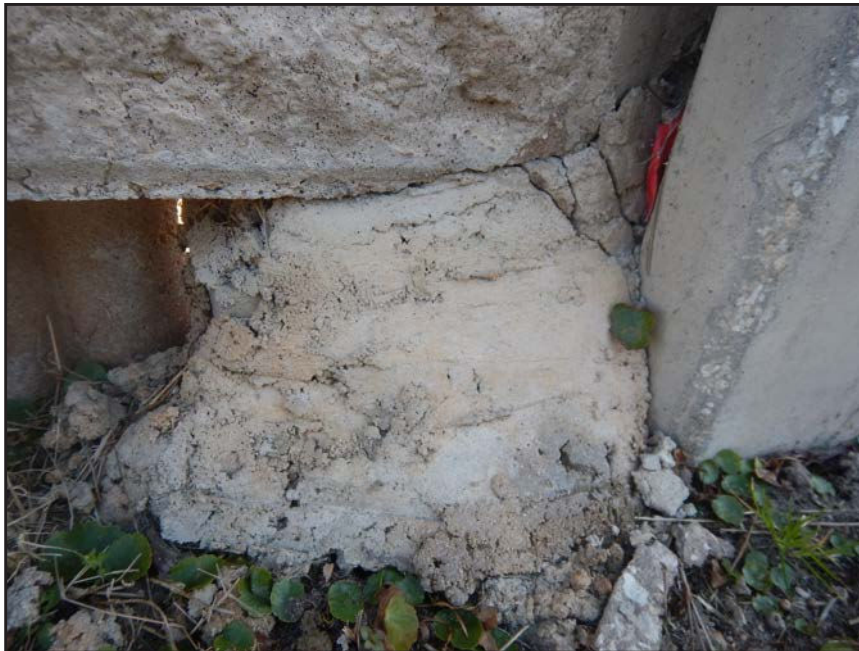
NO. 151 - COLUMN 78S -
INADEQUATE BEARING OF A
PRECAST WALL PANEL ON A
FAILED GROUT PEDESTAL OR A
FAILED PRECAST TONGUE

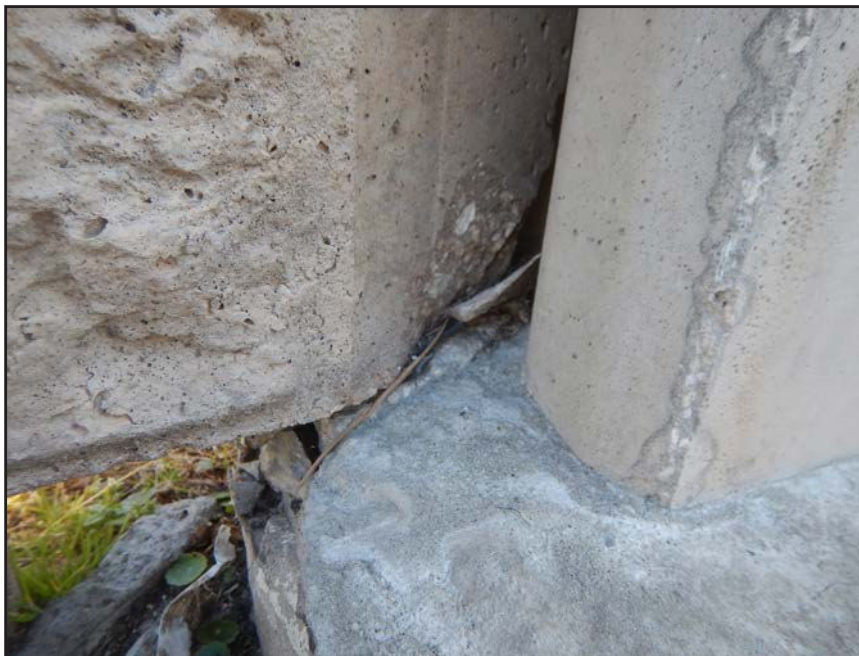
NO. 152 - COLUMN 78S -
INADEQUATE BEARING OF A
PRECAST WALL PANEL ON A
FAILED GROUT PEDESTAL OR A
FAILED PRECAST TONGUE

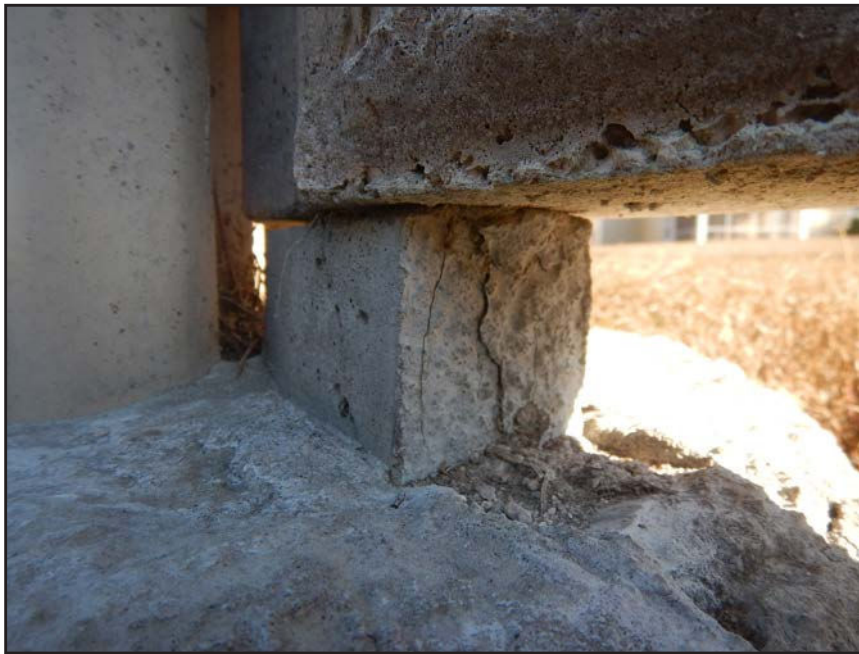
NO. 153 - COLUMN 79S -
INADEQUATE BEARING OF A
PRECAST WALL PANEL ON A
FAILED GROUT PEDESTAL OR A
FAILED PRECAST TONGUE

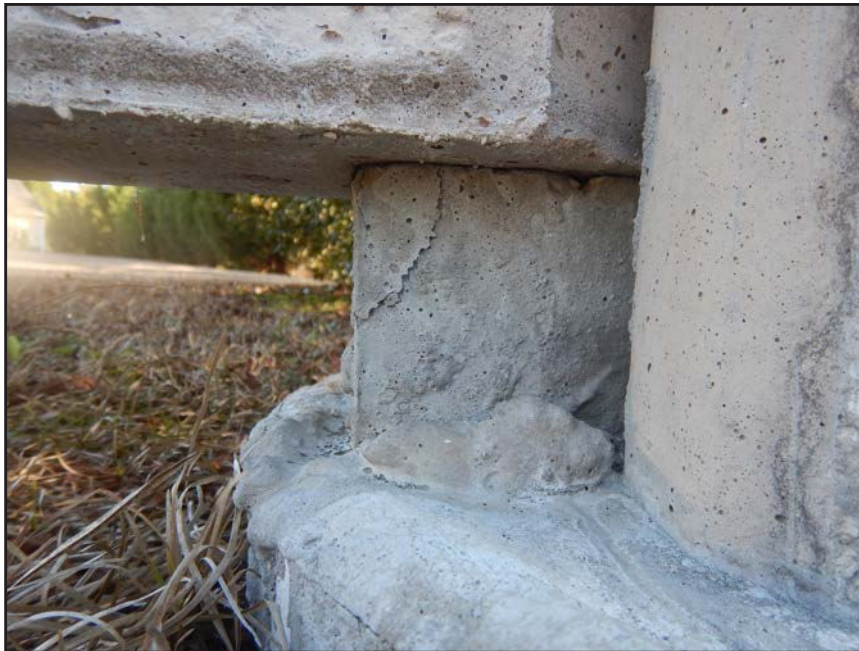
NO. 154 - COLUMN 80S -
INADEQUATE BEARING OF A
PRECAST WALL PANEL ON A
FAILED GROUT PEDESTAL OR A
FAILED PRECAST TONGUE

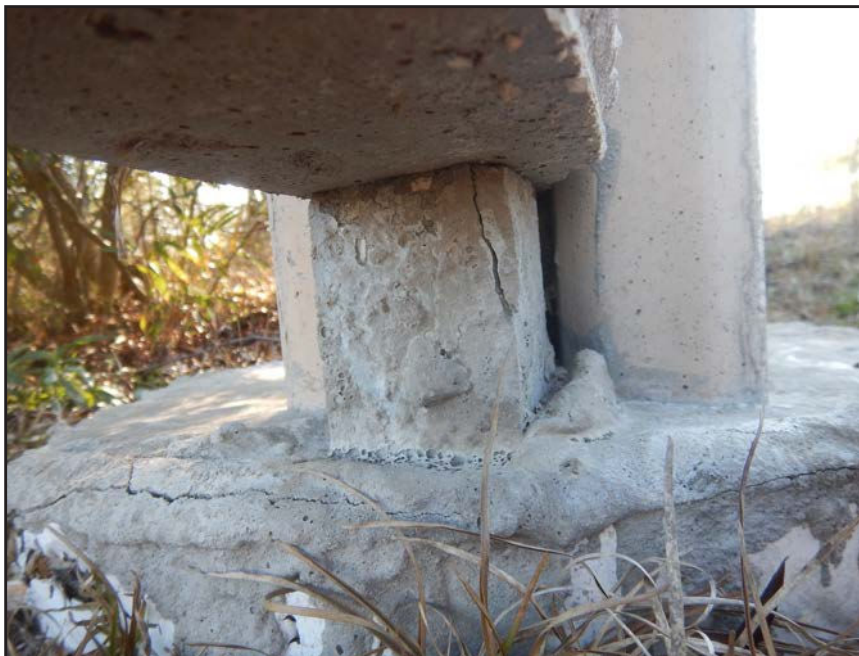
NO. 155 - COLUMN 82S -
INADEQUATE BEARING OF A
PRECAST WALL PANEL ON A
FAILED GROUT PEDESTAL OR A
FAILED PRECAST TONGUE

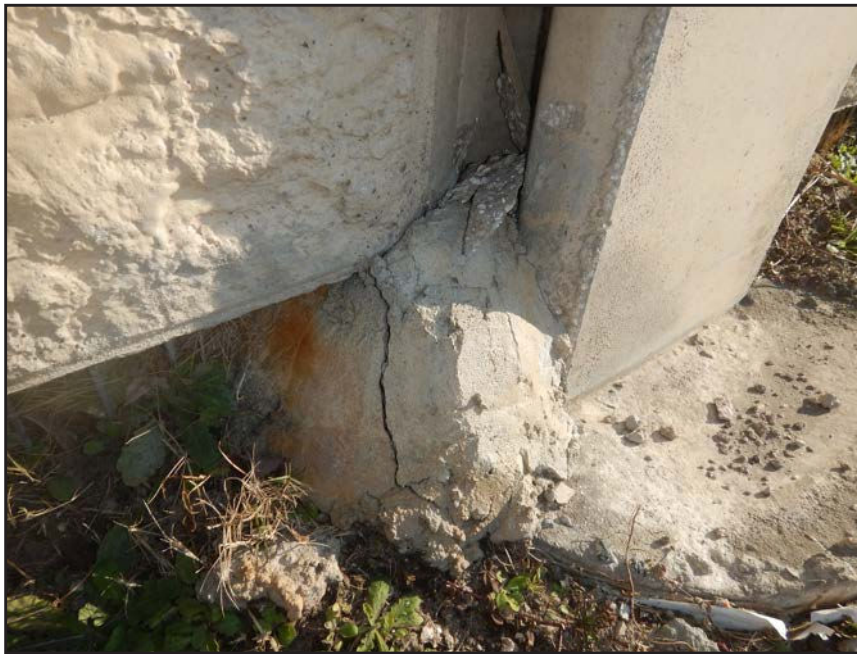
NO. 156 - COLUMN 82S -
INADEQUATE BEARING OF A
PRECAST WALL PANEL ON A
FAILED GROUT PEDESTAL OR A
FAILED PRECAST TONGUE

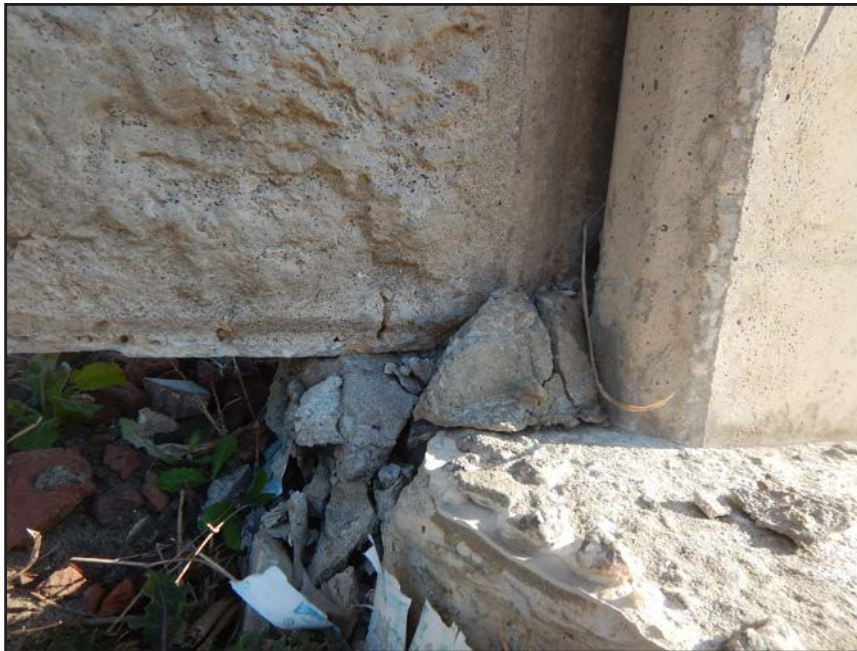
NO. 157 - COLUMN 6SS -
INADEQUATE BEARING OF A
PRECAST WALL PANEL ON A
FAILED GROUT PEDESTAL OR A
FAILED PRECAST TONGUE

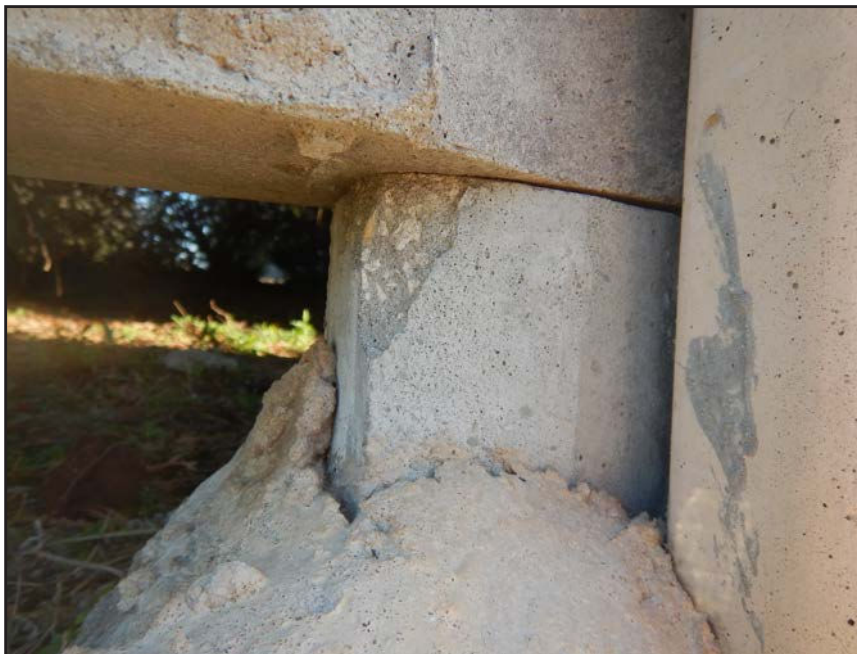
NO. 158 - COLUMN 9SS -
INADEQUATE BEARING OF A
PRECAST WALL PANEL ON A
FAILED GROUT PEDESTAL OR A
FAILED PRECAST TONGUE

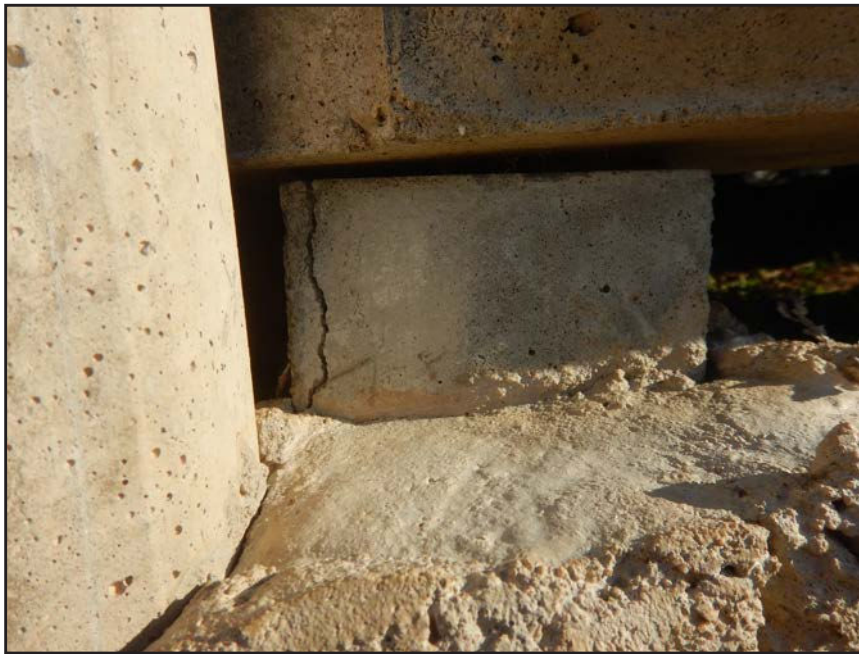
NO. 159 - COLUMN 13SS -
INADEQUATE BEARING OF A
PRECAST WALL PANEL ON A
FAILED GROUT PEDESTAL OR A
FAILED PRECAST TONGUE

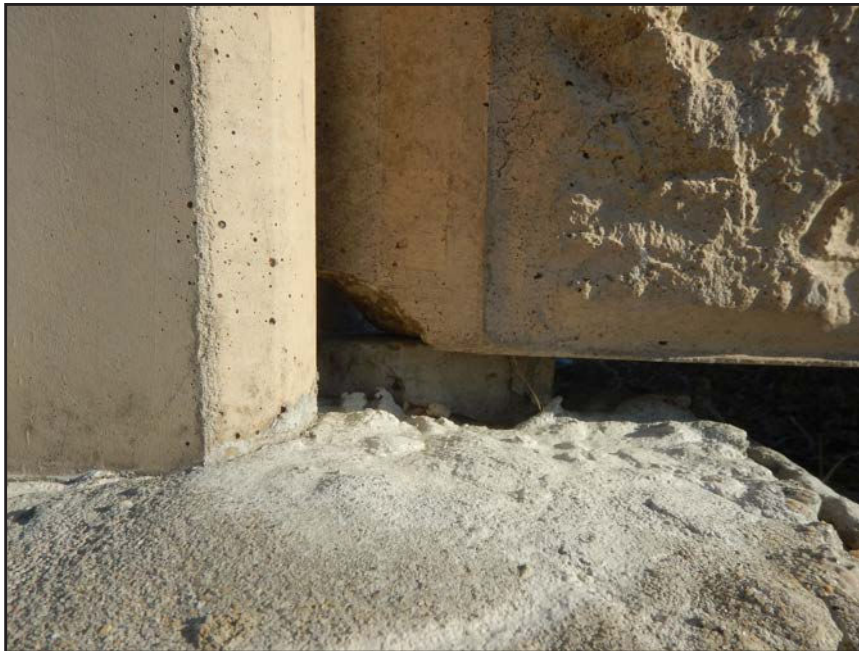
NO. 160 - COLUMN 13SS -
INADEQUATE BEARING OF A
PRECAST WALL PANEL ON A
FAILED GROUT PEDESTAL OR A
FAILED PRECAST TONGUE

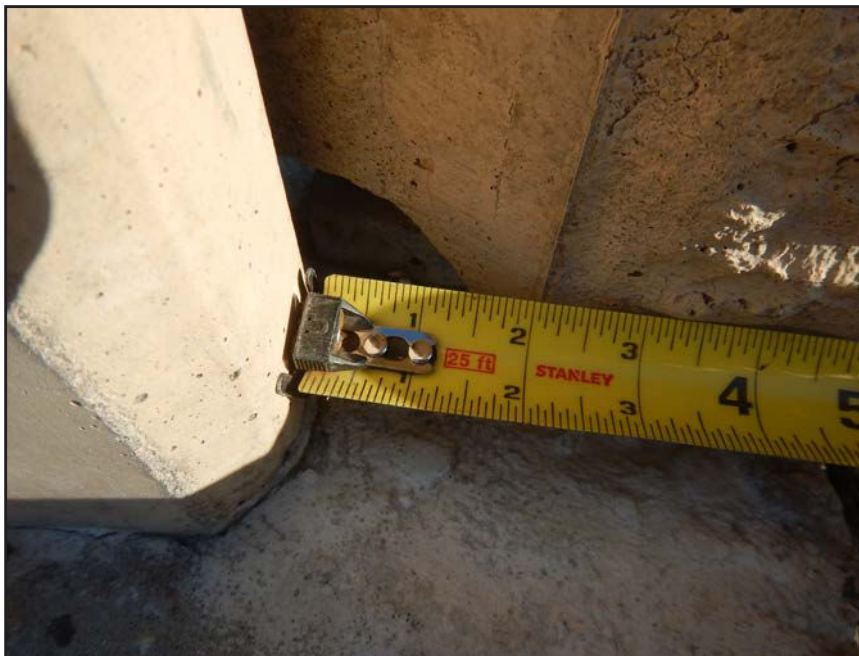
NO. 161 - COLUMN 16SS -
INADEQUATE BEARING OF A
PRECAST WALL PANEL ON A
FAILED GROUT PEDESTAL OR A
FAILED PRECAST TONGUE

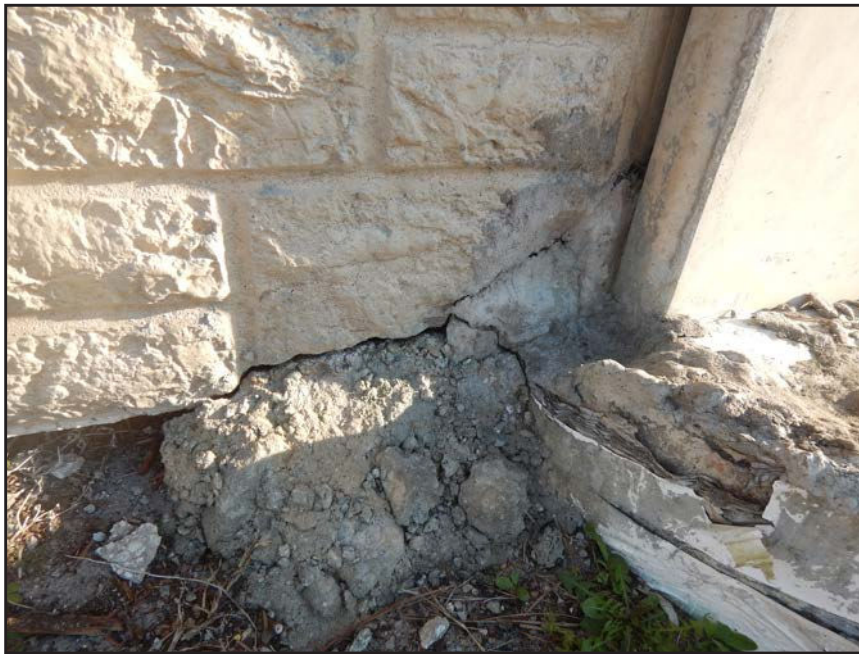
NO. 162 - COLUMN 16SS -
INADEQUATE BEARING OF A
PRECAST WALL PANEL ON A
FAILED GROUT PEDESTAL OR A
FAILED PRECAST TONGUE

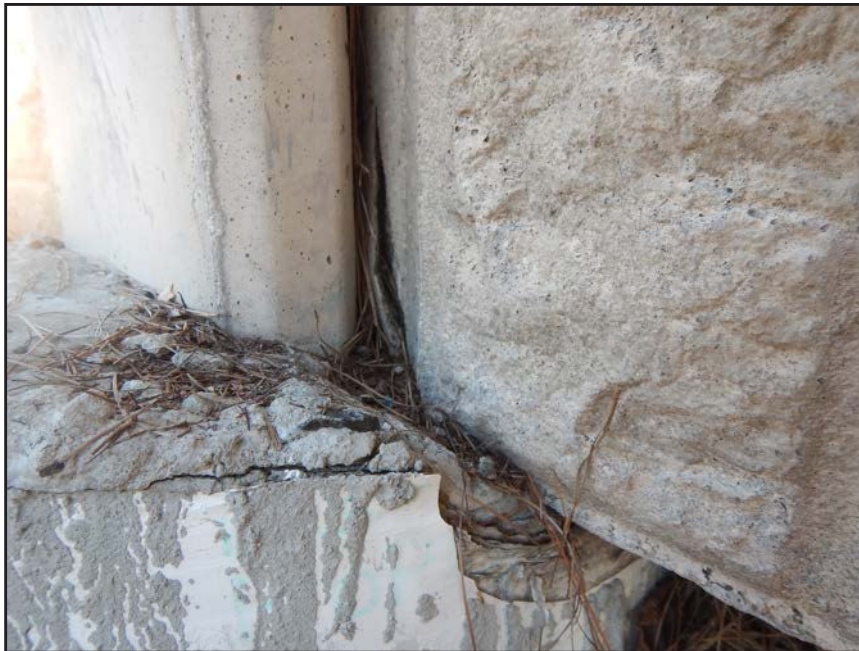
NO. 163 - COLUMN 21SS -
INADEQUATE BEARING OF A
PRECAST WALL PANEL ON A
FAILED GROUT PEDESTAL OR A
FAILED PRECAST TONGUE

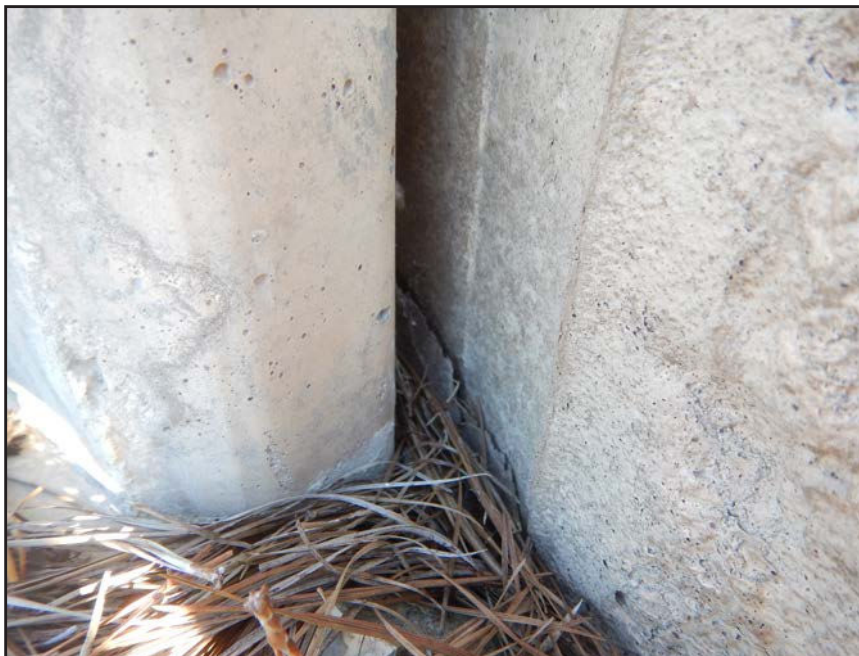
NO. 164 - COLUMN 24SS -
INADEQUATE BEARING OF A
PRECAST WALL PANEL ON A
FAILED GROUT PEDESTAL OR A
FAILED PRECAST TONGUE

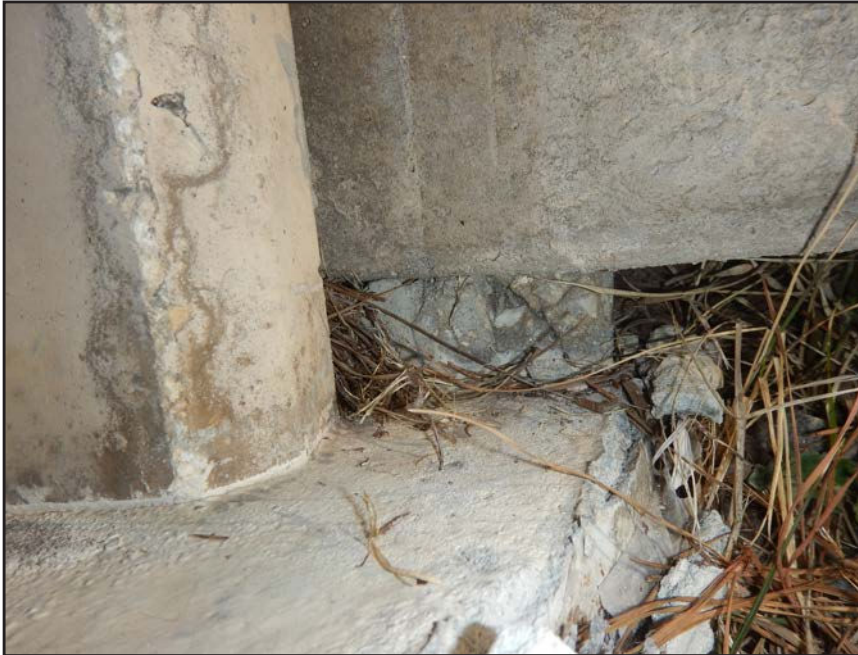
NO. 165 - COLUMN 26SS -
INADEQUATE BEARING OF A
PRECAST WALL PANEL ON A
FAILED GROUT PEDESTAL OR A
FAILED PRECAST TONGUE

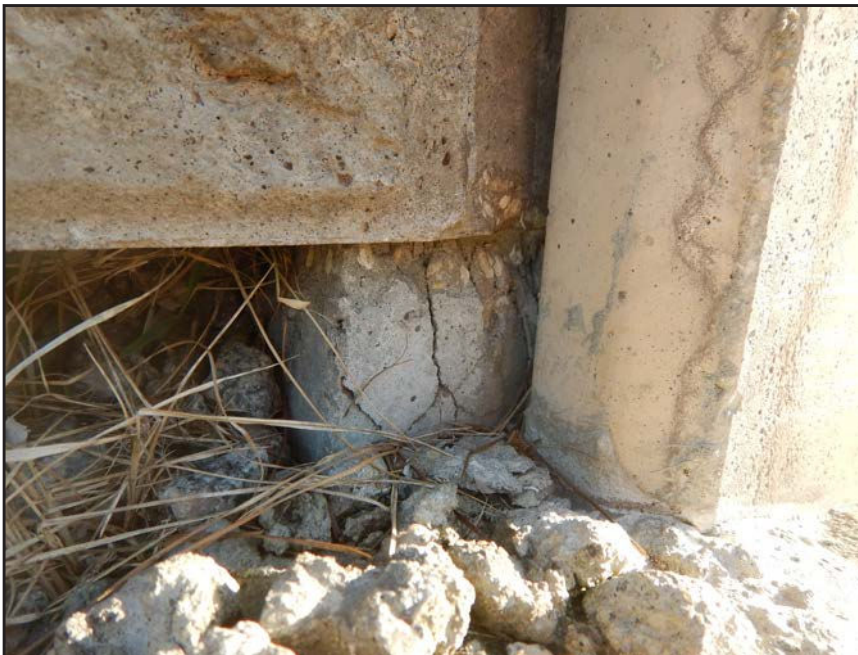
NO. 166 - COLUMN 27SS -
INADEQUATE BEARING OF A
PRECAST WALL PANEL ON A
FAILED GROUT PEDESTAL OR A
FAILED PRECAST TONGUE

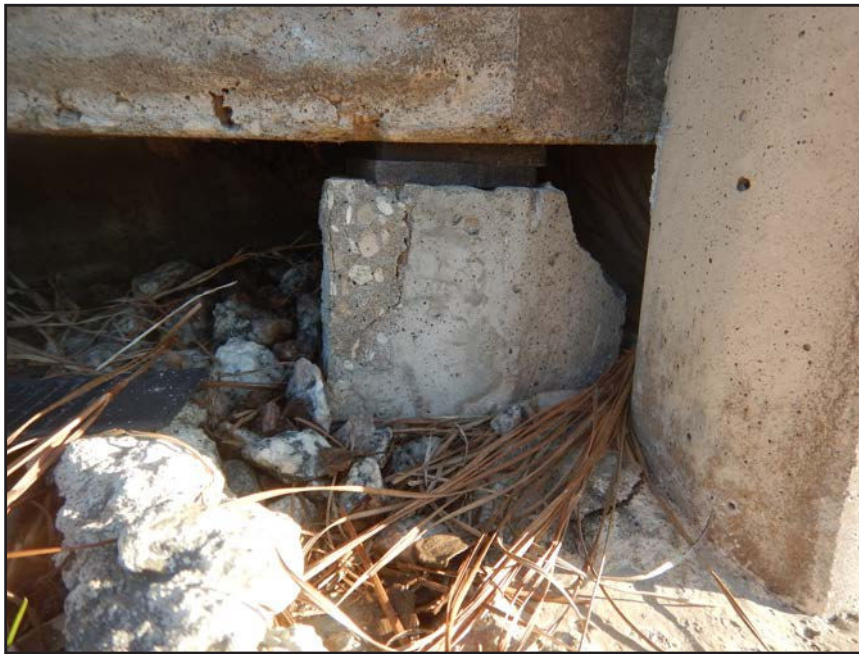
NO. 167 - COLUMN 29SS -
INADEQUATE BEARING OF A
PRECAST WALL PANEL ON A
FAILED GROUT PEDESTAL OR A
FAILED PRECAST TONGUE

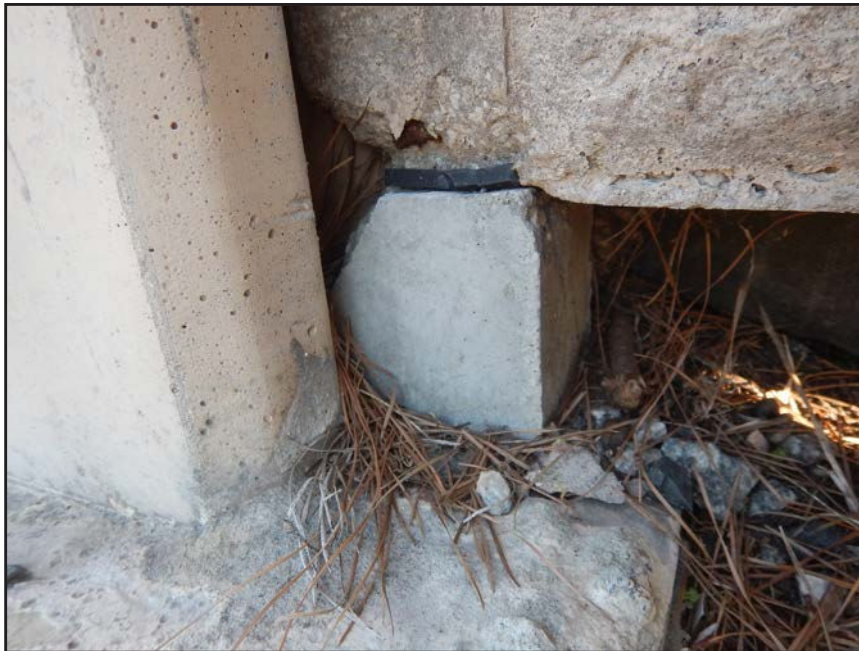
NO. 168 - COLUMN 32SS -
INADEQUATE BEARING OF A
PRECAST WALL PANEL ON A
FAILED GROUT PEDESTAL OR A
FAILED PRECAST TONGUE

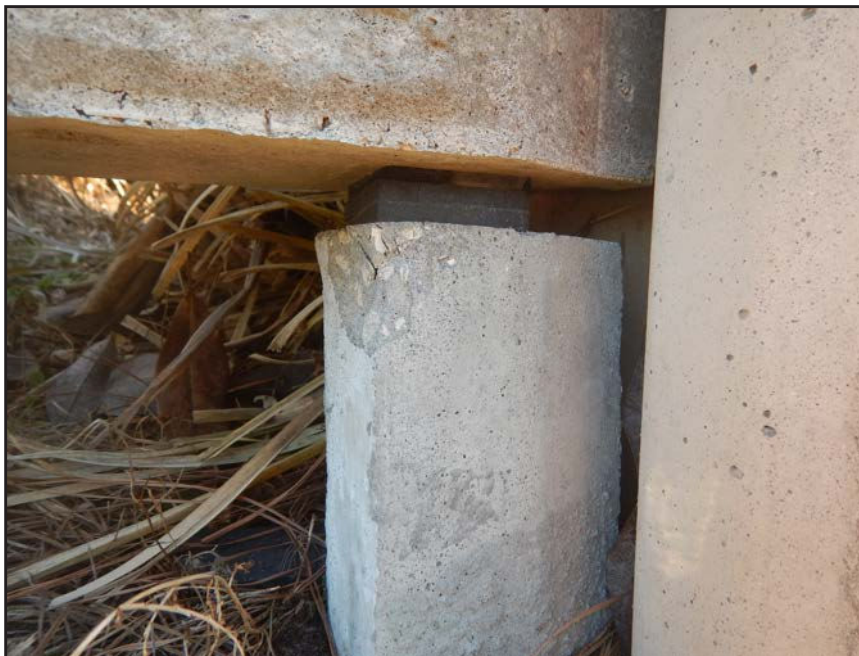
NO. 169 - COLUMN 32SS -
INADEQUATE BEARING OF A
PRECAST WALL PANEL ON A
FAILED GROUT PEDESTAL OR A
FAILED PRECAST TONGUE

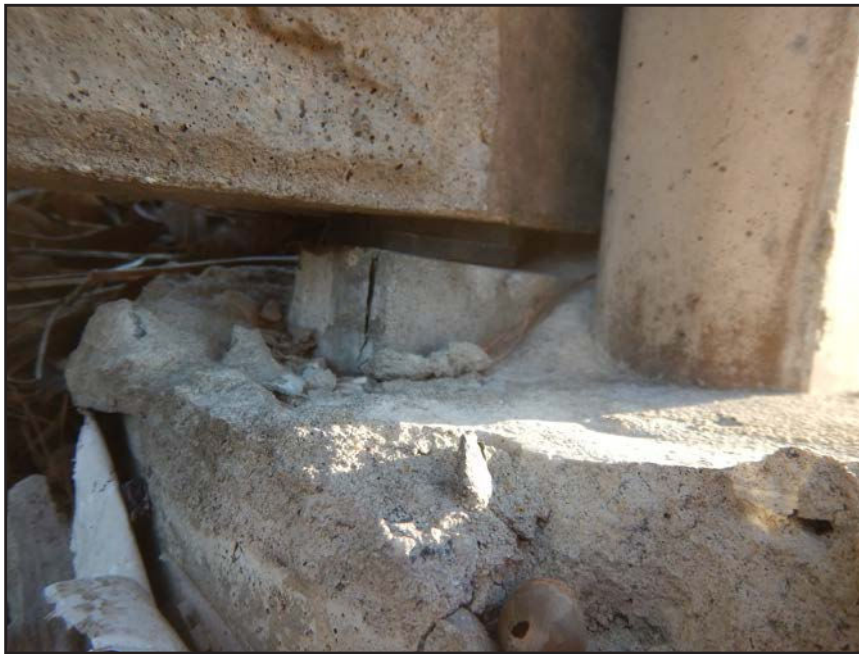
NO. 170 - COLUMN 33SS -
INADEQUATE BEARING OF A
PRECAST WALL PANEL ON A
FAILED GROUT PEDESTAL OR A
FAILED PRECAST TONGUE

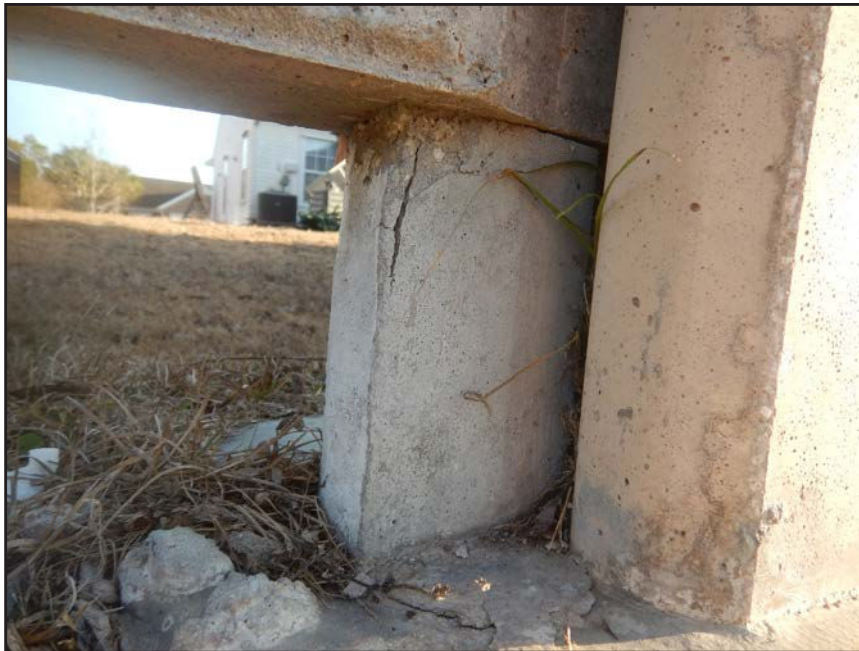
NO. 171 - COLUMN 35SS -
INADEQUATE BEARING OF A
PRECAST WALL PANEL ON A
FAILED GROUT PEDESTAL OR A
FAILED PRECAST TONGUE

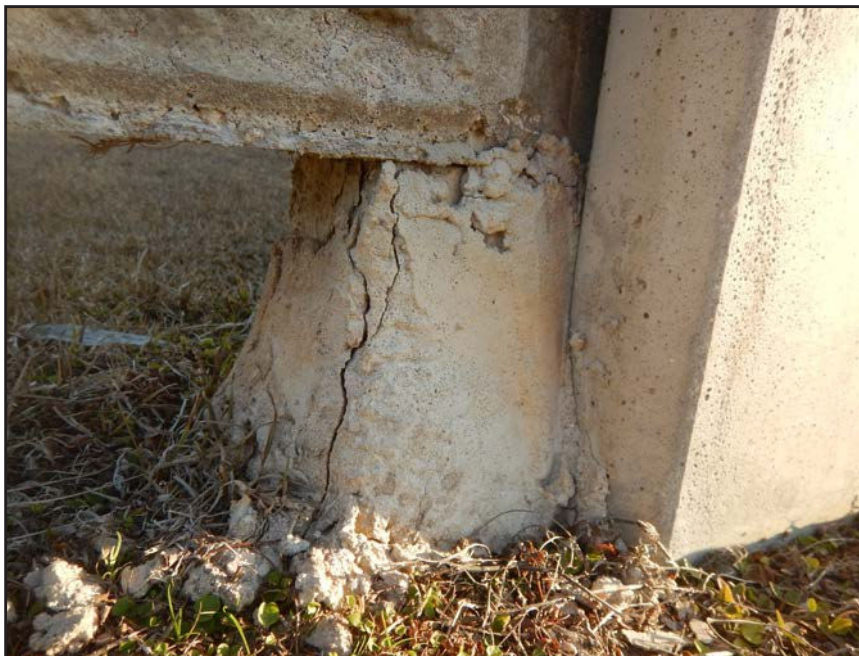
NO. 172 - COLUMN 43SS -
INADEQUATE BEARING OF A
PRECAST WALL PANEL ON A
FAILED GROUT PEDESTAL OR A
FAILED PRECAST TONGUE
