WATER TOWER ROAD SCREEN WALL INVESTIGATIONS

Water Tower Road
Longs, South Carolina

Stantec Project No. 171015900

March 31, 2025

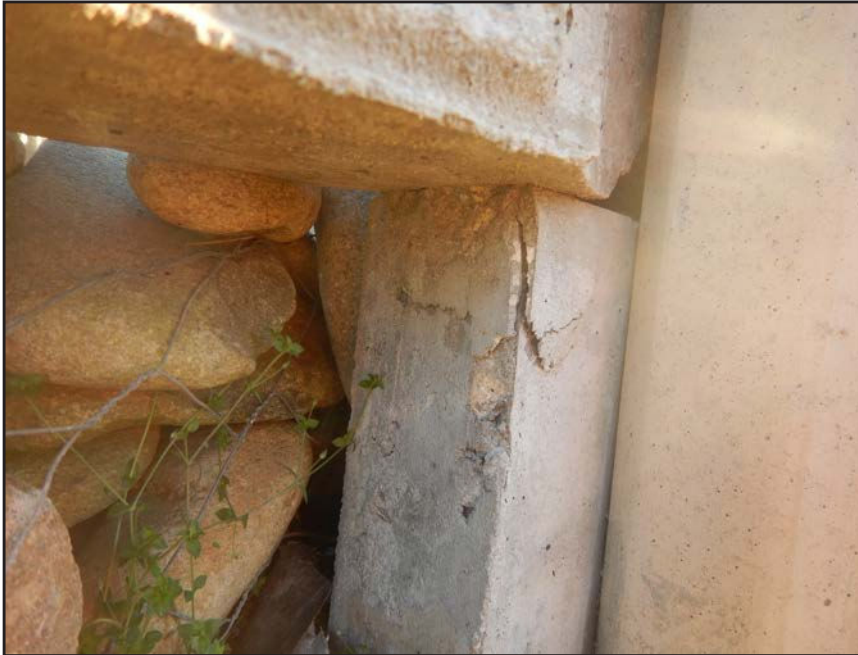
NO. 173 - COLUMN 45SS -
INADEQUATE BEARING OF A
PRECAST WALL PANEL ON A
FAILED GROUT PEDESTAL OR A
FAILED PRECAST TONGUE

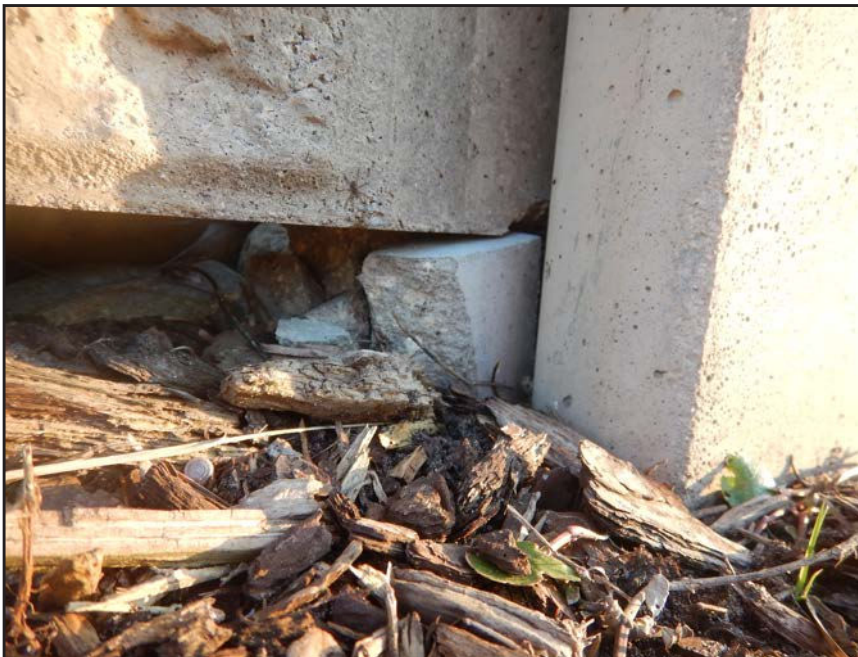
NO. 174 - COLUMN 50SS -
INADEQUATE BEARING OF A
PRECAST WALL PANEL ON A
FAILED GROUT PEDESTAL OR A
FAILED PRECAST TONGUE

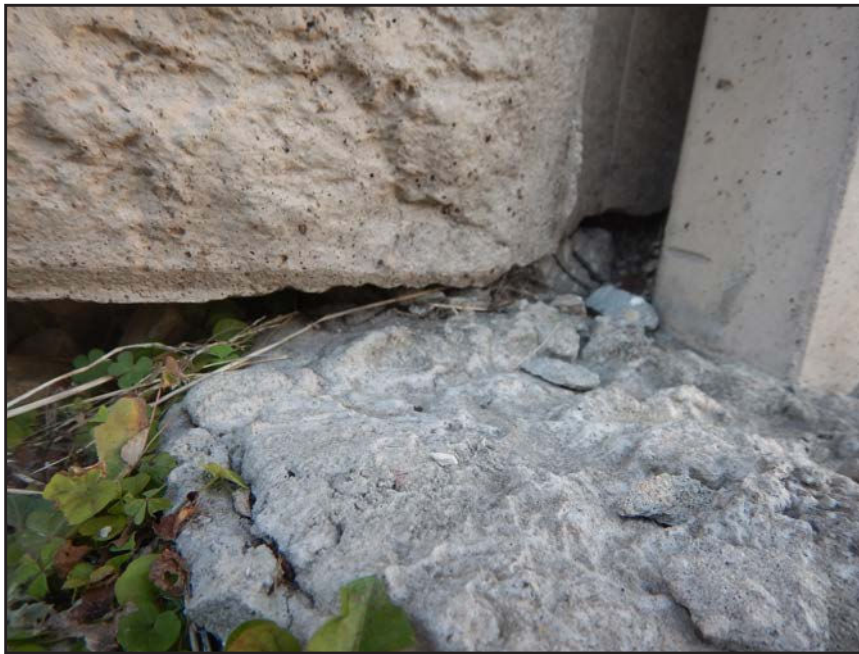
NO. 175 - COLUMN 56SS -
INADEQUATE BEARING OF A
PRECAST WALL PANEL ON A
FAILED GROUT PEDESTAL OR A
FAILED PRECAST TONGUE

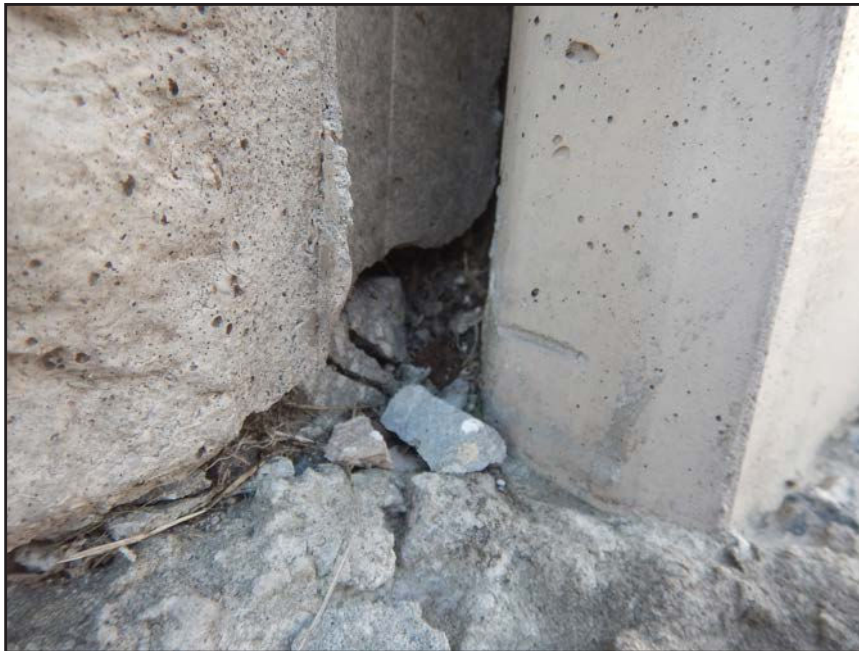
NO. 176 - COLUMN 64SS -
INADEQUATE BEARING OF A
PRECAST WALL PANEL ON A
FAILED GROUT PEDESTAL OR A
FAILED PRECAST TONGUE

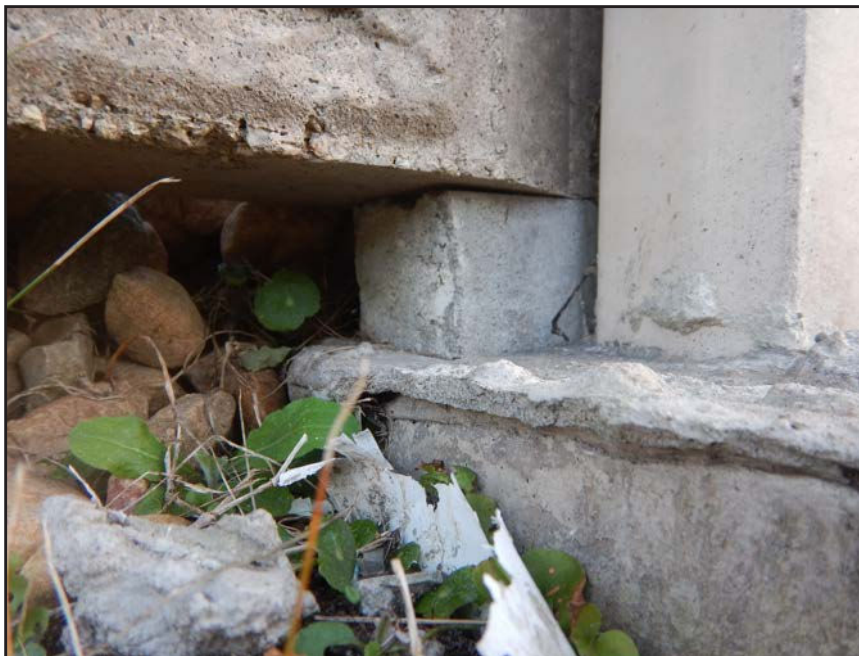
NO. 177 - COLUMN 64SS -
INADEQUATE BEARING OF A
PRECAST WALL PANEL ON A
FAILED GROUT PEDESTAL OR A
FAILED PRECAST TONGUE

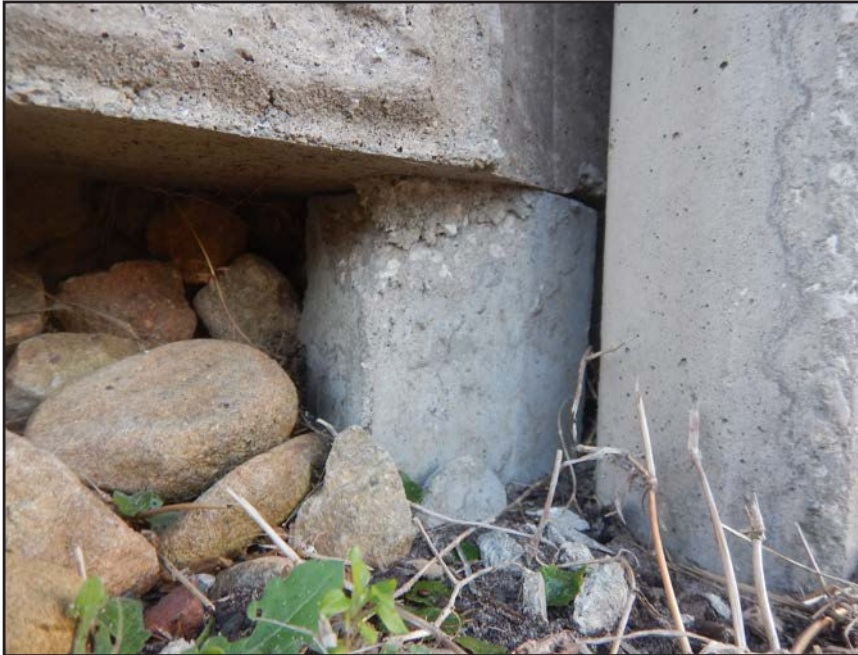
NO. 178 - COLUMN 65SS -
INADEQUATE BEARING OF A
PRECAST WALL PANEL ON A
FAILED GROUT PEDESTAL OR A
FAILED PRECAST TONGUE

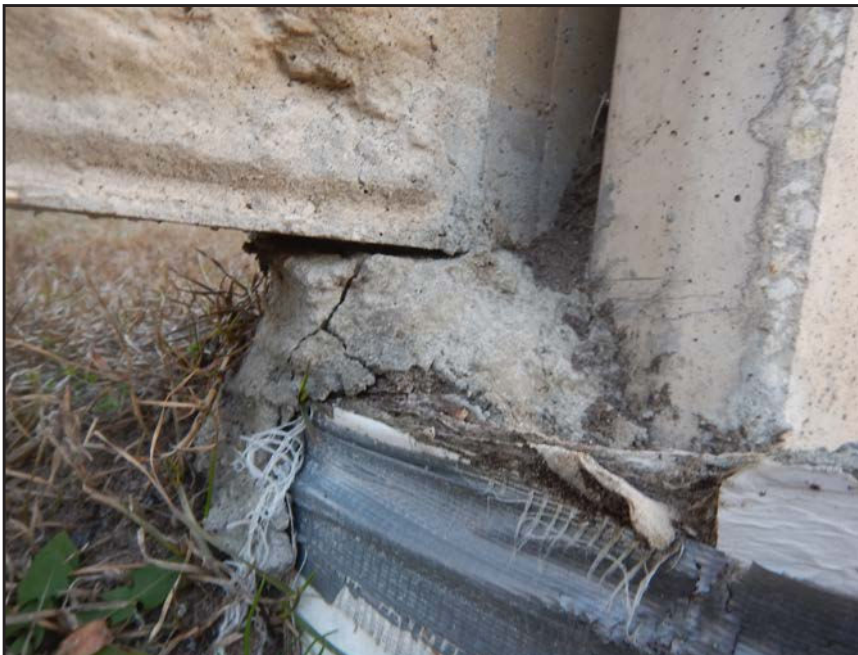
NO. 179 - COLUMN 66SS -
INADEQUATE BEARING OF A
PRECAST WALL PANEL ON A
FAILED GROUT PEDESTAL OR A
FAILED PRECAST TONGUE

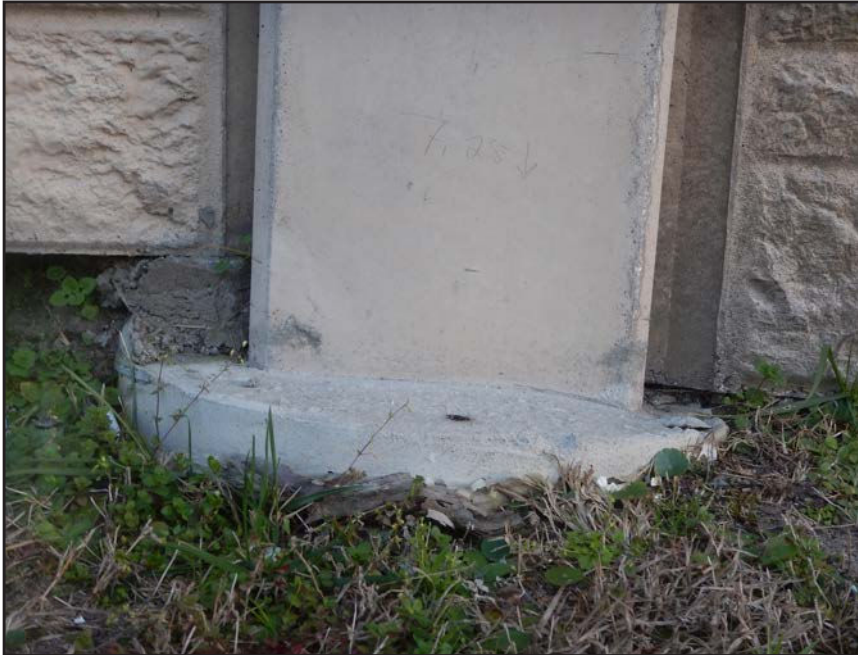
NO. 180 - COLUMN 69SS -
INADEQUATE BEARING OF A
PRECAST WALL PANEL ON A
FAILED GROUT PEDESTAL OR A
FAILED PRECAST TONGUE

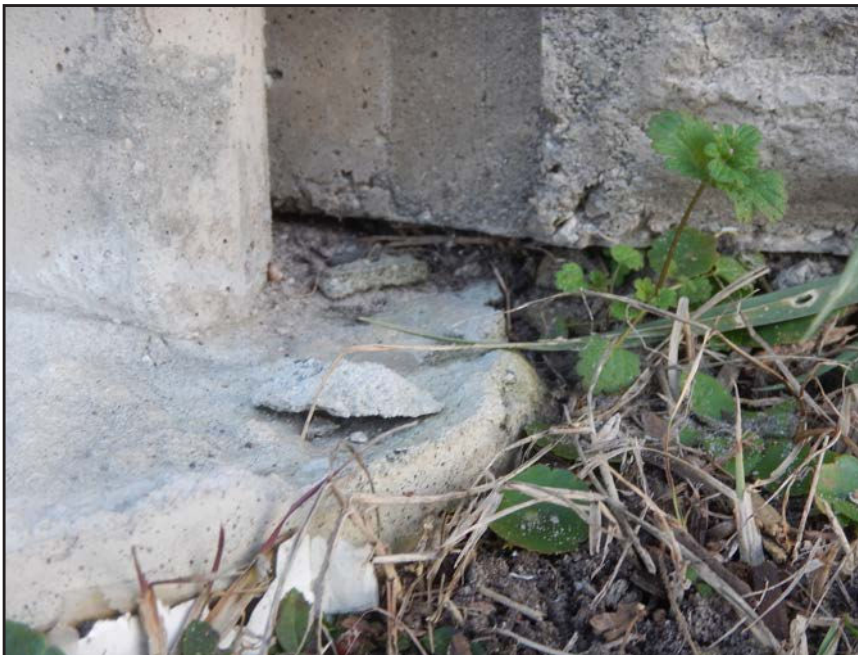
NO. 181 - COLUMN 71SS -
INADEQUATE BEARING OF A
PRECAST WALL PANEL ON A
FAILED GROUT PEDESTAL OR A
FAILED PRECAST TONGUE

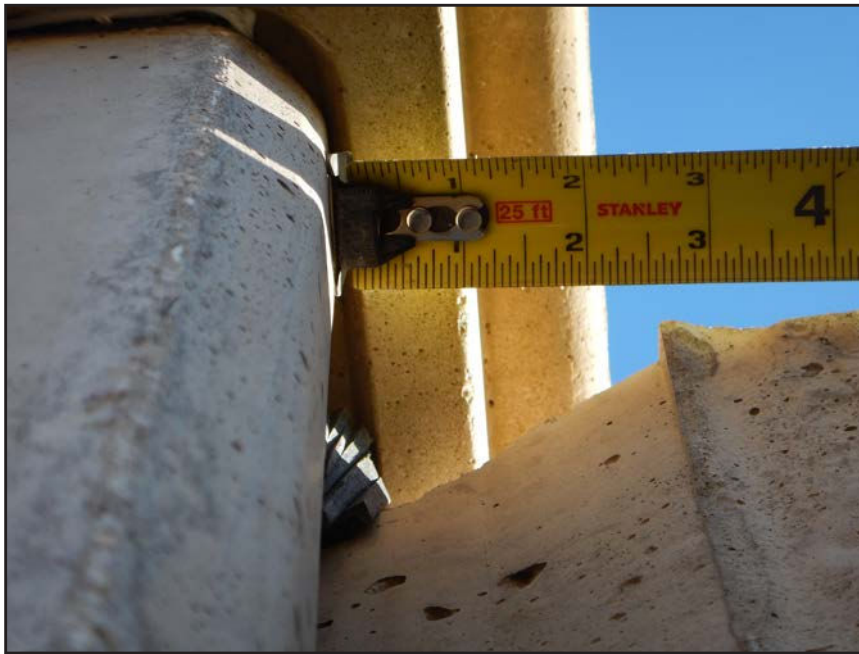
NO. 182 - COLUMN 71SS -
INADEQUATE BEARING OF A
PRECAST WALL PANEL ON A
FAILED GROUT PEDESTAL OR A
FAILED PRECAST TONGUE

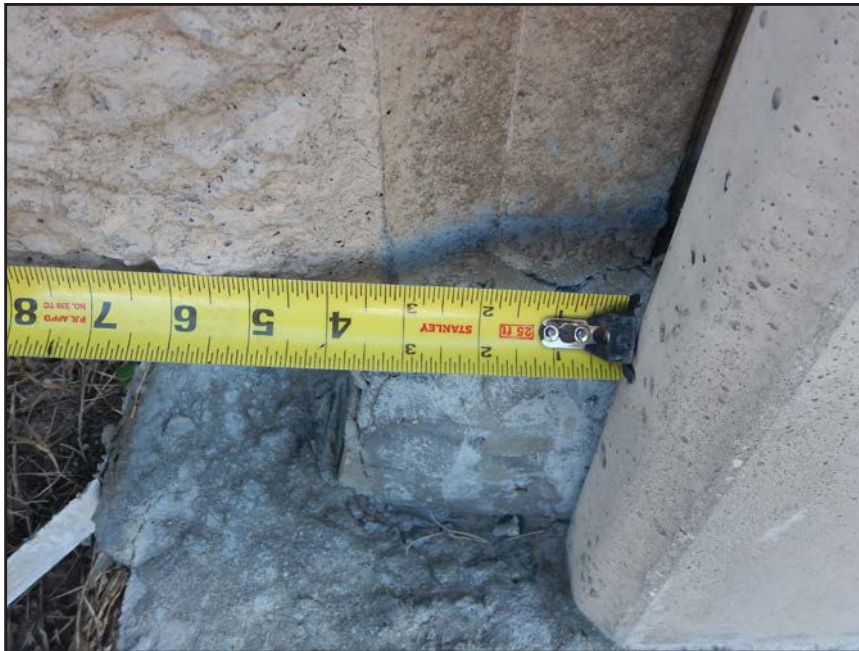
NO. 183 - COLUMN 3N -
INSUFFICIENT SEATING OF A
PRECAST WALL PANEL IN A
PRECAST COLUMN

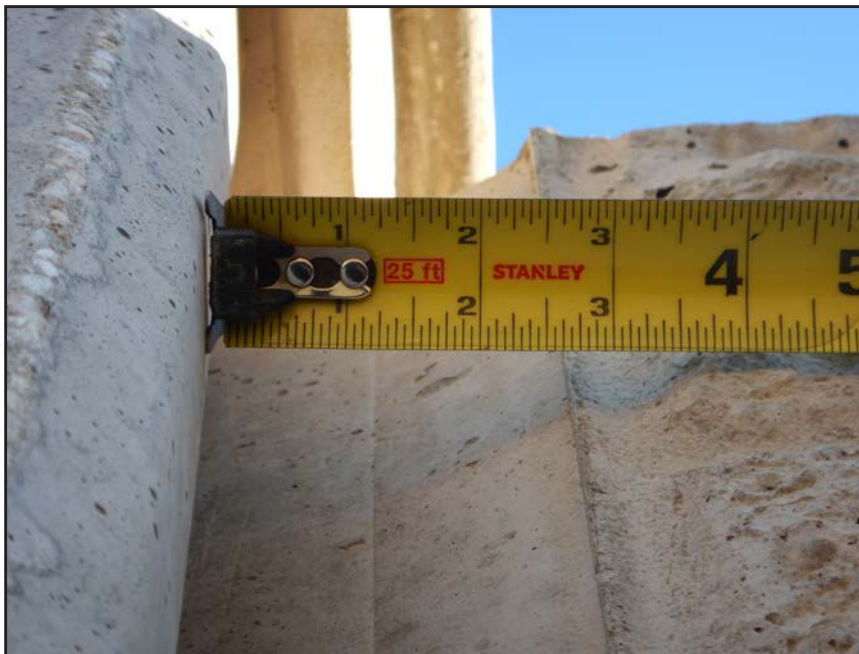
NO. 184 - COLUMN 12N -
INSUFFICIENT SEATING OF A
PRECAST WALL PANEL IN A
PRECAST COLUMN

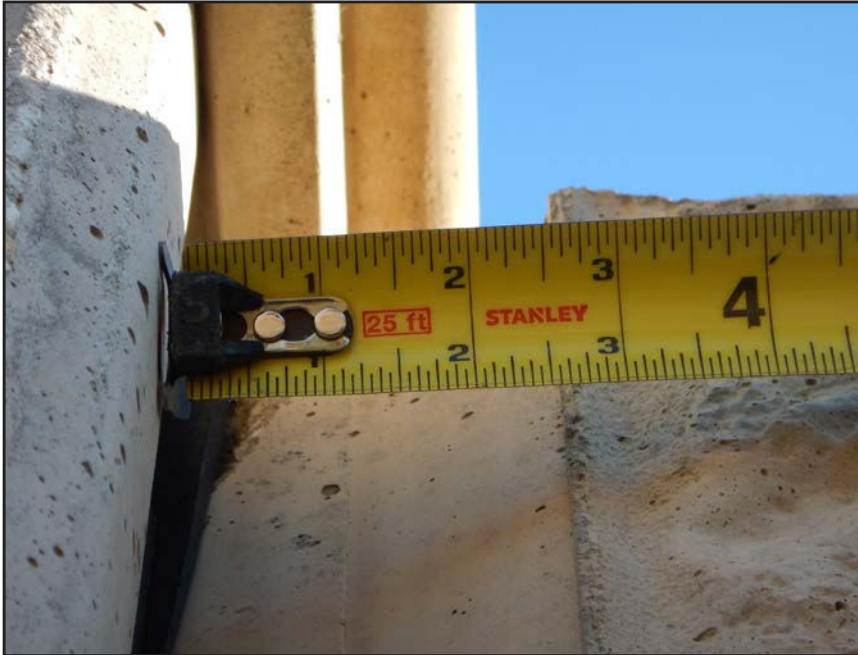
NO. 185 - COLUMN 12N -
INSUFFICIENT SEATING OF A
PRECAST WALL PANEL IN A
PRECAST COLUMN

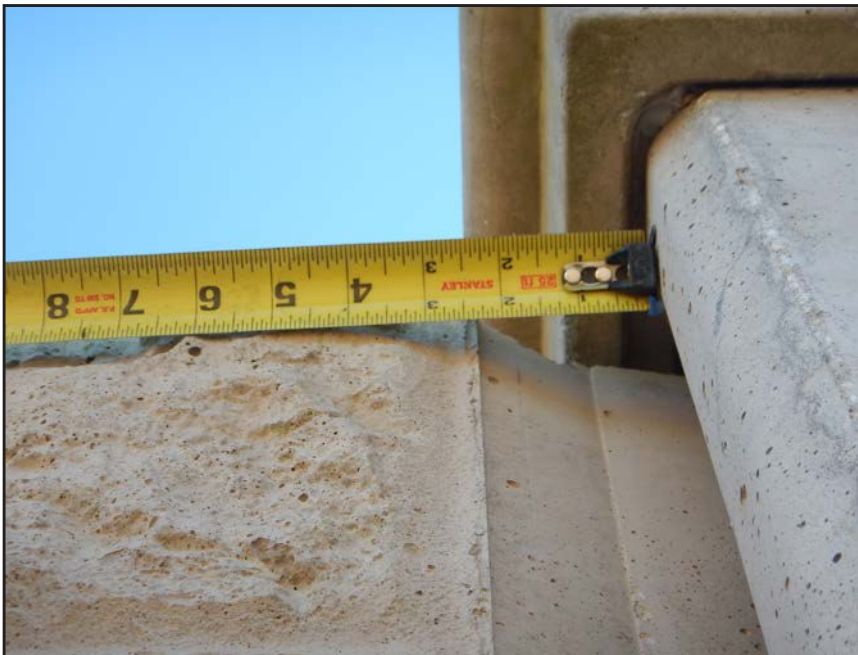
NO. 186 - COLUMN 14N -
INSUFFICIENT SEATING OF A
PRECAST WALL PANEL IN A
PRECAST COLUMN

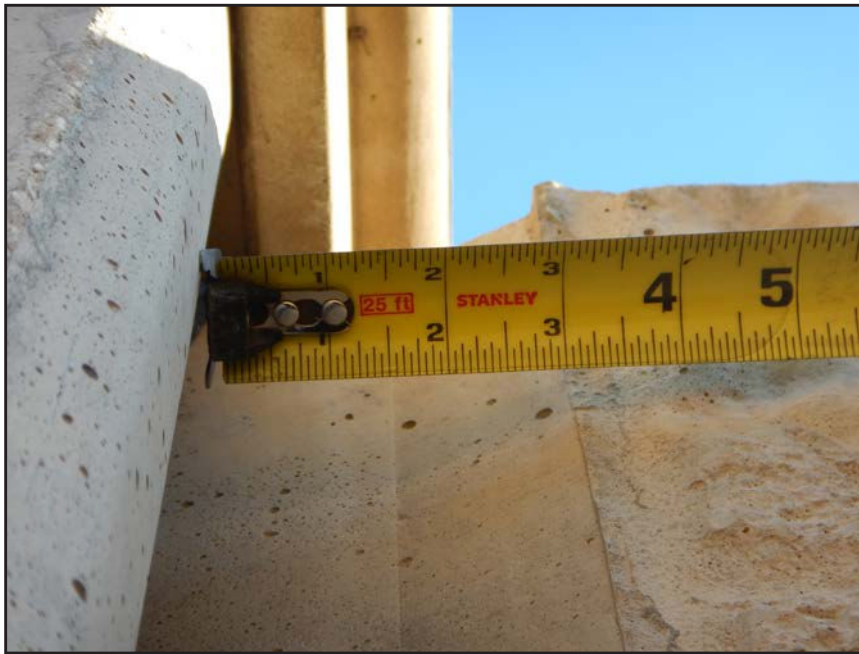
NO. 187 - COLUMN 18N -
INSUFFICIENT SEATING OF A
PRECAST WALL PANEL IN A
PRECAST COLUMN

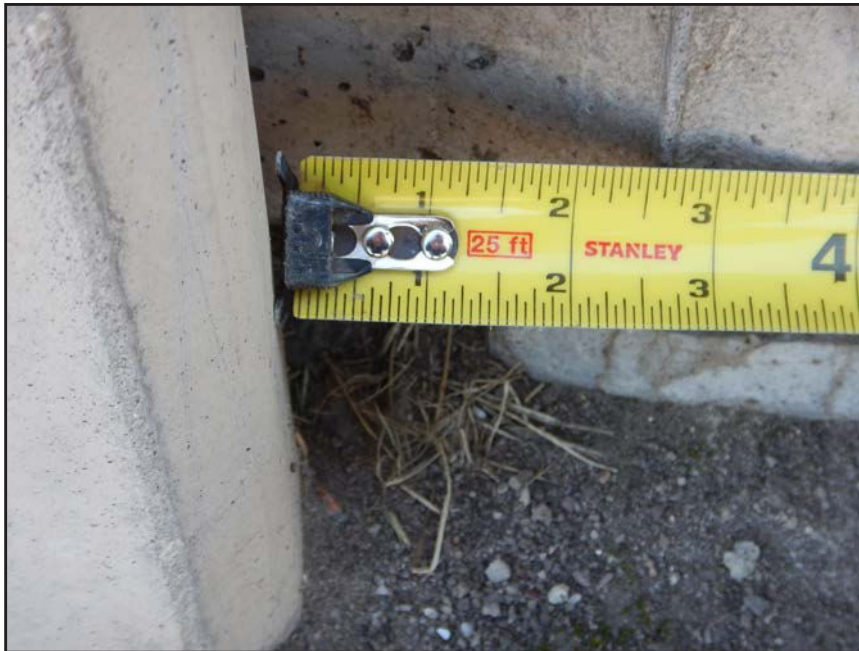
NO. 188 - COLUMN 20N -
INSUFFICIENT SEATING OF A
PRECAST WALL PANEL IN A
PRECAST COLUMN

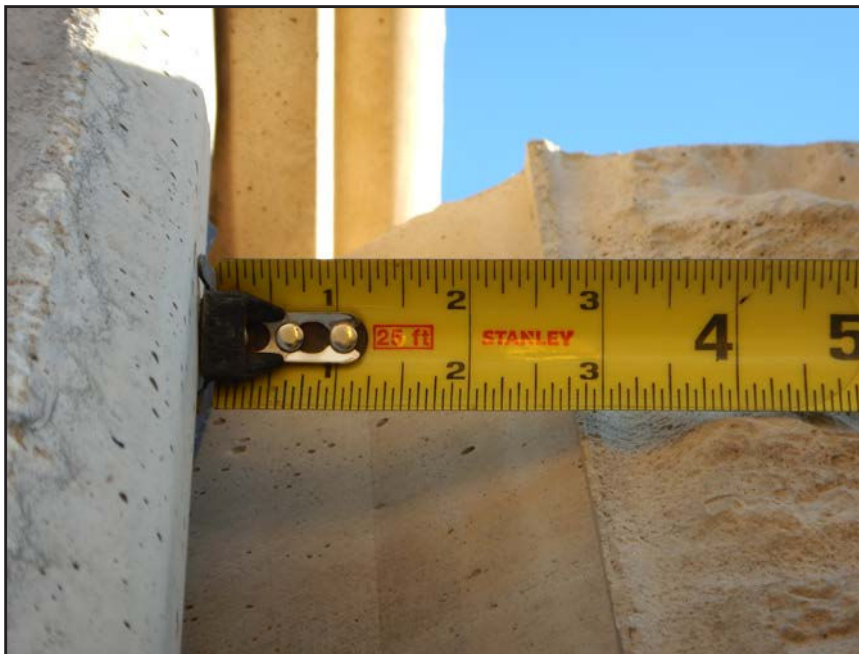
NO. 189 - COLUMN 20N -
INSUFFICIENT SEATING OF A
PRECAST WALL PANEL IN A
PRECAST COLUMN

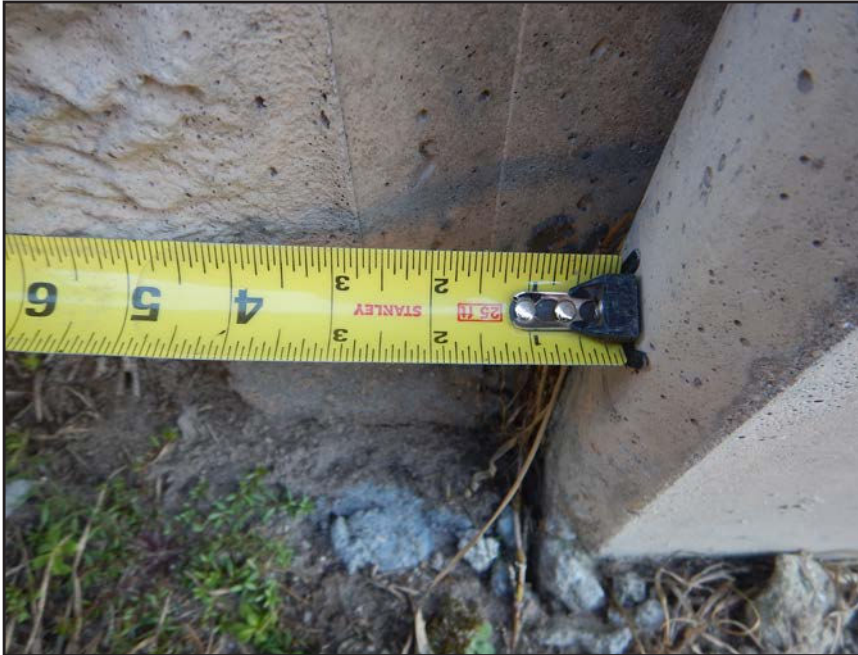
NO. 190 - COLUMN 28N -
INSUFFICIENT SEATING OF A
PRECAST WALL PANEL IN A
PRECAST COLUMN

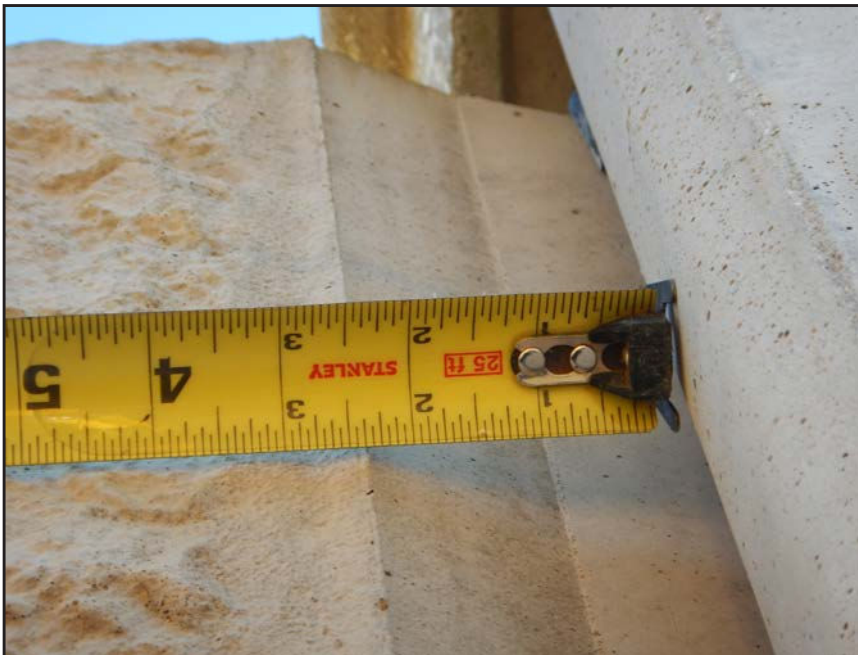
NO. 191 - COLUMN 30N -
INSUFFICIENT SEATING OF A
PRECAST WALL PANEL IN A
PRECAST COLUMN

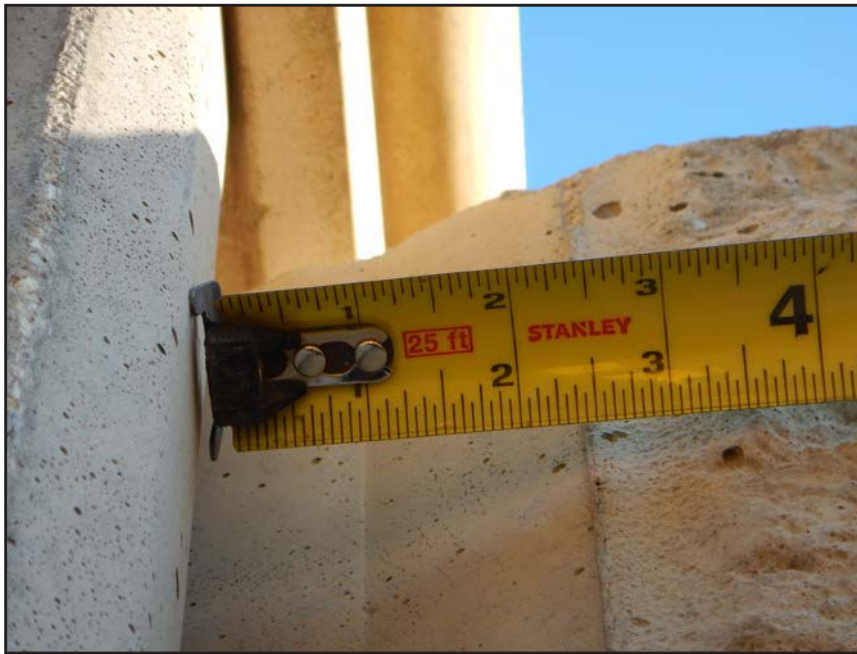
NO. 192 - COLUMN 35N -
INSUFFICIENT SEATING OF A
PRECAST WALL PANEL IN A
PRECAST COLUMN

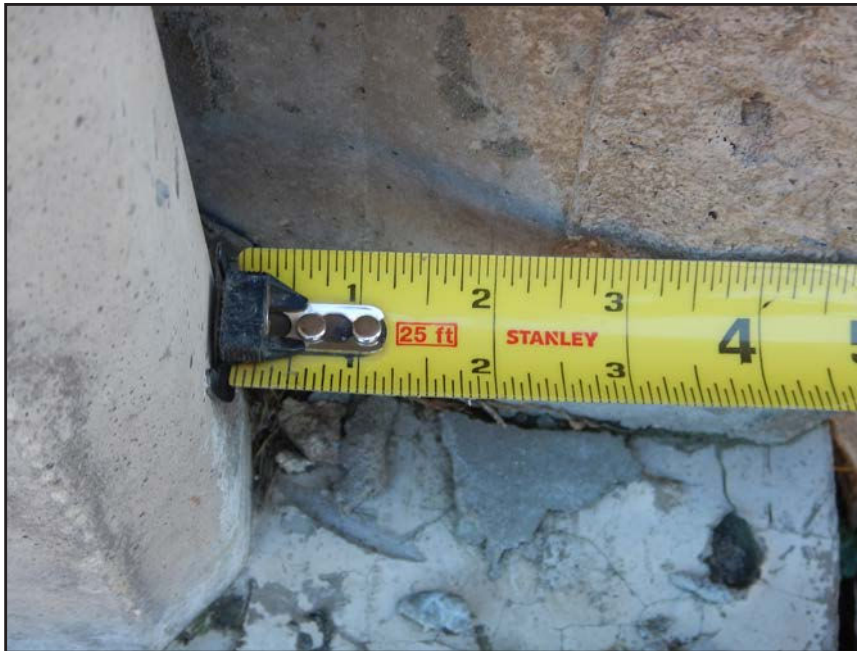
NO. 193 - COLUMN 36N -
INSUFFICIENT SEATING OF A
PRECAST WALL PANEL IN A
PRECAST COLUMN

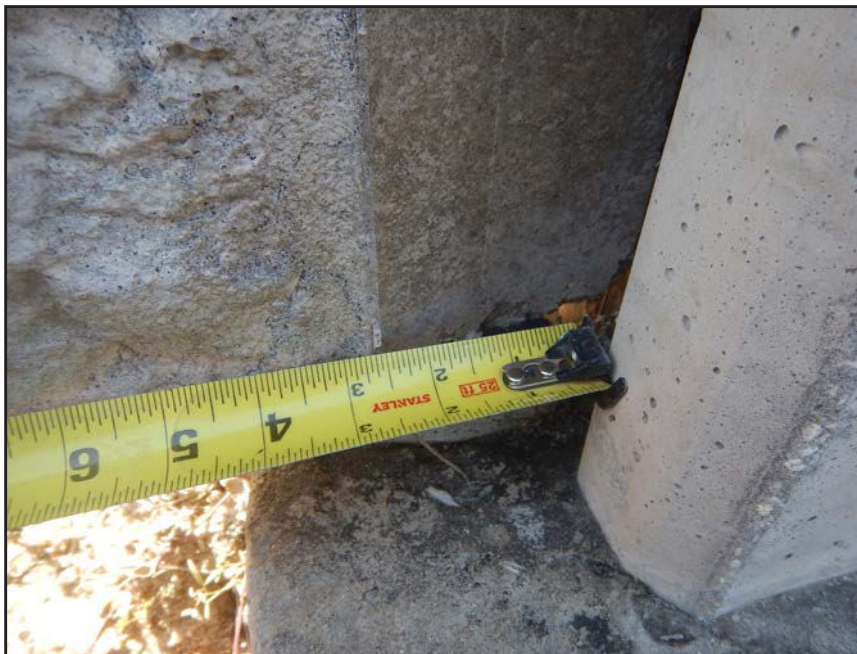
NO. 194 - COLUMN 36N -
INSUFFICIENT SEATING OF A
PRECAST WALL PANEL IN A
PRECAST COLUMN

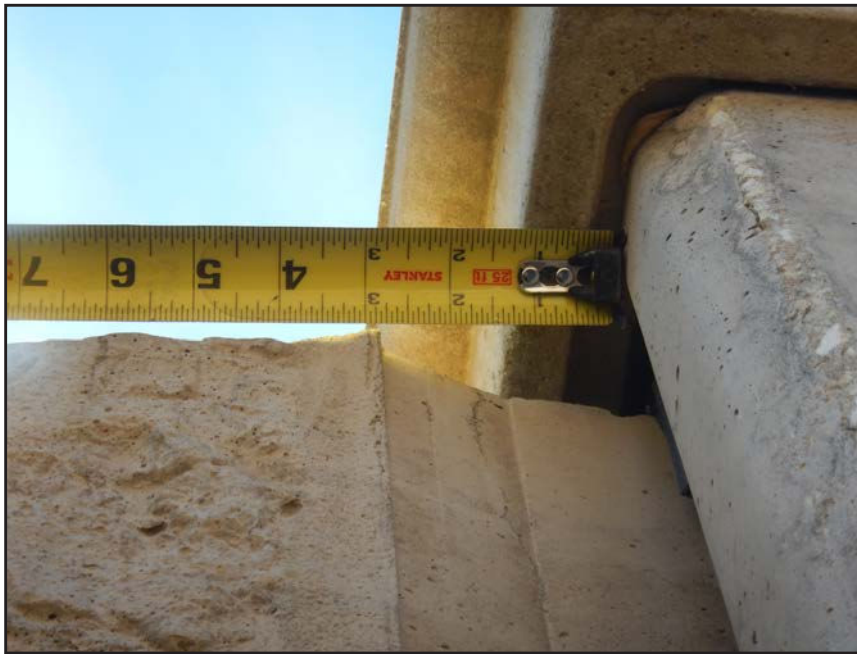
NO. 195 - COLUMN 54N -
INSUFFICIENT SEATING OF A
PRECAST WALL PANEL IN A
PRECAST COLUMN

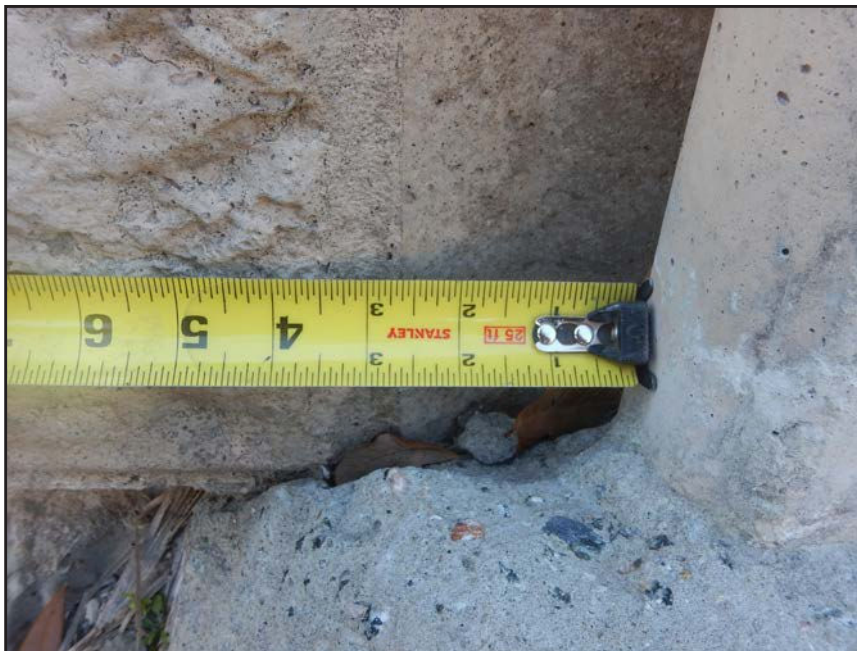
NO. 196 - COLUMN 57N -
INSUFFICIENT SEATING OF A
PRECAST WALL PANEL IN A
PRECAST COLUMN

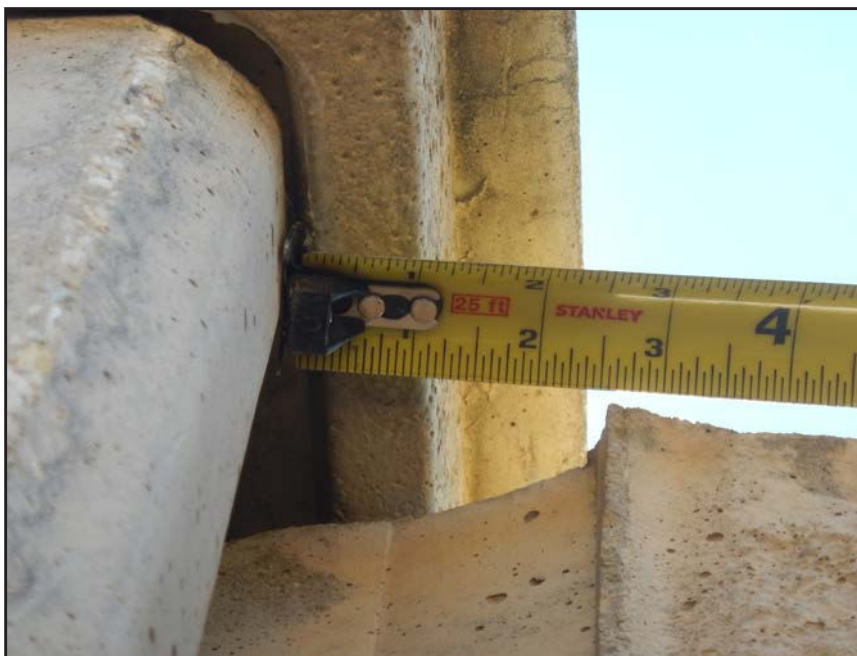
NO. 197 - COLUMN 57N -
INSUFFICIENT SEATING OF A
PRECAST WALL PANEL IN A
PRECAST COLUMN

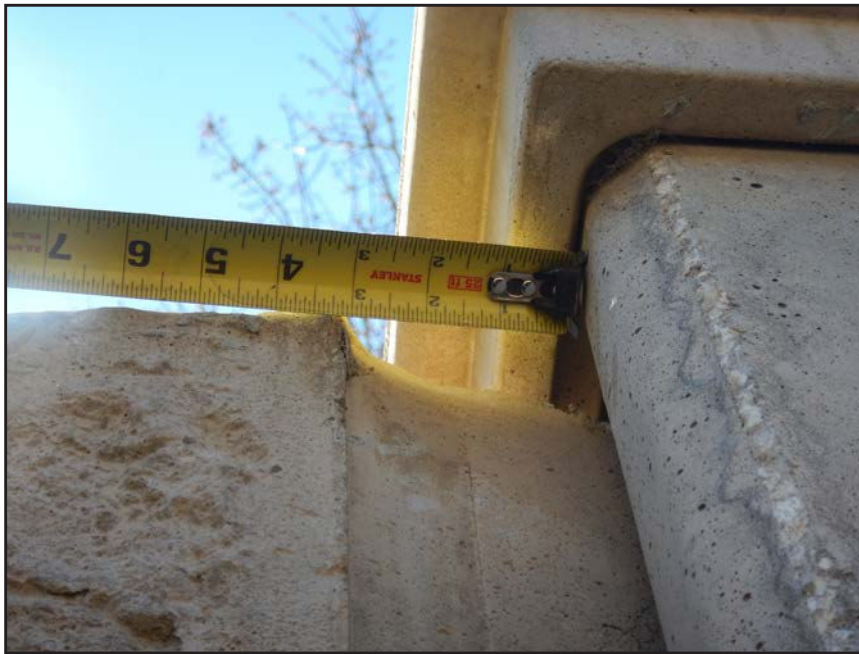
NO. 198 - COLUMN 57N -
INSUFFICIENT SEATING OF A
PRECAST WALL PANEL IN A
PRECAST COLUMN

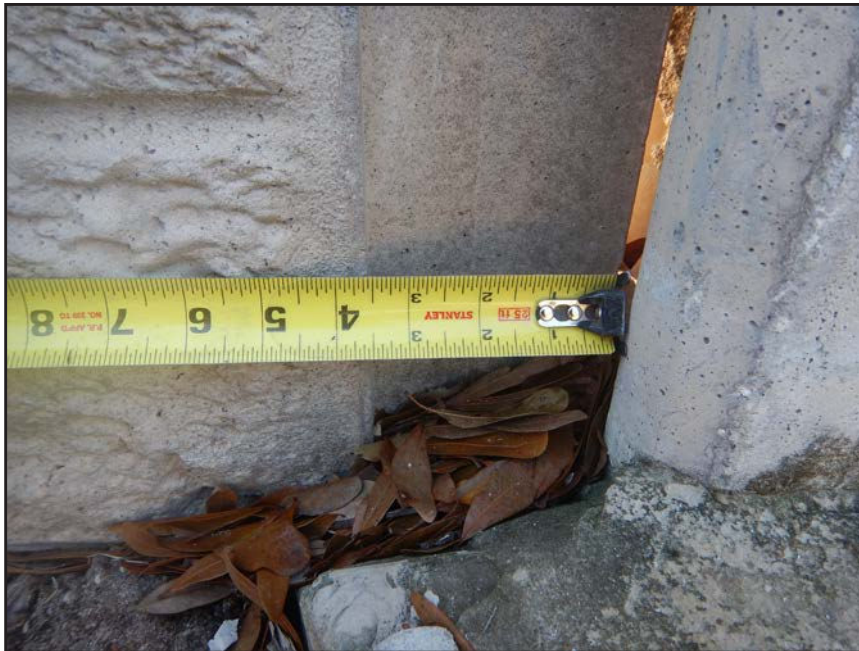
NO. 199 - COLUMN 2NM -
INSUFFICIENT SEATING OF A
PRECAST WALL PANEL IN A
PRECAST COLUMN

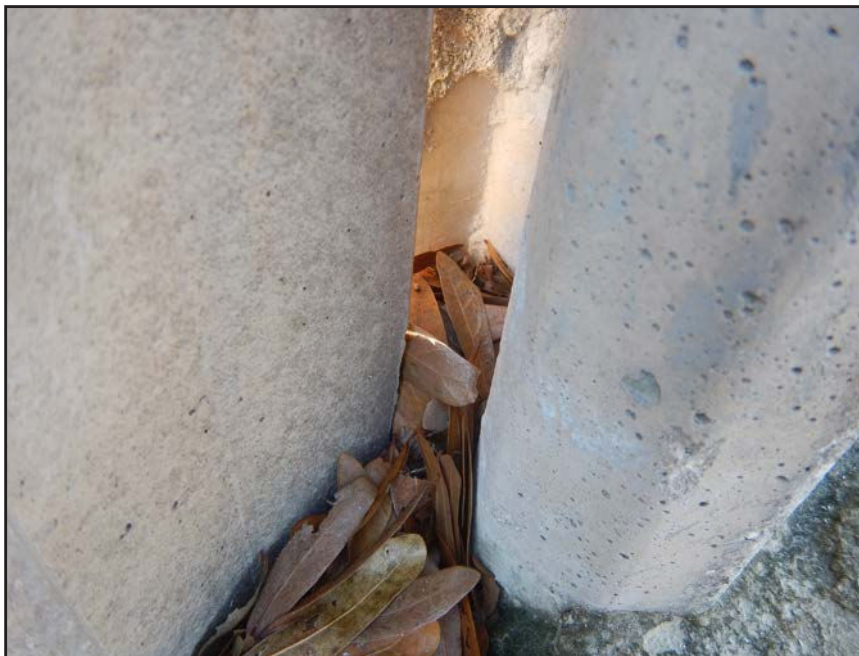
NO. 200 - COLUMN 2NM -
INSUFFICIENT SEATING OF A
PRECAST WALL PANEL IN A
PRECAST COLUMN

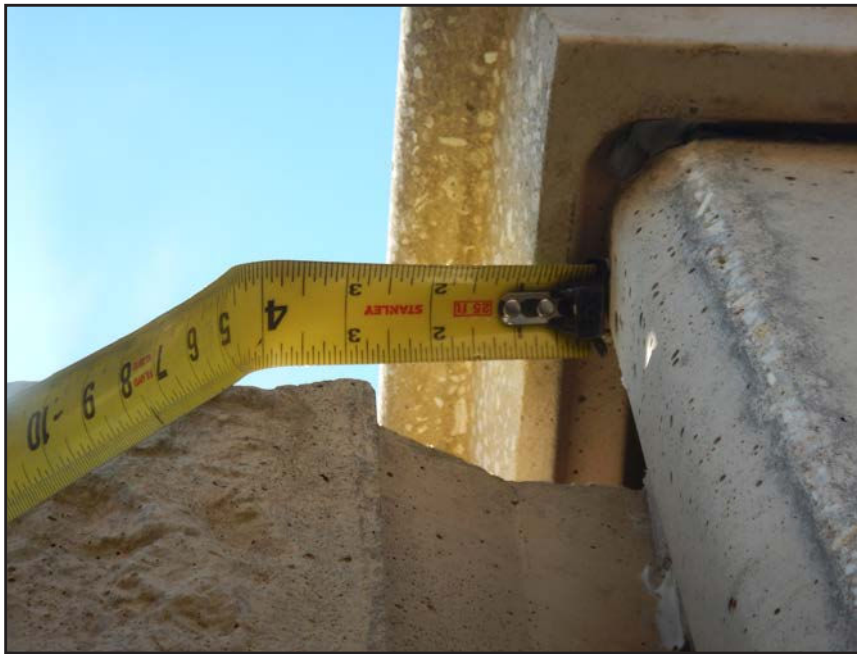
NO. 201 - COLUMN 2NM -
INSUFFICIENT SEATING OF A
PRECAST WALL PANEL IN A
PRECAST COLUMN

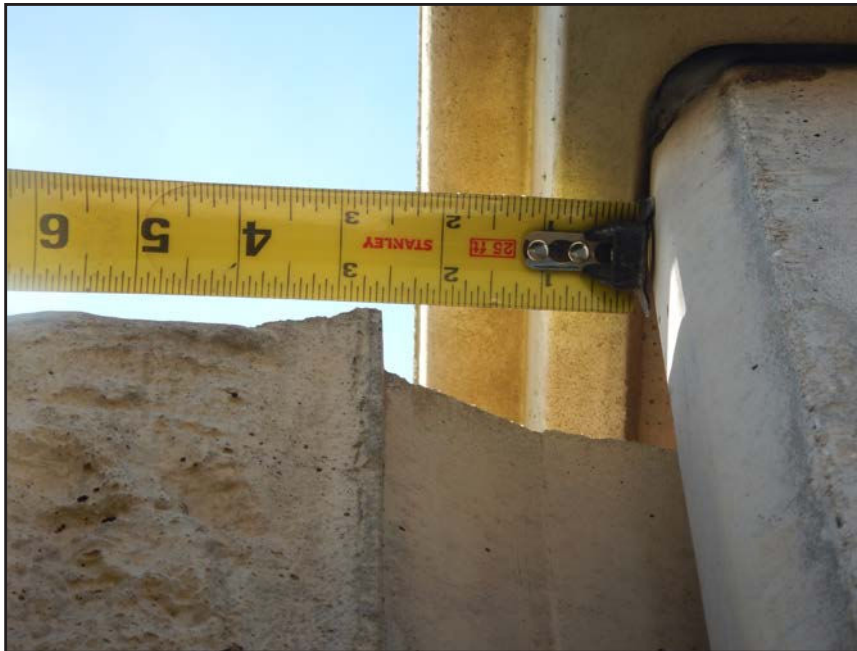
NO. 202 - COLUMN 7NM -
INSUFFICIENT SEATING OF A
PRECAST WALL PANEL IN A
PRECAST COLUMN

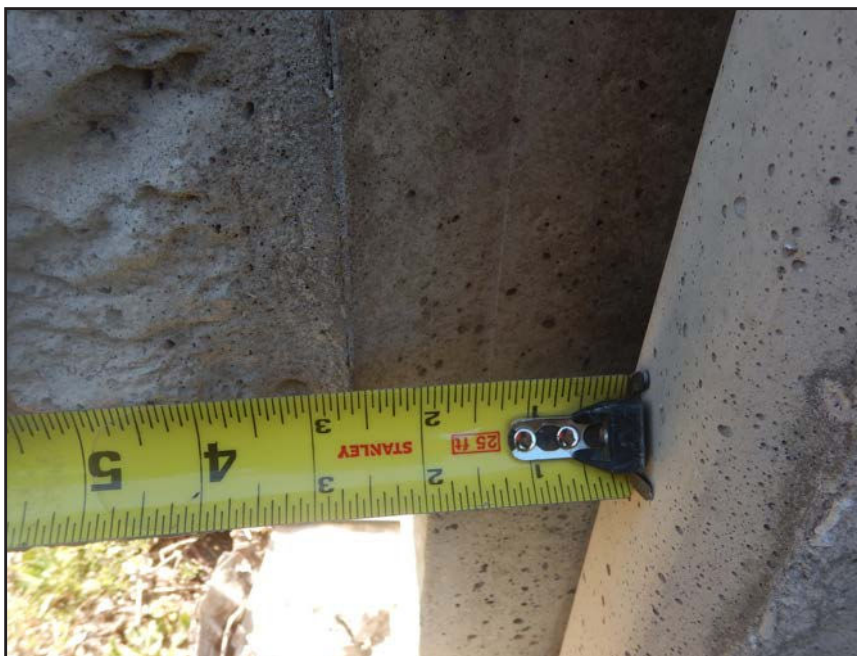
NO. 203 - COLUMN 9NM -
INSUFFICIENT SEATING OF A
PRECAST WALL PANEL IN A
PRECAST COLUMN

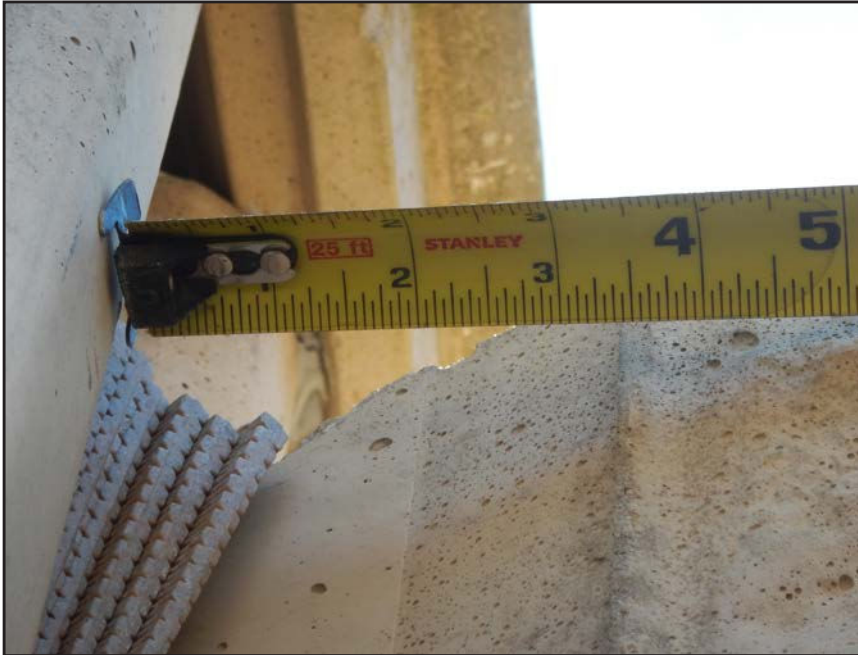
NO. 204 - COLUMN 9NM -
INSUFFICIENT SEATING OF A
PRECAST WALL PANEL IN A
PRECAST COLUMN

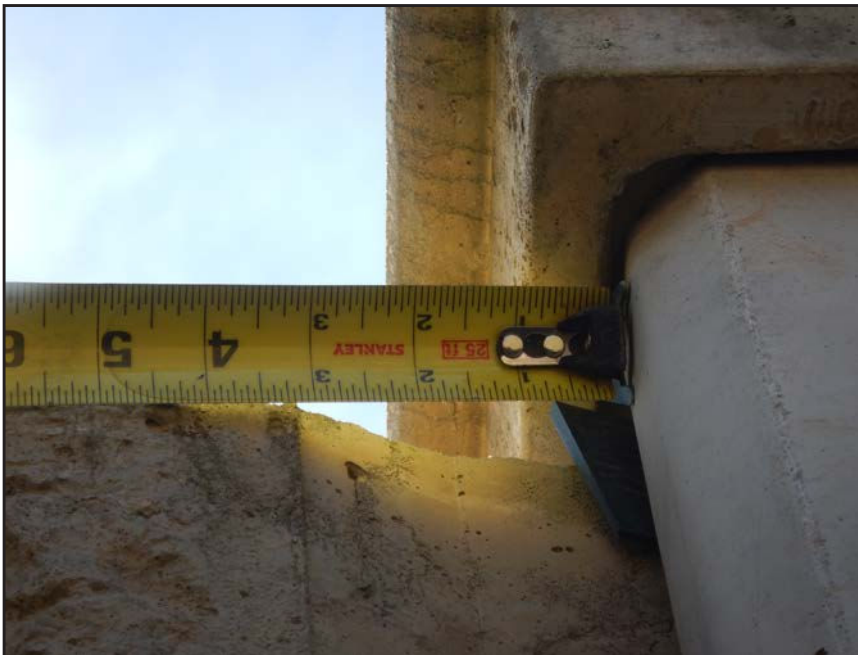
NO. 205 - COLUMN 11NM -
INSUFFICIENT SEATING OF A
PRECAST WALL PANEL IN A
PRECAST COLUMN

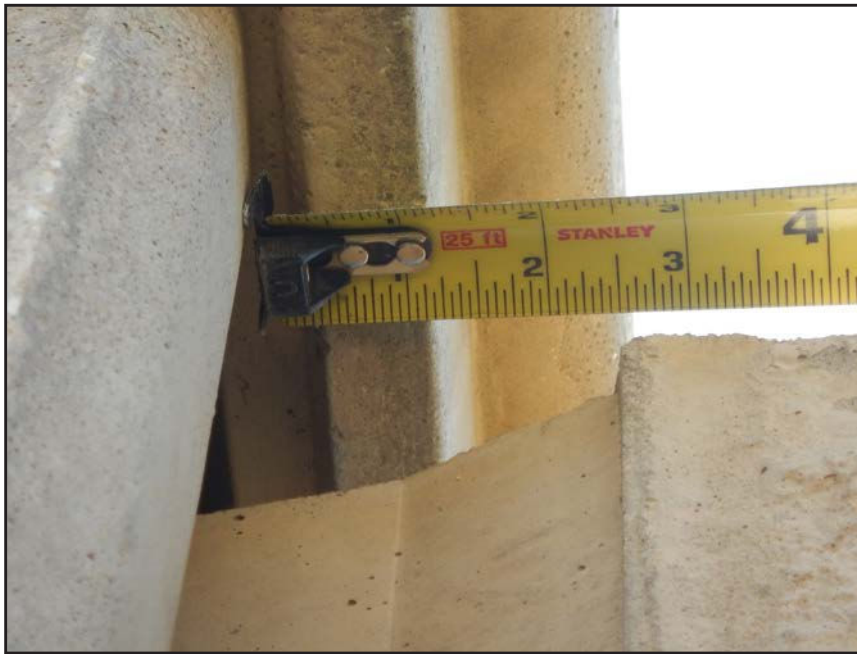
NO. 206 - COLUMN 14NM -
INSUFFICIENT SEATING OF A
PRECAST WALL PANEL IN A
PRECAST COLUMN

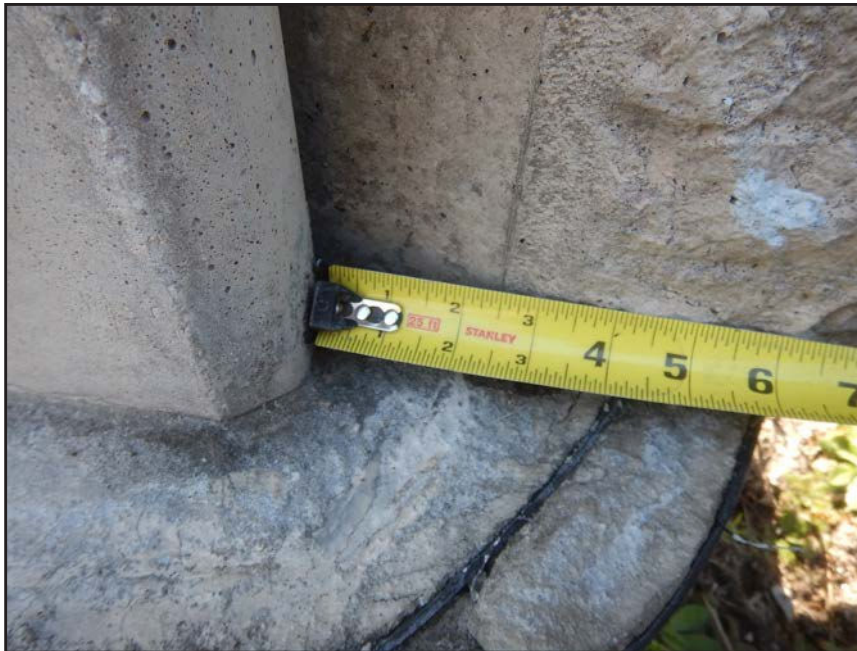
NO. 207 - COLUMN 6SM -
INSUFFICIENT SEATING OF A
PRECAST WALL PANEL IN A
PRECAST COLUMN

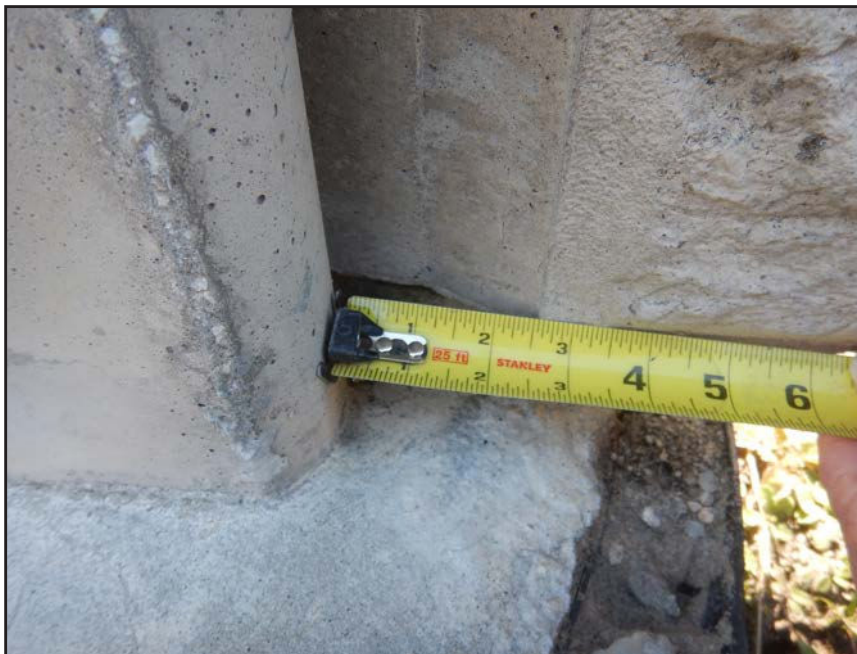
NO. 208 - COLUMN 6SM -
INSUFFICIENT SEATING OF A
PRECAST WALL PANEL IN A
PRECAST COLUMN

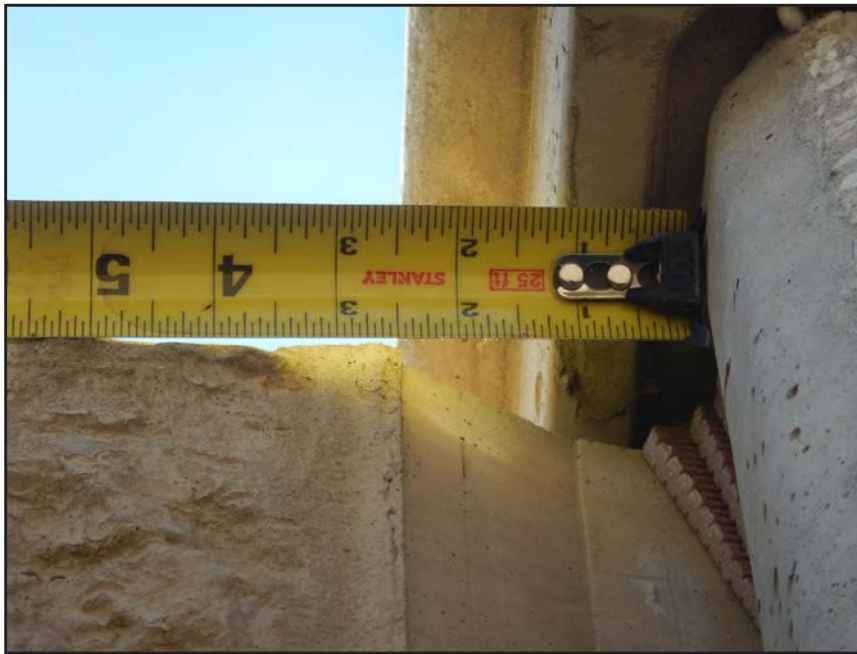
NO. 209 - COLUMN 8SM -
INSUFFICIENT SEATING OF A
PRECAST WALL PANEL IN A
PRECAST COLUMN

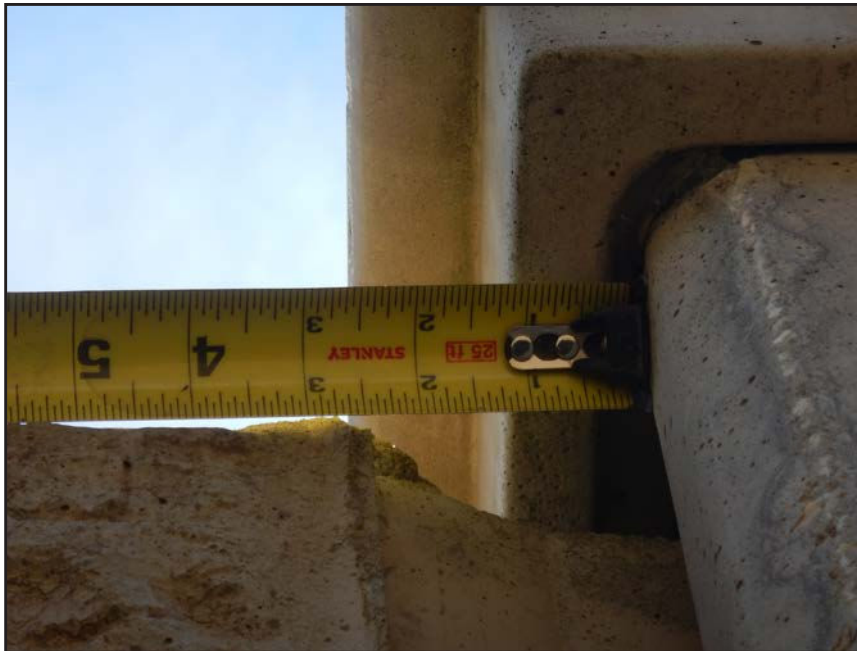
NO. 210 - COLUMN 11SM -
INSUFFICIENT SEATING OF A
PRECAST WALL PANEL IN A
PRECAST COLUMN

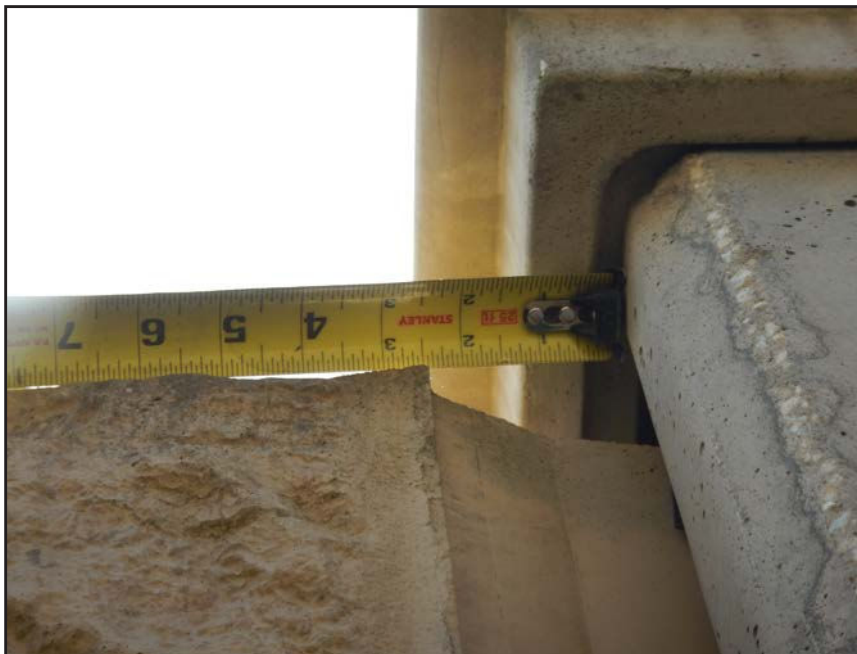
NO. 211 - COLUMN 19SM -
INSUFFICIENT SEATING OF A
PRECAST WALL PANEL IN A
PRECAST COLUMN
