WATER TOWER ROAD SCREEN WALL INVESTIGATIONS

Water Tower Road
Longs, South Carolina

Stantec Project No. 171015900

March 31, 2025

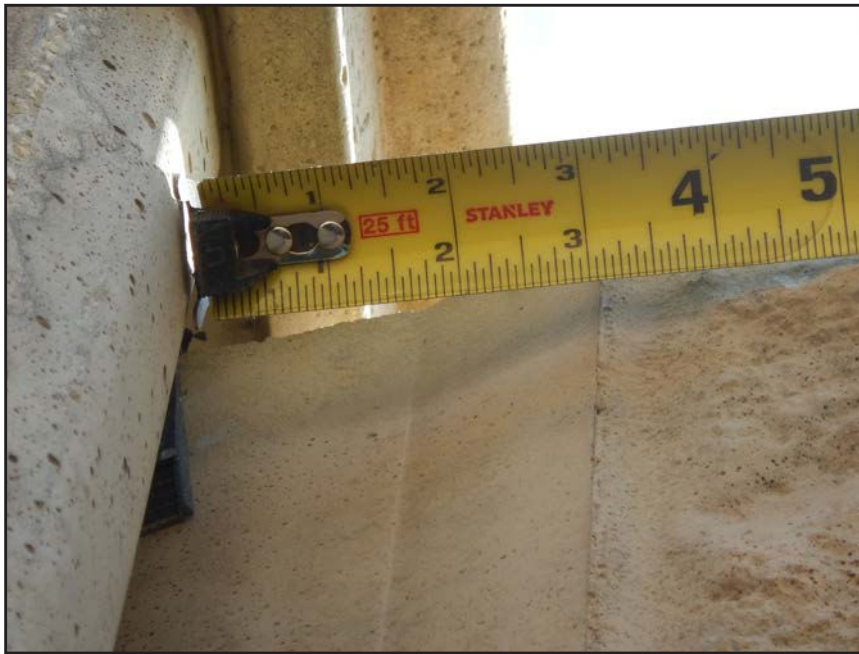
NO. 212 - COLUMN 21SM -
INSUFFICIENT SEATING OF A
PRECAST WALL PANEL IN A
PRECAST COLUMN

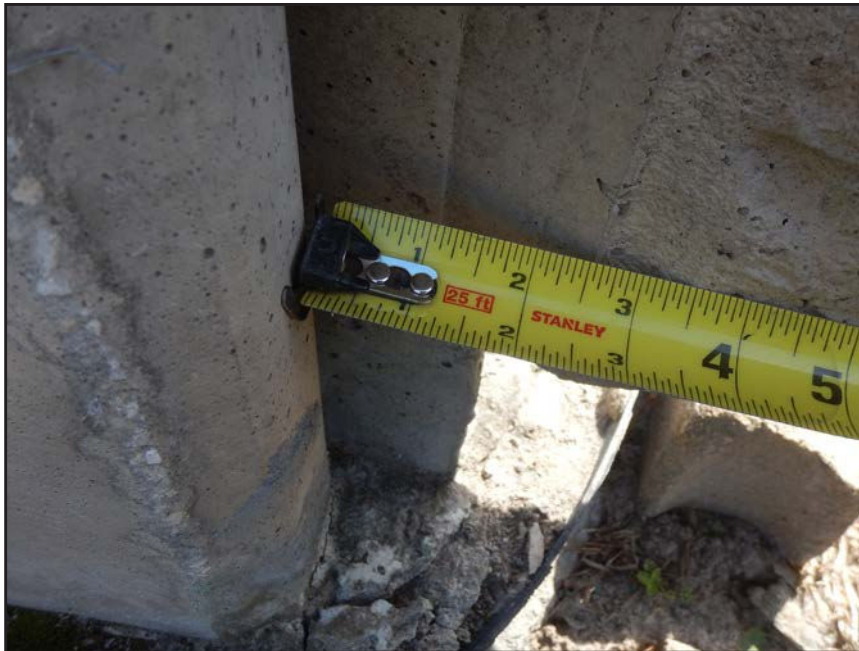
NO. 213 - COLUMN 4S -
INSUFFICIENT SEATING OF A
PRECAST WALL PANEL IN A
PRECAST COLUMN

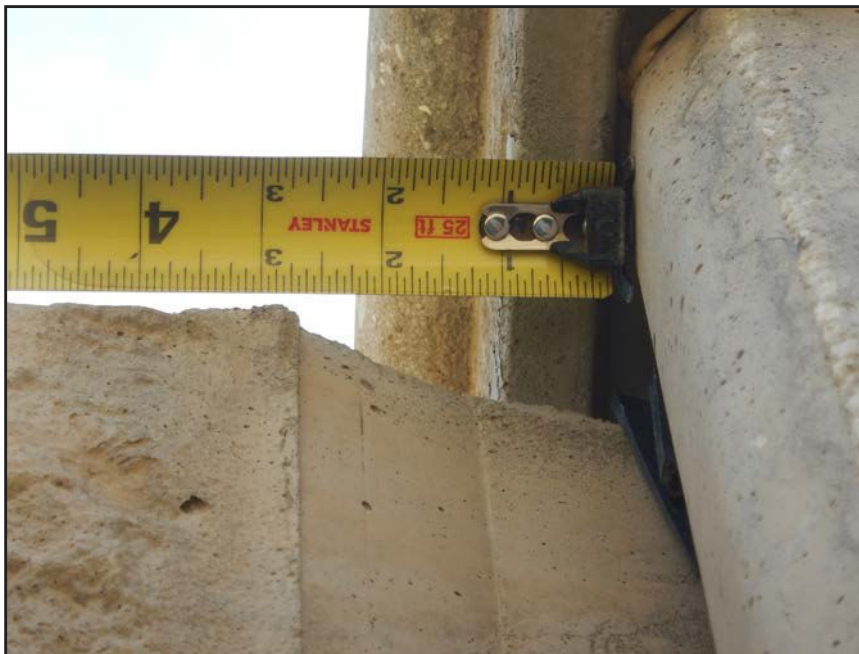
NO. 214 - COLUMN 4S -
INSUFFICIENT SEATING OF A
PRECAST WALL PANEL IN A
PRECAST COLUMN

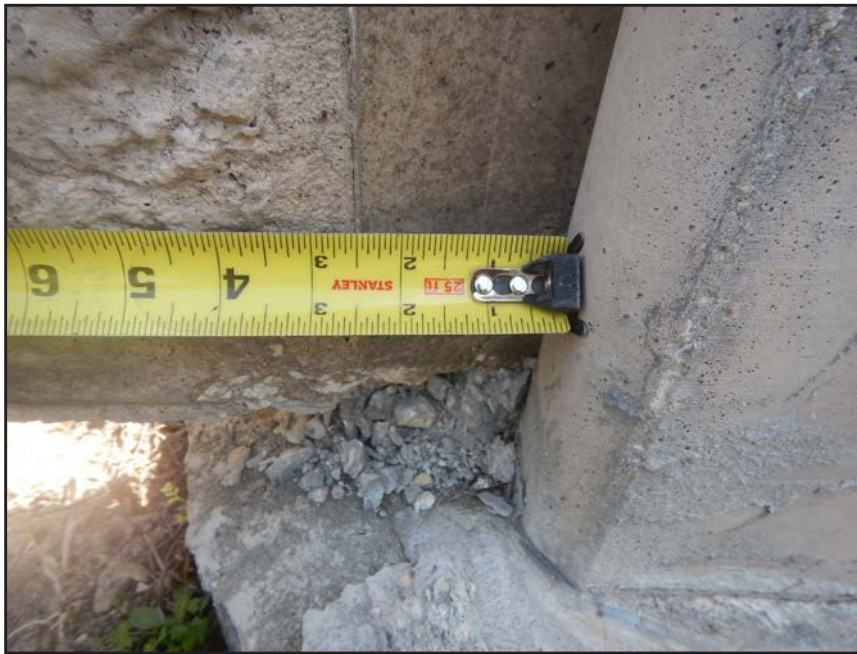
NO. 215 - COLUMN 10S -
INSUFFICIENT SEATING OF A
PRECAST WALL PANEL IN A
PRECAST COLUMN

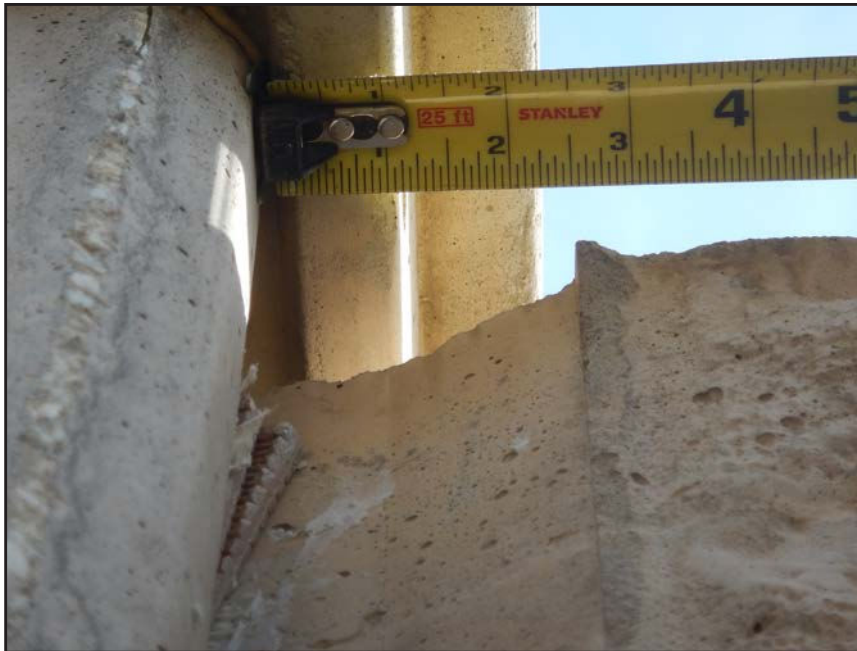
NO. 216 - COLUMN 12S -
INSUFFICIENT SEATING OF A
PRECAST WALL PANEL IN A
PRECAST COLUMN

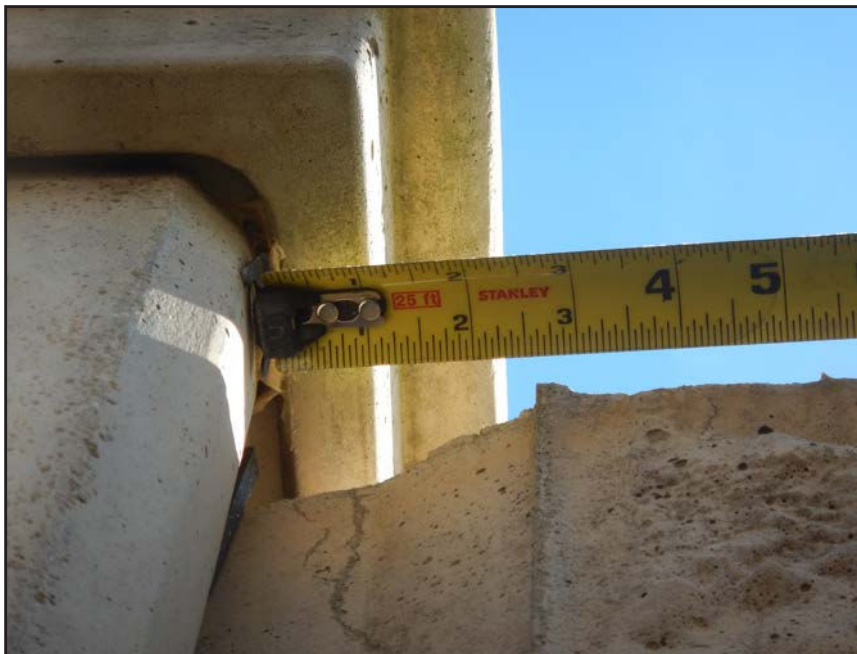
NO. 217 - COLUMN 13S -
INSUFFICIENT SEATING OF A
PRECAST WALL PANEL IN A
PRECAST COLUMN

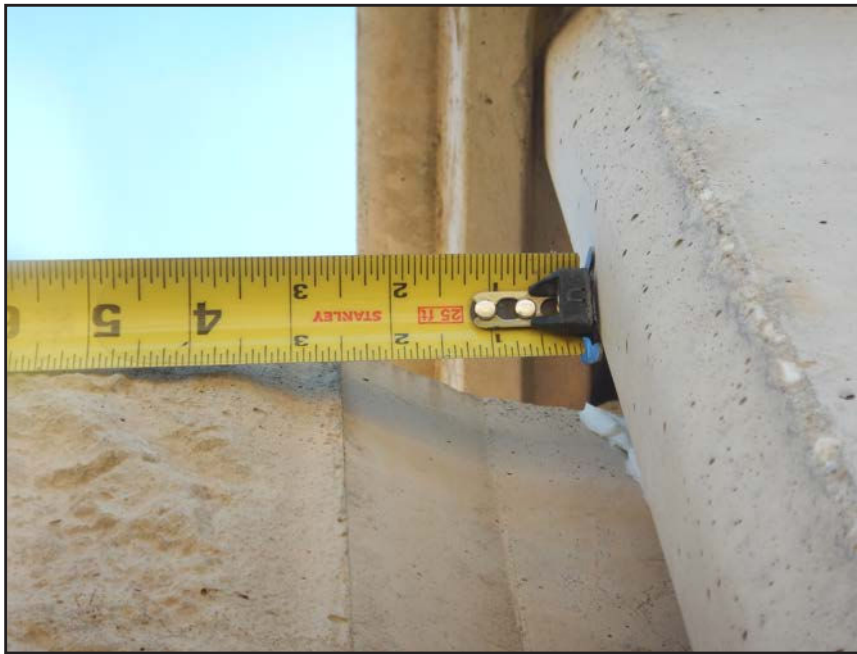
NO. 218 - COLUMN 24S -
INSUFFICIENT SEATING OF A
PRECAST WALL PANEL IN A
PRECAST COLUMN

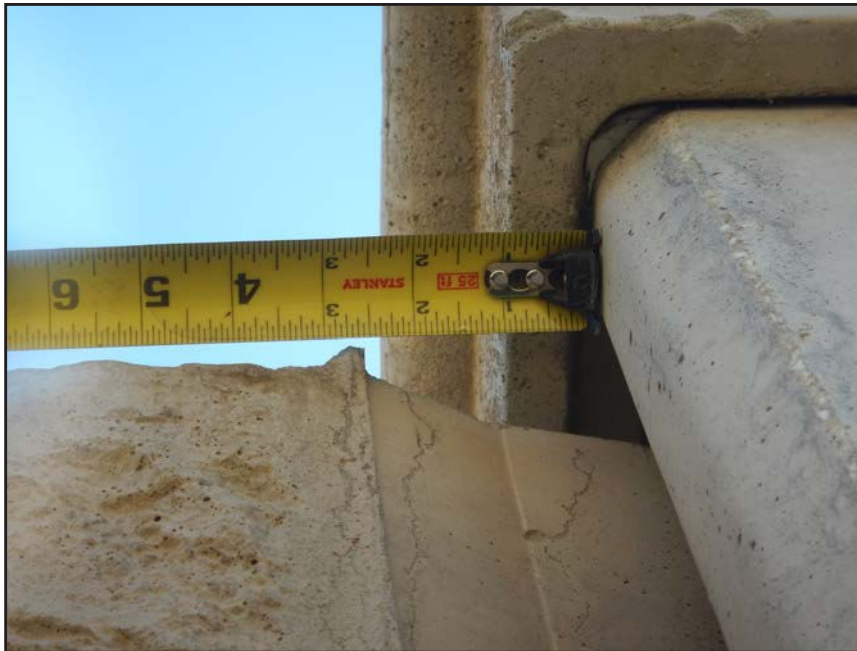
NO. 219 - COLUMN 28S -
INSUFFICIENT SEATING OF A
PRECAST WALL PANEL IN A
PRECAST COLUMN

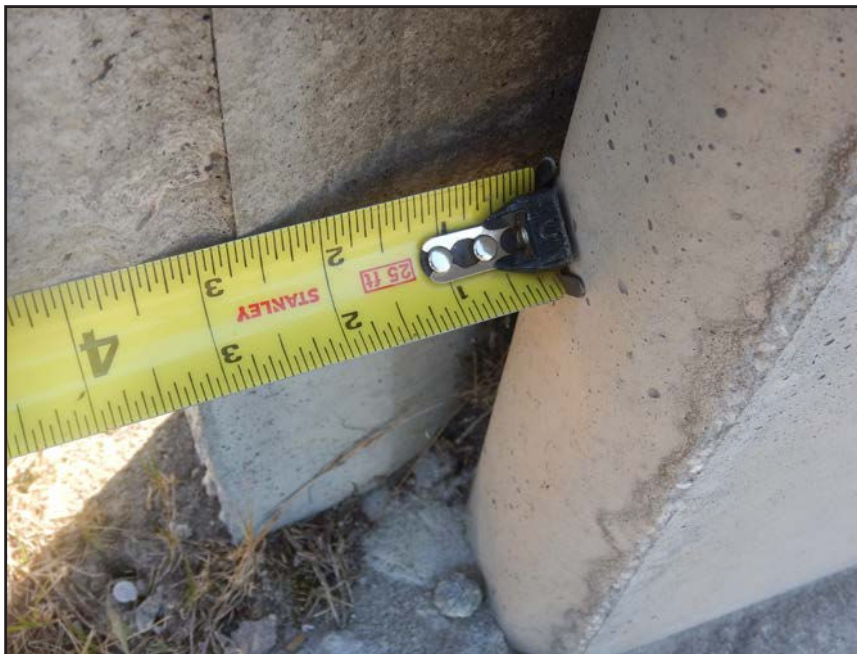
NO. 220 - COLUMN 29S -
INSUFFICIENT SEATING OF A
PRECAST WALL PANEL IN A
PRECAST COLUMN

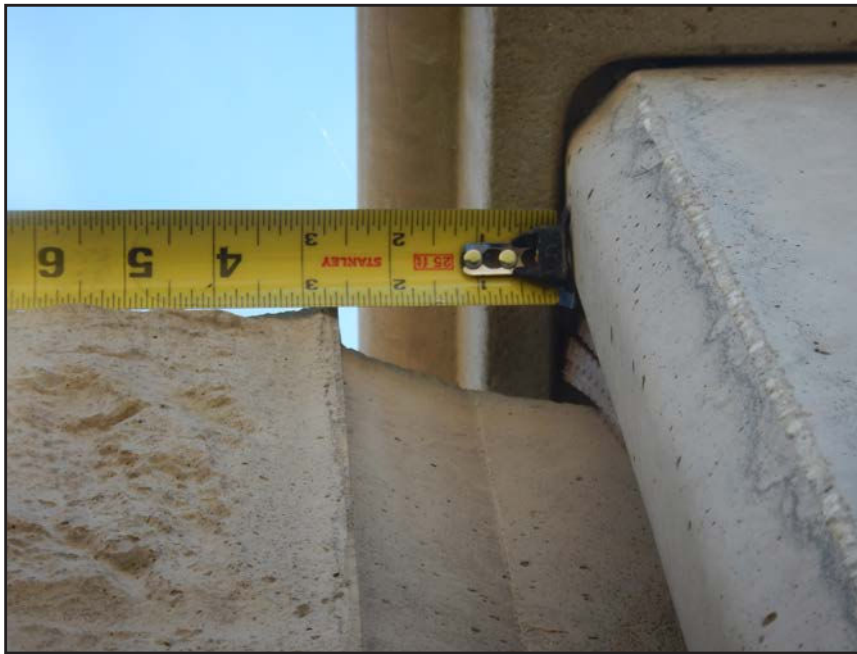
NO. 221 - COLUMN 29S -
INSUFFICIENT SEATING OF A
PRECAST WALL PANEL IN A
PRECAST COLUMN

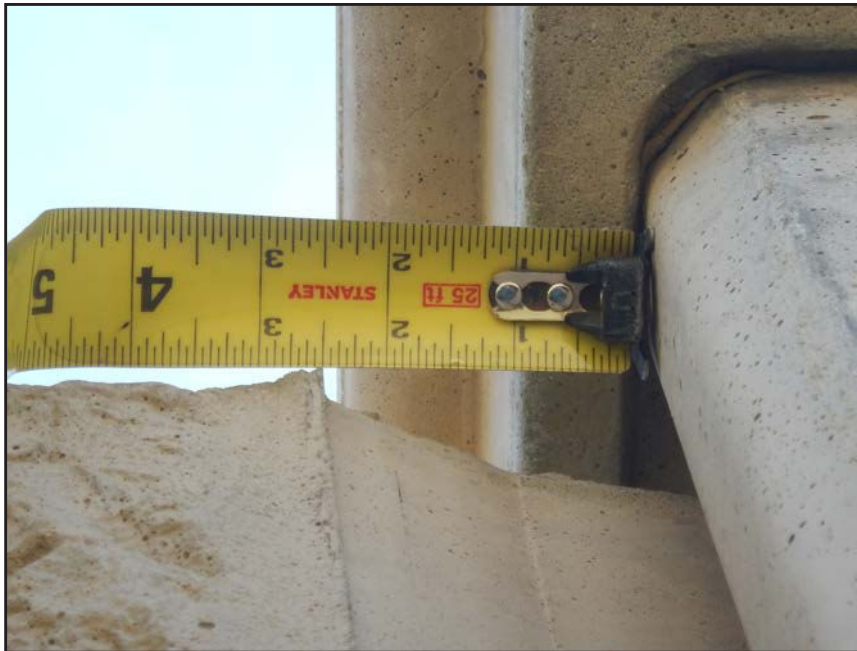
NO. 222 - COLUMN 34S -
INSUFFICIENT SEATING OF A
PRECAST WALL PANEL IN A
PRECAST COLUMN

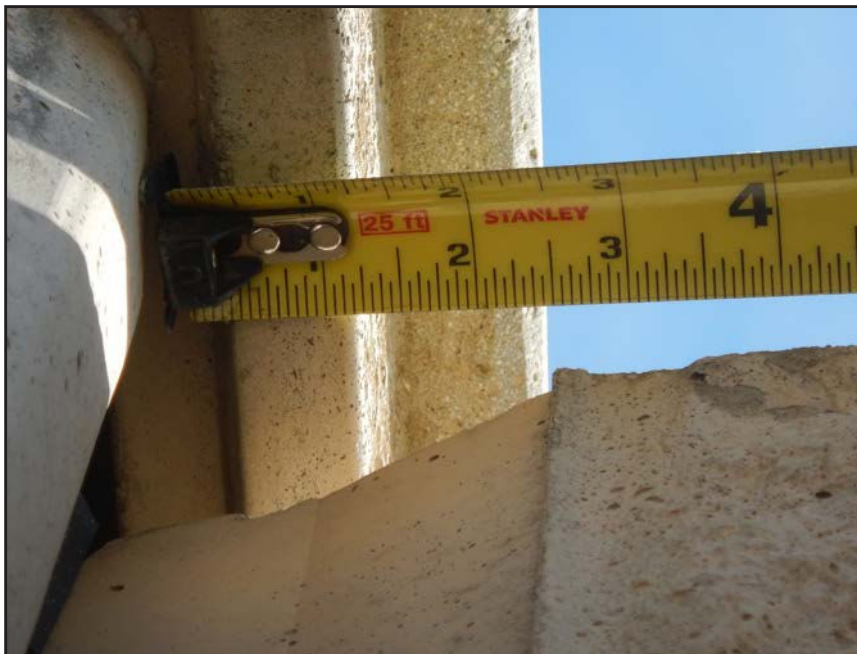
NO. 223 - COLUMN 35S -
INSUFFICIENT SEATING OF A
PRECAST WALL PANEL IN A
PRECAST COLUMN

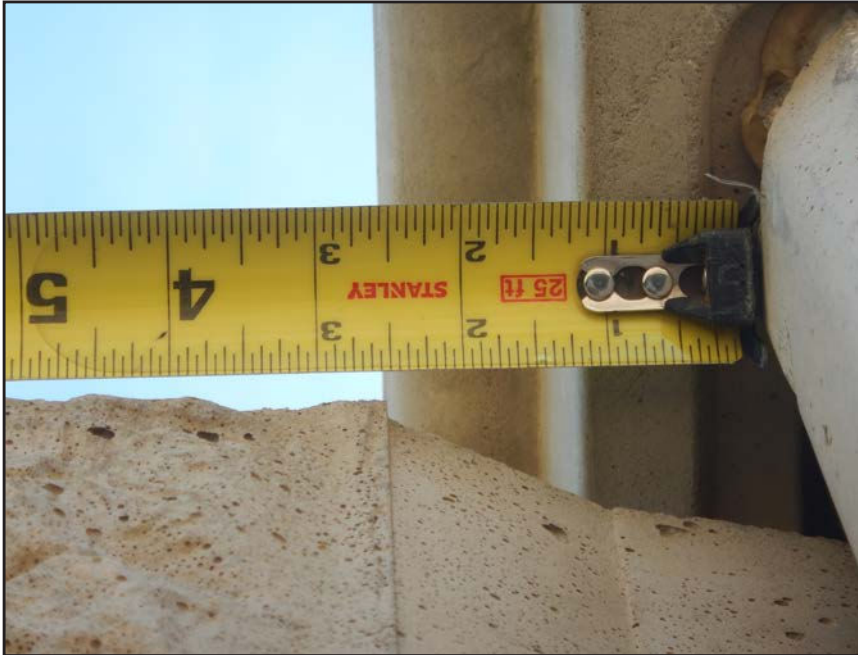
NO. 224 - COLUMN 37S -
INSUFFICIENT SEATING OF A
PRECAST WALL PANEL IN A
PRECAST COLUMN

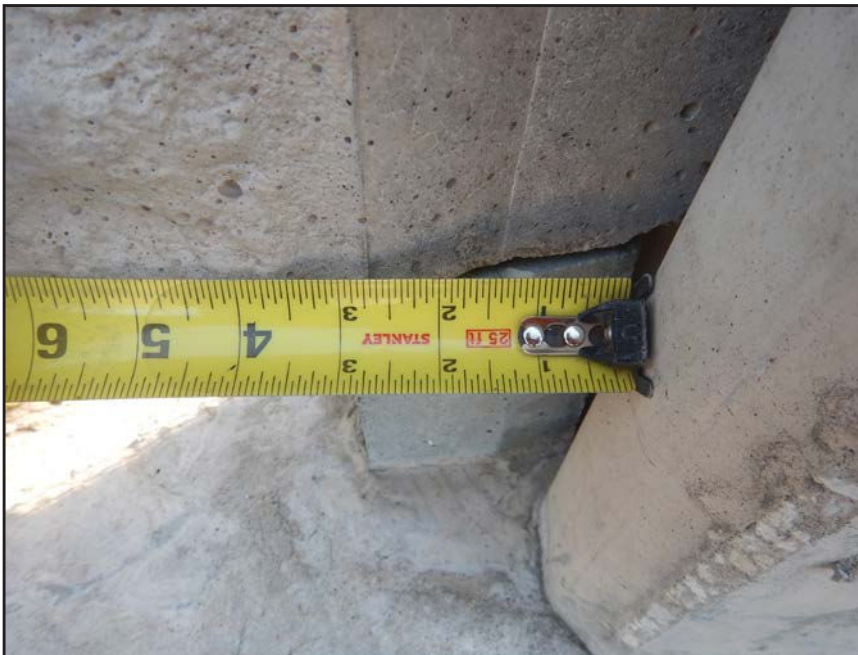
NO. 225 - COLUMN 41S -
INSUFFICIENT SEATING OF A
PRECAST WALL PANEL IN A
PRECAST COLUMN

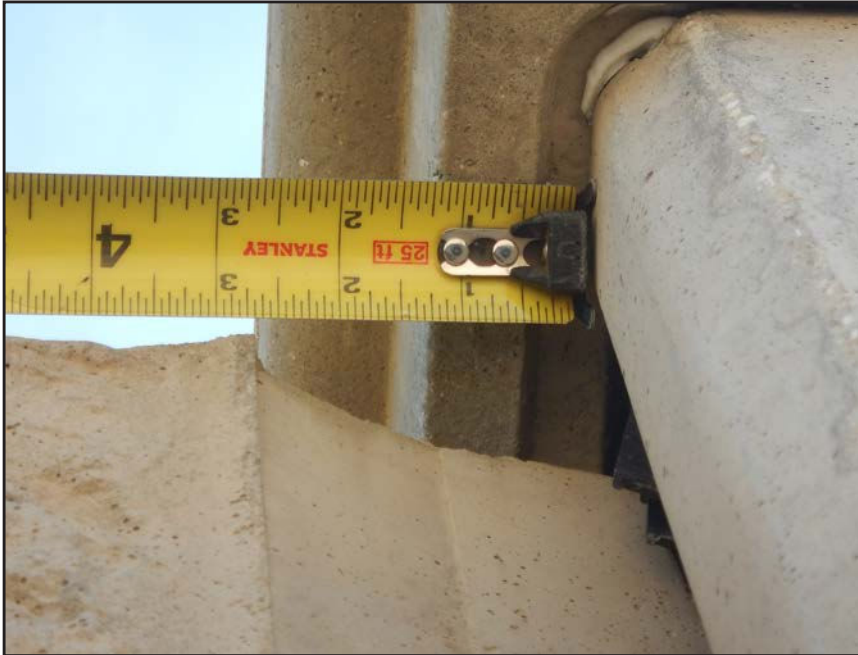
NO. 226 - COLUMN 41S -
INSUFFICIENT SEATING OF A
PRECAST WALL PANEL IN A
PRECAST COLUMN

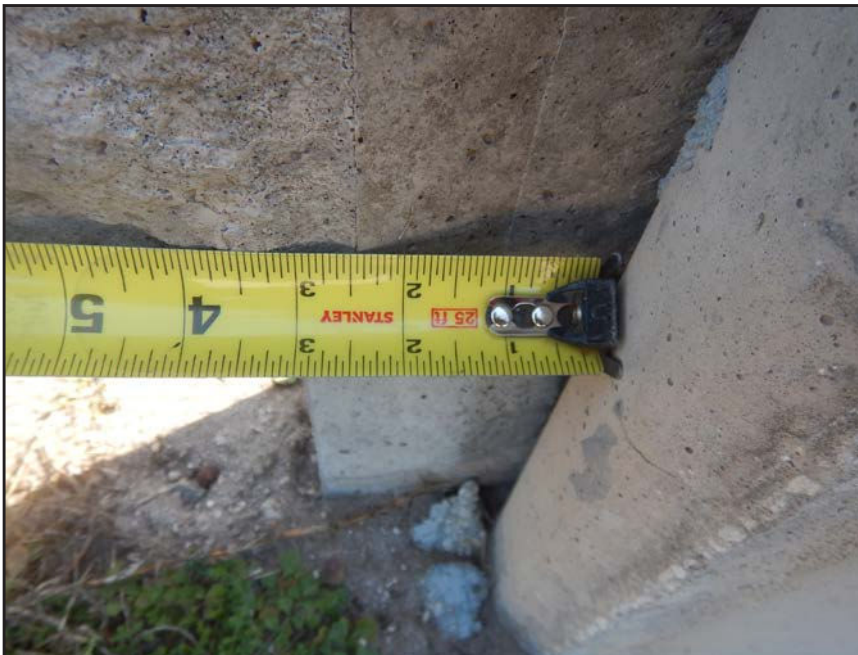
NO. 227 - COLUMN 42S -
INSUFFICIENT SEATING OF A
PRECAST WALL PANEL IN A
PRECAST COLUMN

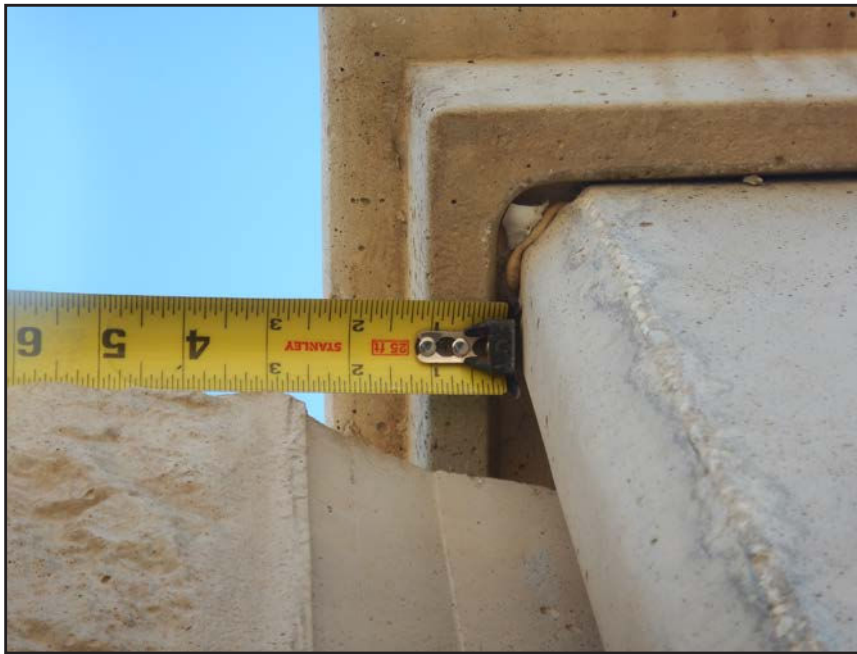
NO. 228 - COLUMN 42S -
INSUFFICIENT SEATING OF A
PRECAST WALL PANEL IN A
PRECAST COLUMN

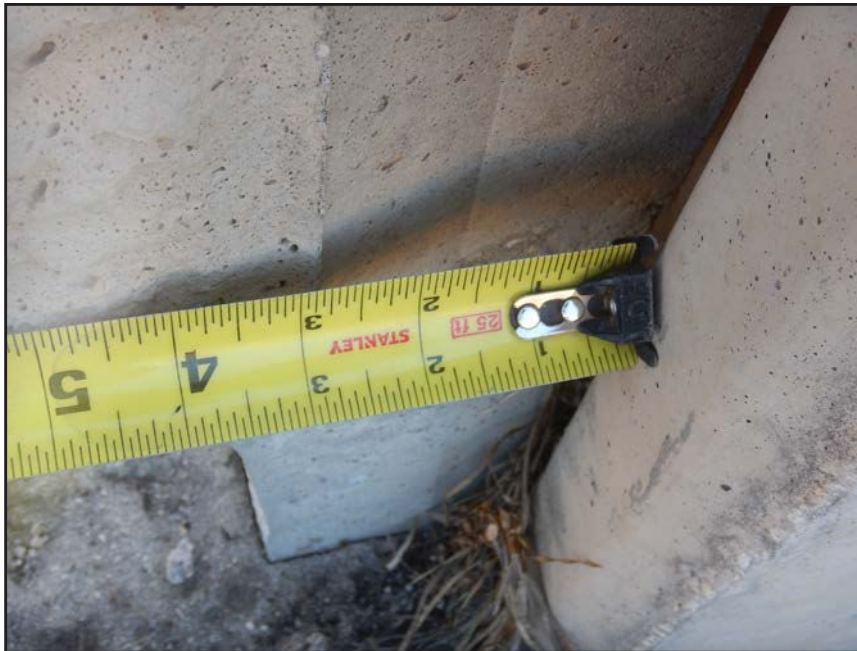
NO. 229 - COLUMN 47S -
INSUFFICIENT SEATING OF A
PRECAST WALL PANEL IN A
PRECAST COLUMN

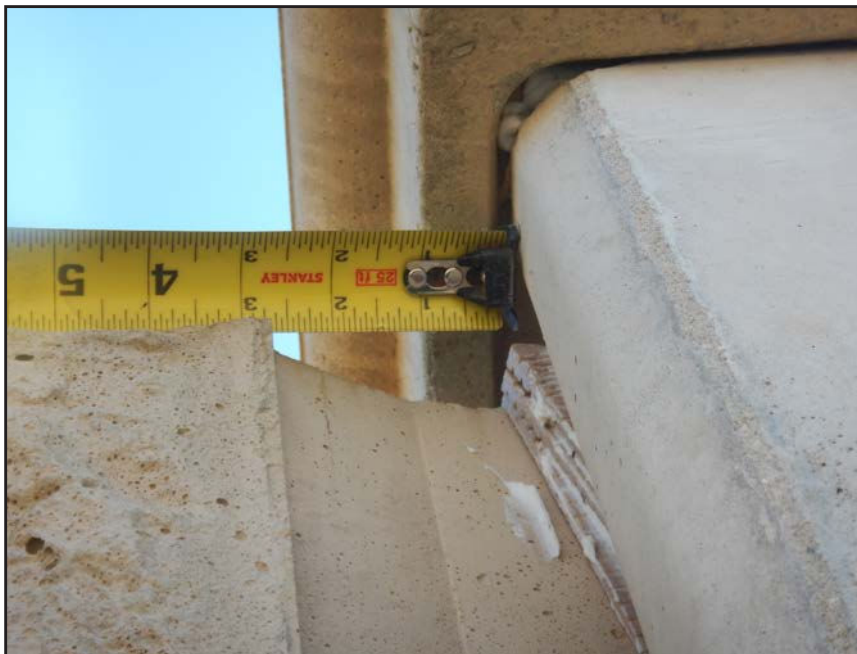
NO. 230 - COLUMN 47S -
INSUFFICIENT SEATING OF A
PRECAST WALL PANEL IN A
PRECAST COLUMN

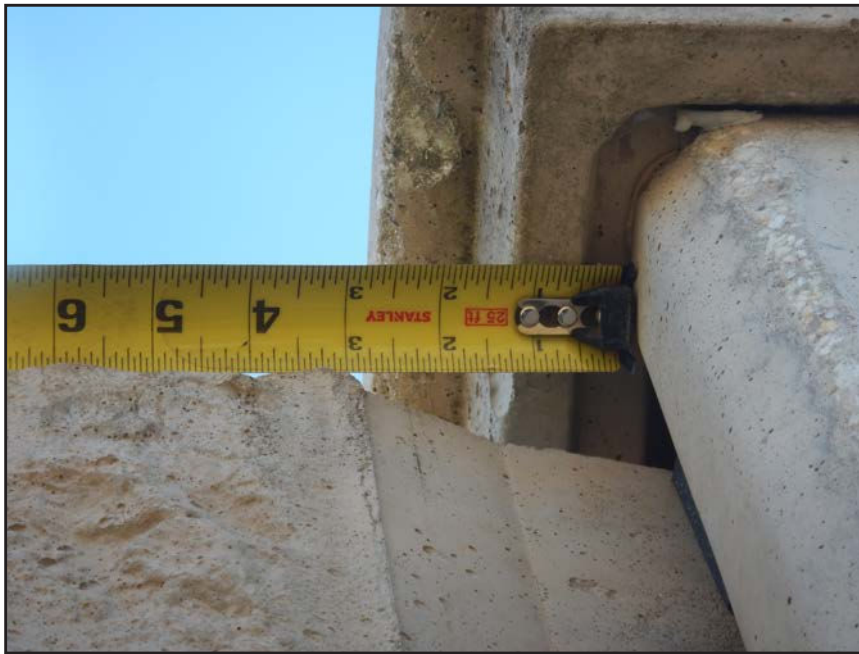
NO. 231 - COLUMN 53S -
INSUFFICIENT SEATING OF A
PRECAST WALL PANEL IN A
PRECAST COLUMN

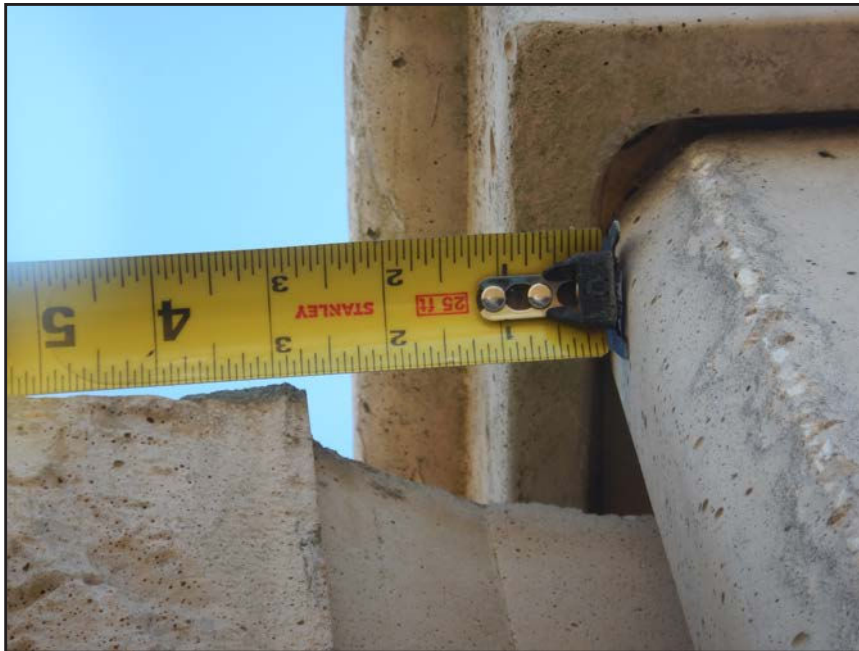
NO. 232 - COLUMN 58S -
INSUFFICIENT SEATING OF A
PRECAST WALL PANEL IN A
PRECAST COLUMN

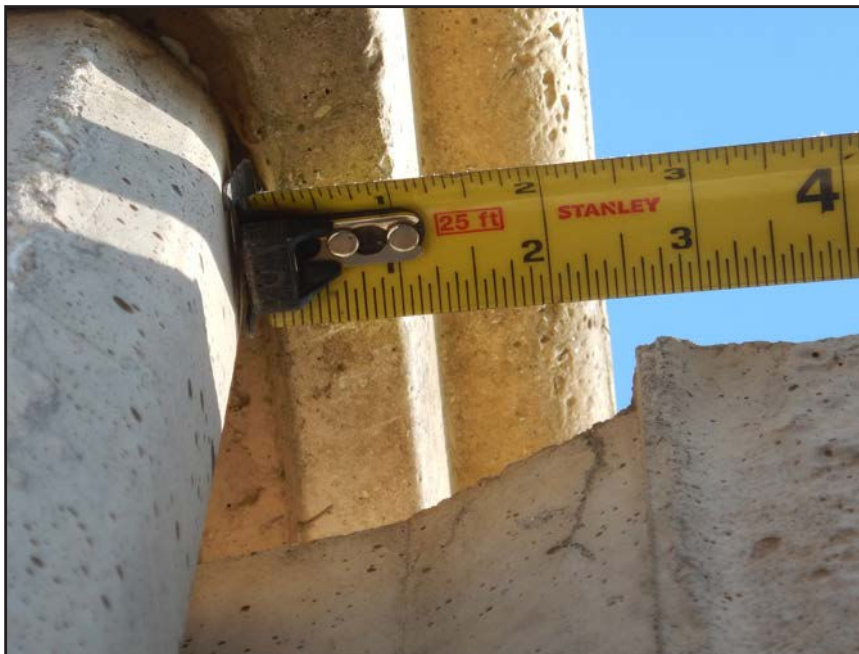
NO. 233 - COLUMN 63S -
INSUFFICIENT SEATING OF A
PRECAST WALL PANEL IN A
PRECAST COLUMN

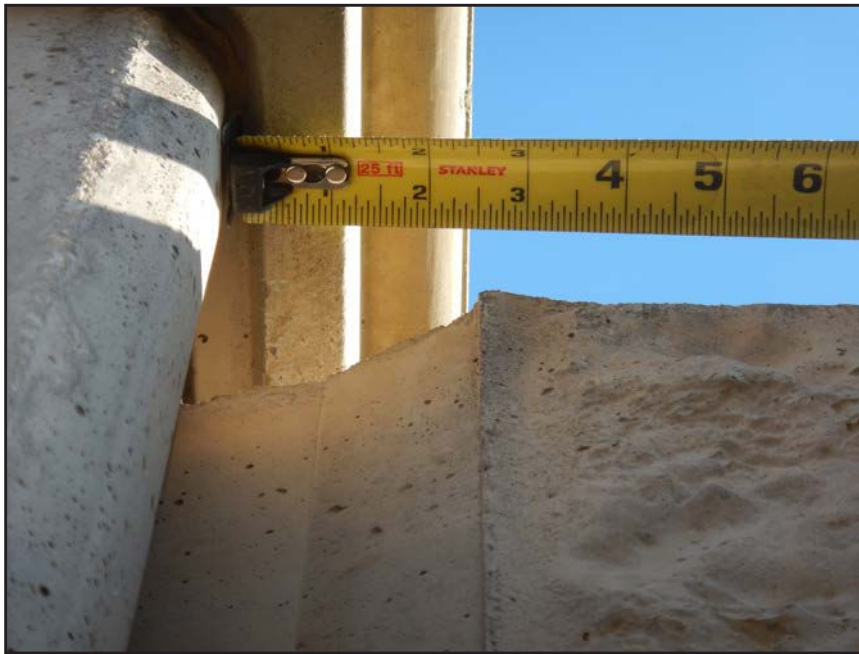
NO. 234 - COLUMN 68S -
INSUFFICIENT SEATING OF A
PRECAST WALL PANEL IN A
PRECAST COLUMN

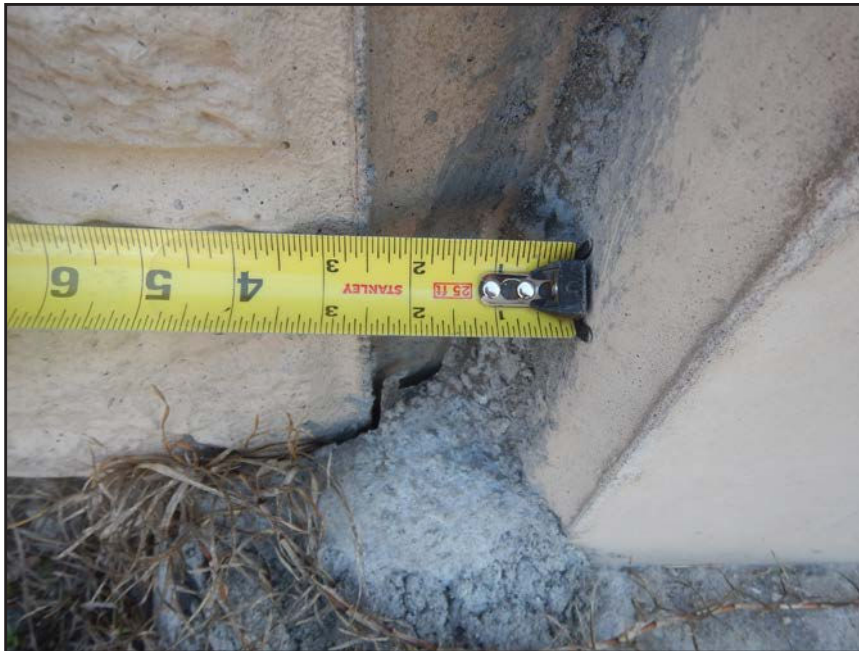
NO. 235 - COLUMN 69S -
INSUFFICIENT SEATING OF A
PRECAST WALL PANEL IN A
PRECAST COLUMN

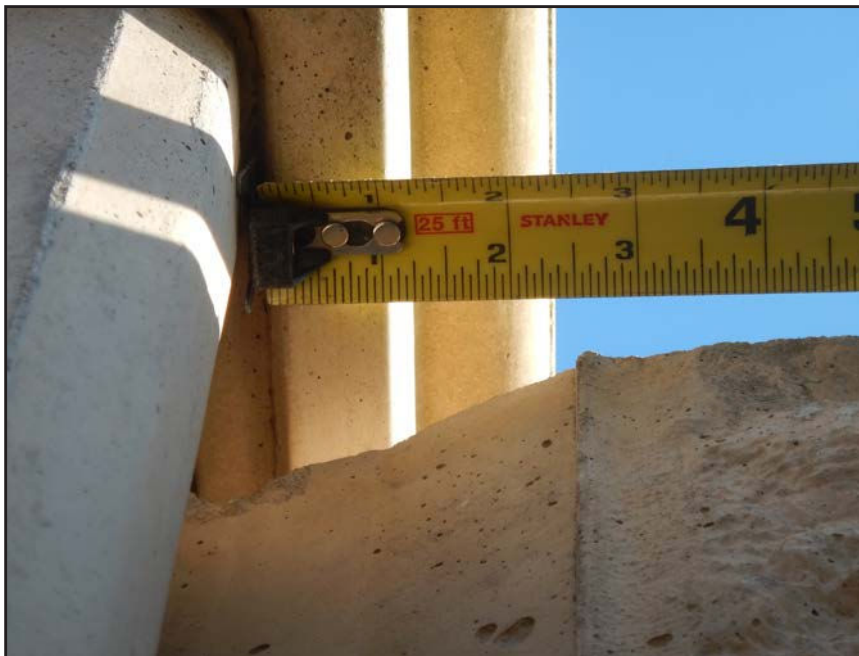
NO. 236 - COLUMN 70S -
INSUFFICIENT SEATING OF A
PRECAST WALL PANEL IN A
PRECAST COLUMN

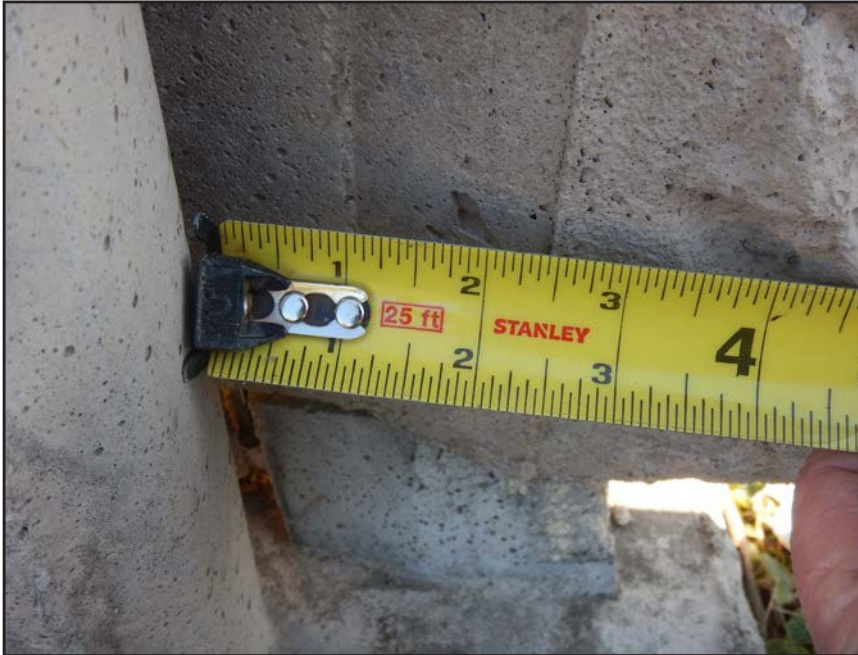
NO. 237 - COLUMN 72S -
INSUFFICIENT SEATING OF A
PRECAST WALL PANEL IN A
PRECAST COLUMN

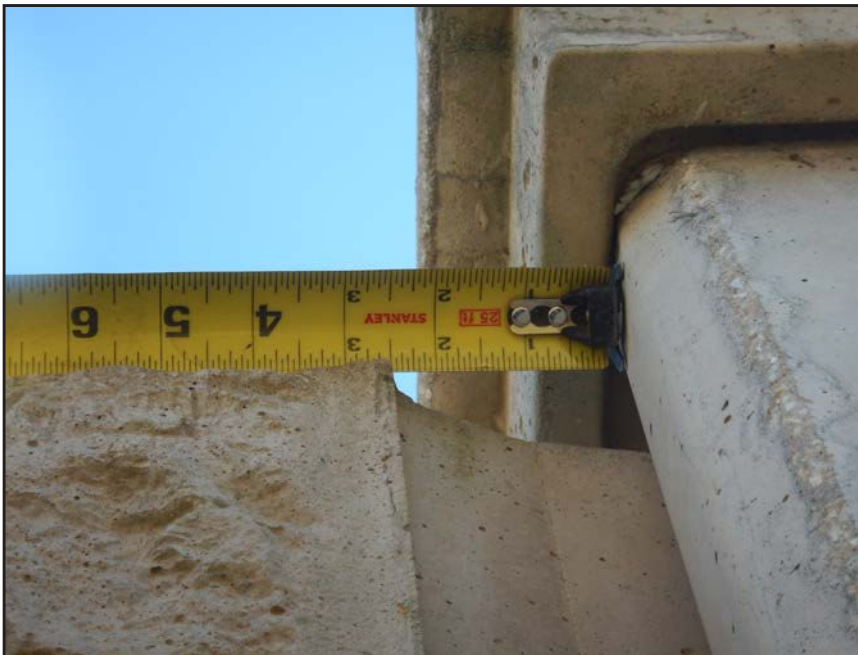
NO. 238 - COLUMN 75S -
INSUFFICIENT SEATING OF A
PRECAST WALL PANEL IN A
PRECAST COLUMN

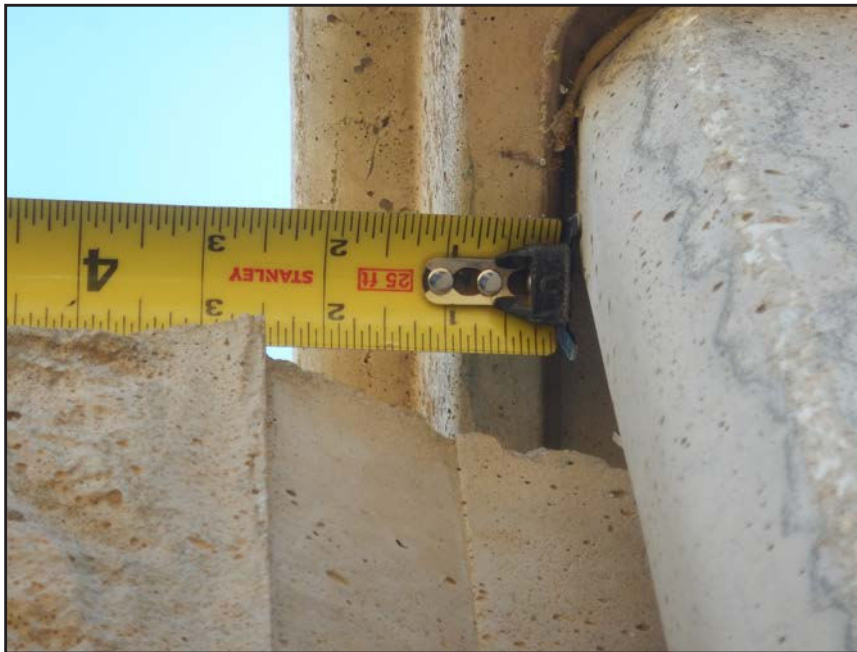
NO. 239 - COLUMN 76S -
INSUFFICIENT SEATING OF A
PRECAST WALL PANEL IN A
PRECAST COLUMN

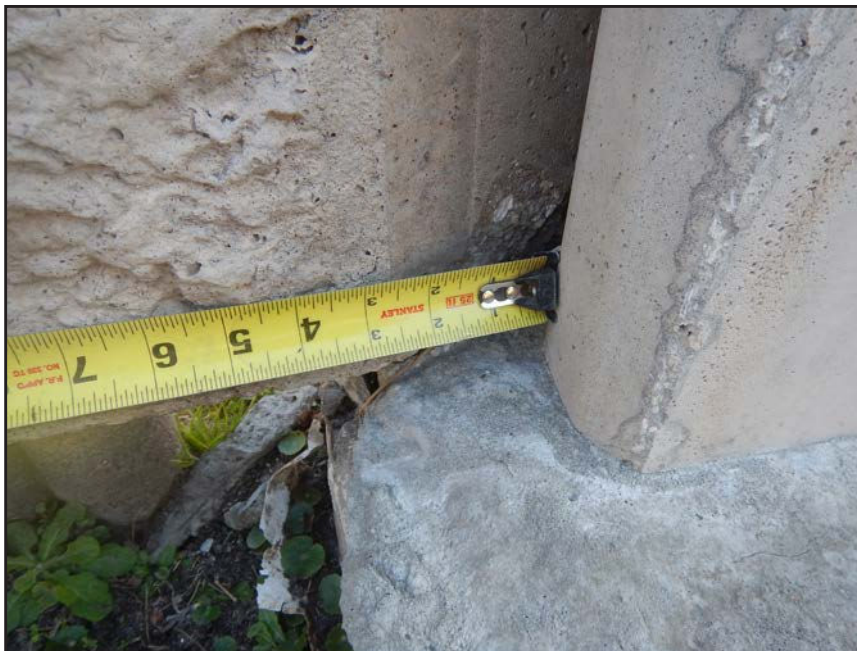
NO. 240 - COLUMN 79S -
INSUFFICIENT SEATING OF A
PRECAST WALL PANEL IN A
PRECAST COLUMN

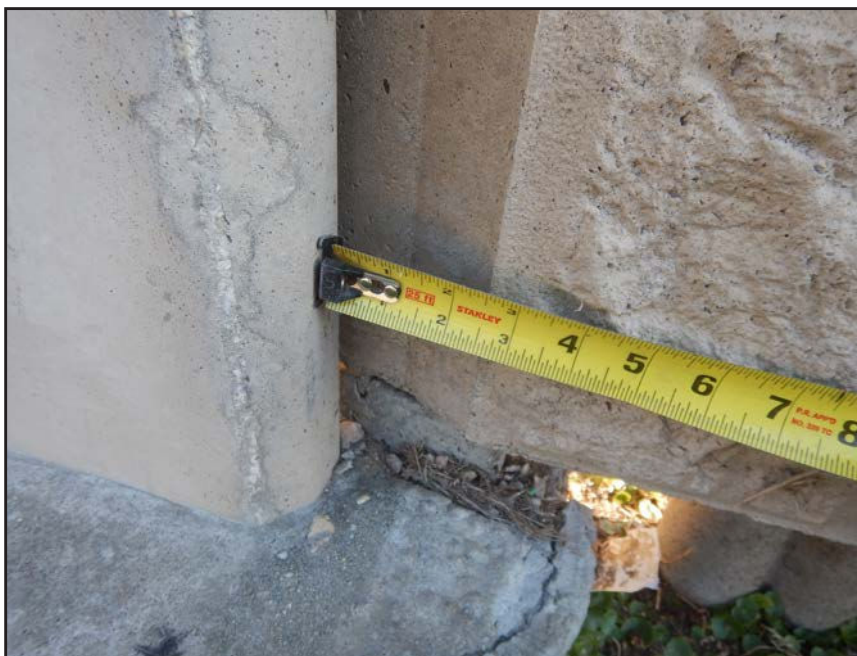
NO. 241 - COLUMN 79S -
INSUFFICIENT SEATING OF A
PRECAST WALL PANEL IN A
PRECAST COLUMN

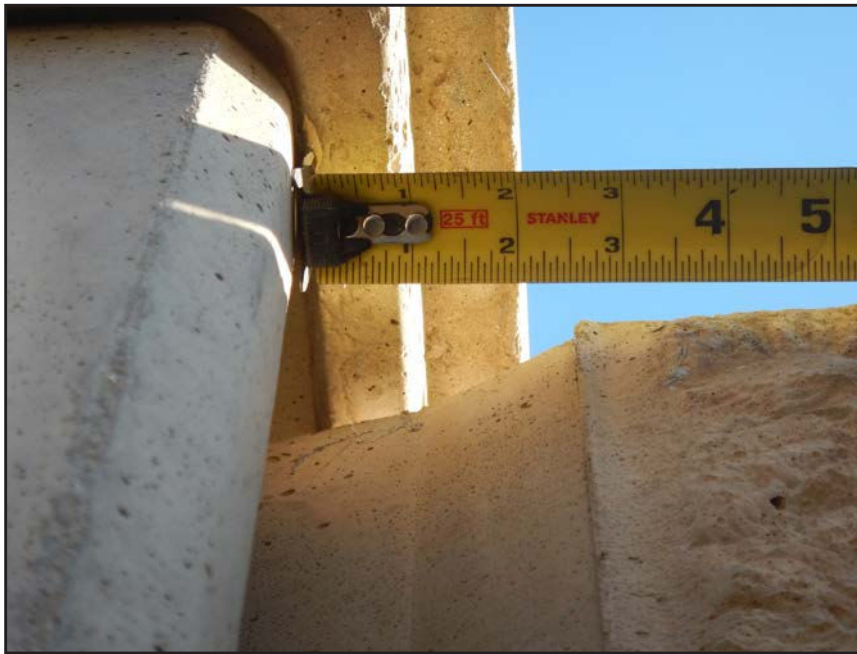
NO. 242 - COLUMN 79S -
INSUFFICIENT SEATING OF A
PRECAST WALL PANEL IN A
PRECAST COLUMN

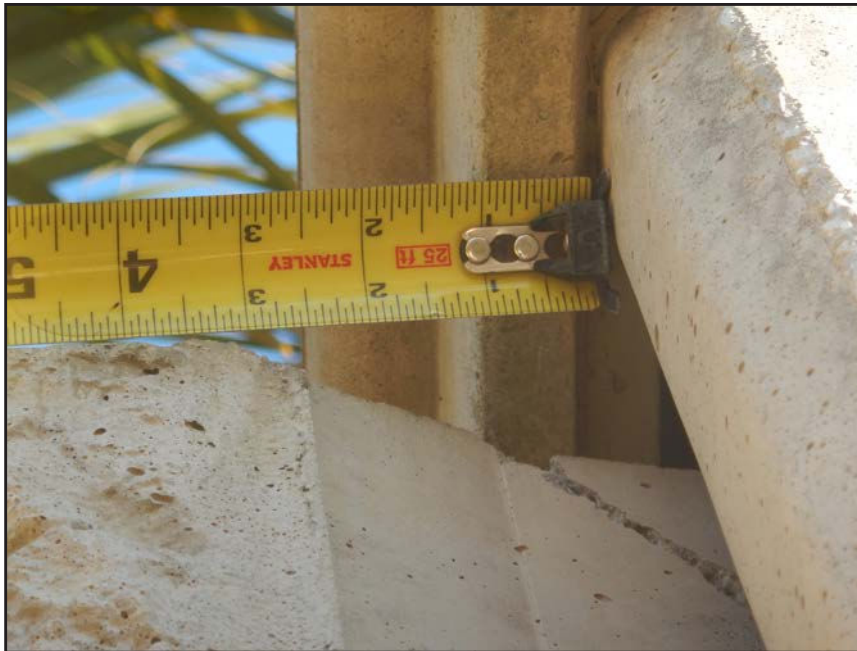
NO. 243 - COLUMN 80S -
INSUFFICIENT SEATING OF A
PRECAST WALL PANEL IN A
PRECAST COLUMN

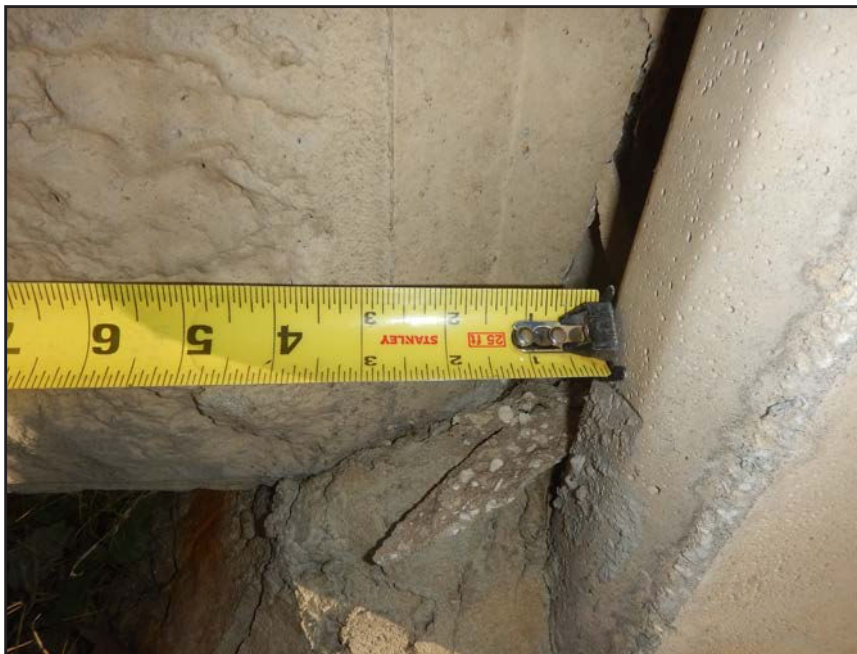
NO. 244 - COLUMN 6SS -
INSUFFICIENT SEATING OF A
PRECAST WALL PANEL IN A
PRECAST COLUMN

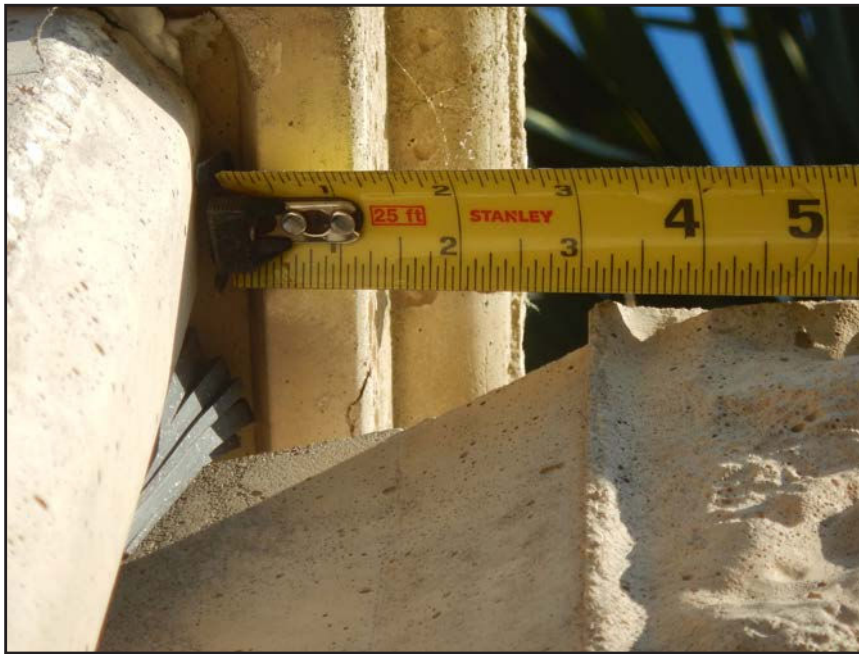
NO. 245 - COLUMN 6SS -
INSUFFICIENT SEATING OF A
PRECAST WALL PANEL IN A
PRECAST COLUMN

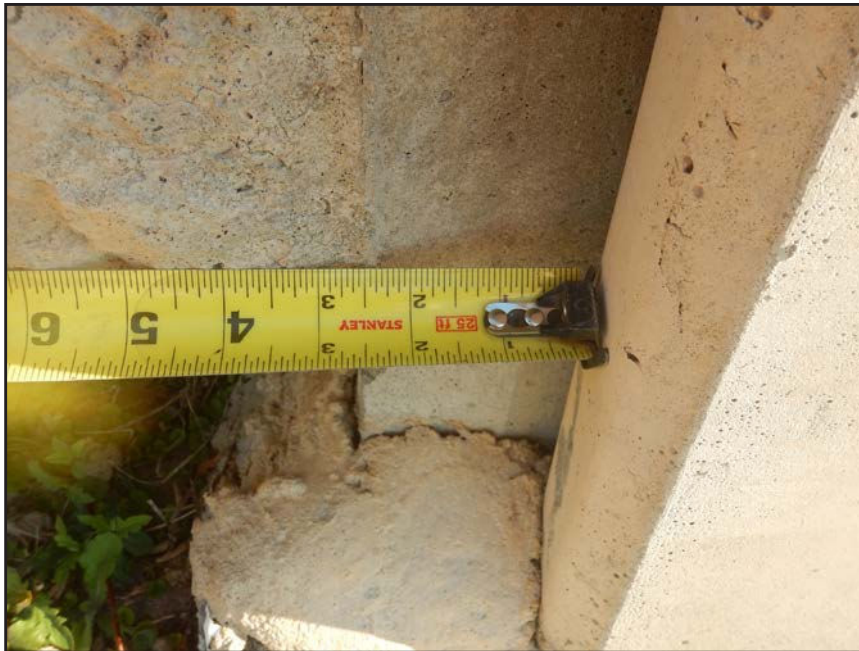
NO. 246 - COLUMN 6SS -
INSUFFICIENT SEATING OF A
PRECAST WALL PANEL IN A
PRECAST COLUMN

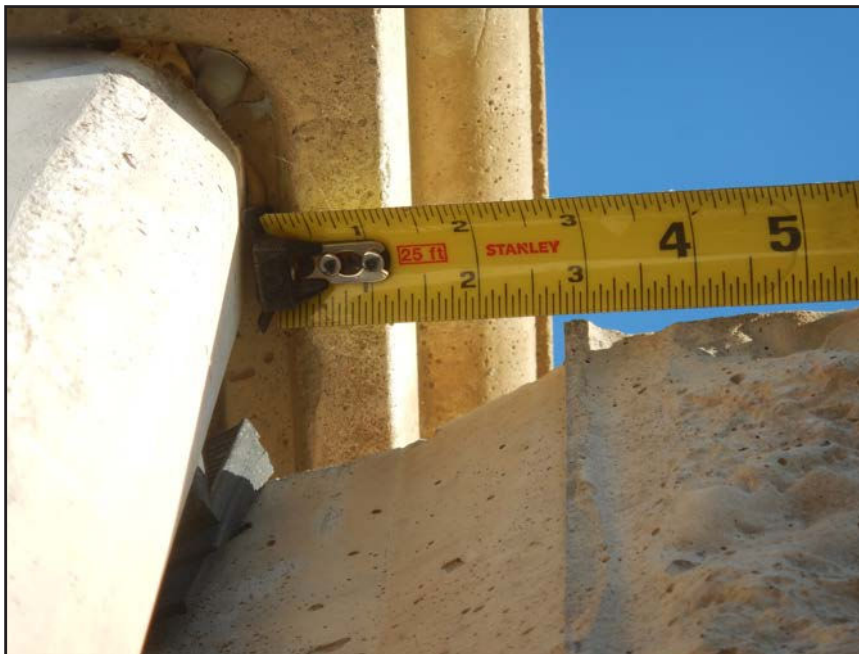
NO. 247 - COLUMN 13SS -
INSUFFICIENT SEATING OF A
PRECAST WALL PANEL IN A
PRECAST COLUMN

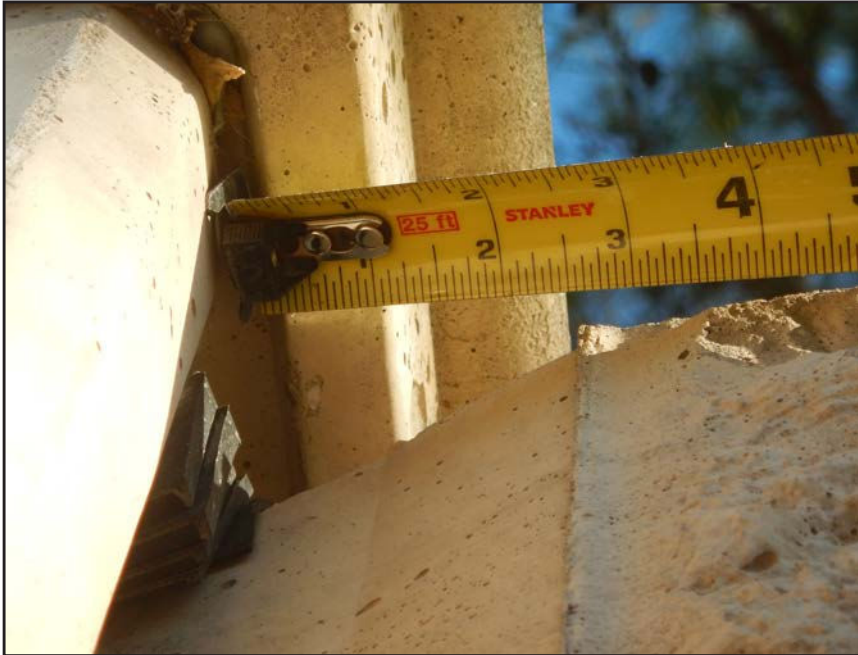
NO. 248 - COLUMN 18SS -
INSUFFICIENT SEATING OF A
PRECAST WALL PANEL IN A
PRECAST COLUMN

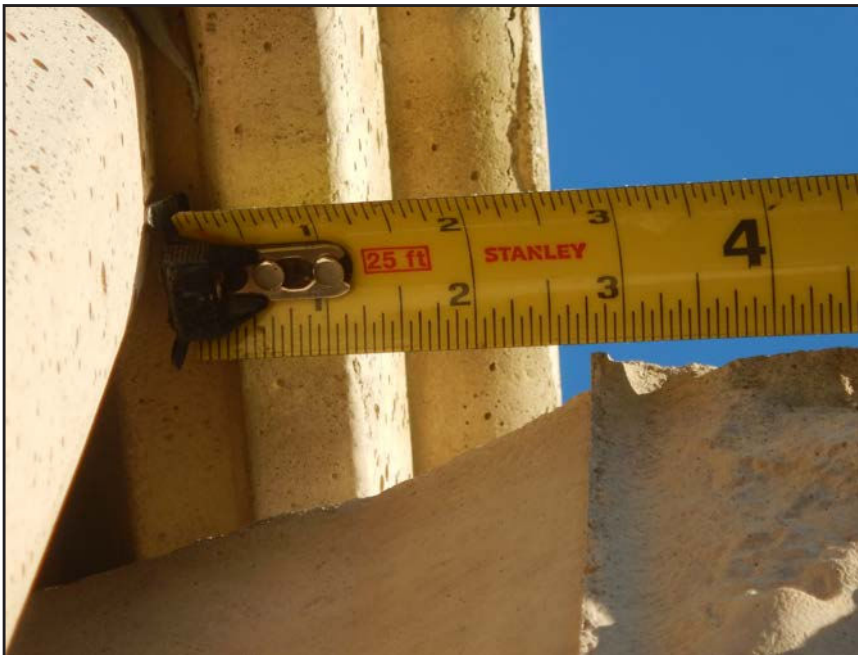
NO. 249 - COLUMN 24SS -
INSUFFICIENT SEATING OF A
PRECAST WALL PANEL IN A
PRECAST COLUMN

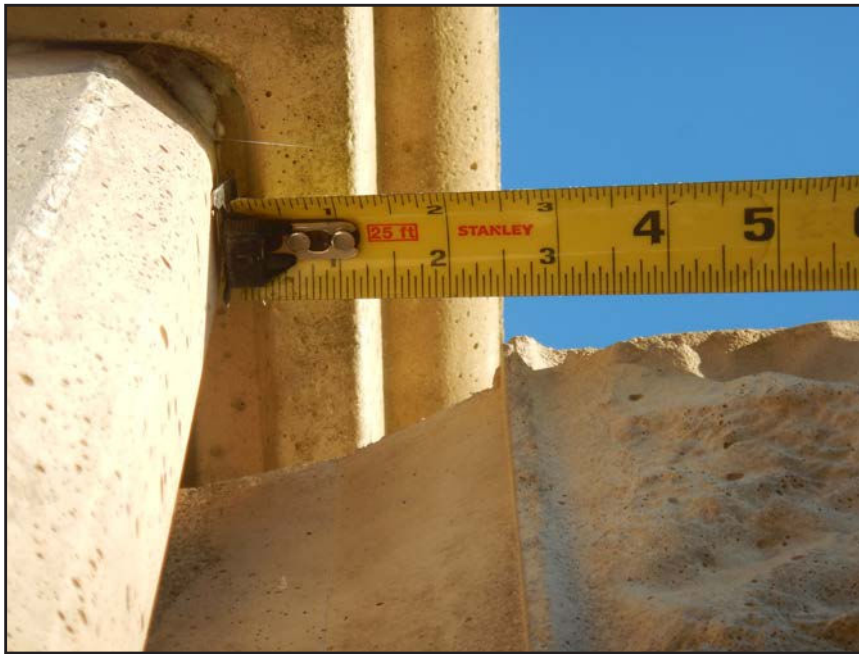
NO. 250 - COLUMN 27SS -
INSUFFICIENT SEATING OF A
PRECAST WALL PANEL IN A
PRECAST COLUMN
