WATER TOWER ROAD SCREEN WALL INVESTIGATIONS

Water Tower Road
Longs, South Carolina

Stantec Project No. 171015900

March 31, 2025

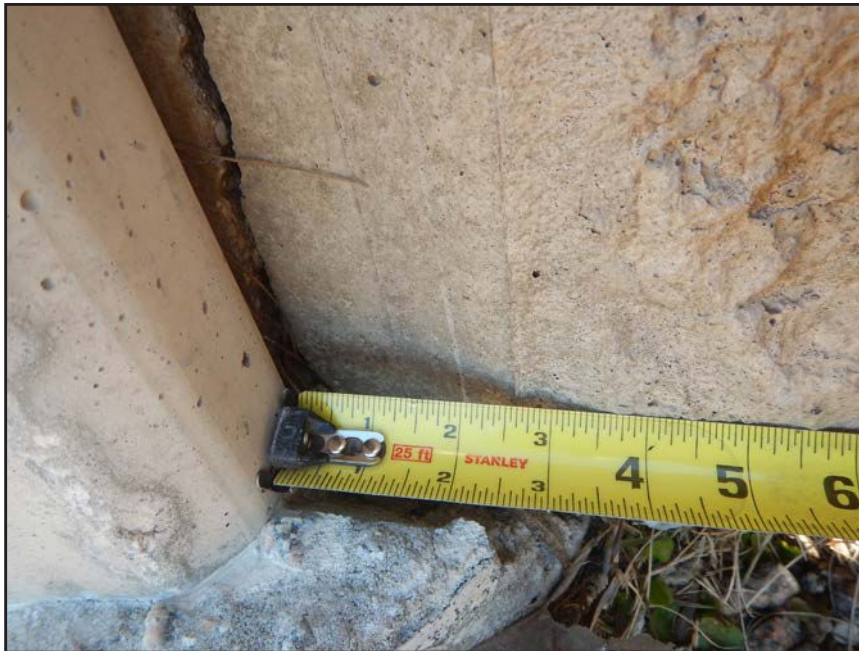
NO. 251 - COLUMN 28SS -
INSUFFICIENT SEATING OF A
PRECAST WALL PANEL IN A
PRECAST COLUMN

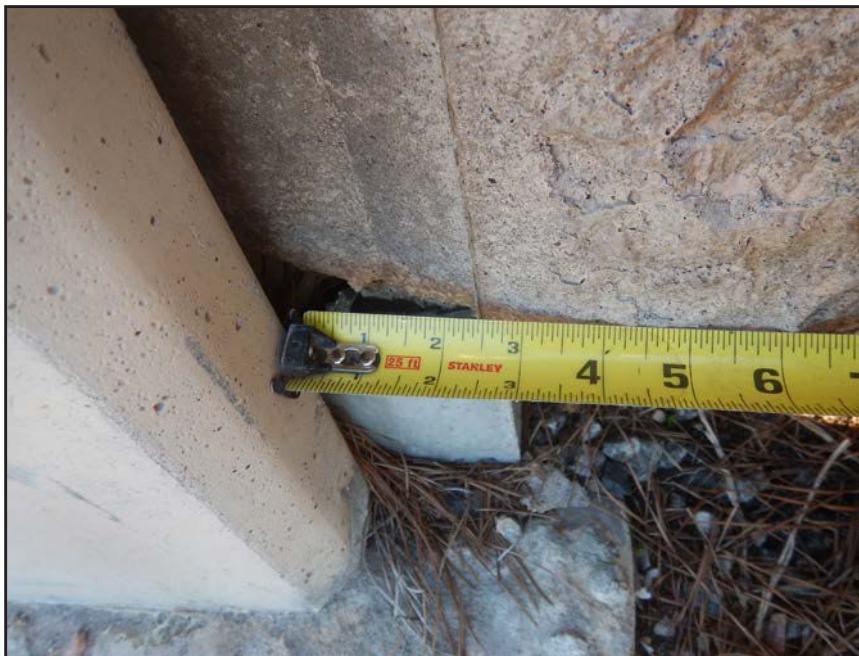
NO. 252 - COLUMN 28SS -
INSUFFICIENT SEATING OF A
PRECAST WALL PANEL IN A
PRECAST COLUMN

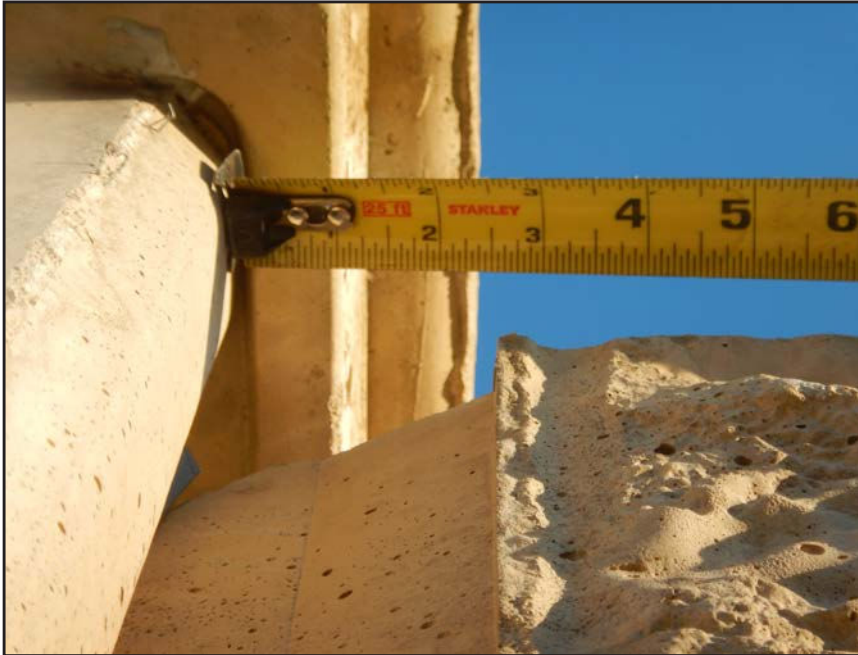
NO. 253 - COLUMN 32SS -
INSUFFICIENT SEATING OF A
PRECAST WALL PANEL IN A
PRECAST COLUMN

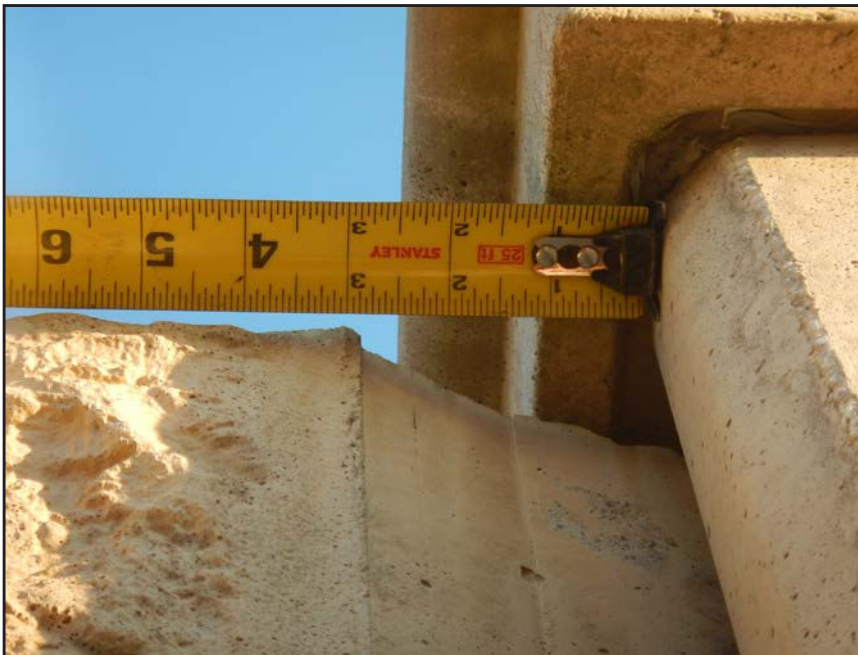
NO. 254 - COLUMN 46SS -
INSUFFICIENT SEATING OF A
PRECAST WALL PANEL IN A
PRECAST COLUMN

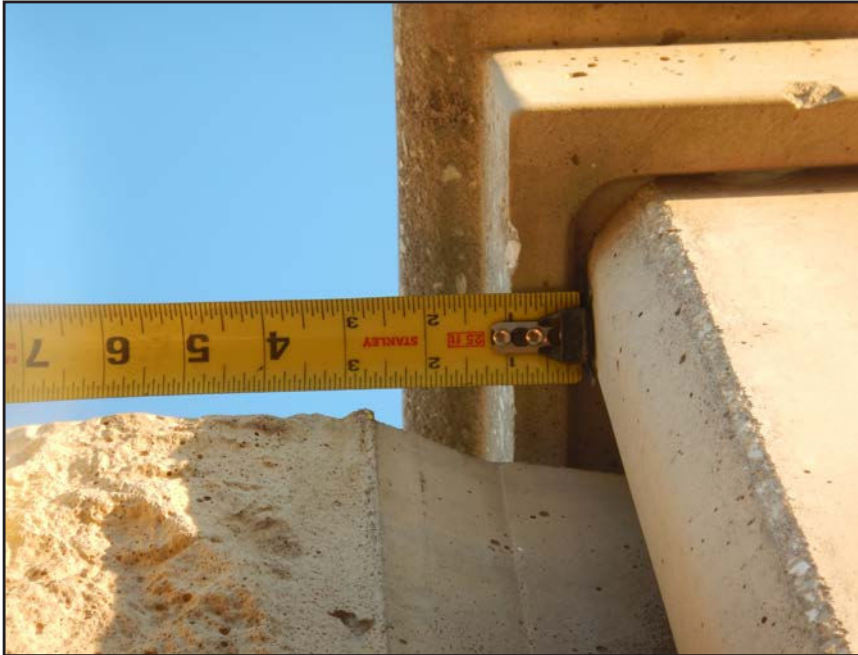
NO. 255 - COLUMN 47SS -
INSUFFICIENT SEATING OF A
PRECAST WALL PANEL IN A
PRECAST COLUMN

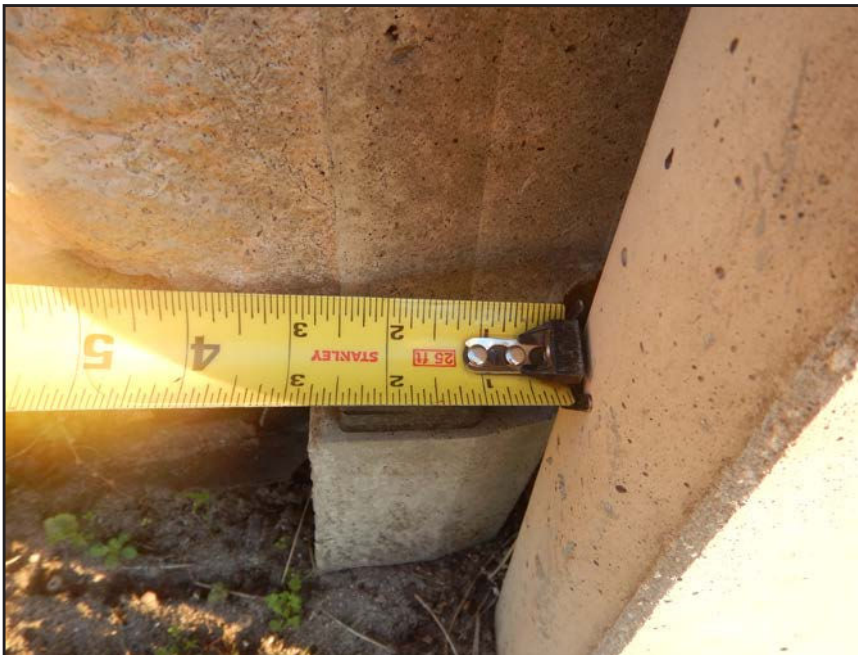
NO. 256 - COLUMN 51SS -
INSUFFICIENT SEATING OF A
PRECAST WALL PANEL IN A
PRECAST COLUMN

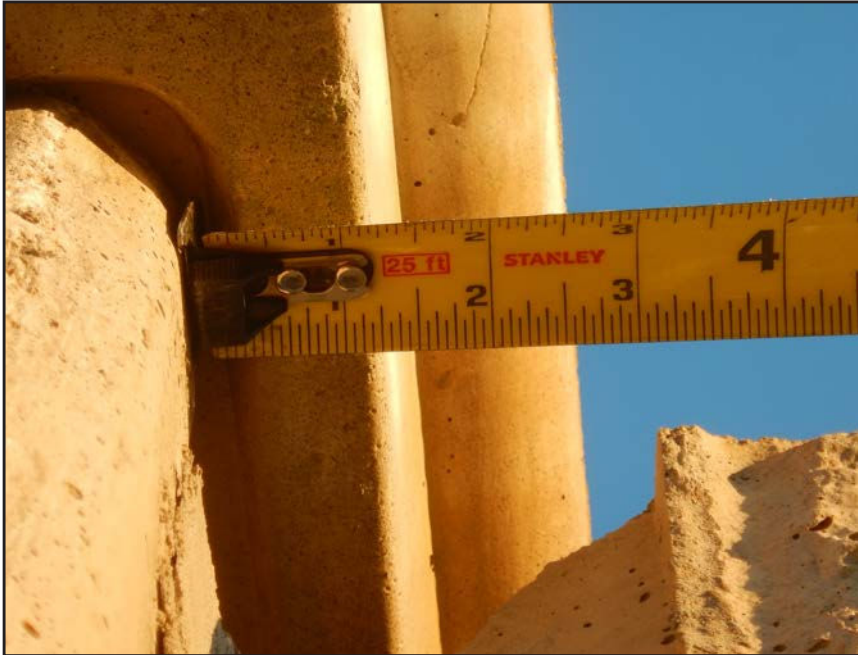
NO. 257 - COLUMN 51SS -
INSUFFICIENT SEATING OF A
PRECAST WALL PANEL IN A
PRECAST COLUMN

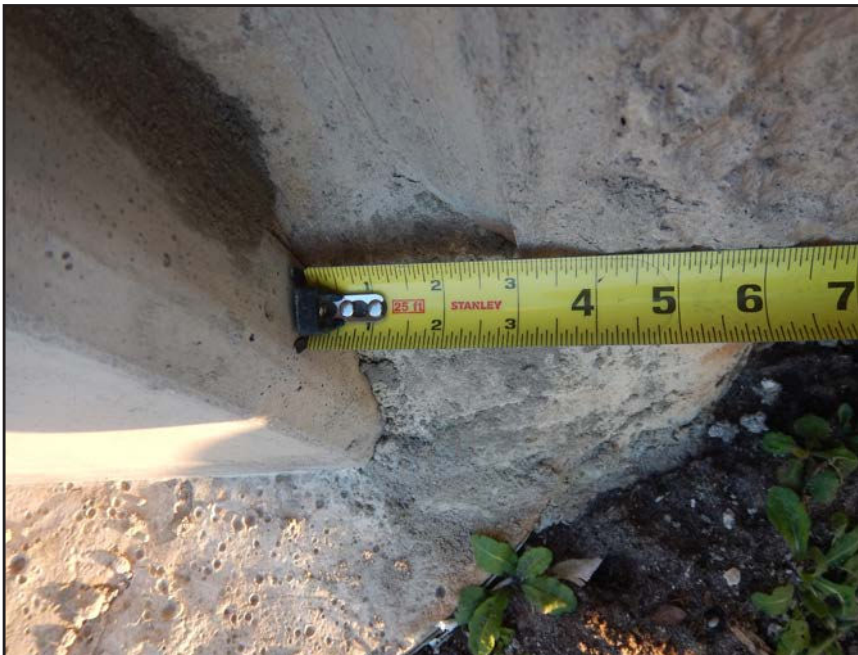
NO. 258 - COLUMN 55SS -
INSUFFICIENT SEATING OF A
PRECAST WALL PANEL IN A
PRECAST COLUMN

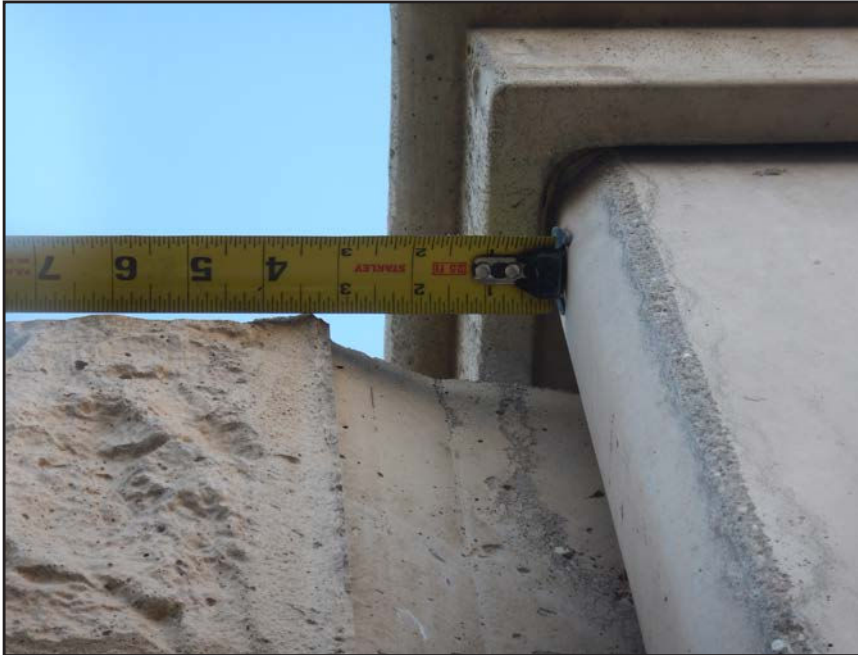
NO. 259 - COLUMN 55SS -
INSUFFICIENT SEATING OF A
PRECAST WALL PANEL IN A
PRECAST COLUMN

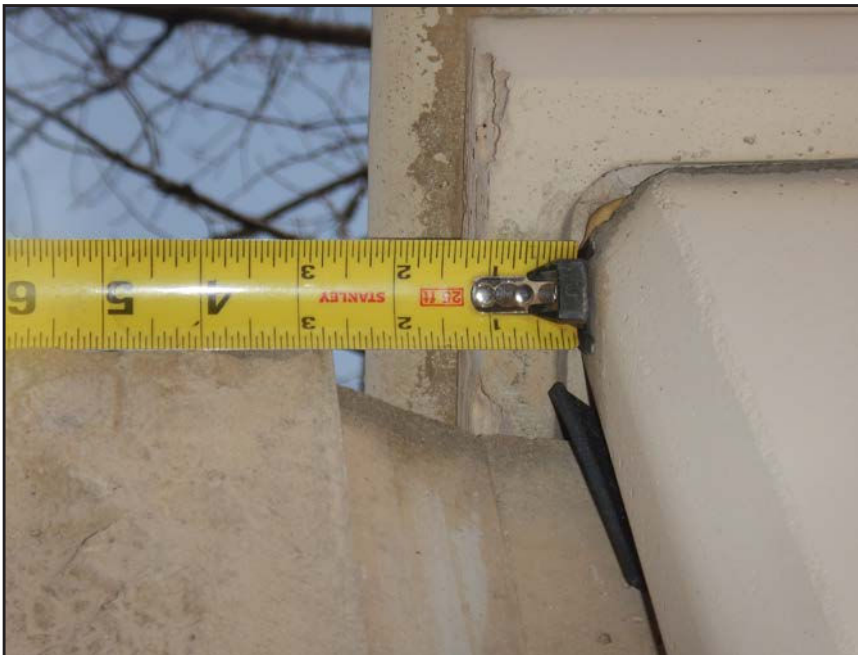
NO. 260 - COLUMN 71SS -
INSUFFICIENT SEATING OF A
PRECAST WALL PANEL IN A
PRECAST COLUMN

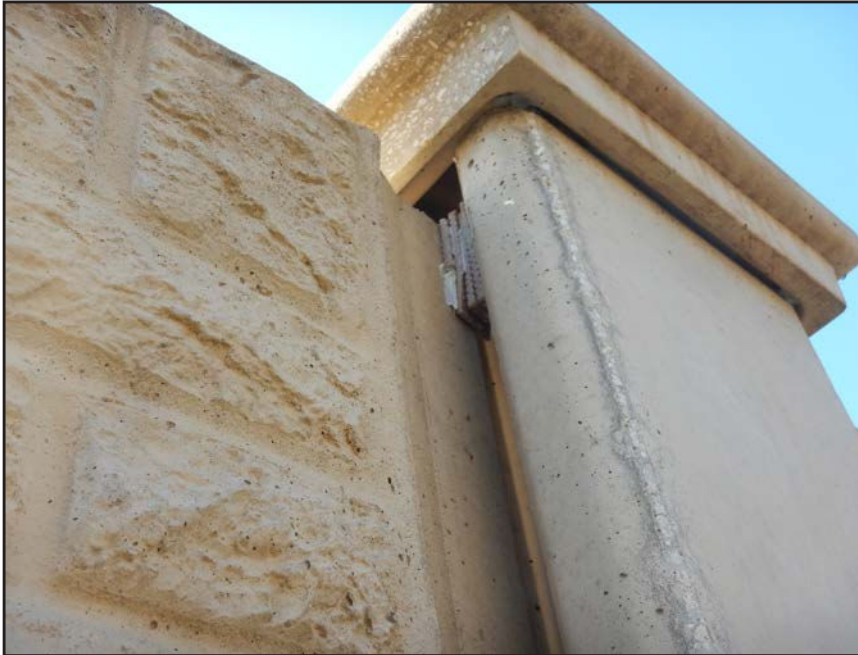
NO. 264 - COLUMN 22N -
INADEQUATE SHIMS STABILIZING
A WALL PANEL TO COLUMN
CONNECTION AT EXCESSIVE
PLAY BETWEEN ADJACENT
MEMBERS

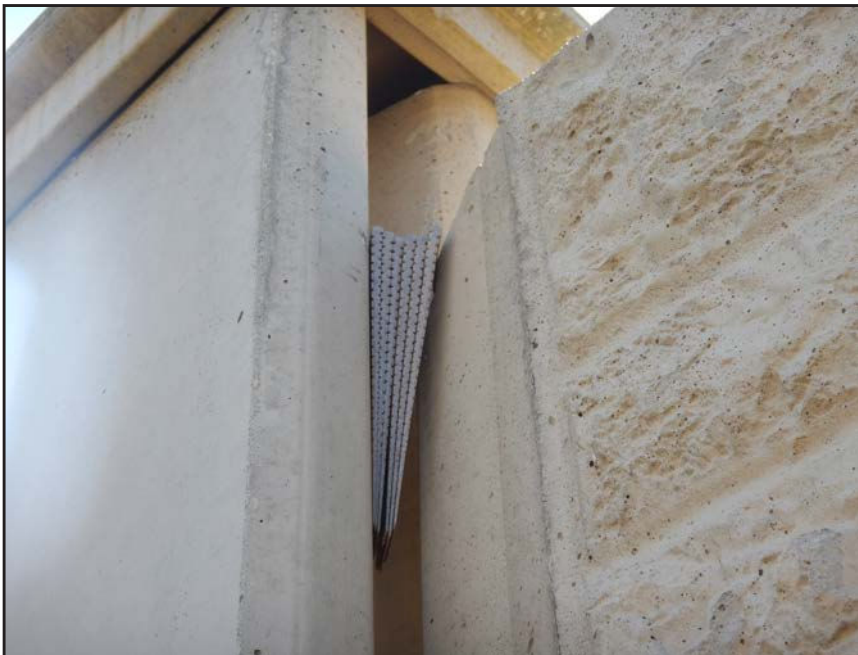
NO. 265 - COLUMN 7NM -
INADEQUATE SHIMS STABILIZING
A WALL PANEL TO COLUMN
CONNECTION AT EXCESSIVE
PLAY BETWEEN ADJACENT
MEMBERS

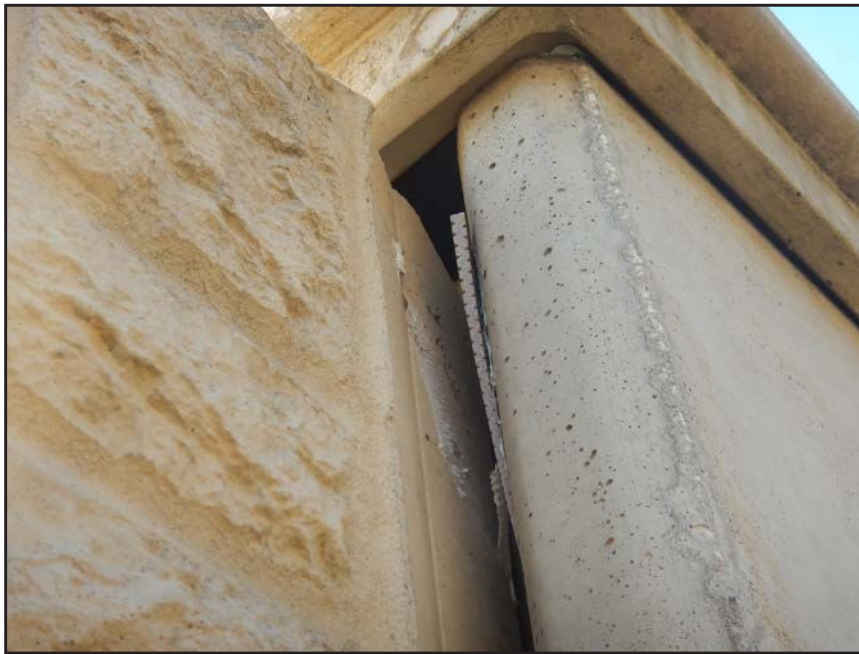
NO. 266 - COLUMN 11NM -
INADEQUATE SHIMS STABILIZING
A WALL PANEL TO COLUMN
CONNECTION AT EXCESSIVE
PLAY BETWEEN ADJACENT
MEMBERS

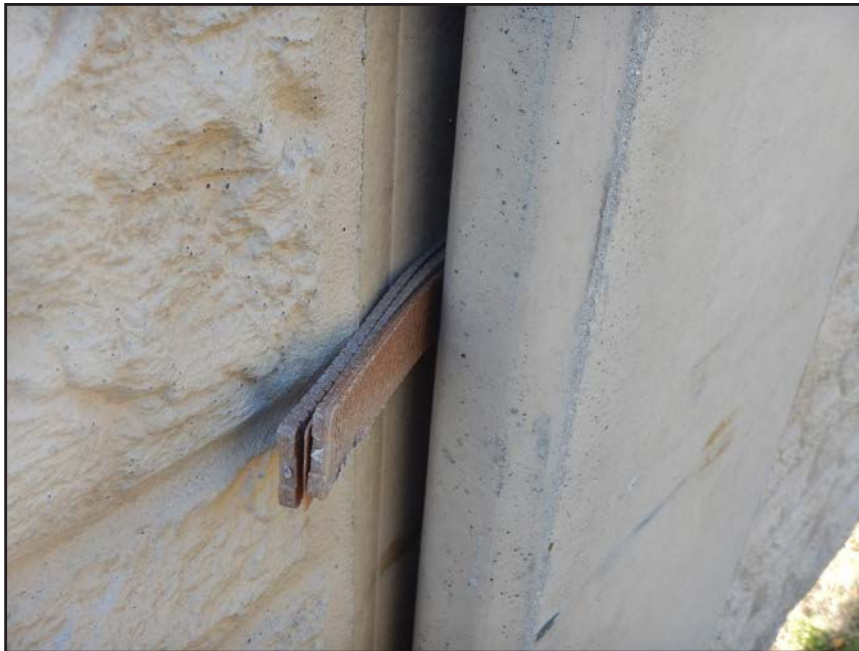
NO. 267 - COLUMN 17SM -
INADEQUATE SHIMS STABILIZING
A WALL PANEL TO COLUMN
CONNECTION AT EXCESSIVE
PLAY BETWEEN ADJACENT
MEMBERS

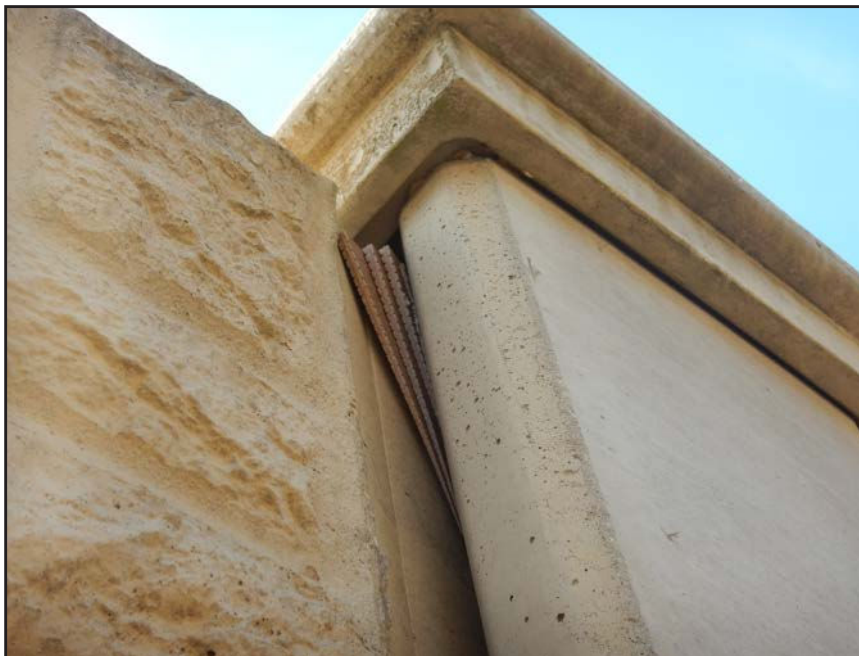
NO. 268 - COLUMN 17SM -
INADEQUATE SHIMS STABILIZING
A WALL PANEL TO COLUMN
CONNECTION AT EXCESSIVE
PLAY BETWEEN ADJACENT
MEMBERS

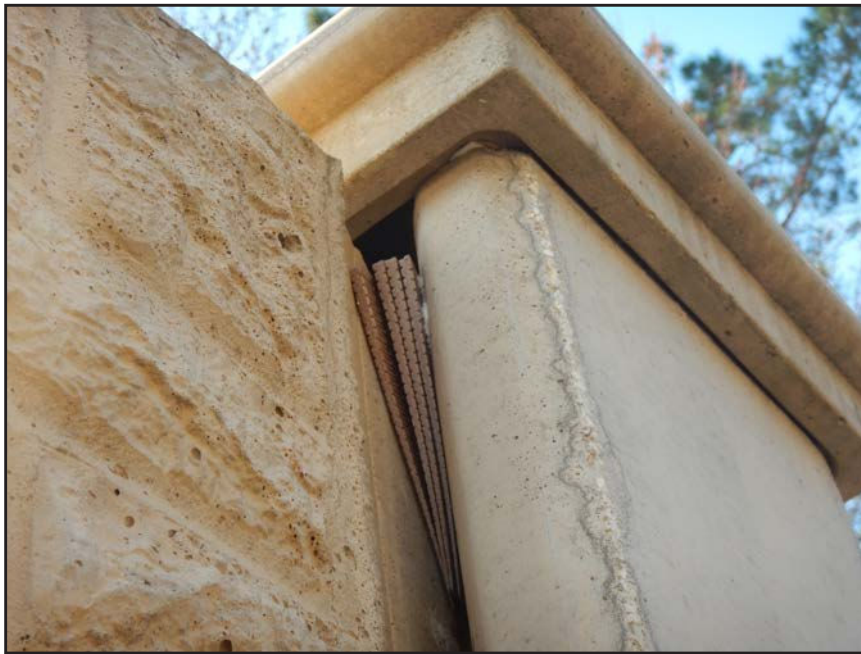
NO. 269 - COLUMN 24SM -
INADEQUATE SHIMS STABILIZING
A WALL PANEL TO COLUMN
CONNECTION AT EXCESSIVE
PLAY BETWEEN ADJACENT
MEMBERS

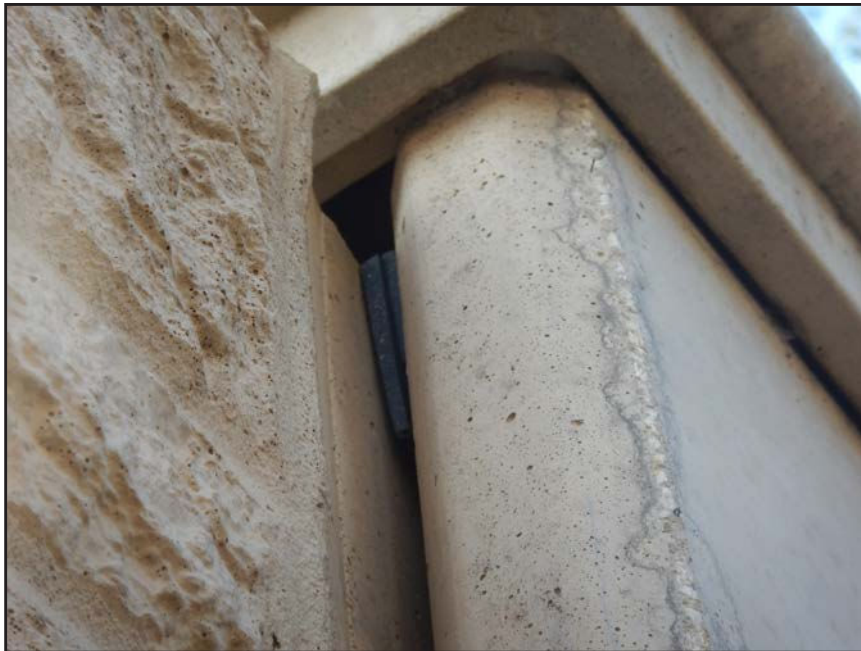
NO. 270 - COLUMN 25SM -
INADEQUATE SHIMS STABILIZING
A WALL PANEL TO COLUMN
CONNECTION AT EXCESSIVE
PLAY BETWEEN ADJACENT
MEMBERS

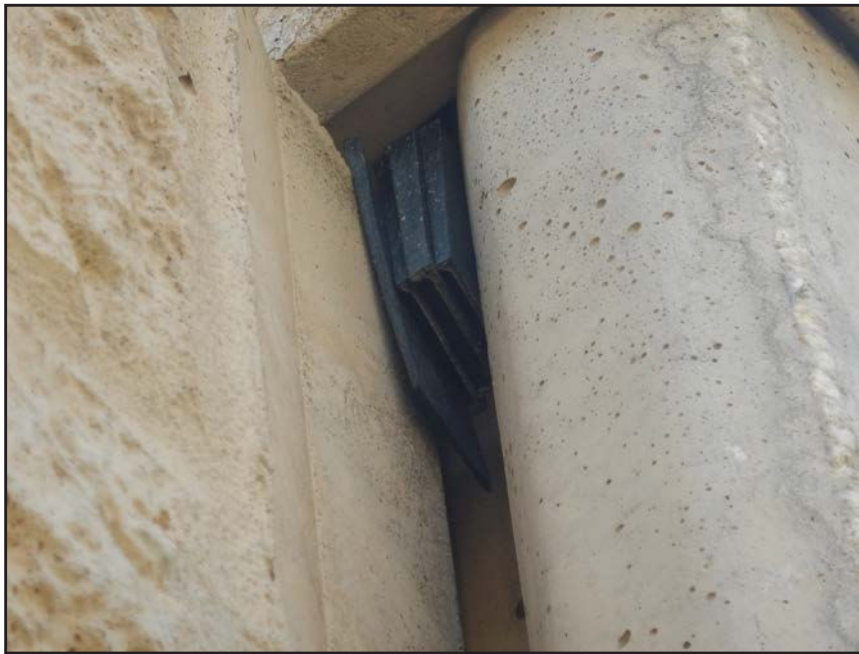
NO. 272 - COLUMN 4S -
INADEQUATE SHIMS STABILIZING
A WALL PANEL TO COLUMN
CONNECTION AT EXCESSIVE
PLAY BETWEEN ADJACENT
MEMBERS

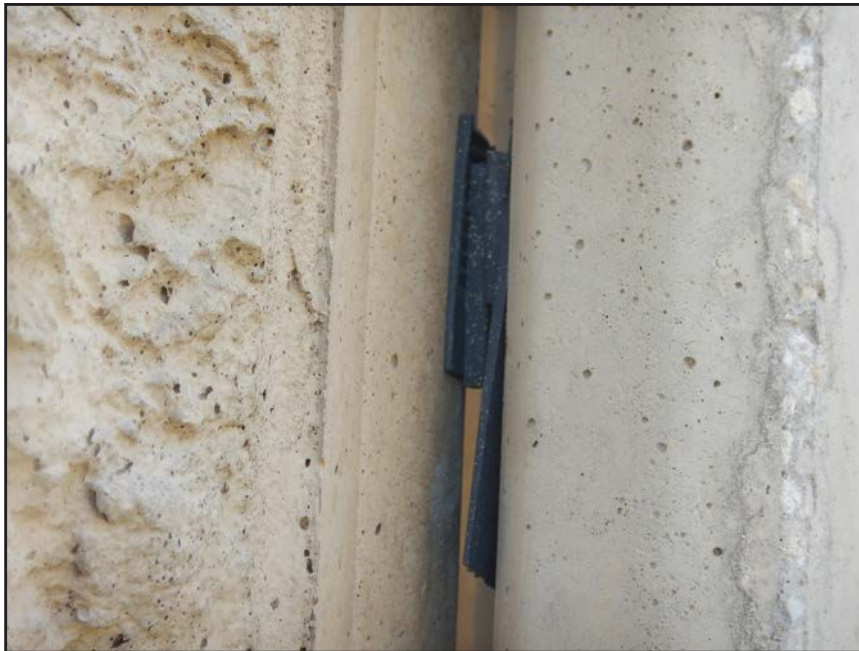
NO. 273 - COLUMN 10S -
INADEQUATE SHIMS STABILIZING
A WALL PANEL TO COLUMN
CONNECTION AT EXCESSIVE
PLAY BETWEEN ADJACENT
MEMBERS

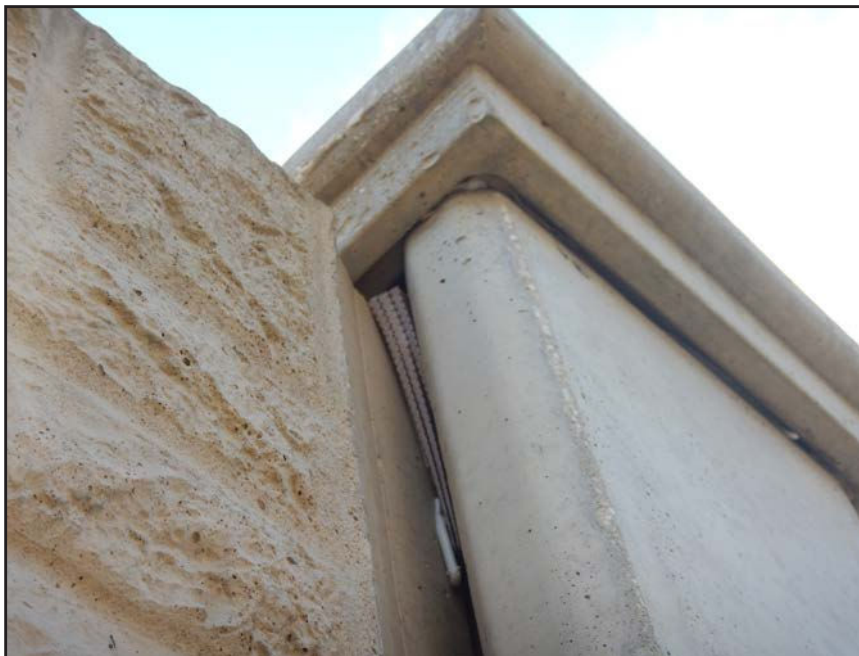
NO. 274 - COLUMN 10S -
INADEQUATE SHIMS STABILIZING
A WALL PANEL TO COLUMN
CONNECTION AT EXCESSIVE
PLAY BETWEEN ADJACENT
MEMBERS

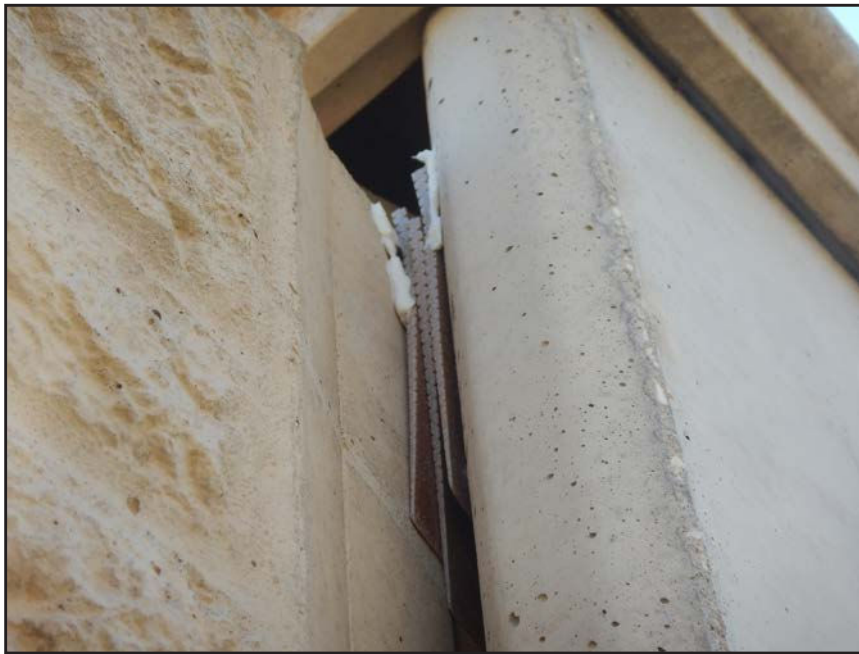
NO. 275 - COLUMN 23S -
INADEQUATE SHIMS STABILIZING
A WALL PANEL TO COLUMN
CONNECTION AT EXCESSIVE
PLAY BETWEEN ADJACENT
MEMBERS

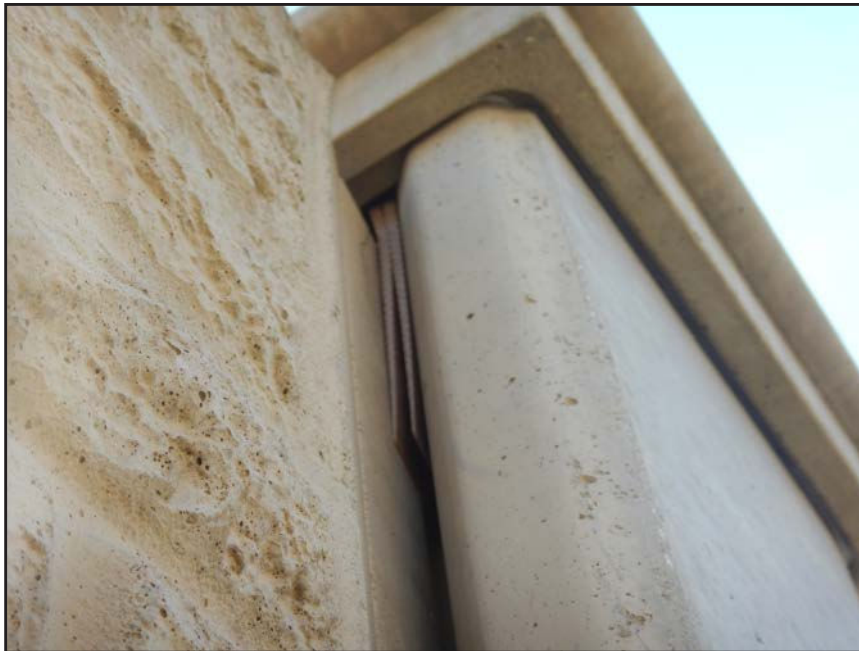
NO. 276 - COLUMN 28S -
INADEQUATE SHIMS STABILIZING
A WALL PANEL TO COLUMN
CONNECTION AT EXCESSIVE
PLAY BETWEEN ADJACENT
MEMBERS

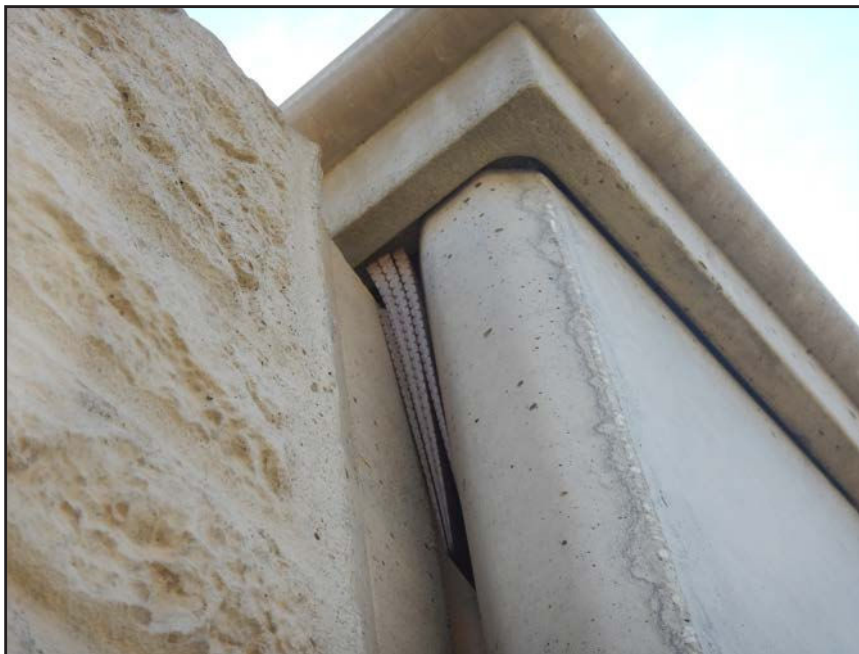
NO. 277 - COLUMN 31S -
INADEQUATE SHIMS STABILIZING
A WALL PANEL TO COLUMN
CONNECTION AT EXCESSIVE
PLAY BETWEEN ADJACENT
MEMBERS

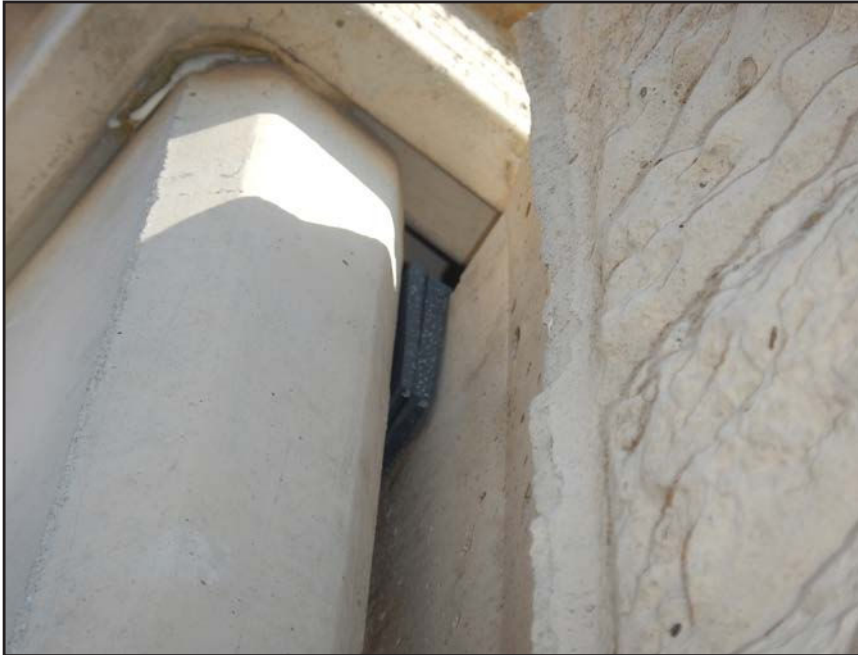
NO. 278 - COLUMN 34S -
INADEQUATE SHIMS STABILIZING
A WALL PANEL TO COLUMN
CONNECTION AT EXCESSIVE
PLAY BETWEEN ADJACENT
MEMBERS

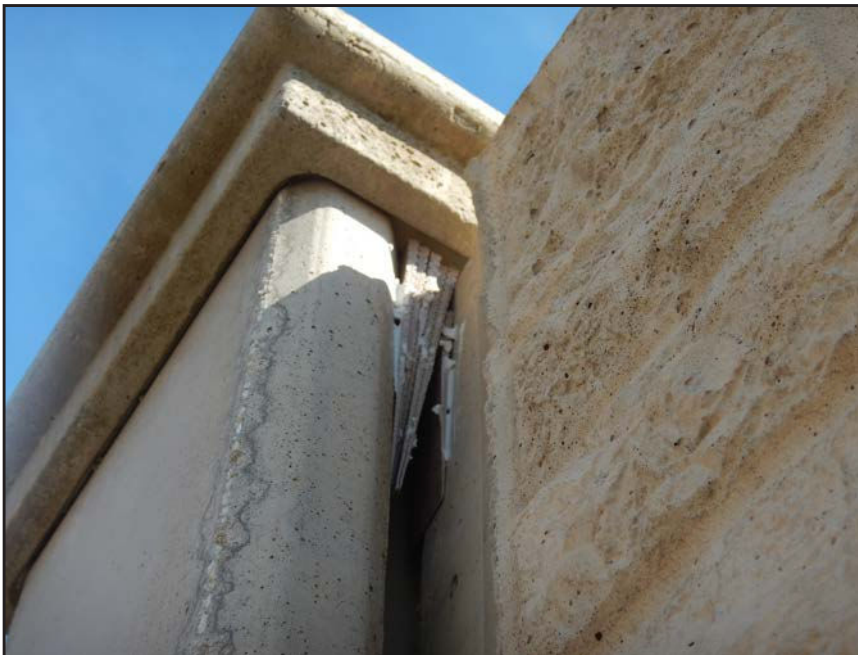
NO. 279 - COLUMN 41S -
INADEQUATE SHIMS STABILIZING
A WALL PANEL TO COLUMN
CONNECTION AT EXCESSIVE
PLAY BETWEEN ADJACENT
MEMBERS

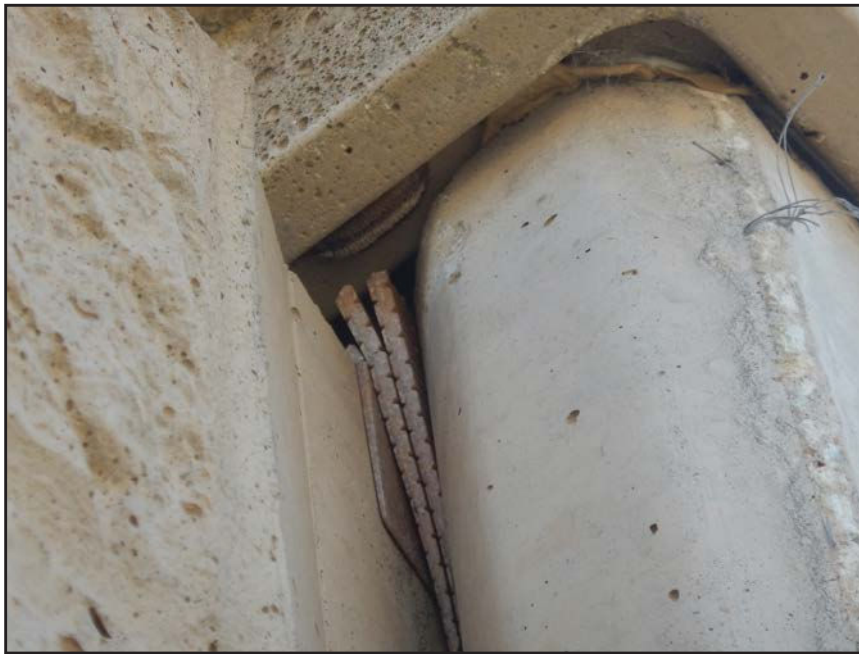
NO. 280 - COLUMN 42S -
INADEQUATE SHIMS STABILIZING
A WALL PANEL TO COLUMN
CONNECTION AT EXCESSIVE
PLAY BETWEEN ADJACENT
MEMBERS

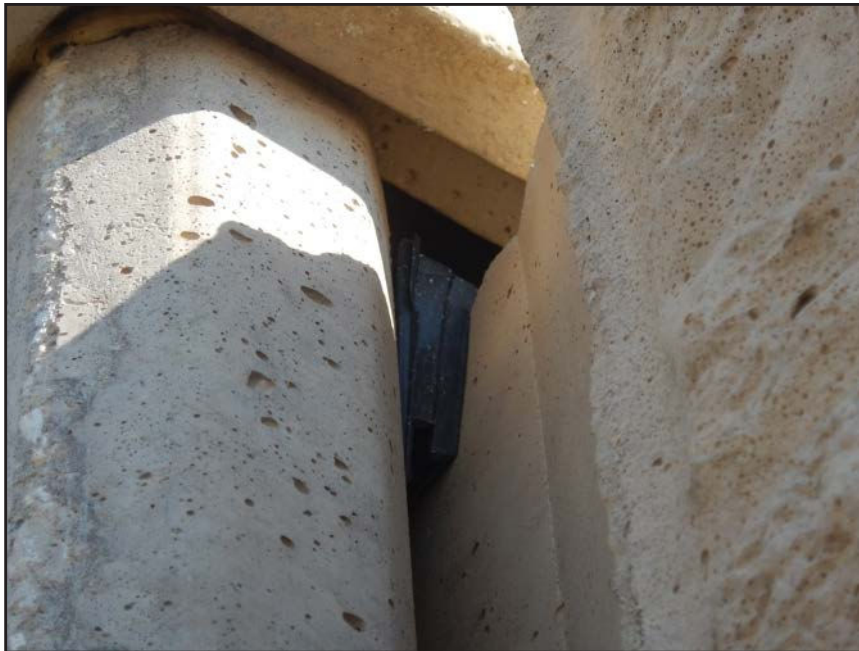
NO. 281 - COLUMN 45S -
INADEQUATE SHIMS STABILIZING
A WALL PANEL TO COLUMN
CONNECTION AT EXCESSIVE
PLAY BETWEEN ADJACENT
MEMBERS

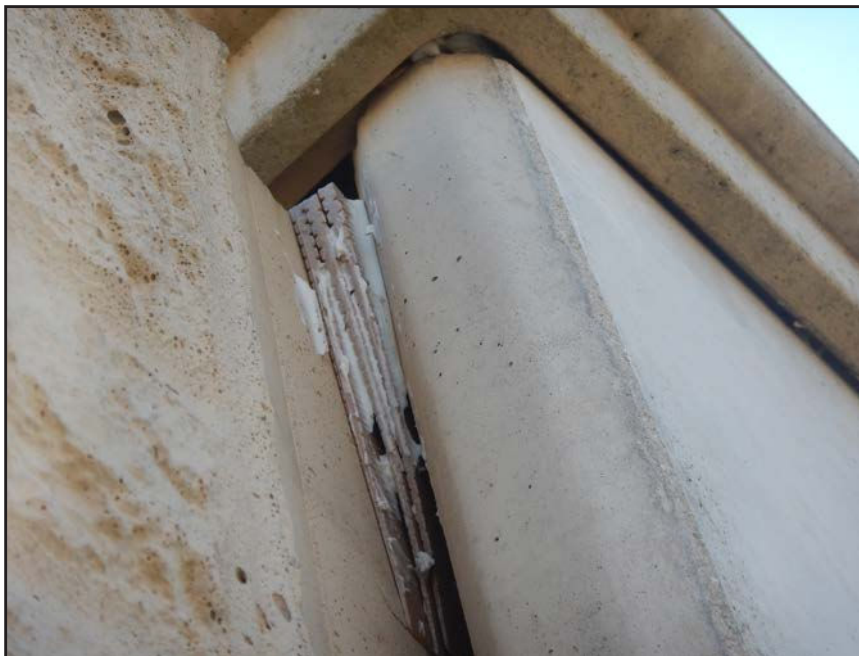
NO. 282 - COLUMN 45S -
INADEQUATE SHIMS STABILIZING
A WALL PANEL TO COLUMN
CONNECTION AT EXCESSIVE
PLAY BETWEEN ADJACENT
MEMBERS

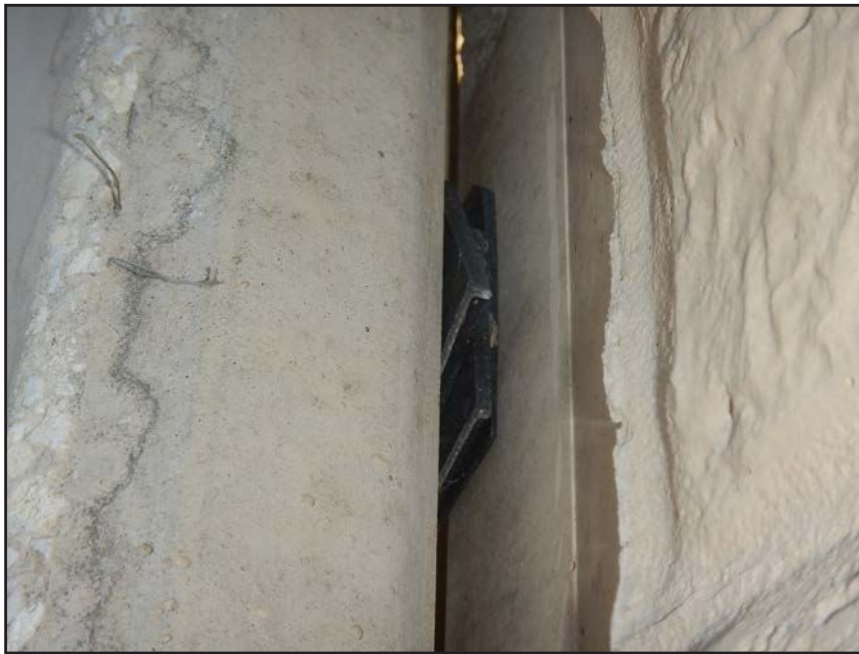
NO. 283 - COLUMN 53S -
INADEQUATE SHIMS STABILIZING
A WALL PANEL TO COLUMN
CONNECTION AT EXCESSIVE
PLAY BETWEEN ADJACENT
MEMBERS

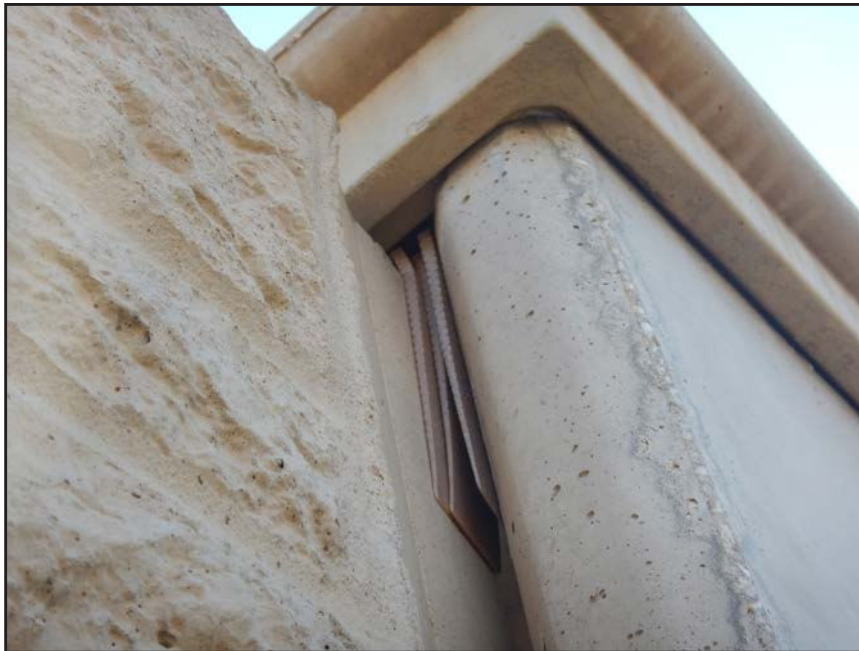
NO. 284 - COLUMN 59S -
INADEQUATE SHIMS STABILIZING
A WALL PANEL TO COLUMN
CONNECTION AT EXCESSIVE
PLAY BETWEEN ADJACENT
MEMBERS

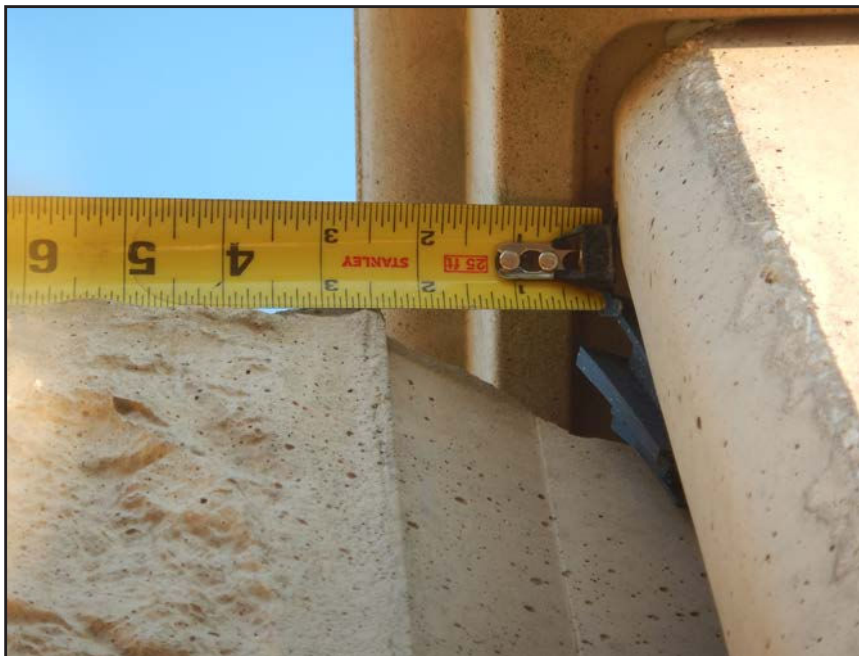
NO. 285 - COLUMN 66S -
INADEQUATE SHIMS STABILIZING
A WALL PANEL TO COLUMN
CONNECTION AT EXCESSIVE
PLAY BETWEEN ADJACENT
MEMBERS

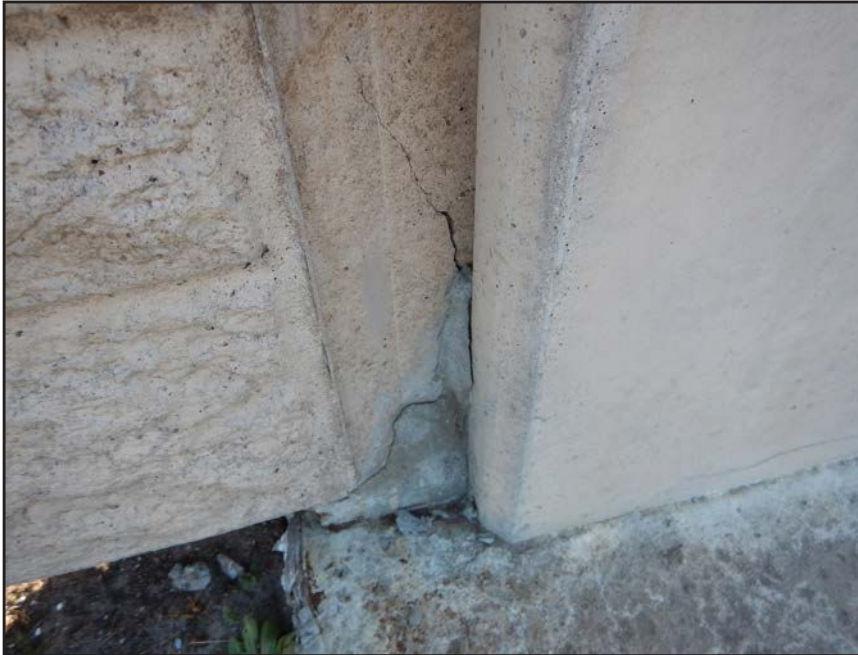
NO. 286 - COLUMN 50SS -
INADEQUATE SHIMS STABILIZING
A WALL PANEL TO COLUMN
CONNECTION AT EXCESSIVE
PLAY BETWEEN ADJACENT
MEMBERS

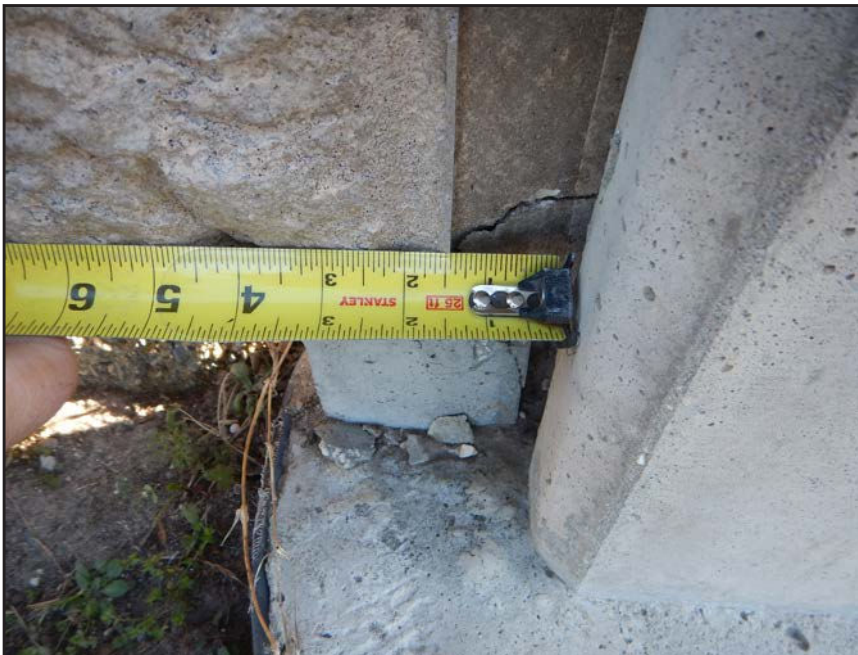
NO. 287 - COLUMN 9N -
CRACKED AND FAILED
TONGUE OF A PRECAST WALL
PANEL IN A PRECAST COLUMN

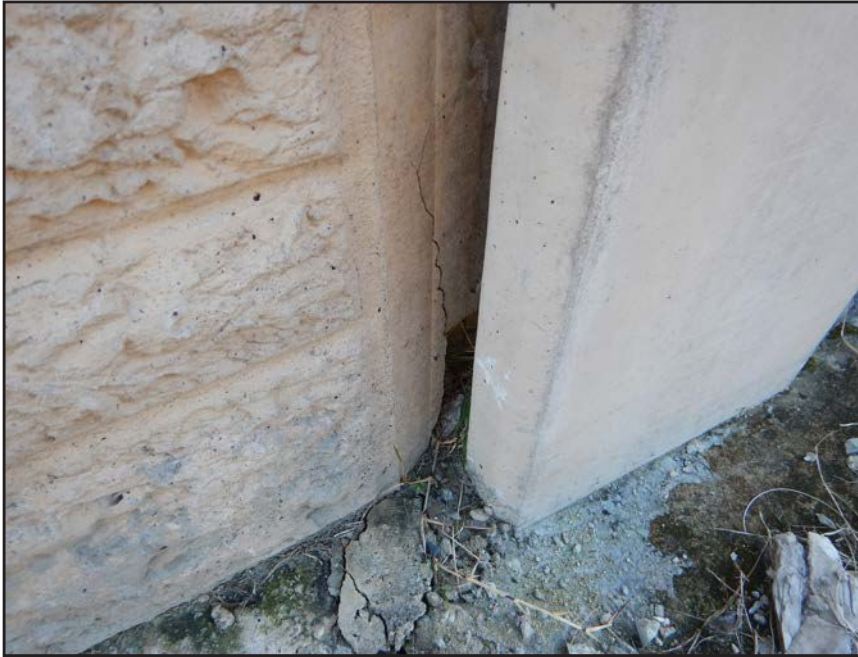
NO. 288 - COLUMN 10N -
CRACKED AND FAILED
TONGUE OF A PRECAST WALL
PANEL IN A PRECAST COLUMN

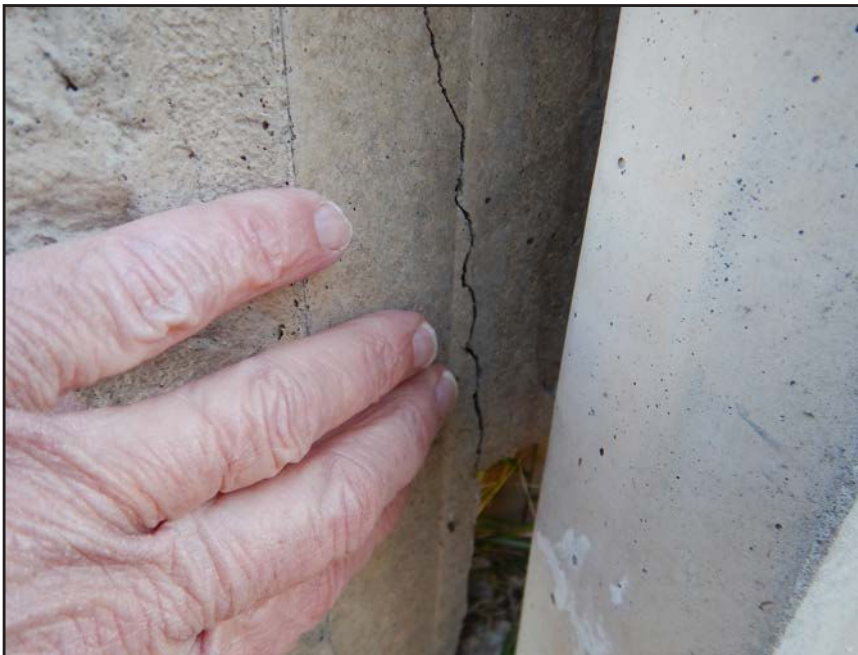
NO. 289 - COLUMN 28N -
CRACKED AND FAILED
TONGUE OF A PRECAST WALL
PANEL IN A PRECAST COLUMN

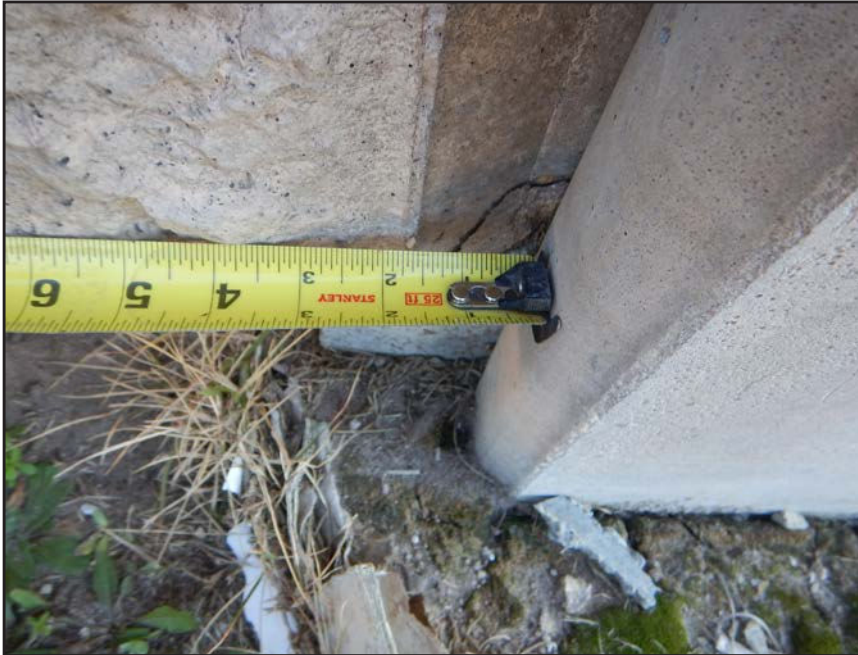
NO. 290 - COLUMN 28N -
CRACKED AND FAILED
TONGUE OF A PRECAST WALL
PANEL IN A PRECAST COLUMN

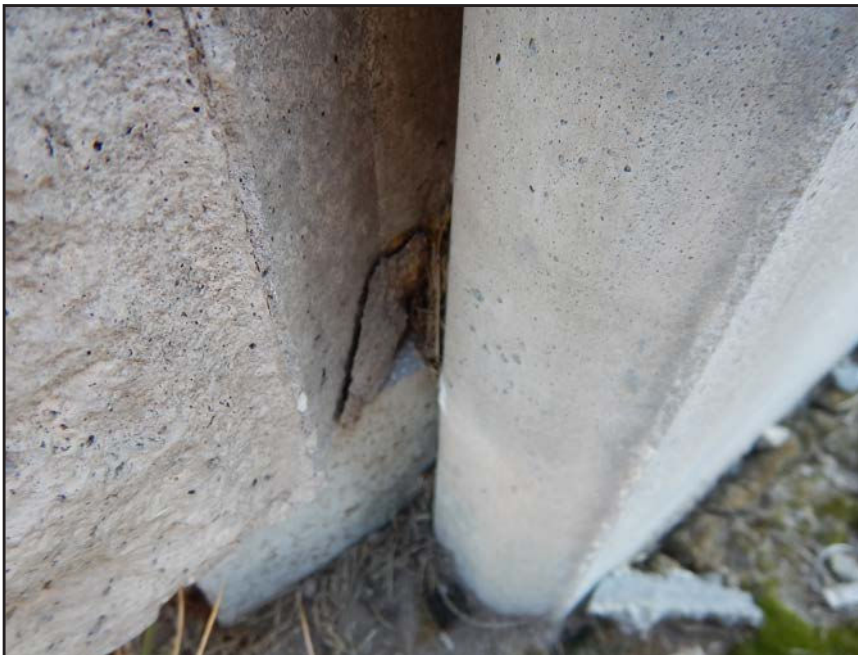
NO. 291 - COLUMN 33N -
CRACKED AND FAILED
TONGUE OF A PRECAST WALL
PANEL IN A PRECAST COLUMN

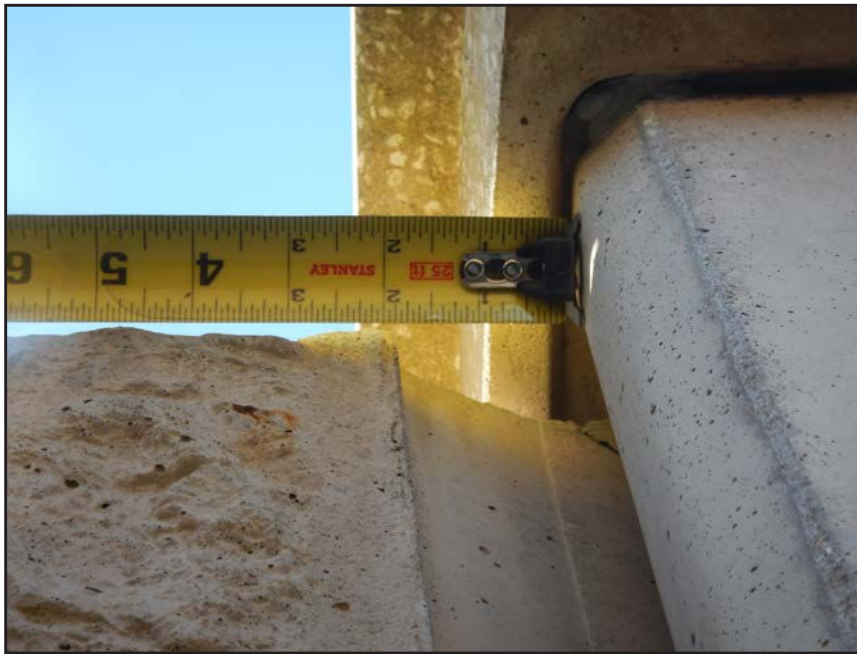
NO. 292 - COLUMN 33N -
CRACKED AND FAILED
TONGUE OF A PRECAST WALL
PANEL IN A PRECAST COLUMN

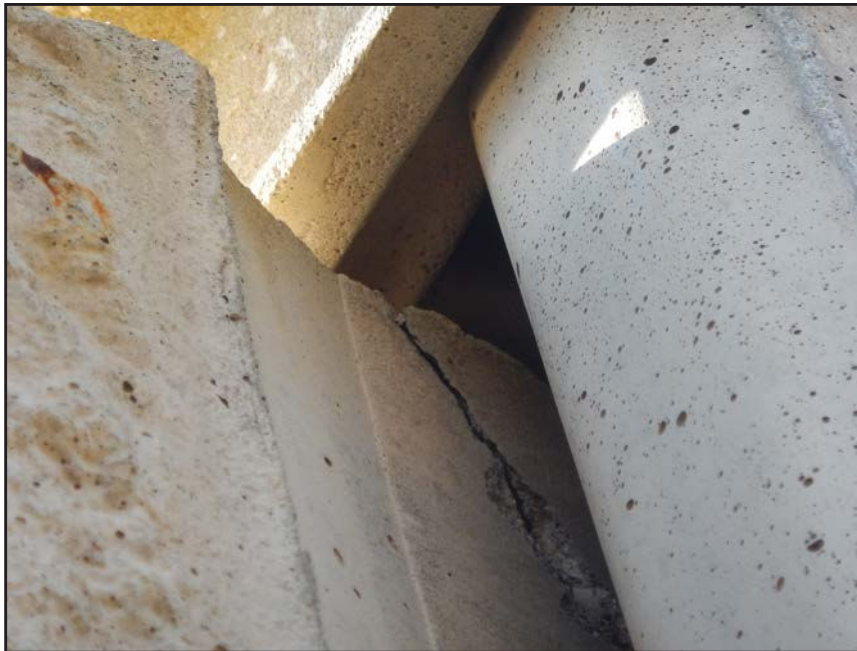
NO. 293 - COLUMN 44N -
CRACKED AND FAILED
TONGUE OF A PRECAST WALL
PANEL IN A PRECAST COLUMN
