WATER TOWER ROAD SCREEN WALL INVESTIGATIONS

Water Tower Road
Longs, South Carolina

Stantec Project No. 171015900

March 31, 2025

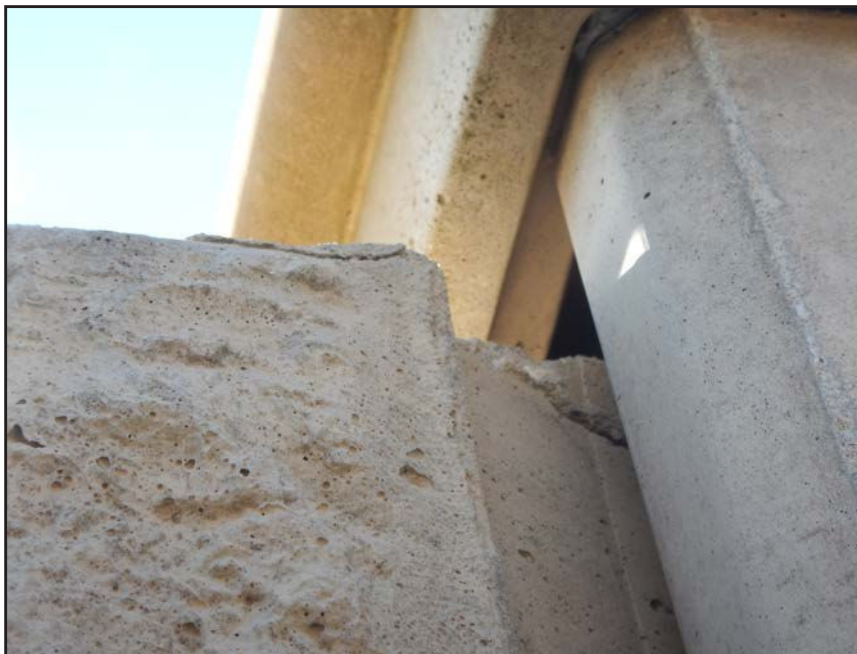
NO. 294 - COLUMN 44N -
CRACKED AND FAILED
TONGUE OF A PRECAST WALL
PANEL IN A PRECAST COLUMN

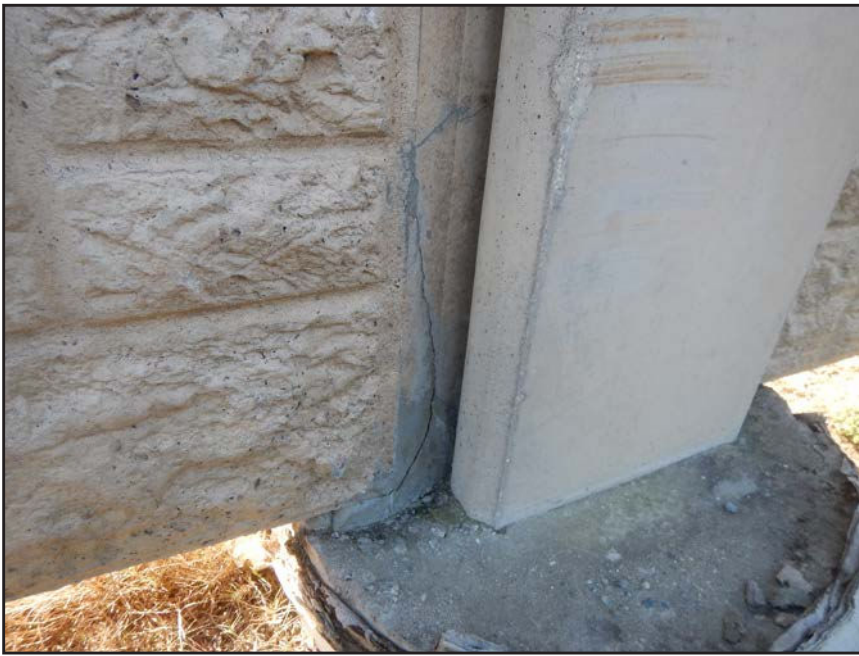
NO. 295 - COLUMN 47N -
CRACKED AND FAILED
TONGUE OF A PRECAST WALL
PANEL IN A PRECAST COLUMN

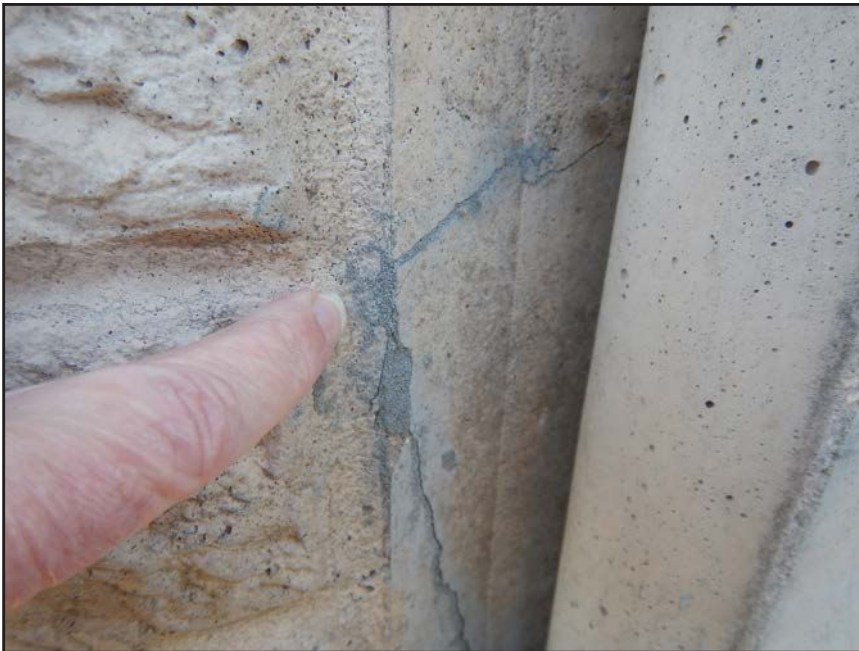
NO. 296 - COLUMN 49N -
CRACKED AND FAILED
TONGUE OF A PRECAST WALL
PANEL IN A PRECAST COLUMN

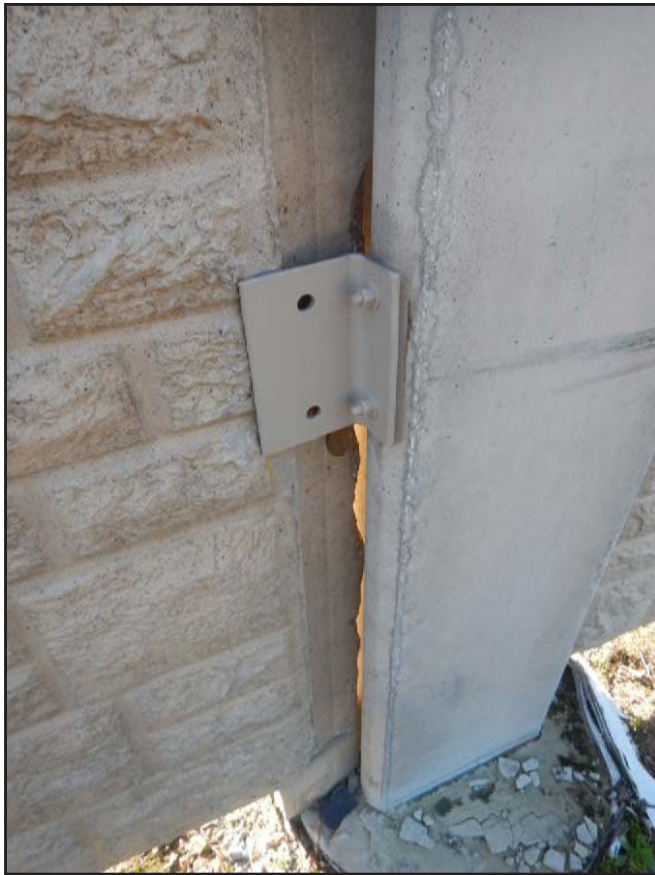
NO. 298 - COLUMN 49N -
CRACKED AND FAILED
TONGUE OF A PRECAST WALL
PANEL IN A PRECAST COLUMN

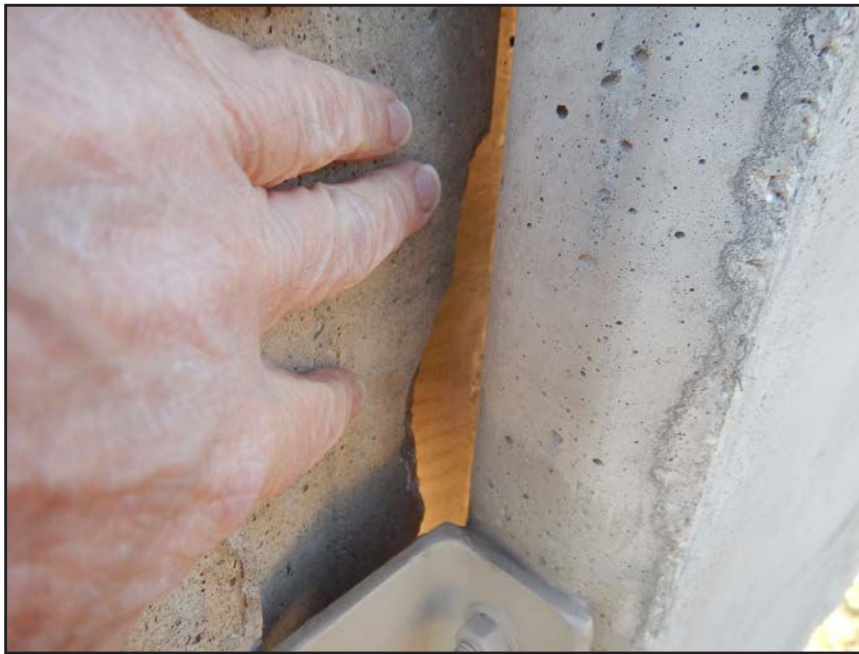
NO. 299 - COLUMN 50N - CRACKED AND
FAILED TONGUE OF A PRECAST WALL PANEL IN
A PRECAST COLUMN

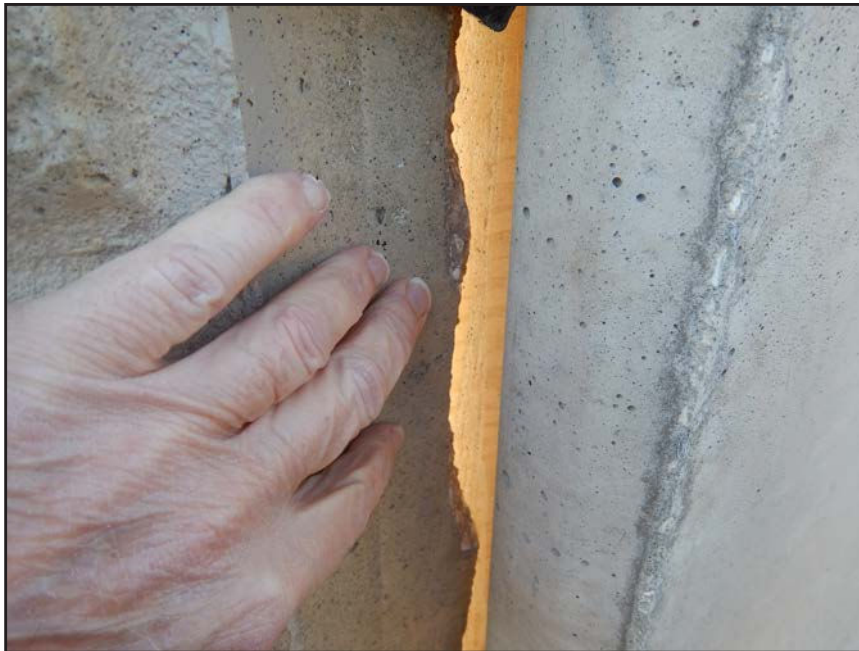
NO. 300 - COLUMN 50N -
CRACKED AND FAILED
TONGUE OF A PRECAST WALL
PANEL IN A PRECAST COLUMN

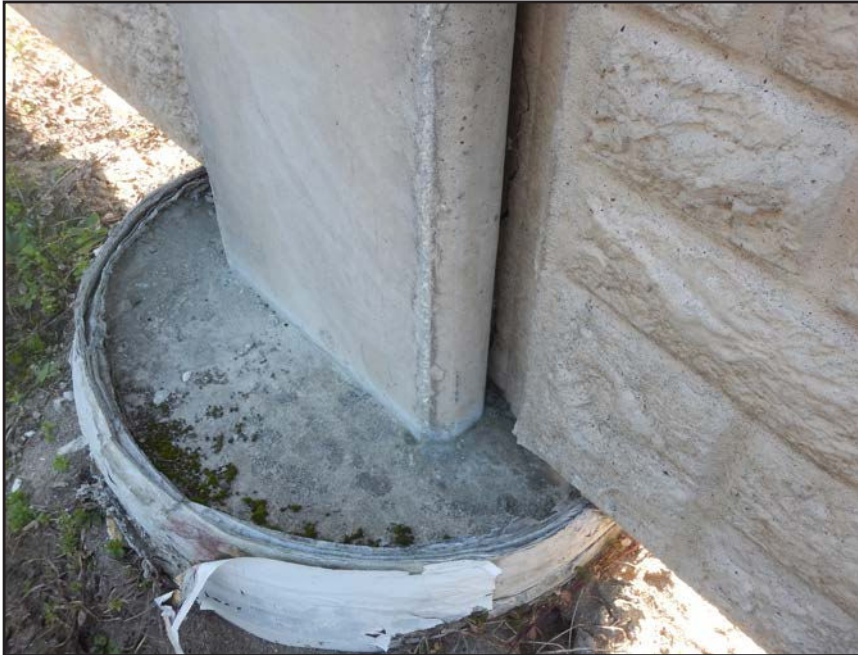
NO. 302 - COLUMN 50N -
CRACKED AND FAILED
TONGUE OF A PRECAST WALL
PANEL IN A PRECAST COLUMN

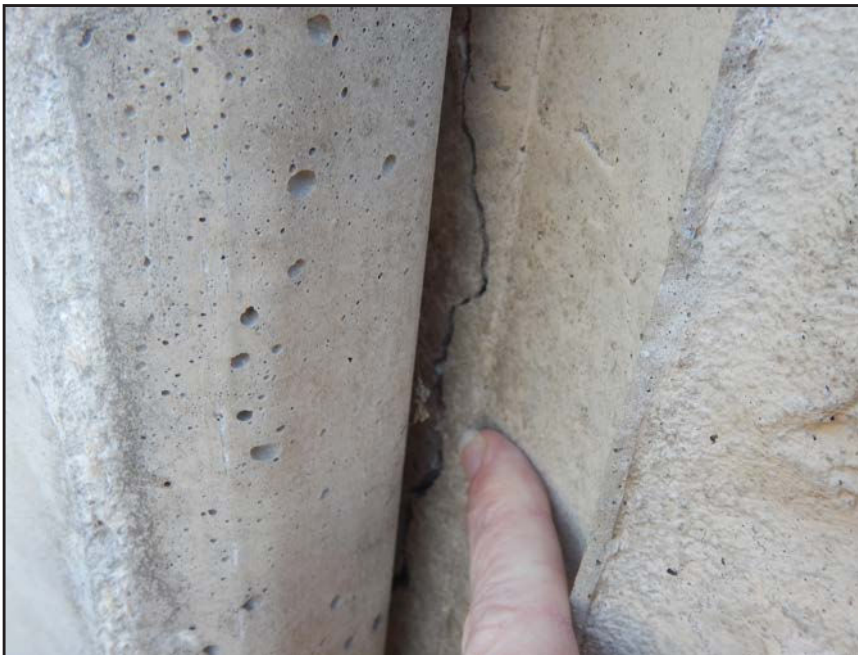
NO. 303 - COLUMN 51N -
CRACKED AND FAILED
TONGUE OF A PRECAST WALL
PANEL IN A PRECAST COLUMN

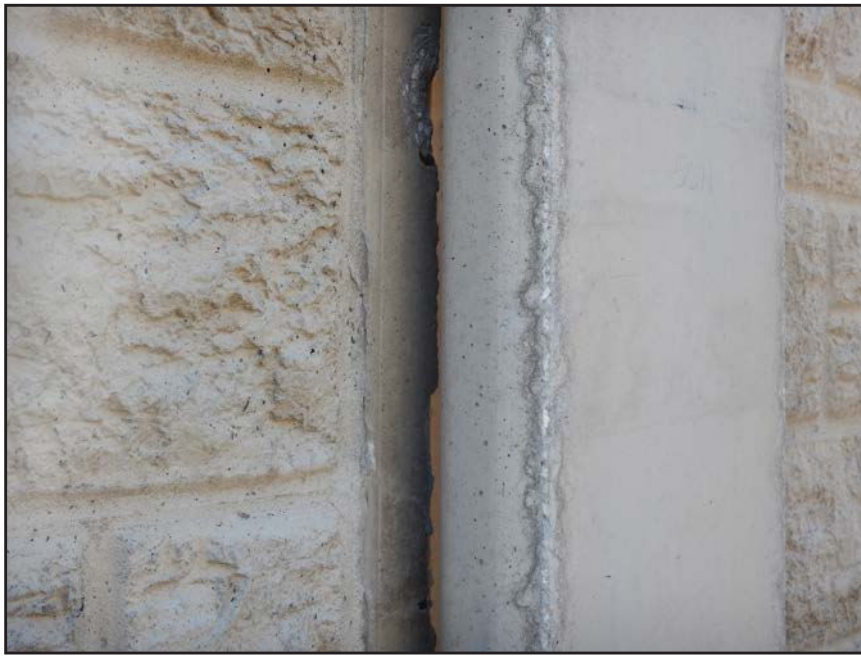
NO. 304 - COLUMN 51N -
CRACKED AND FAILED
TONGUE OF A PRECAST WALL
PANEL IN A PRECAST COLUMN

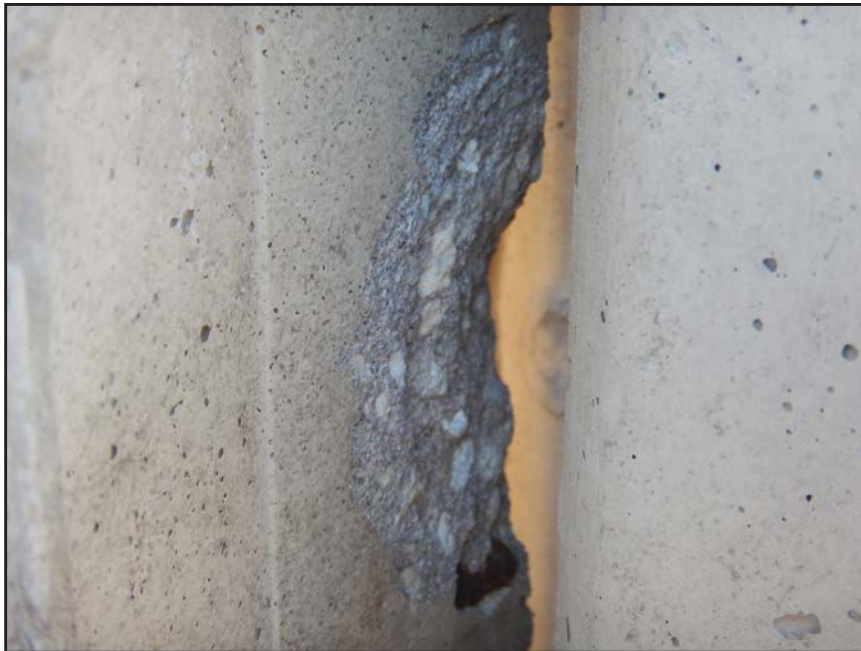
NO. 305 - COLUMN 56N -
CRACKED AND FAILED
TONGUE OF A PRECAST WALL
PANEL IN A PRECAST COLUMN

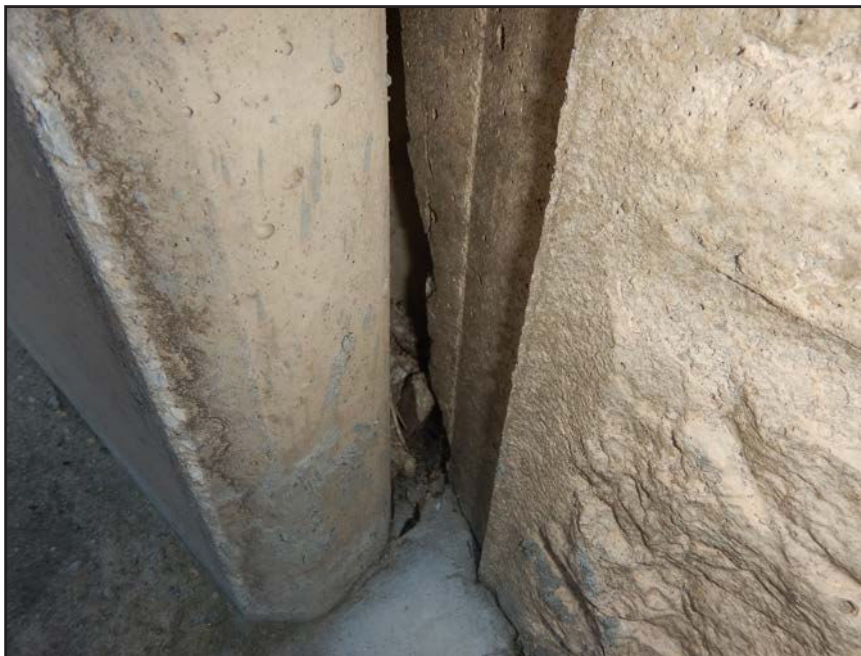
NO. 306 - COLUMN 56N -
CRACKED AND FAILED
TONGUE OF A PRECAST WALL
PANEL IN A PRECAST COLUMN

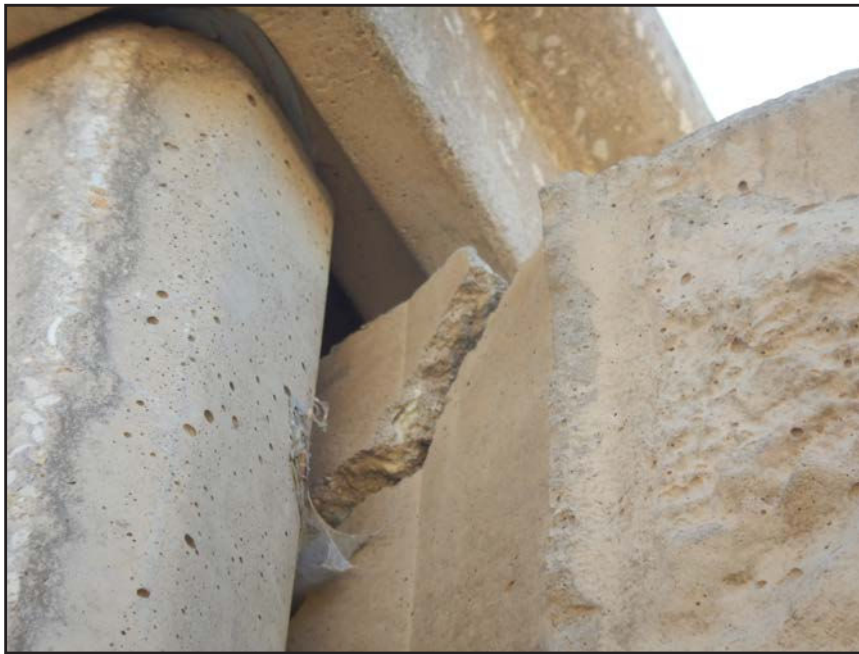
NO. 307 - COLUMN 56N -
CRACKED AND FAILED
TONGUE OF A PRECAST WALL
PANEL IN A PRECAST COLUMN

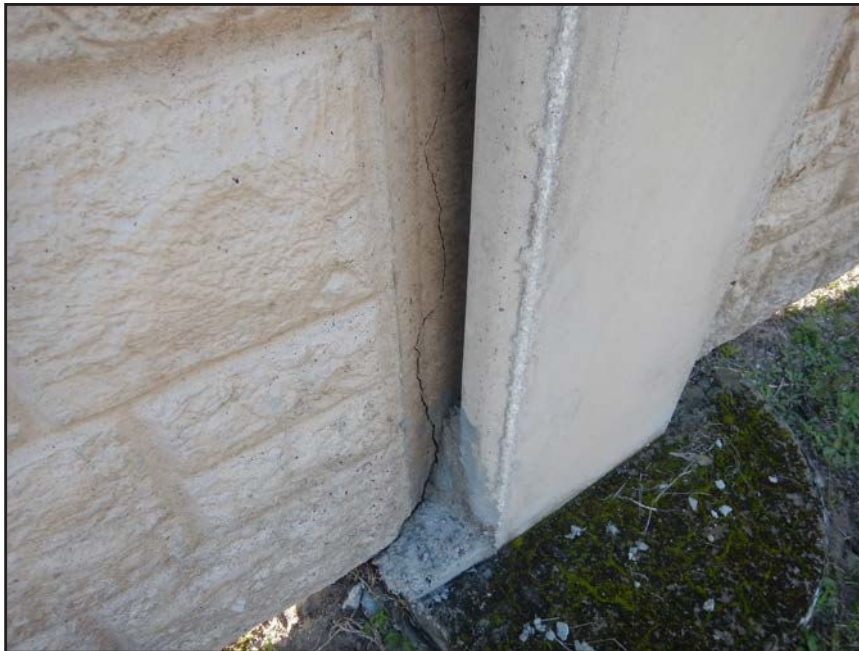
NO. 308 - COLUMN 5NM -
CRACKED AND FAILED
TONGUE OF A PRECAST WALL
PANEL IN A PRECAST COLUMN

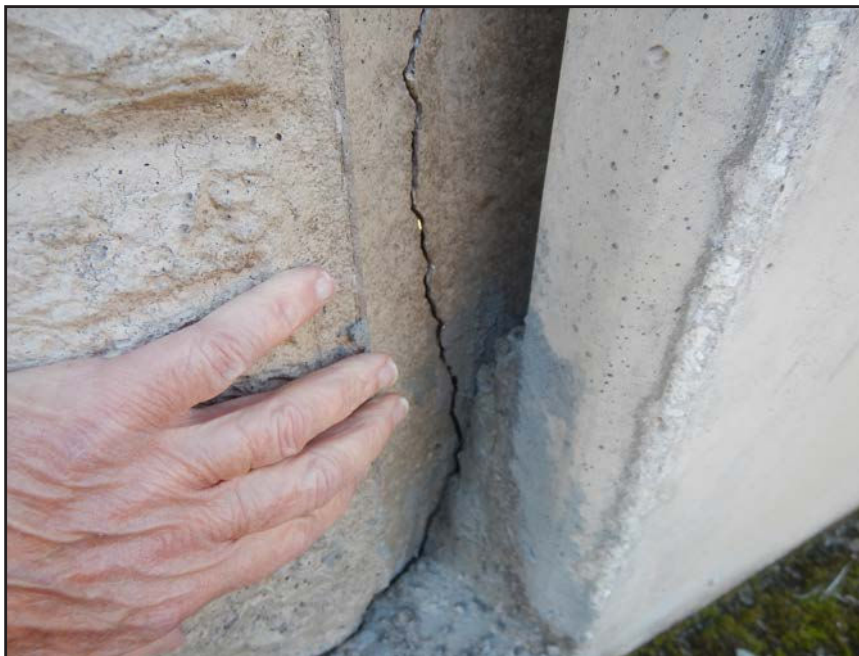
NO. 309 - COLUMN 7NM -
CRACKED AND FAILED
TONGUE OF A PRECAST WALL
PANEL IN A PRECAST COLUMN

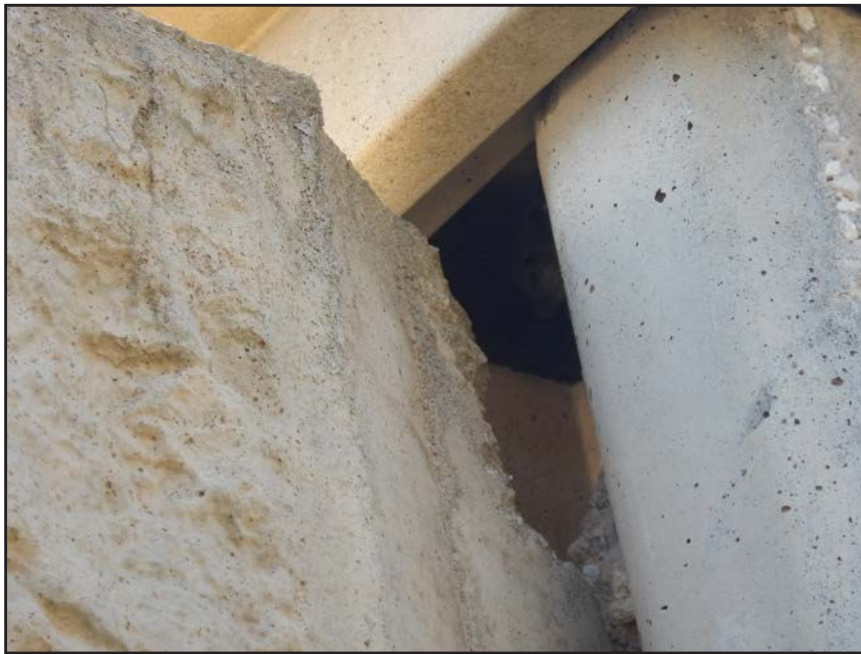
NO. 310 - COLUMN 7NM -
CRACKED AND FAILED
TONGUE OF A PRECAST WALL
PANEL IN A PRECAST COLUMN

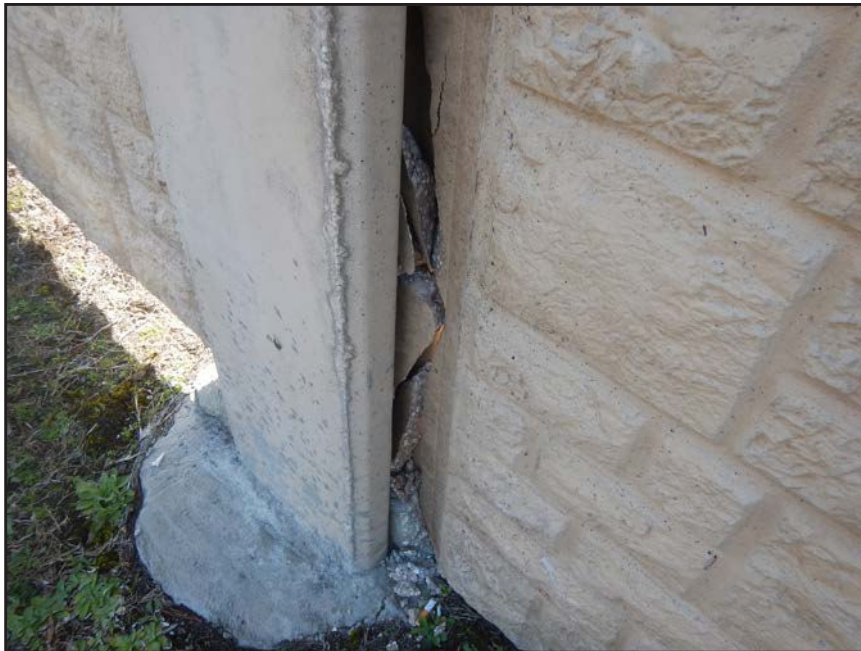
NO. 311 - COLUMN 8NM -
CRACKED AND FAILED
TONGUE OF A PRECAST WALL
PANEL IN A PRECAST COLUMN

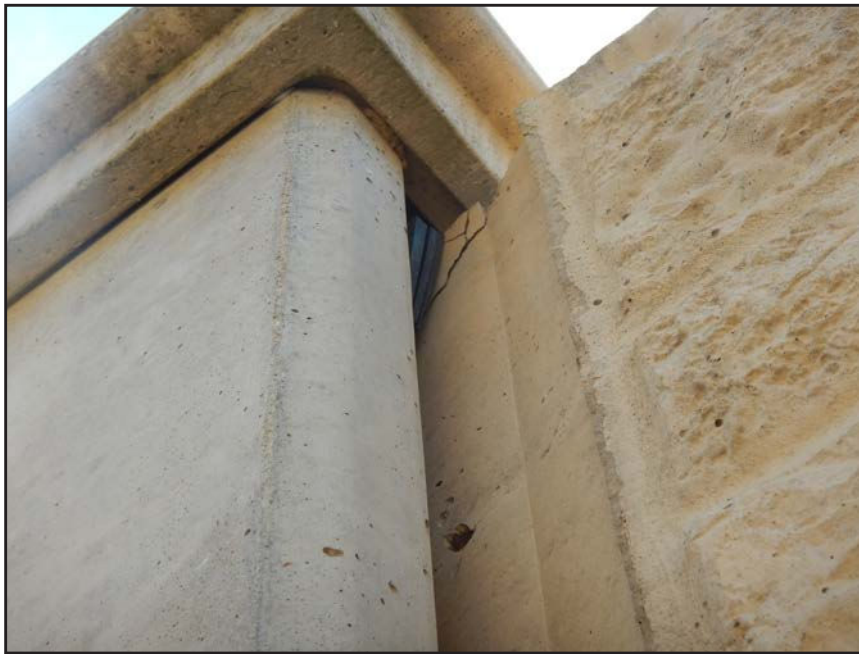
NO. 313 - COLUMN 13NM -
CRACKED AND FAILED
TONGUE OF A PRECAST WALL
PANEL IN A PRECAST COLUMN

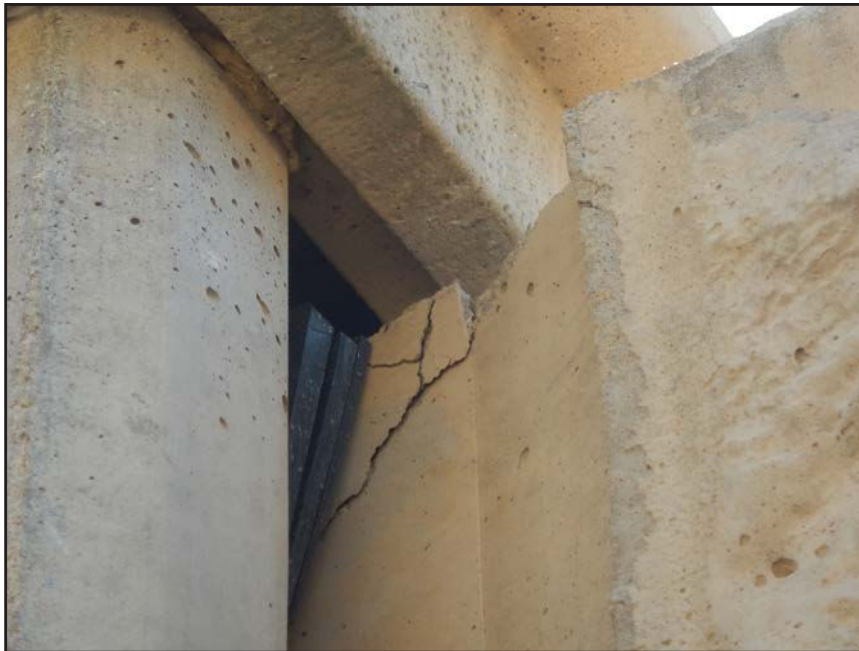
NO. 314 - COLUMN 16SM -
CRACKED AND FAILED
TONGUE OF A PRECAST WALL
PANEL IN A PRECAST COLUMN

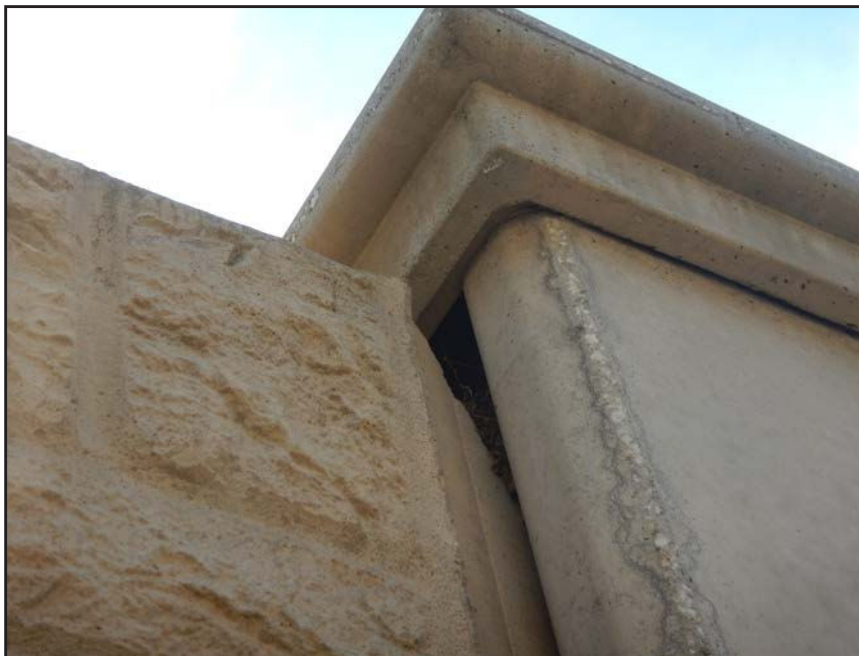
NO. 315 - COLUMN 16SM -
CRACKED AND FAILED
TONGUE OF A PRECAST WALL
PANEL IN A PRECAST COLUMN

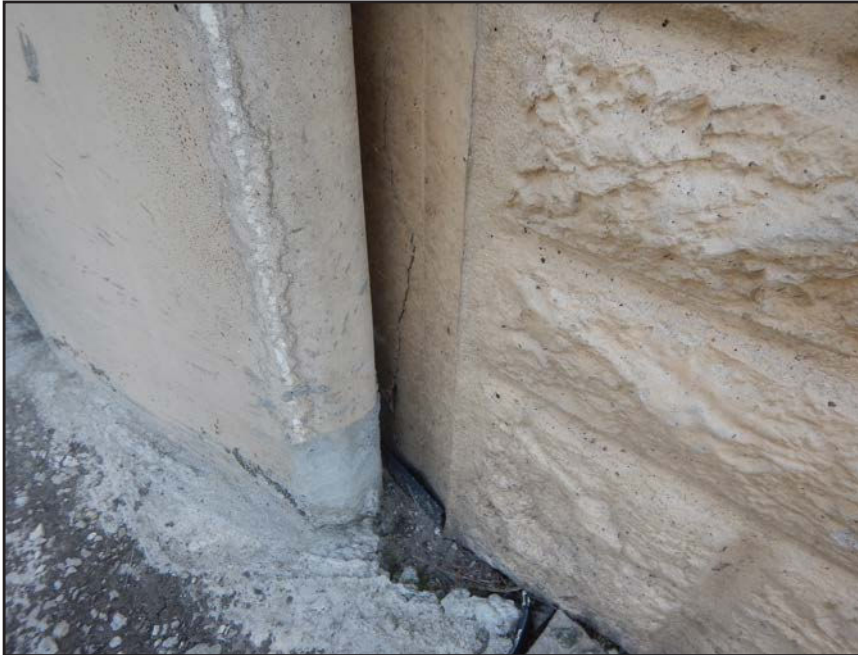
NO. 316 - COLUMN 3S -
CRACKED AND FAILED
TONGUE OF A PRECAST WALL
PANEL IN A PRECAST COLUMN

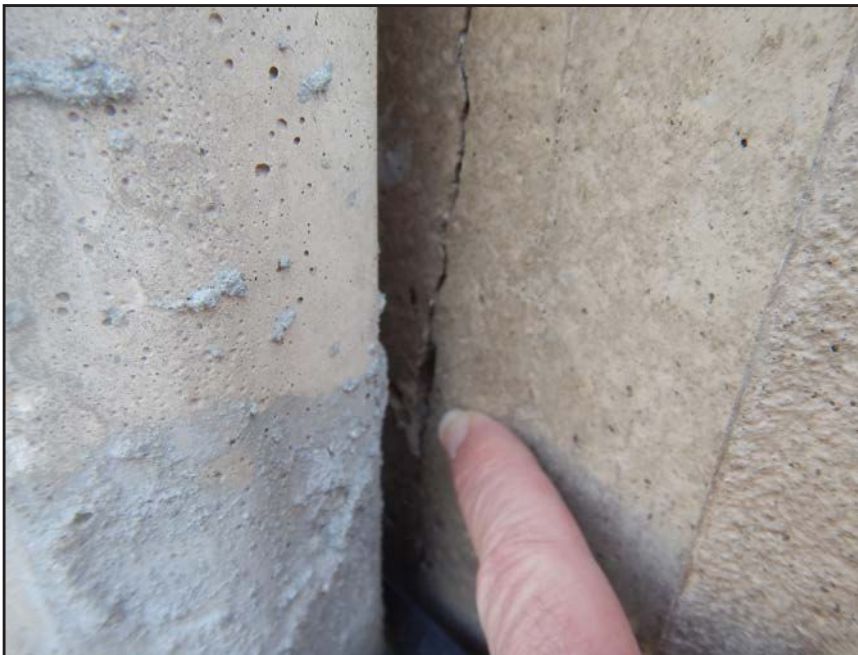
NO. 317 - COLUMN 13S -
CRACKED AND FAILED
TONGUE OF A PRECAST WALL
PANEL IN A PRECAST COLUMN

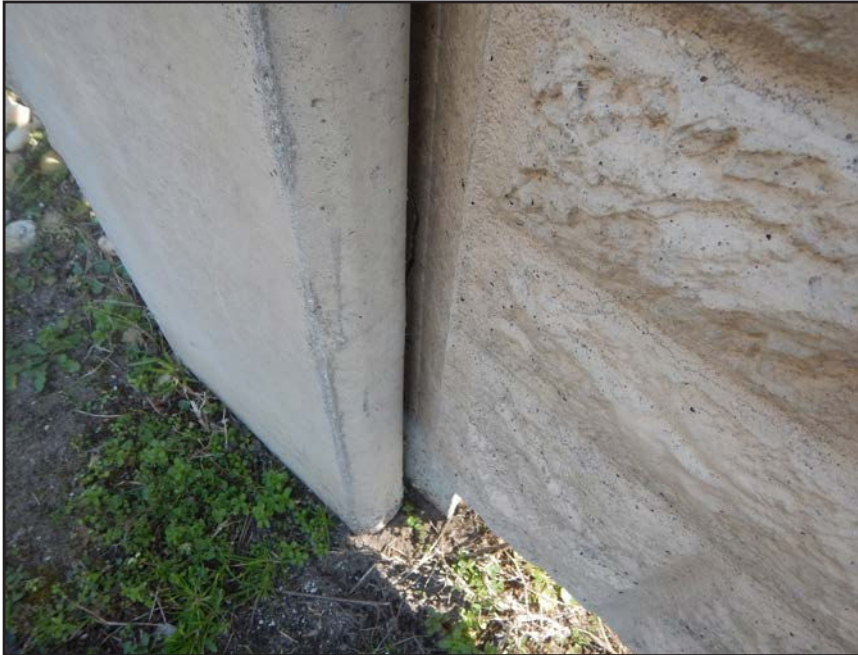
NO. 318 - COLUMN 13S -
CRACKED AND FAILED
TONGUE OF A PRECAST WALL
PANEL IN A PRECAST COLUMN

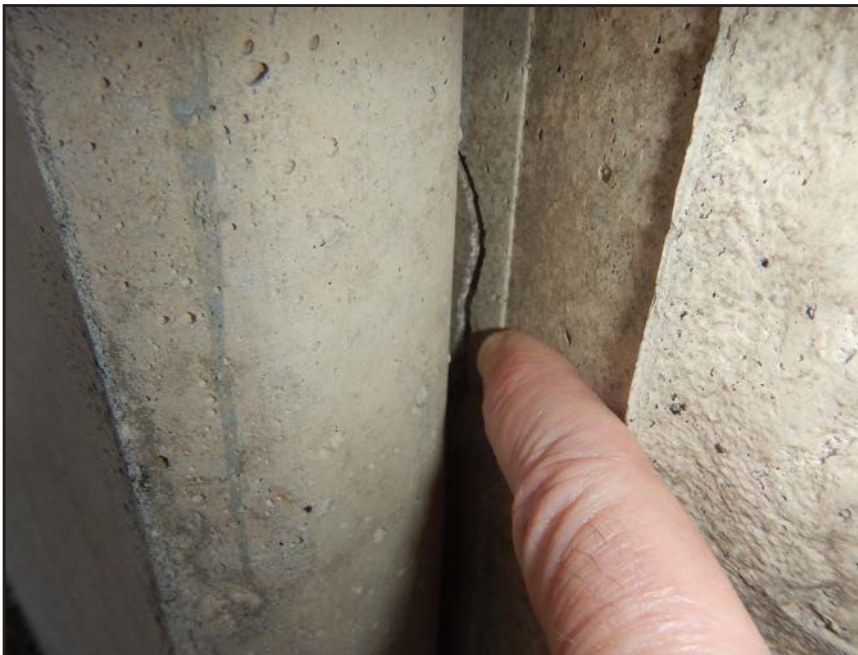
NO. 319 - COLUMN 15S -
CRACKED AND FAILED
TONGUE OF A PRECAST WALL
PANEL IN A PRECAST COLUMN

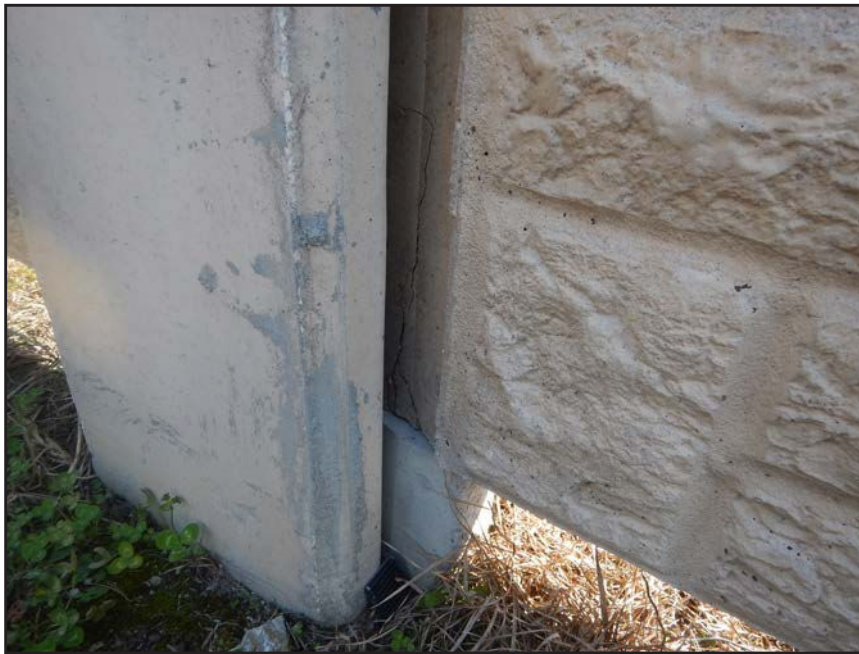
NO. 320 - COLUMN 15S -
CRACKED AND FAILED
TONGUE OF A PRECAST WALL
PANEL IN A PRECAST COLUMN

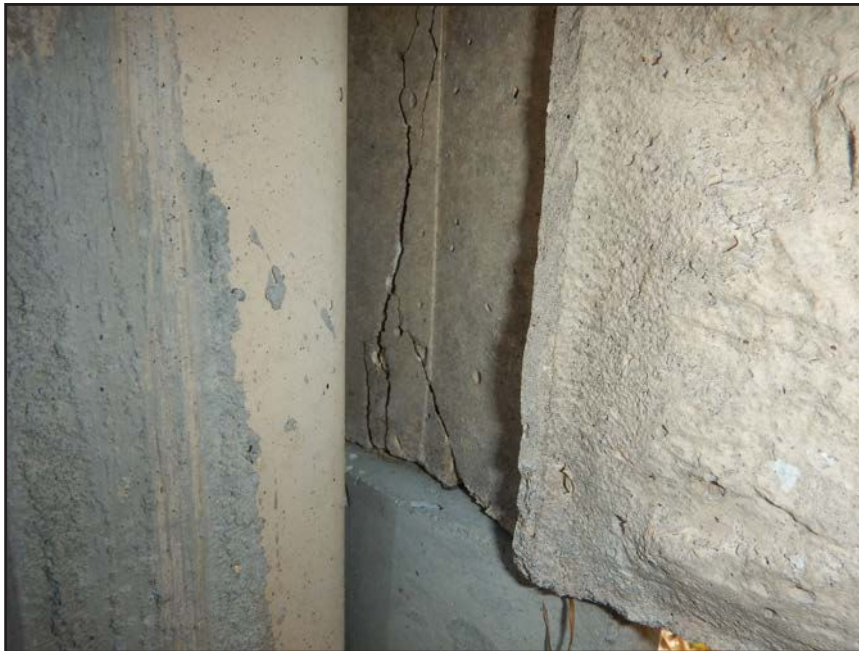
NO. 321 - COLUMN 19S -
CRACKED AND FAILED
TONGUE OF A PRECAST WALL
PANEL IN A PRECAST COLUMN

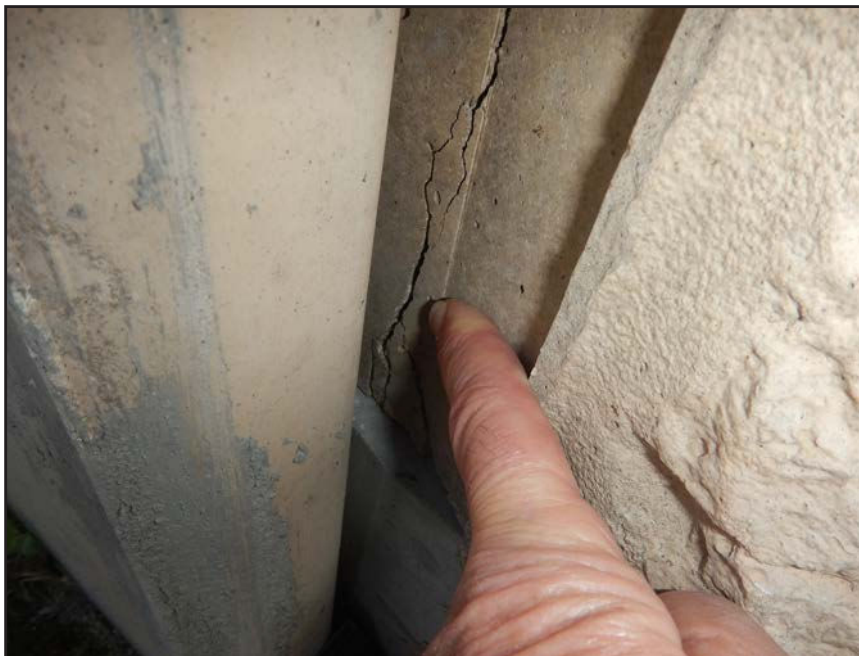
NO. 322 - COLUMN 19S -
CRACKED AND FAILED
TONGUE OF A PRECAST WALL
PANEL IN A PRECAST COLUMN

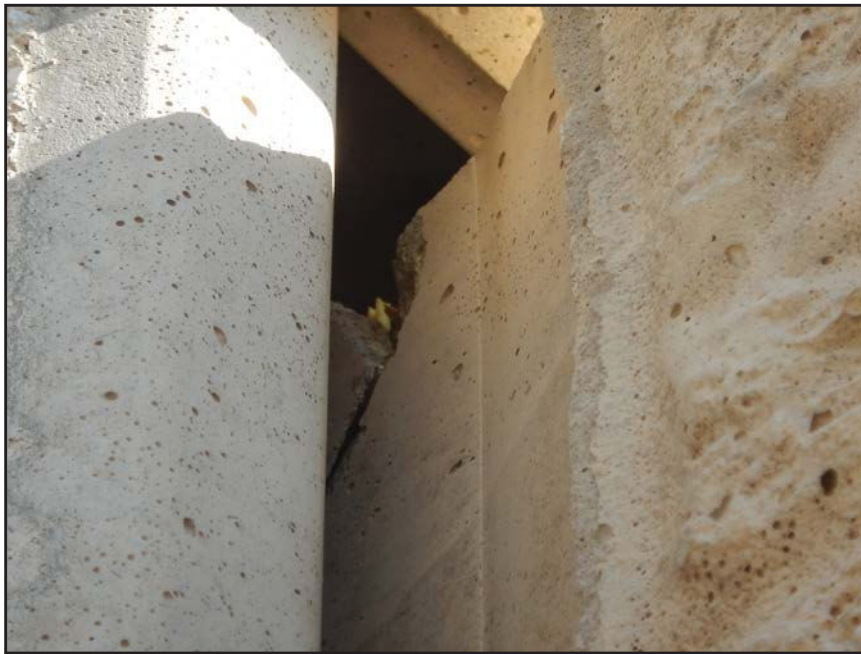
NO. 323 - COLUMN 19S -
CRACKED AND FAILED
TONGUE OF A PRECAST WALL
PANEL IN A PRECAST COLUMN

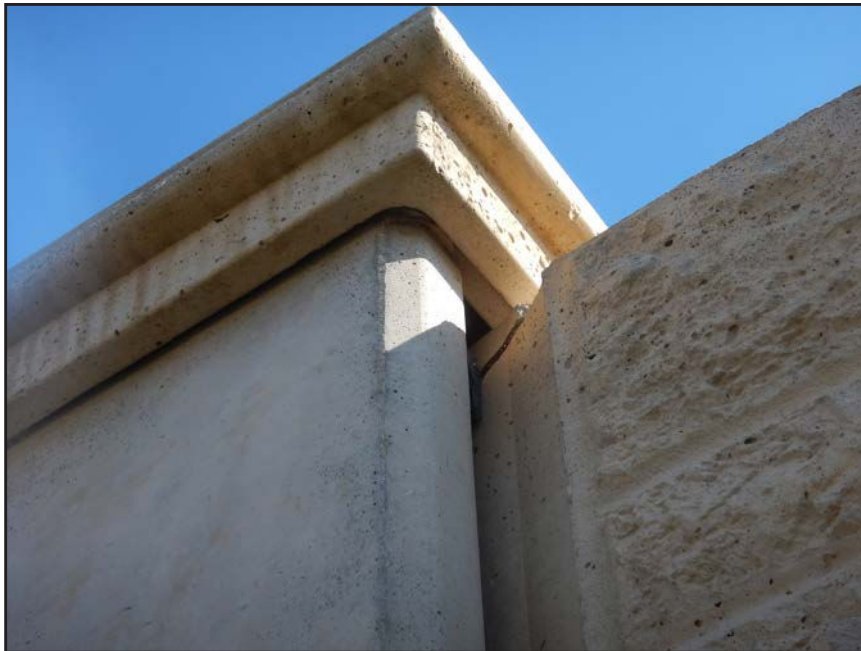
NO. 324 - COLUMN 25S -
CRACKED AND FAILED
TONGUE OF A PRECAST WALL
PANEL IN A PRECAST COLUMN

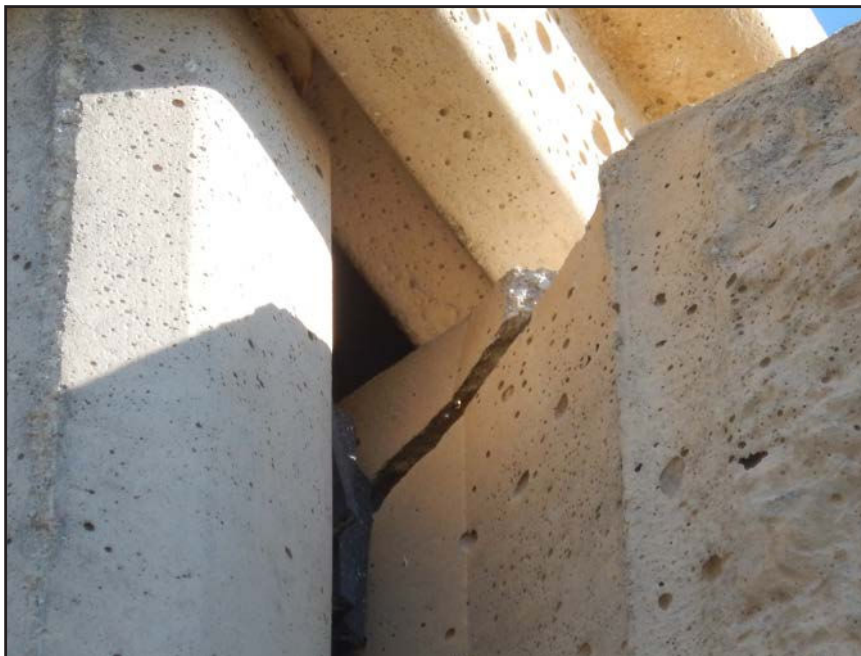
NO. 325 - COLUMN 50S -
CRACKED AND FAILED
TONGUE OF A PRECAST WALL
PANEL IN A PRECAST COLUMN

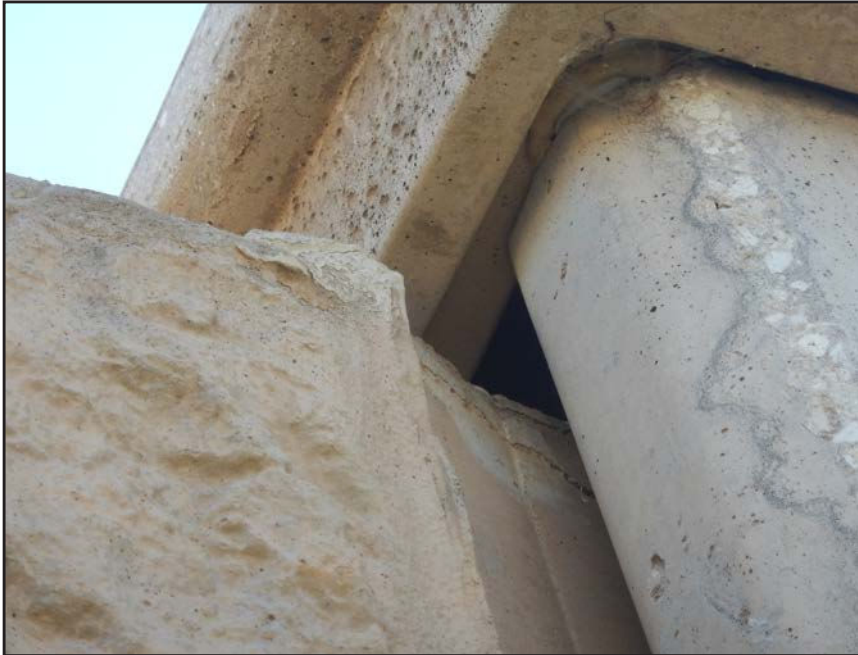
NO. 326- COLUMN 50S -
CRACKED AND FAILED
TONGUE OF A PRECAST WALL
PANEL IN A PRECAST COLUMN

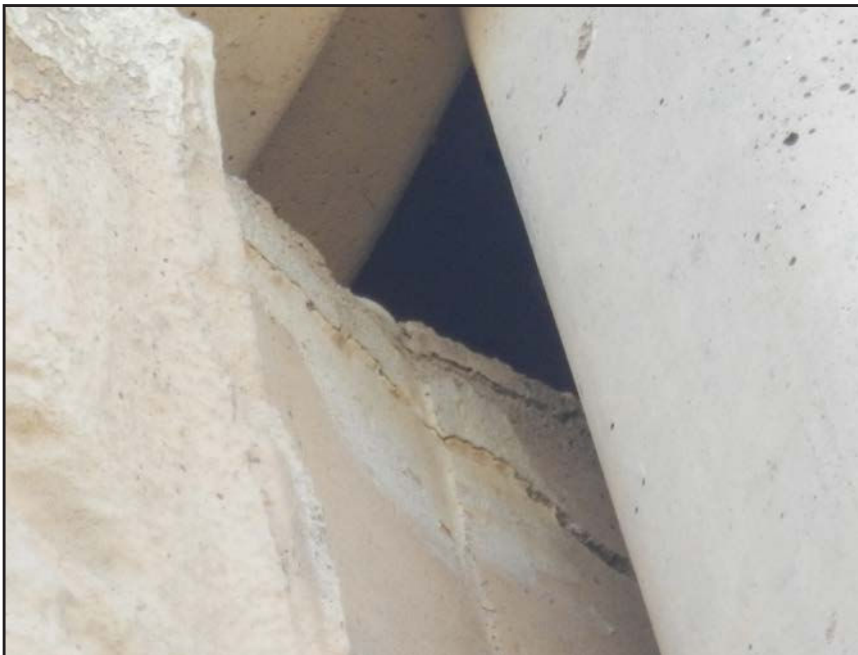
NO. 327 - COLUMN 54S -
CRACKED AND FAILED
TONGUE OF A PRECAST WALL
PANEL IN A PRECAST COLUMN

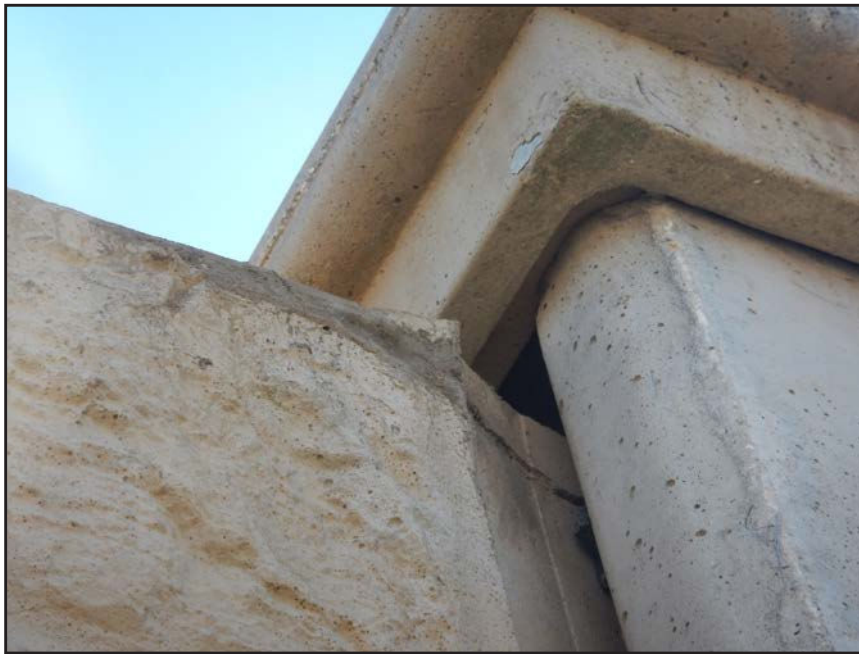
NO. 328 - COLUMN 54S -
CRACKED AND FAILED
TONGUE OF A PRECAST WALL
PANEL IN A PRECAST COLUMN

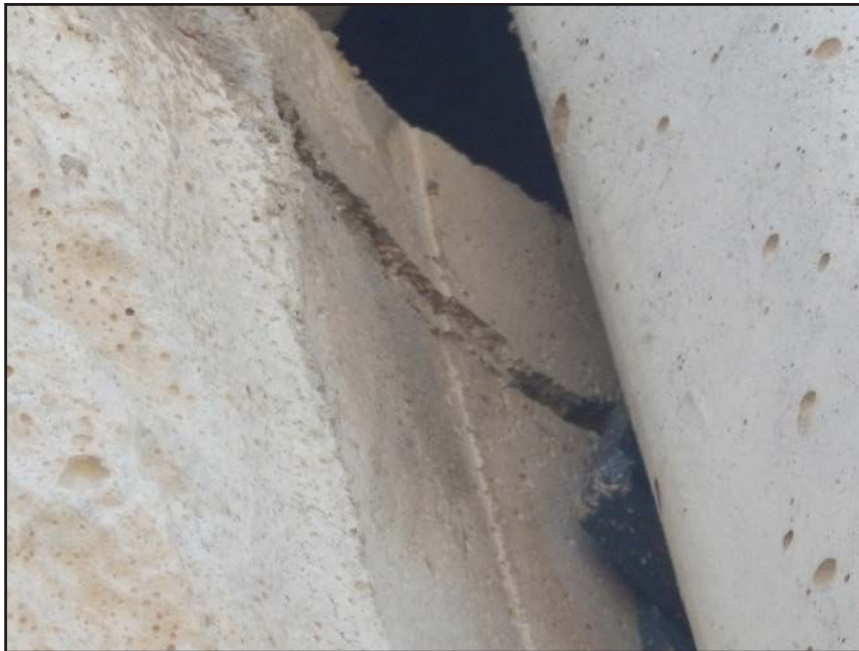
NO. 329 - COLUMN 56S -
CRACKED AND FAILED
TONGUE OF A PRECAST WALL
PANEL IN A PRECAST COLUMN

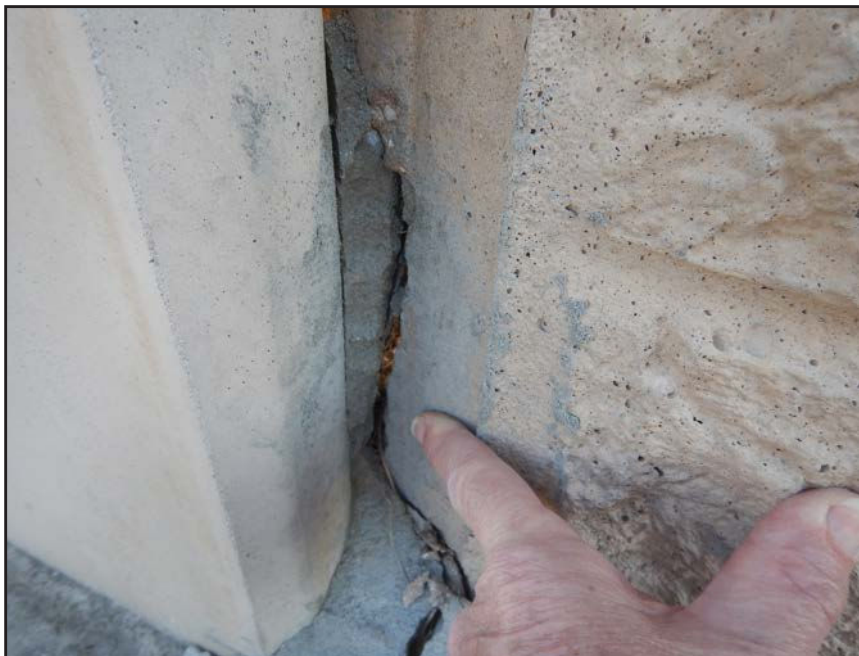
NO. 330 - COLUMN 56S -
CRACKED AND FAILED
TONGUE OF A PRECAST WALL
PANEL IN A PRECAST COLUMN

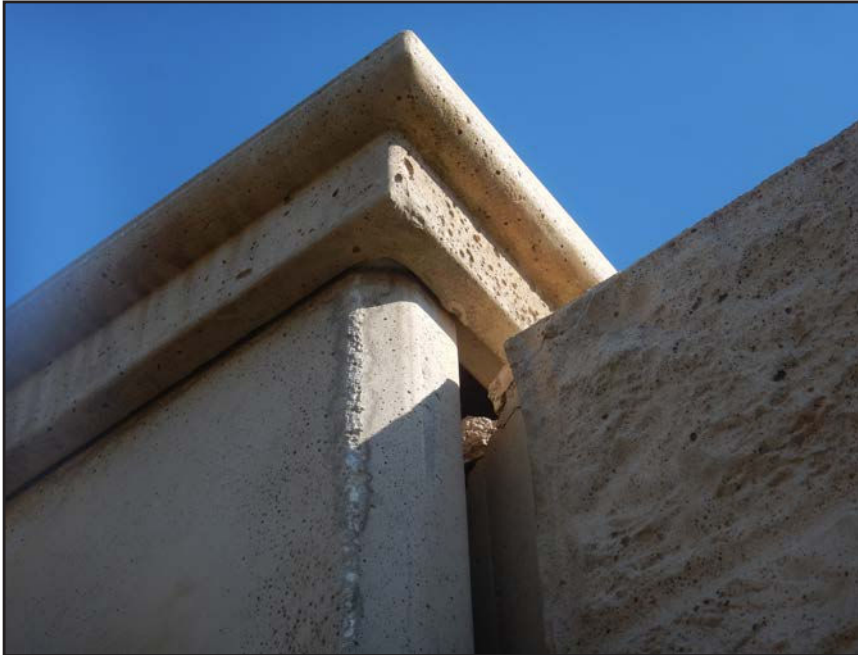
NO. 331 - COLUMN 61S -
CRACKED AND FAILED
TONGUE OF A PRECAST WALL
PANEL IN A PRECAST COLUMN

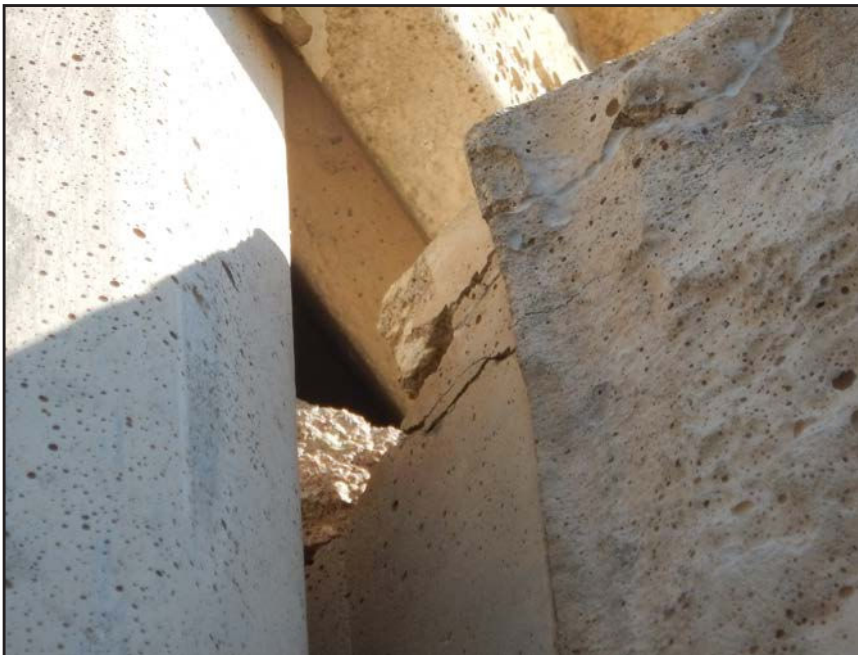
NO. 332 - COLUMN 62S -
CRACKED AND FAILED
TONGUE OF A PRECAST WALL
PANEL IN A PRECAST COLUMN

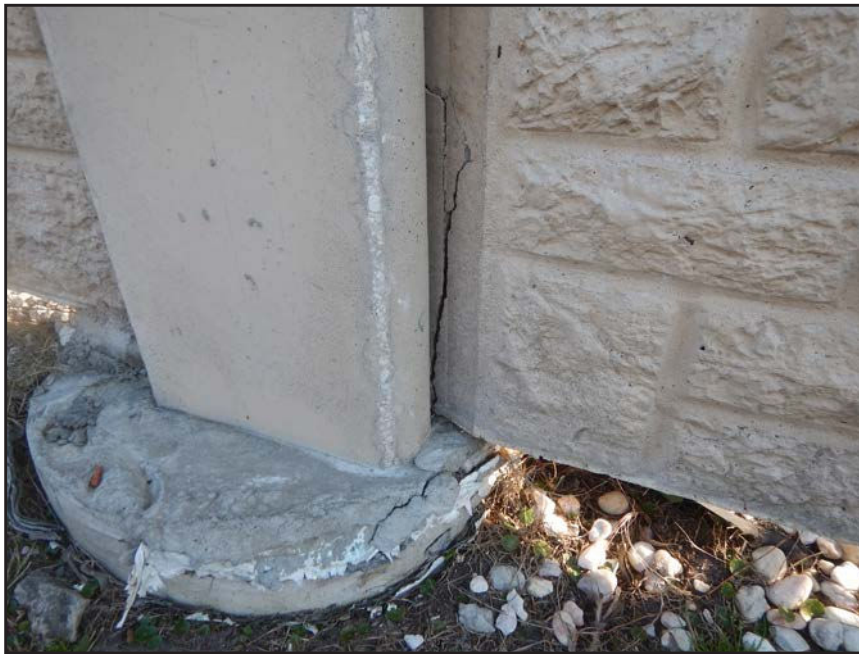
NO. 333 - COLUMN 62S -
CRACKED AND FAILED
TONGUE OF A PRECAST WALL
PANEL IN A PRECAST COLUMN

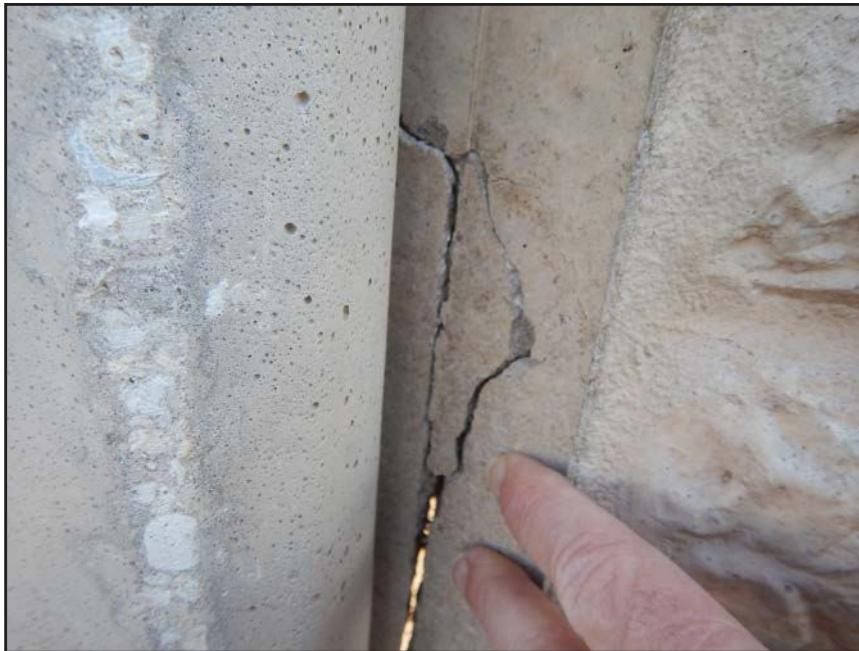
NO. 334 - COLUMN 67S -
CRACKED AND FAILED
TONGUE OF A PRECAST WALL
PANEL IN A PRECAST COLUMN

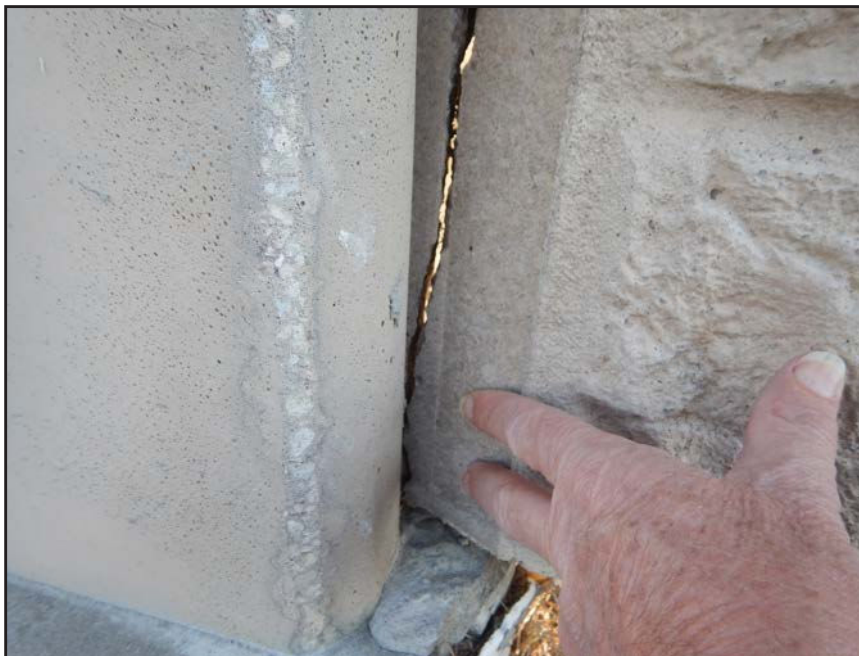
NO. 335 - COLUMN 67S -
CRACKED AND FAILED
TONGUE OF A PRECAST WALL
PANEL IN A PRECAST COLUMN
