WATER TOWER ROAD SCREEN WALL INVESTIGATIONS

Water Tower Road
Longs, South Carolina

Stantec Project No. 171015900

March 31, 2025

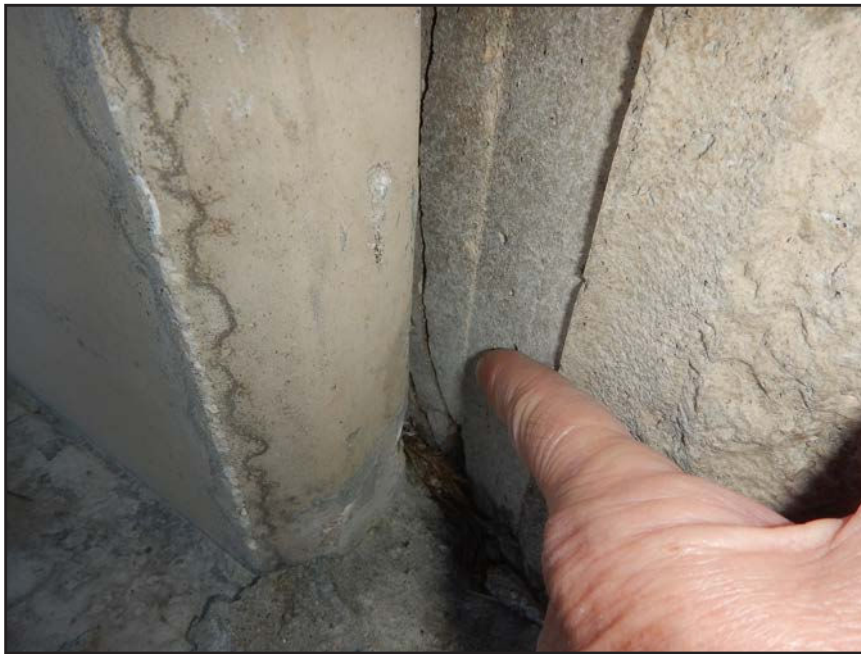
NO. 336 - COLUMN 67S -
CRACKED AND FAILED
TONGUE OF A PRECAST WALL
PANEL IN A PRECAST COLUMN

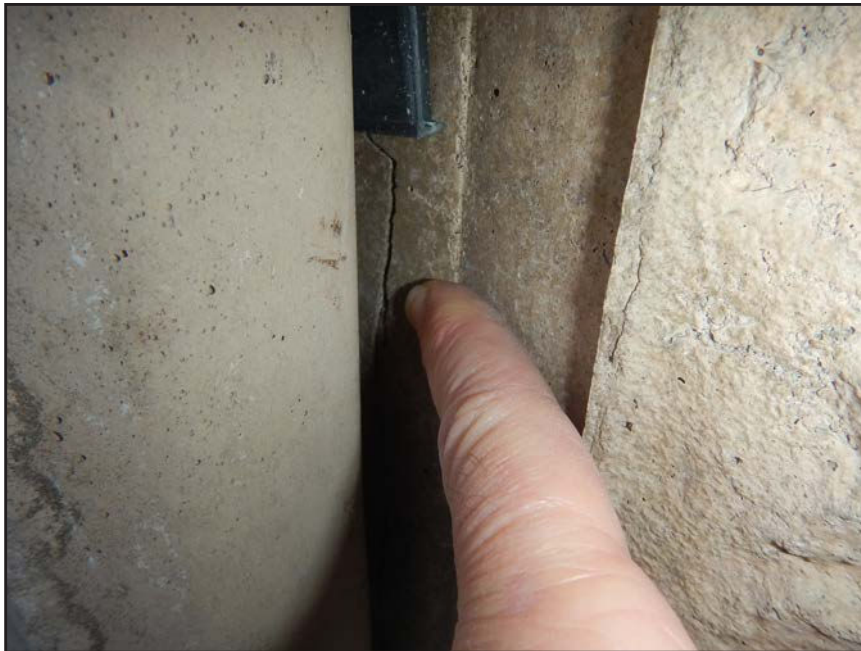
NO. 337 - COLUMN 70S -
CRACKED AND FAILED
TONGUE OF A PRECAST WALL
PANEL IN A PRECAST COLUMN

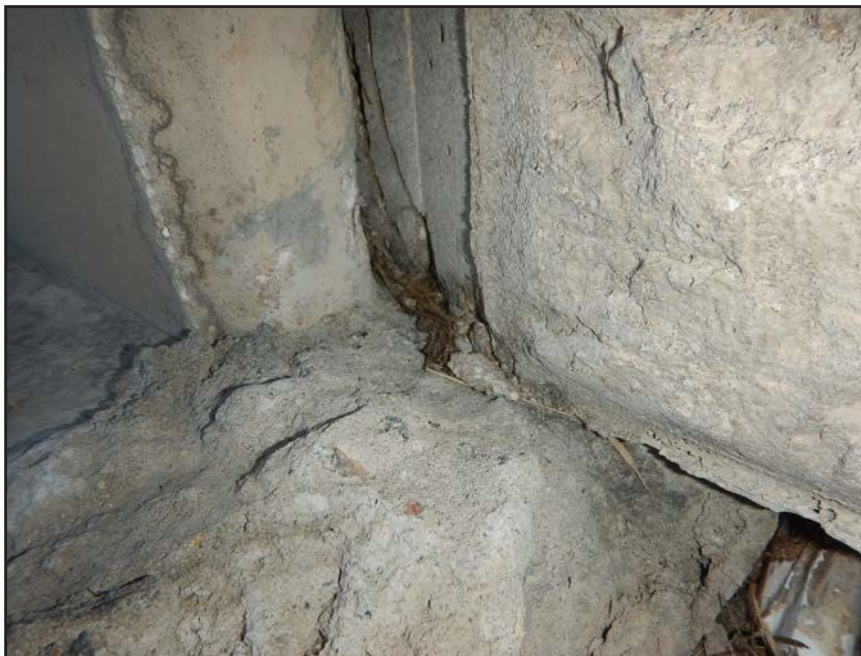
NO. 338 - COLUMN 70S -
CRACKED AND FAILED
TONGUE OF A PRECAST WALL
PANEL IN A PRECAST COLUMN

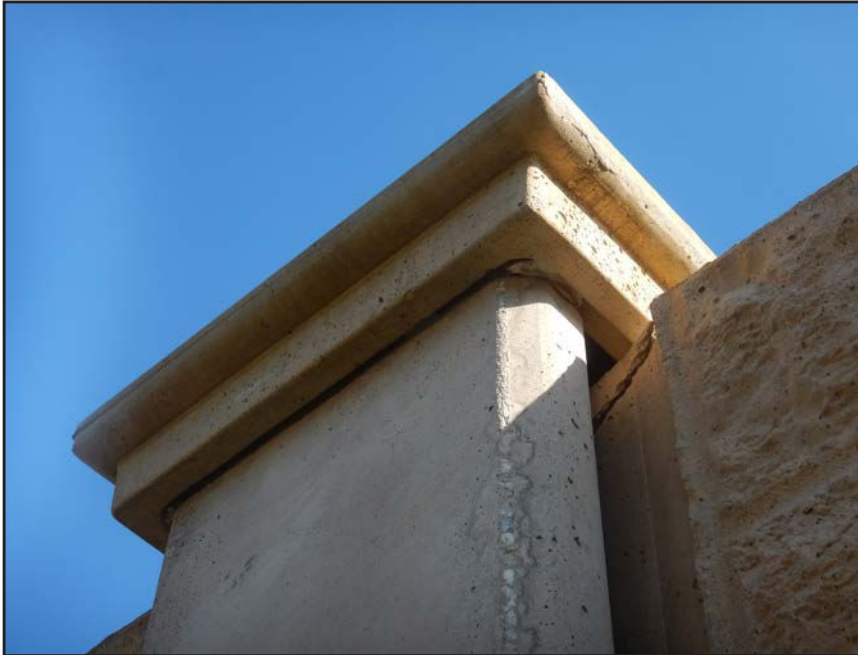
NO. 339 - COLUMN 70S -
CRACKED AND FAILED
TONGUE OF A PRECAST WALL
PANEL IN A PRECAST COLUMN

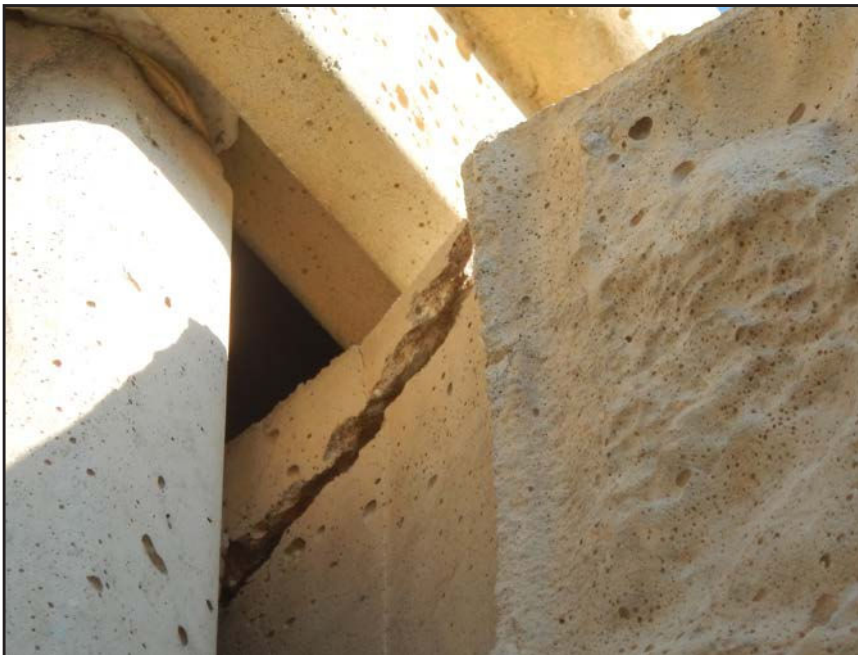
NO. 340 - COLUMN 77S -
CRACKED AND FAILED
TONGUE OF A PRECAST WALL
PANEL IN A PRECAST COLUMN

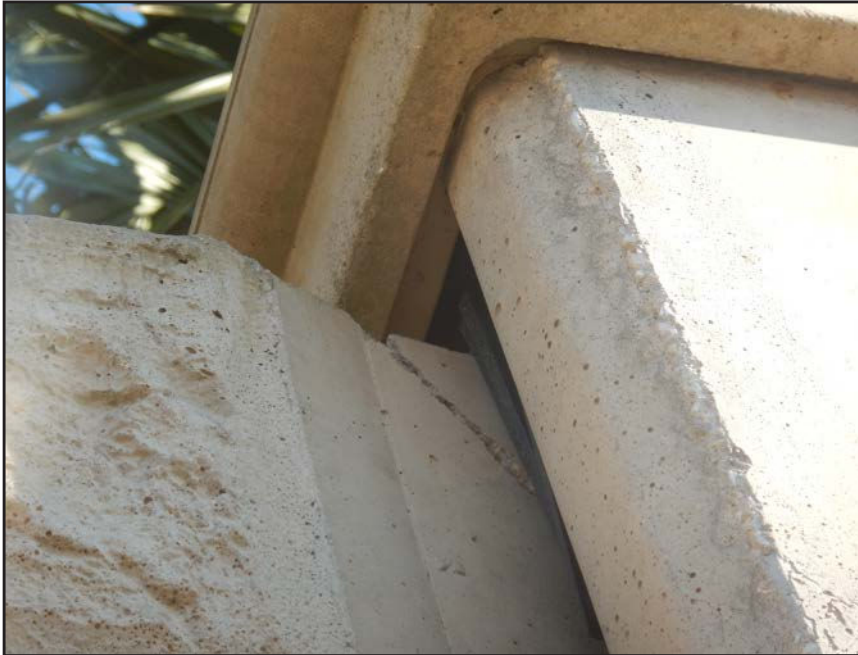
NO. 341 - COLUMN 77S -
CRACKED AND FAILED
TONGUE OF A PRECAST WALL
PANEL IN A PRECAST COLUMN

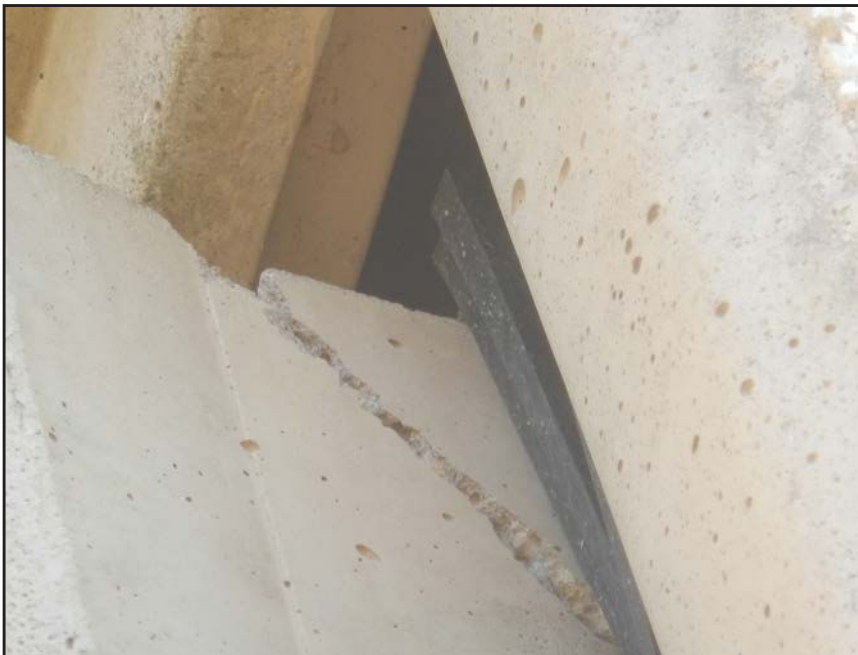
NO. 342 - COLUMN 6SS -
CRACKED AND FAILED
TONGUE OF A PRECAST WALL
PANEL IN A PRECAST COLUMN

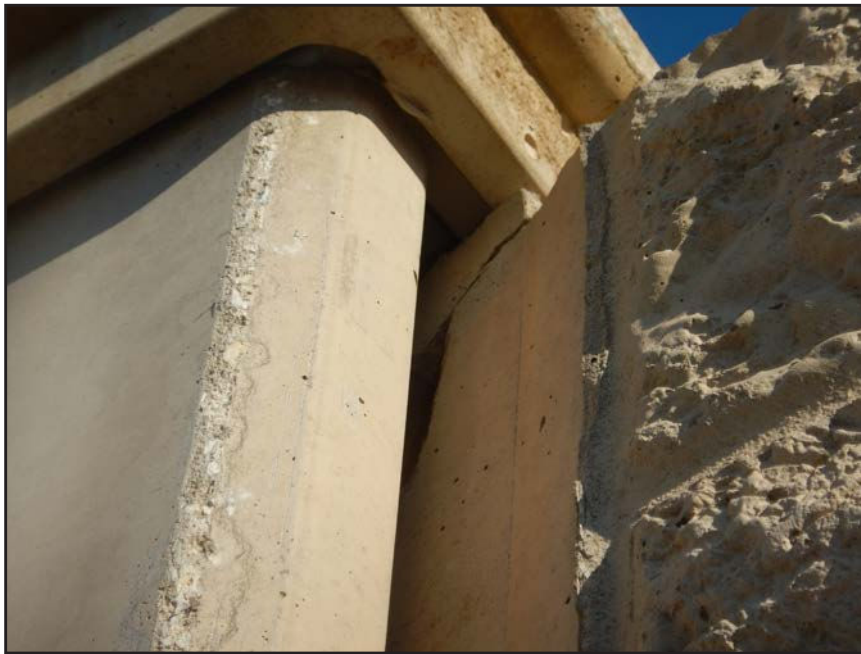
NO. 343 - COLUMN 6SS -
CRACKED AND FAILED
TONGUE OF A PRECAST WALL
PANEL IN A PRECAST COLUMN

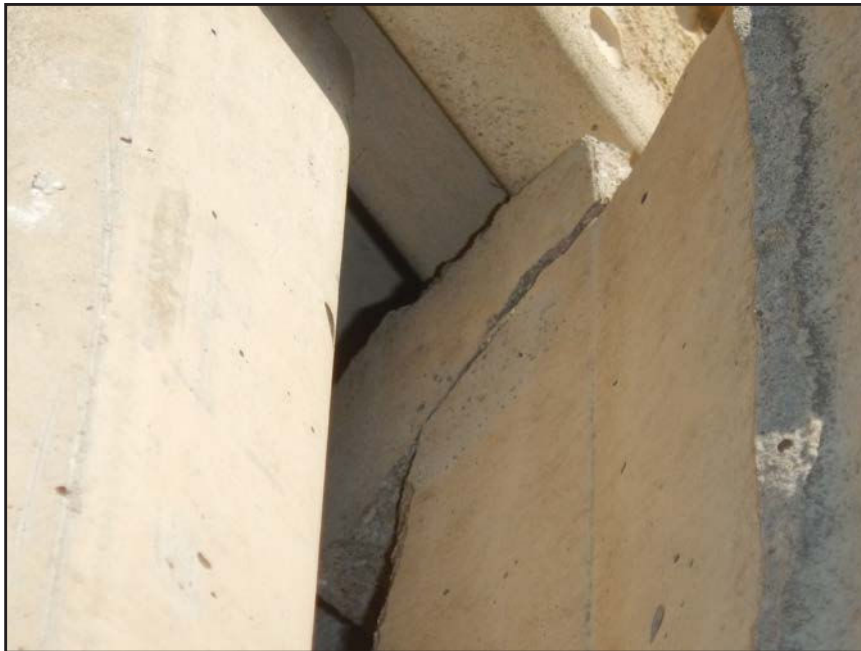
NO. 344 - COLUMN 8SS -
CRACKED AND FAILED
TONGUE OF A PRECAST WALL
PANEL IN A PRECAST COLUMN

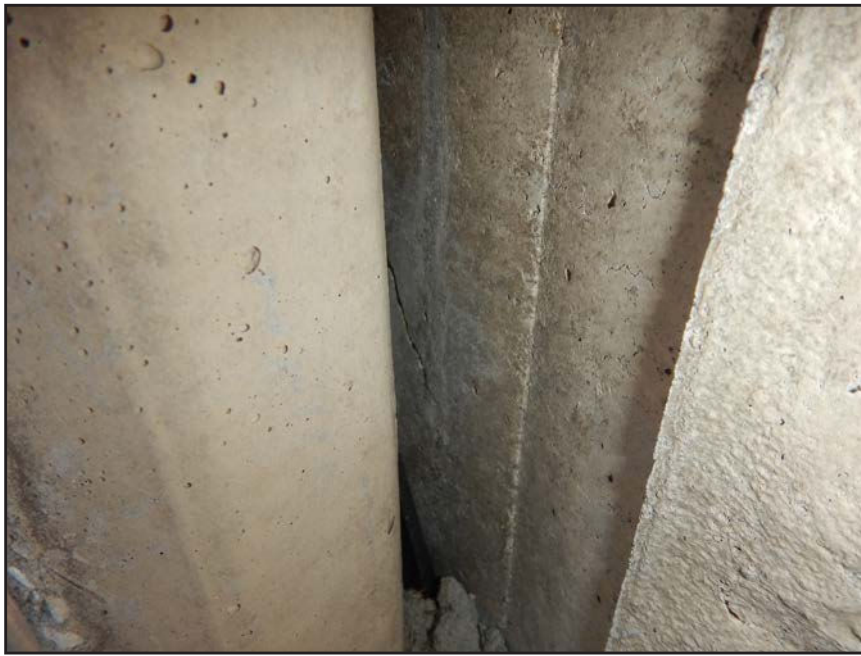
NO. 346 - COLUMN 8SS -
CRACKED AND FAILED
TONGUE OF A PRECAST WALL
PANEL IN A PRECAST COLUMN

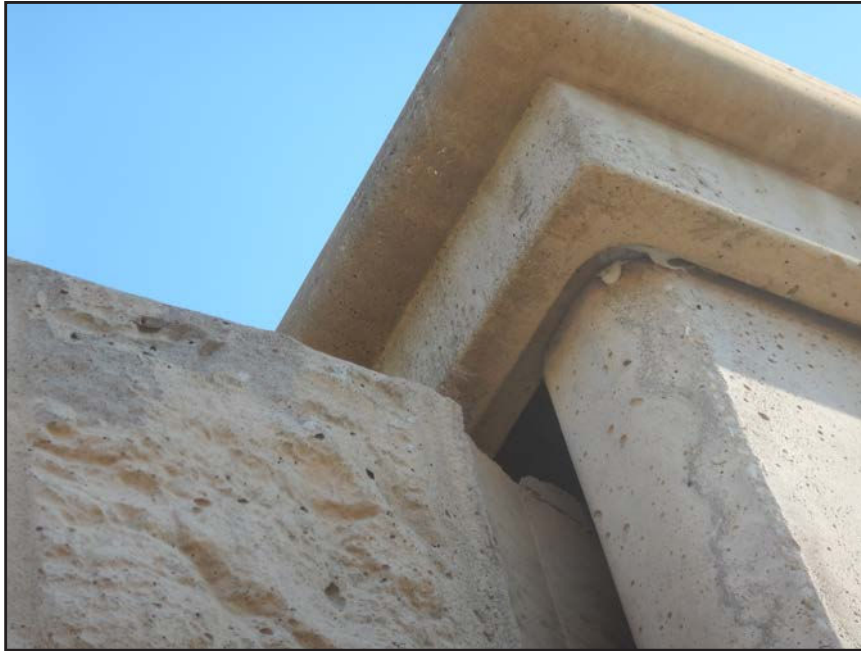
NO. 347 - COLUMN 8SS -
CRACKED AND FAILED
TONGUE OF A PRECAST WALL
PANEL IN A PRECAST COLUMN

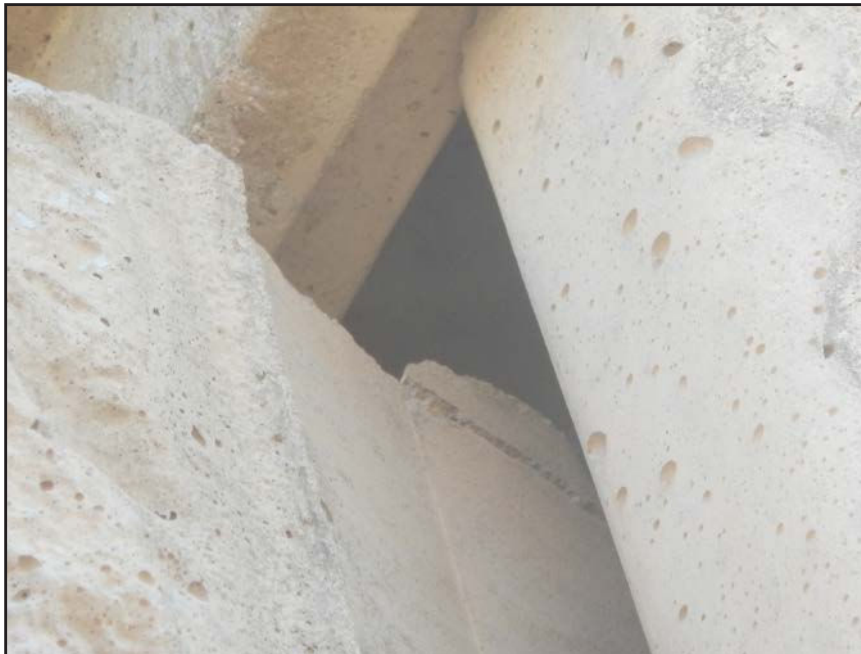
NO. 348 - COLUMN 16SS -
CRACKED AND FAILED
TONGUE OF A PRECAST WALL
PANEL IN A PRECAST COLUMN

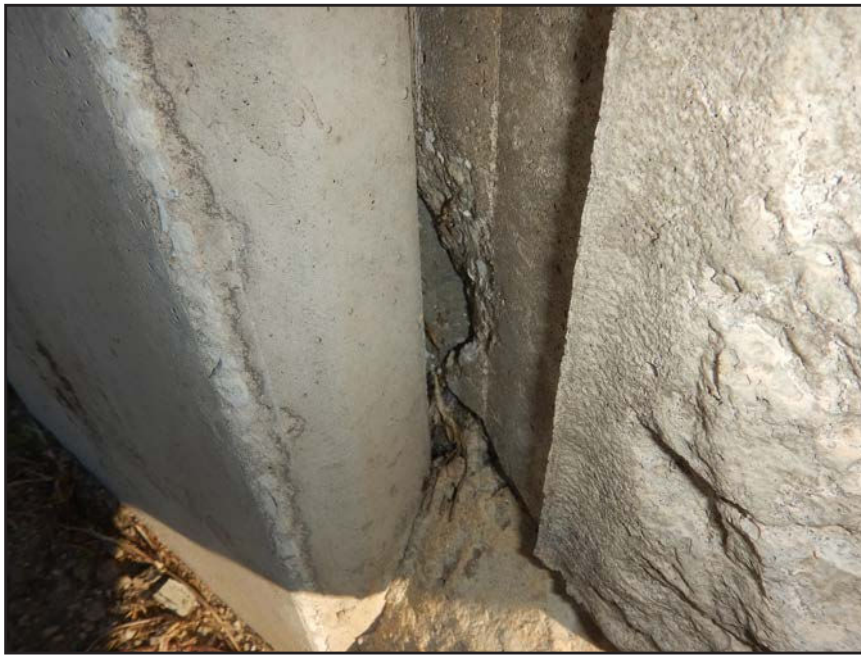
NO. 349 - COLUMN 16SS -
CRACKED AND FAILED
TONGUE OF A PRECAST WALL
PANEL IN A PRECAST COLUMN

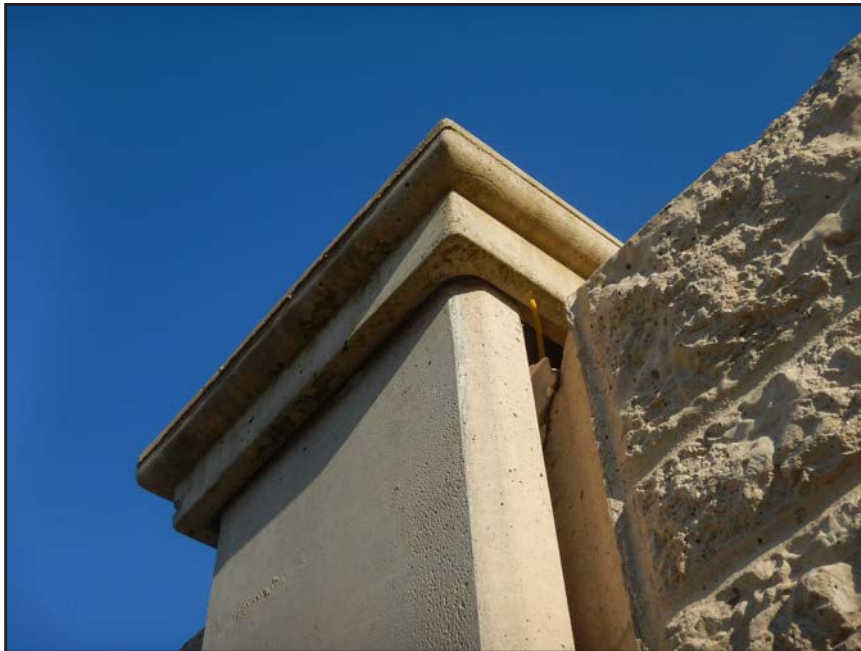
NO. 350 - COLUMN 18SS -
CRACKED AND FAILED
TONGUE OF A PRECAST WALL
PANEL IN A PRECAST COLUMN

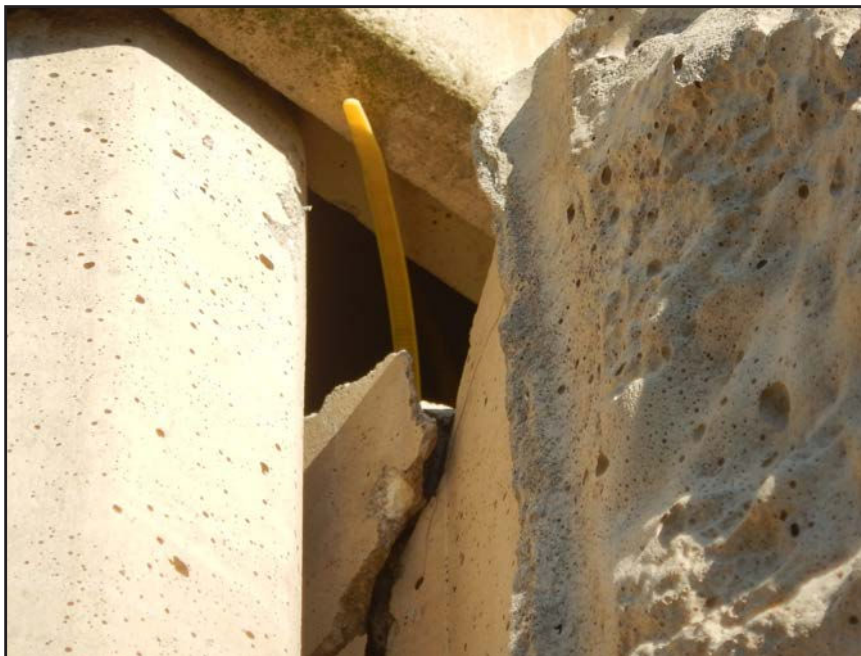
NO. 351 - COLUMN 20SS -
CRACKED AND FAILED
TONGUE OF A PRECAST WALL
PANEL IN A PRECAST COLUMN

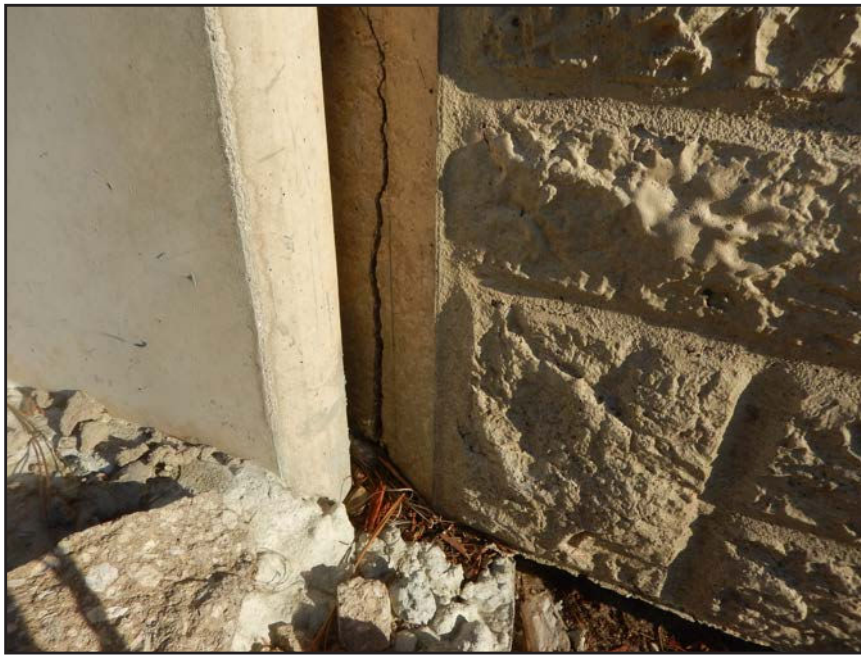
NO. 352 - COLUMN 20SS -
CRACKED AND FAILED
TONGUE OF A PRECAST WALL
PANEL IN A PRECAST COLUMN

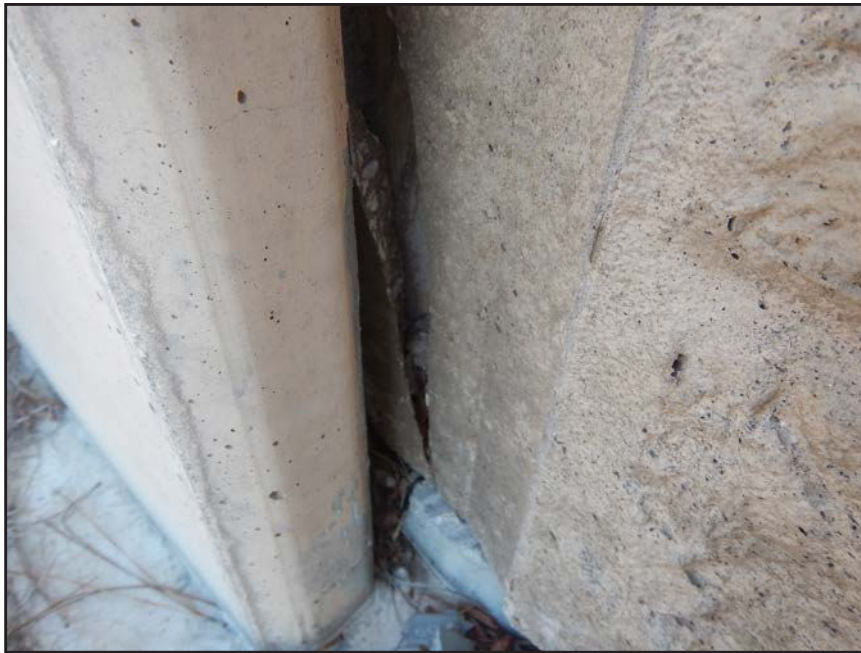
NO. 353 - COLUMN 21SS -
CRACKED AND FAILED
TONGUE OF A PRECAST WALL
PANEL IN A PRECAST COLUMN

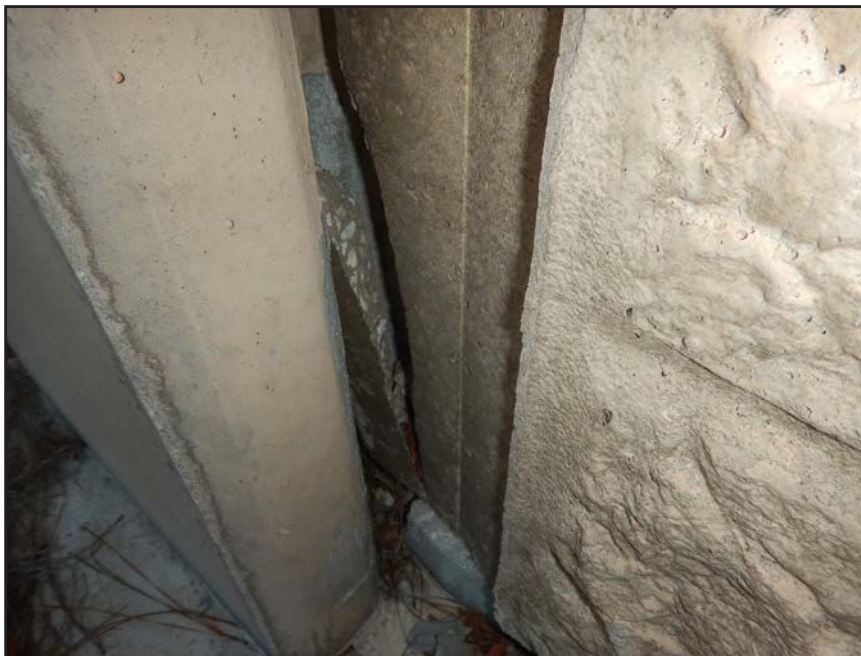
NO. 354 - COLUMN 22SS -
CRACKED AND FAILED
TONGUE OF A PRECAST WALL
PANEL IN A PRECAST COLUMN

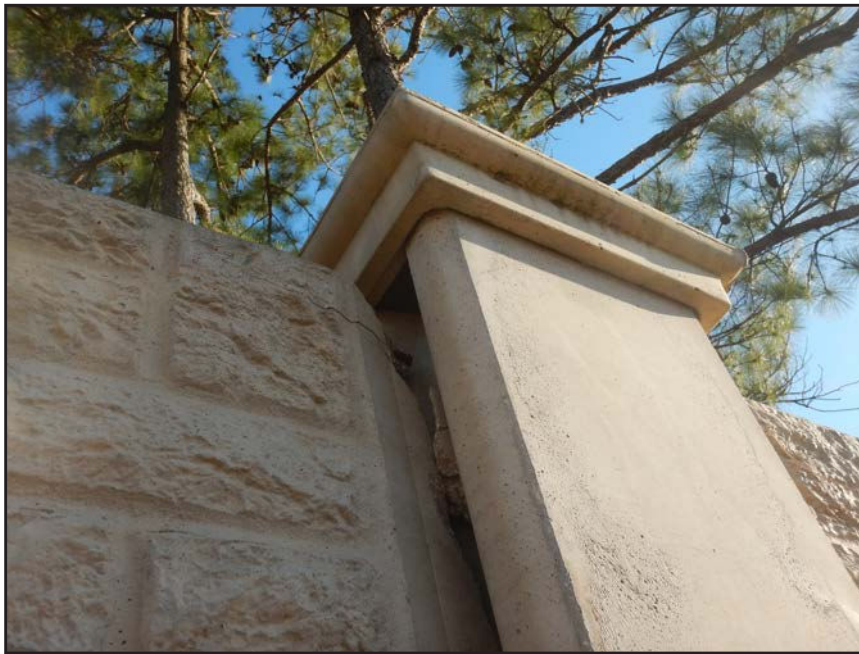
NO. 355 - COLUMN 22SS -
CRACKED AND FAILED
TONGUE OF A PRECAST WALL
PANEL IN A PRECAST COLUMN

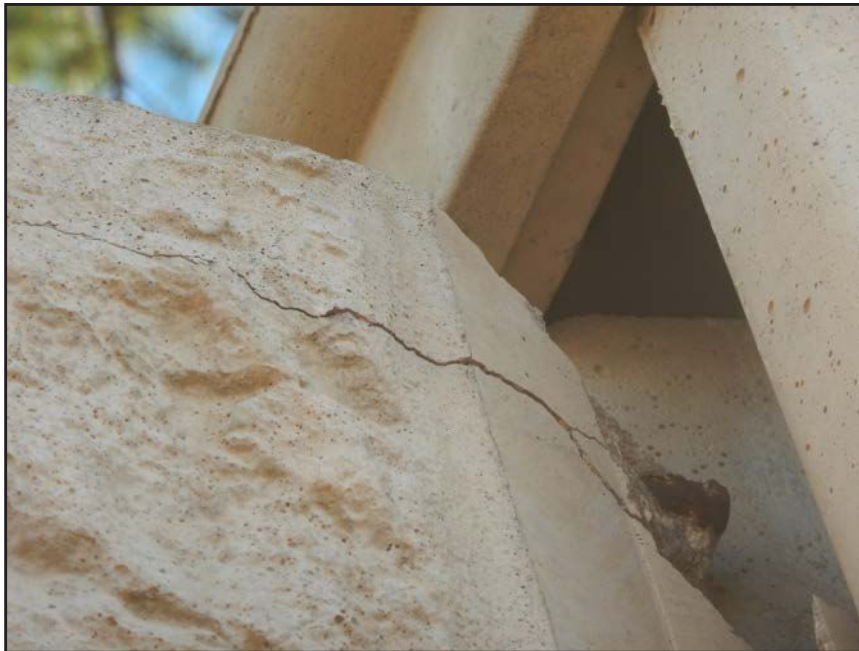
NO. 356 - COLUMN 25SS -
CRACKED AND FAILED
TONGUE OF A PRECAST WALL
PANEL IN A PRECAST COLUMN

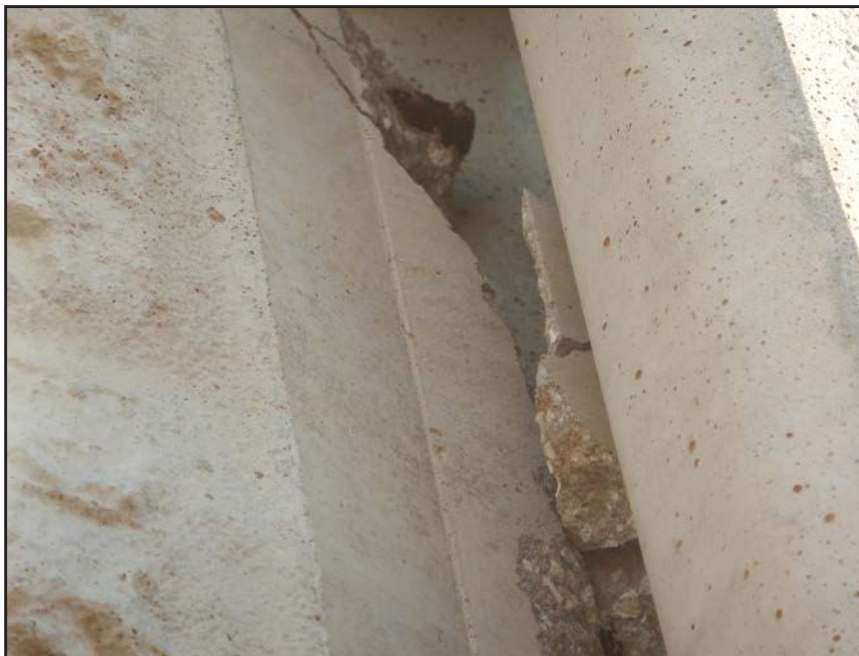
NO. 357 - COLUMN 25SS -
CRACKED AND FAILED
TONGUE OF A PRECAST WALL
PANEL IN A PRECAST COLUMN

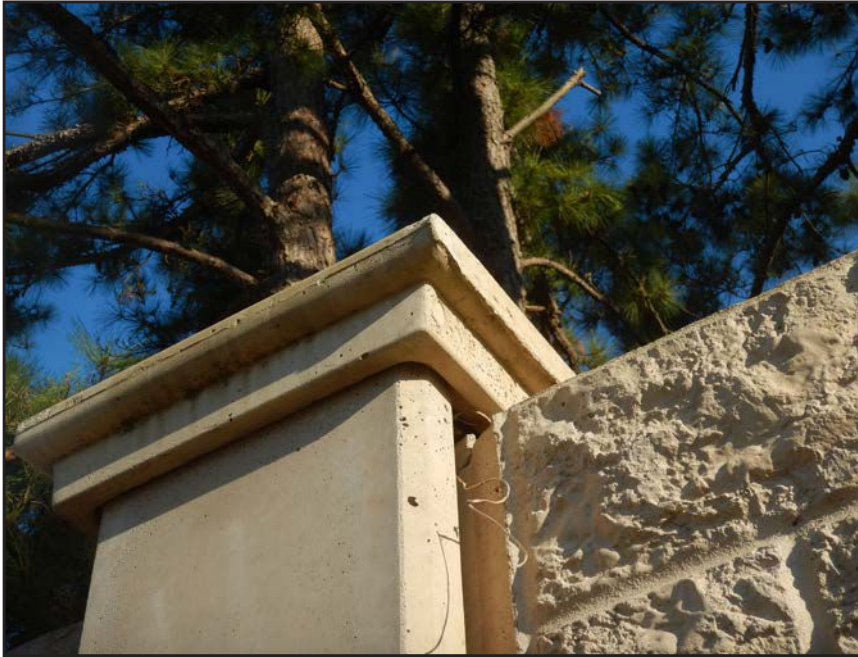
NO. 358- COLUMN 25SS -
CRACKED AND FAILED
TONGUE OF A PRECAST WALL
PANEL IN A PRECAST COLUMN

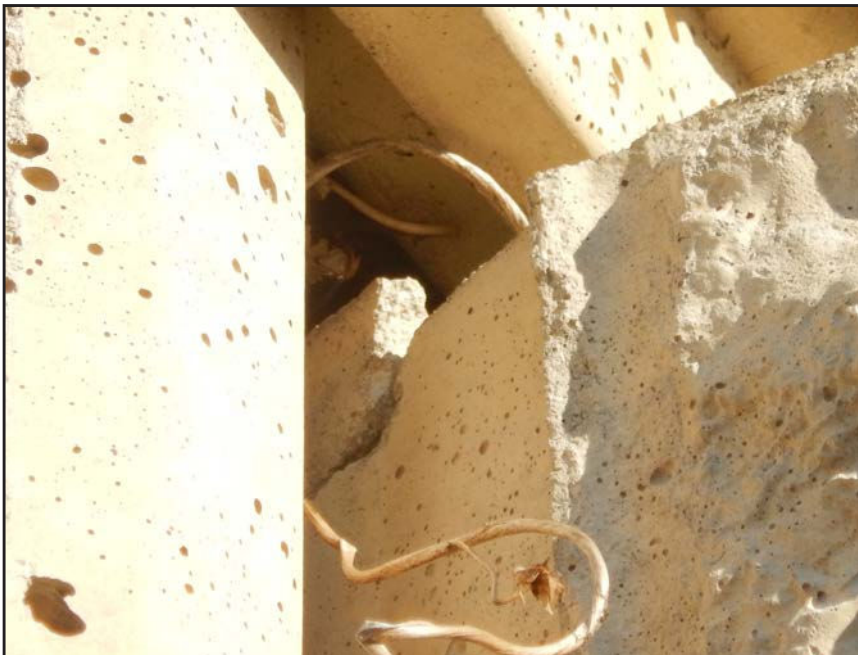
NO. 359 - COLUMN 25SS -
CRACKED AND FAILED
TONGUE OF A PRECAST WALL
PANEL IN A PRECAST COLUMN

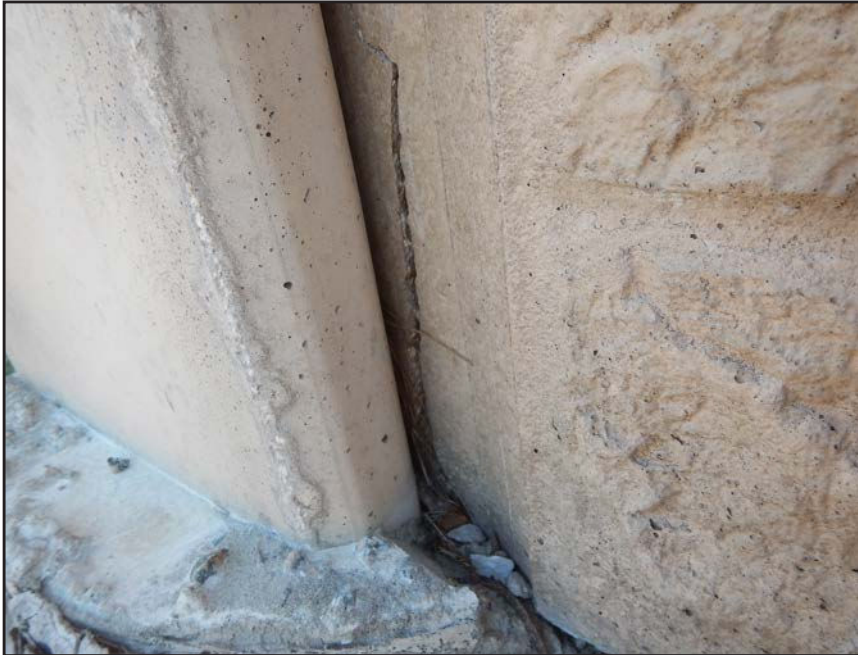
NO. 360 - COLUMN 25SS -
CRACKED AND FAILED
TONGUE OF A PRECAST WALL
PANEL IN A PRECAST COLUMN

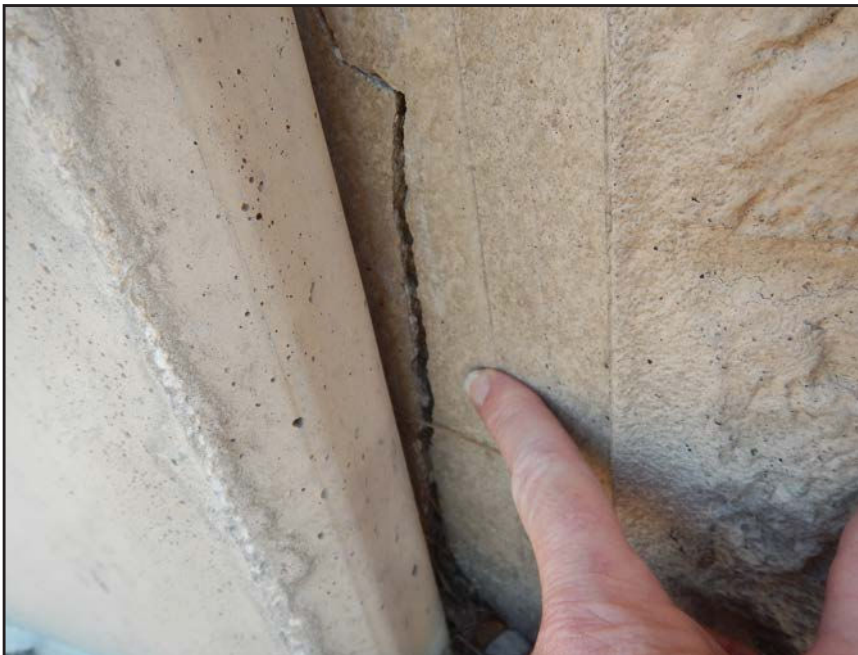
NO. 361 - COLUMN 28SS -
CRACKED AND FAILED
TONGUE OF A PRECAST WALL
PANEL IN A PRECAST COLUMN

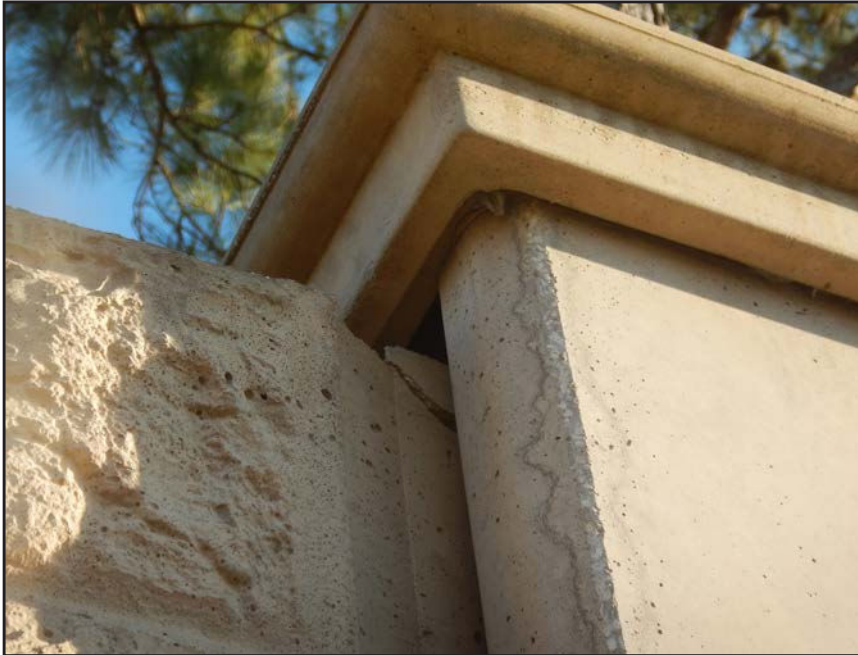
NO. 362 - COLUMN 28SS -
CRACKED AND FAILED
TONGUE OF A PRECAST WALL
PANEL IN A PRECAST COLUMN

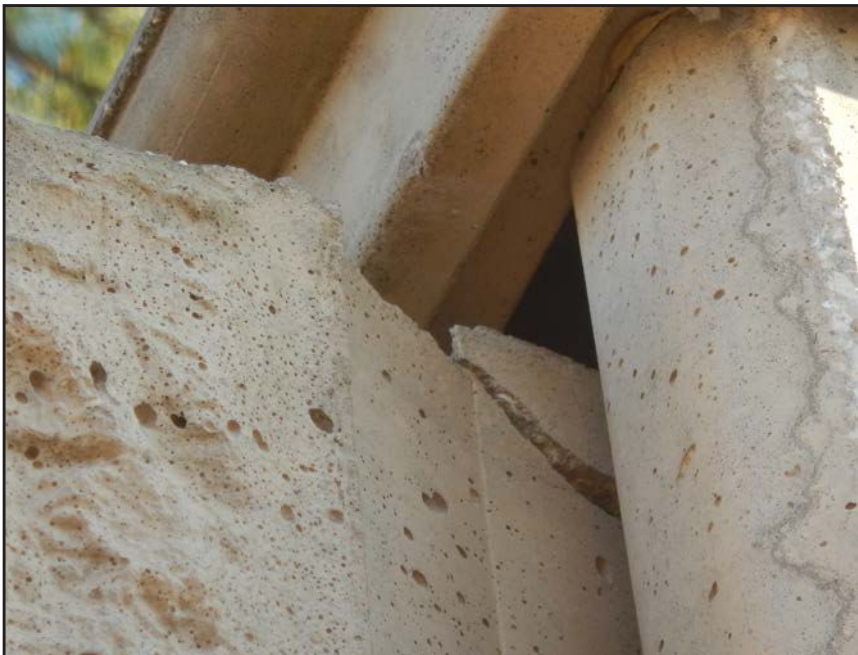
NO. 363 - COLUMN 37SS -
CRACKED AND FAILED
TONGUE OF A PRECAST WALL
PANEL IN A PRECAST COLUMN

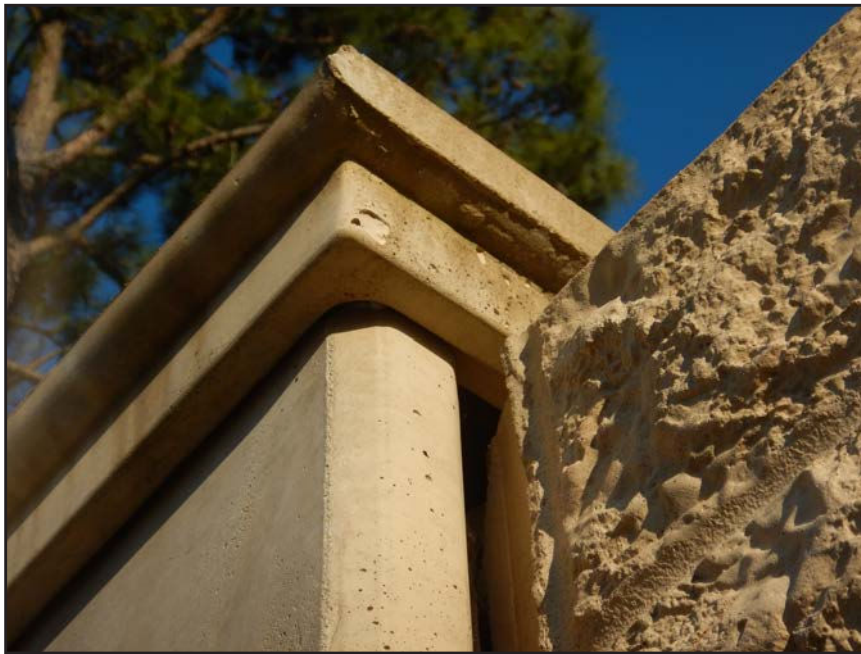
NO. 364 - COLUMN 37SS -
CRACKED AND FAILED
TONGUE OF A PRECAST WALL
PANEL IN A PRECAST COLUMN

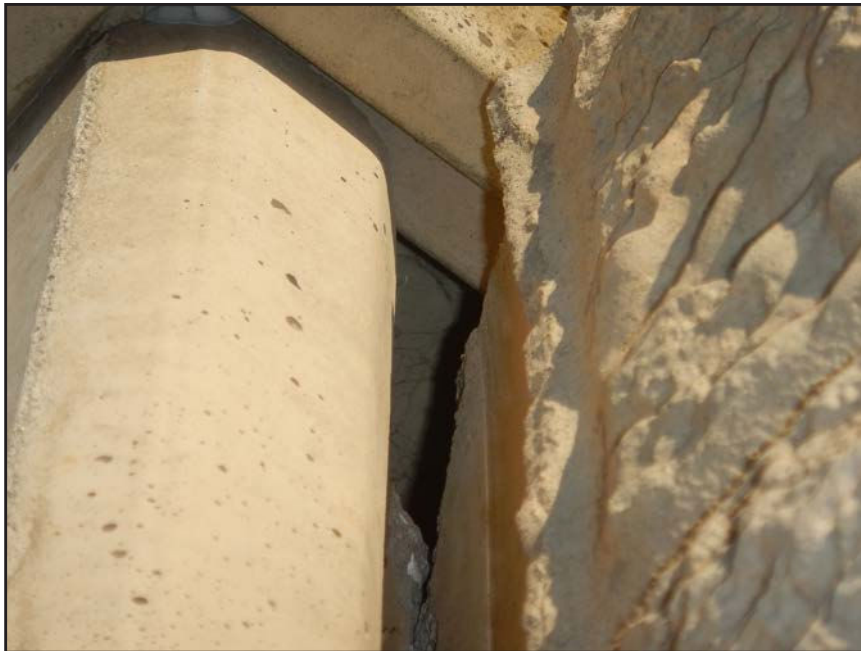
NO. 365 - COLUMN 39SS -
CRACKED AND FAILED
TONGUE OF A PRECAST WALL
PANEL IN A PRECAST COLUMN

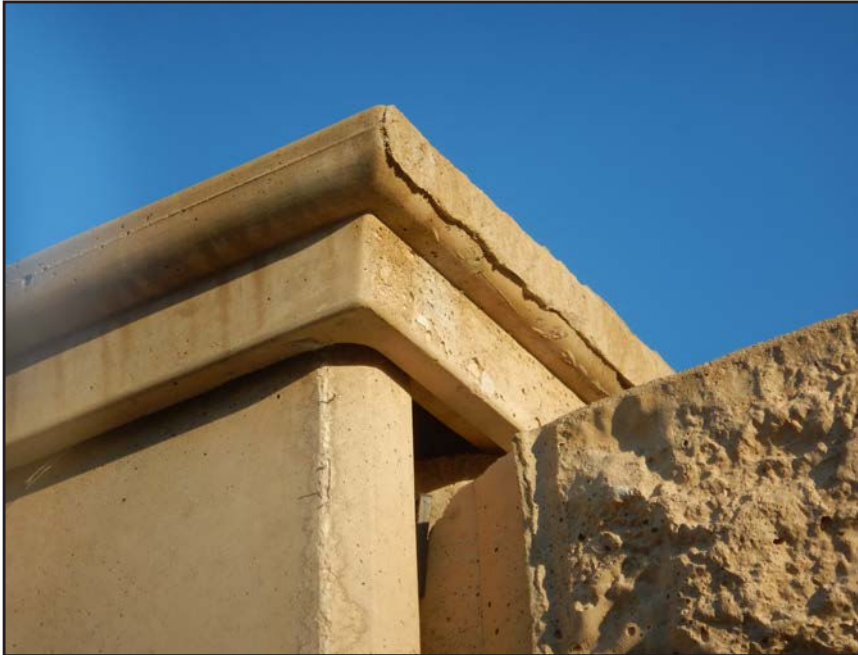
NO. 367 - COLUMN 39SS -
CRACKED AND FAILED
TONGUE OF A PRECAST WALL
PANEL IN A PRECAST COLUMN

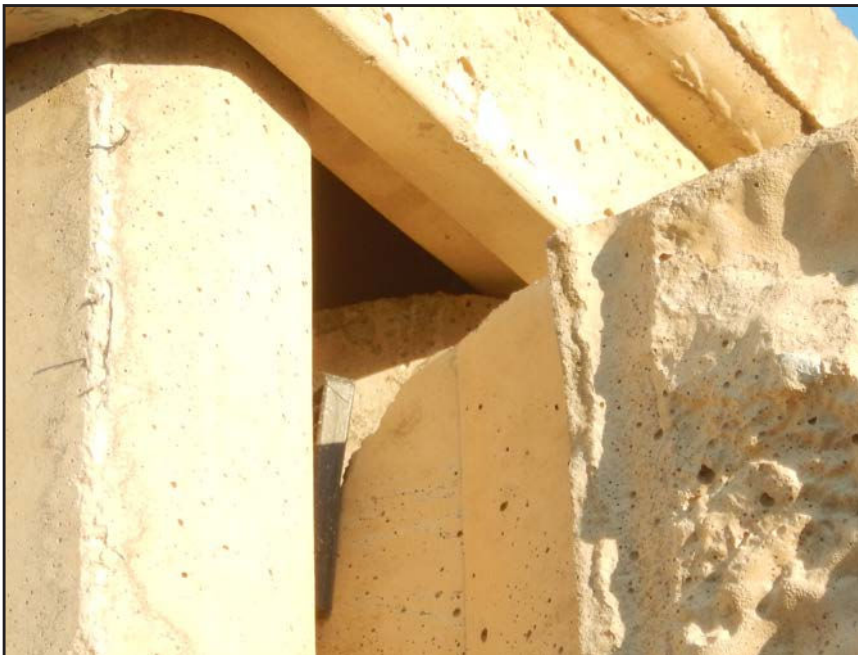
NO. 368 - COLUMN 46SS -
CRACKED AND FAILED
TONGUE OF A PRECAST WALL
PANEL IN A PRECAST COLUMN

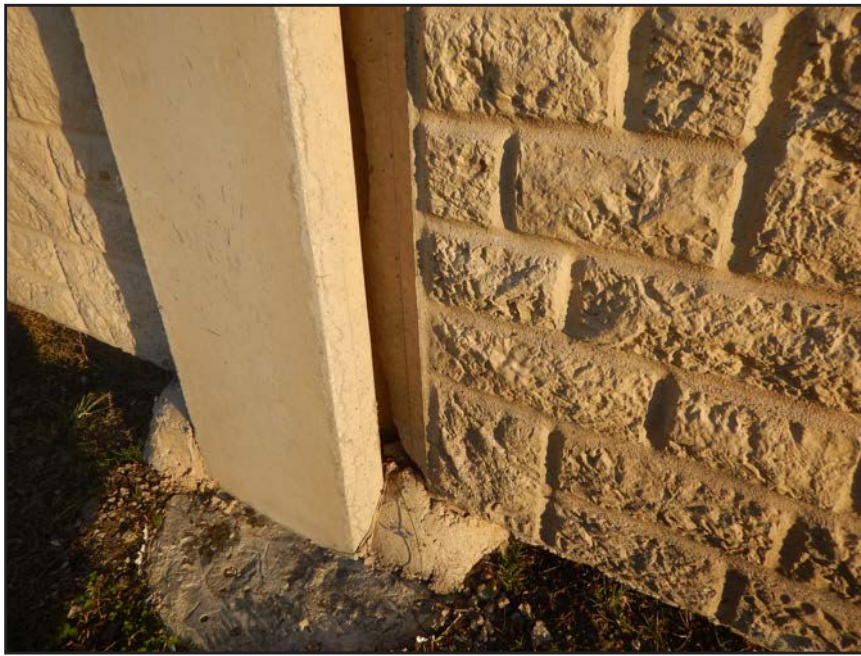
NO. 369 - COLUMN 46SS -
CRACKED AND FAILED
TONGUE OF A PRECAST WALL
PANEL IN A PRECAST COLUMN

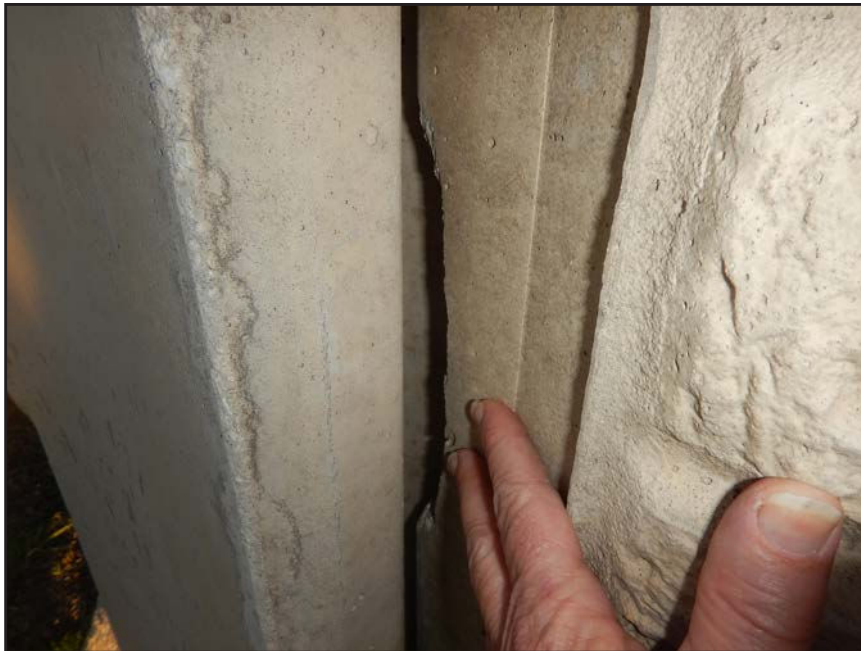
NO. 370 - COLUMN 46SS -
CRACKED AND FAILED
TONGUE OF A PRECAST WALL
PANEL IN A PRECAST COLUMN

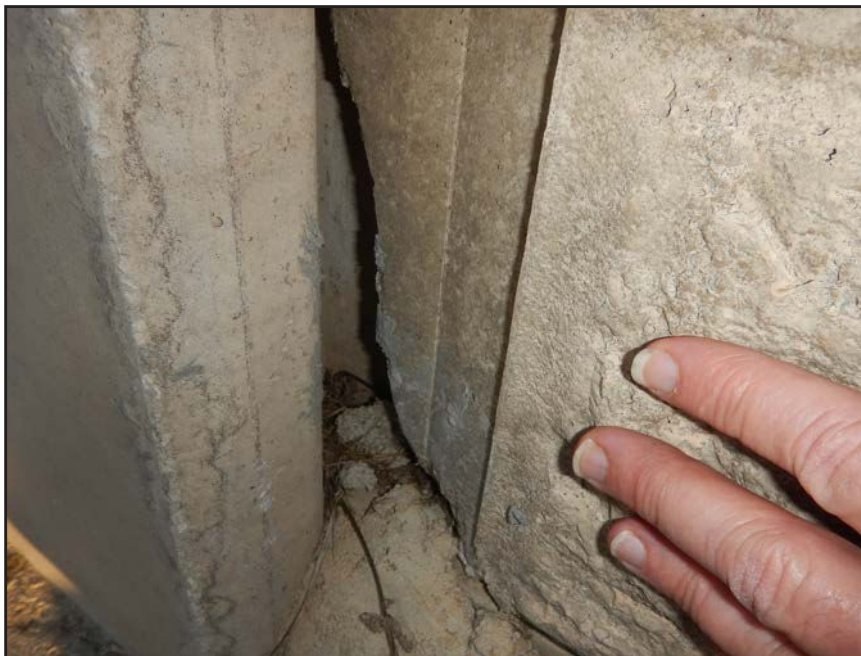
NO. 371 - COLUMN 46SS -
CRACKED AND FAILED
TONGUE OF A PRECAST WALL
PANEL IN A PRECAST COLUMN

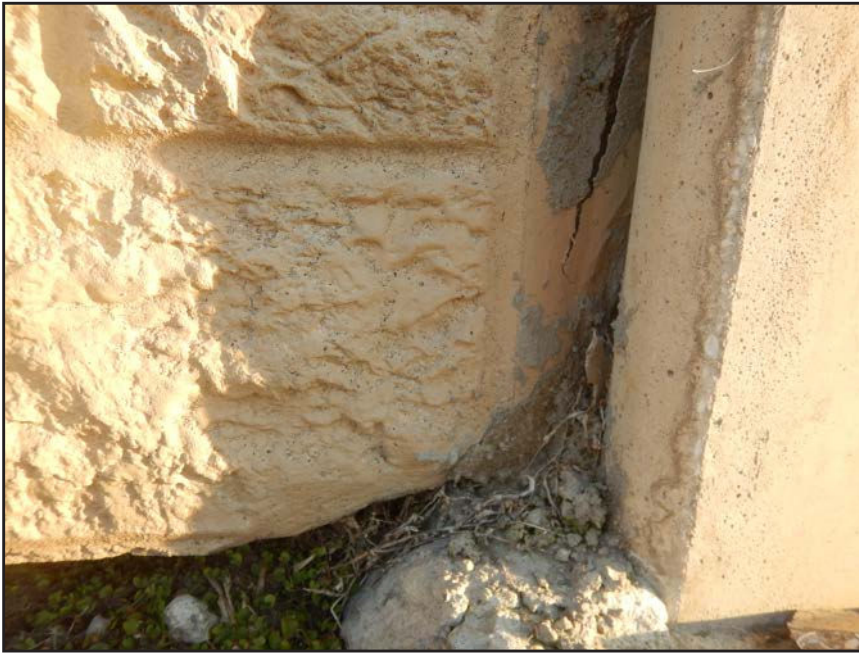
NO. 372 - COLUMN 46SS -
CRACKED AND FAILED
TONGUE OF A PRECAST WALL
PANEL IN A PRECAST COLUMN

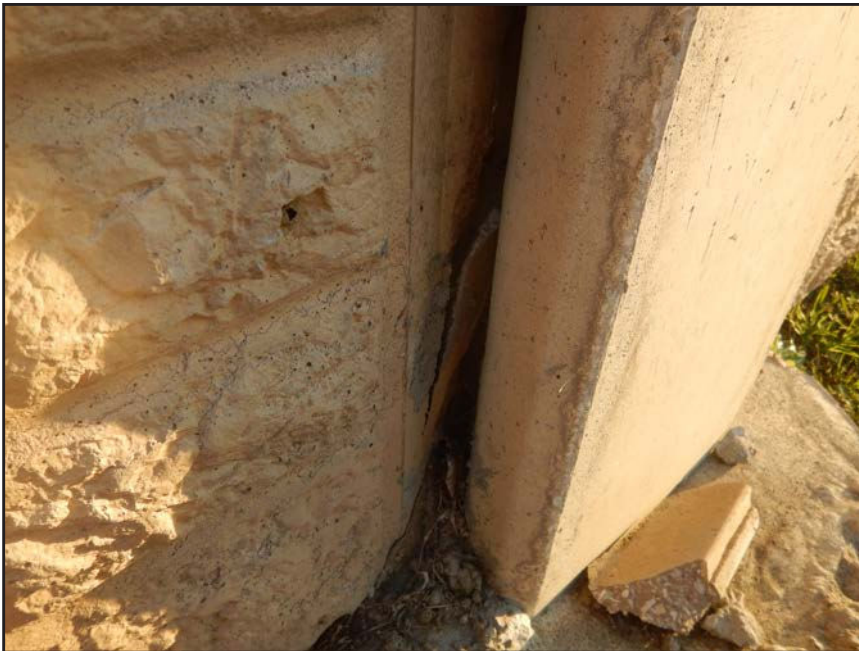
NO. 373 - COLUMN 47SS -
CRACKED AND FAILED
TONGUE OF A PRECAST WALL
PANEL IN A PRECAST COLUMN

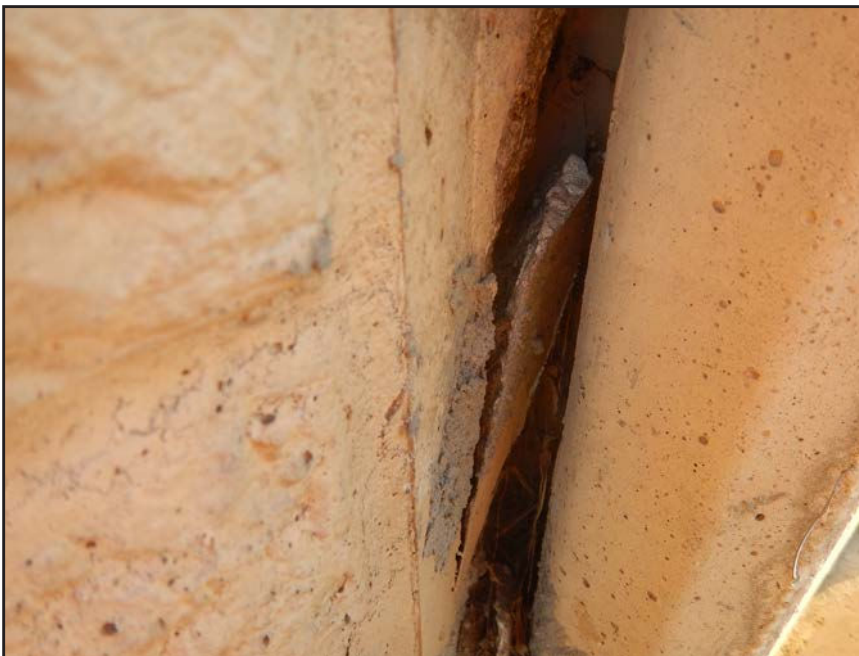
NO. 374 - COLUMN 47SS -
CRACKED AND FAILED
TONGUE OF A PRECAST WALL
PANEL IN A PRECAST COLUMN

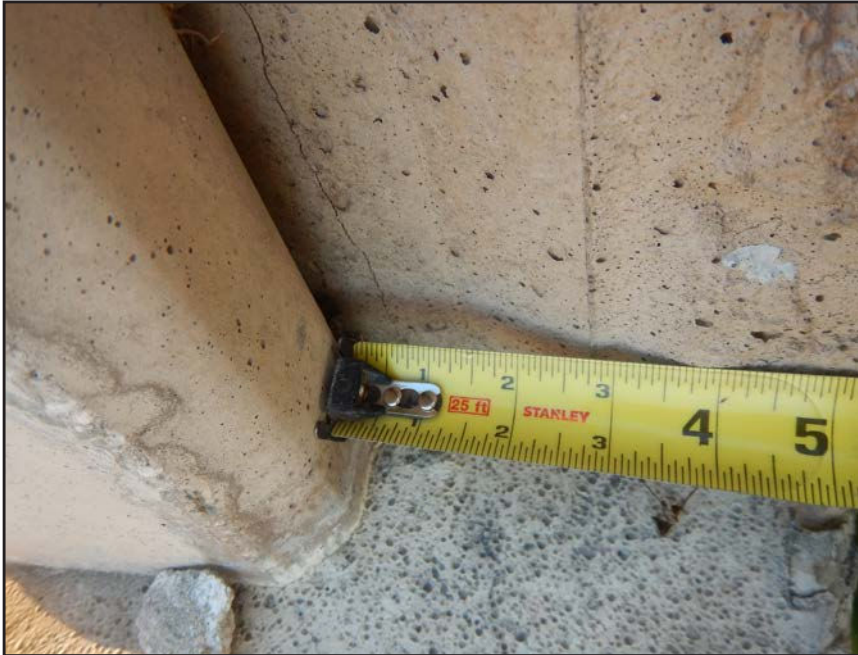
NO. 375 - COLUMN 47SS -
CRACKED AND FAILED
TONGUE OF A PRECAST WALL
PANEL IN A PRECAST COLUMN

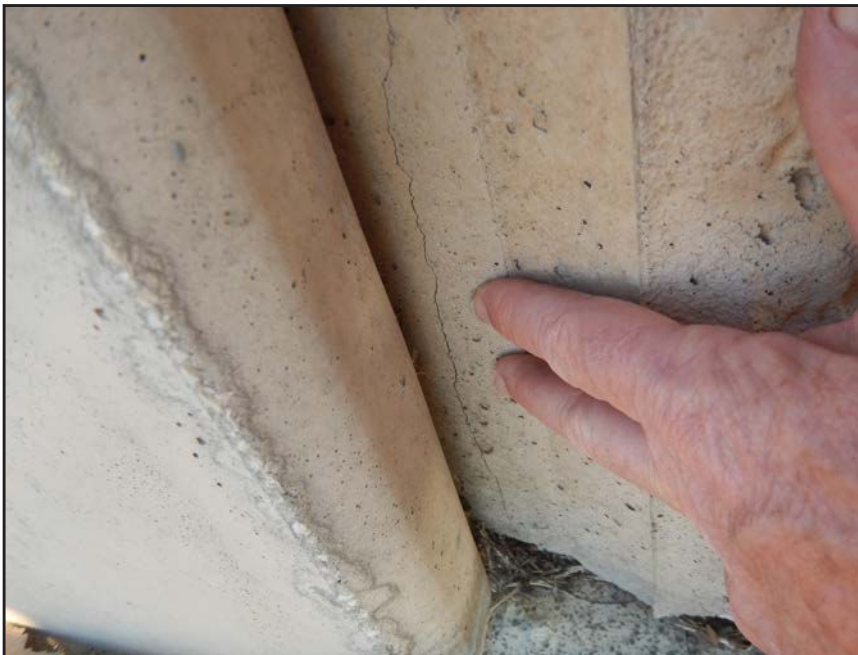
NO. 376 - COLUMN 47SS -
CRACKED AND FAILED
TONGUE OF A PRECAST WALL
PANEL IN A PRECAST COLUMN
