WATER TOWER ROAD SCREEN WALL INVESTIGATIONS

Water Tower Road
Longs, South Carolina

Stantec Project No. 171015900

March 31, 2025

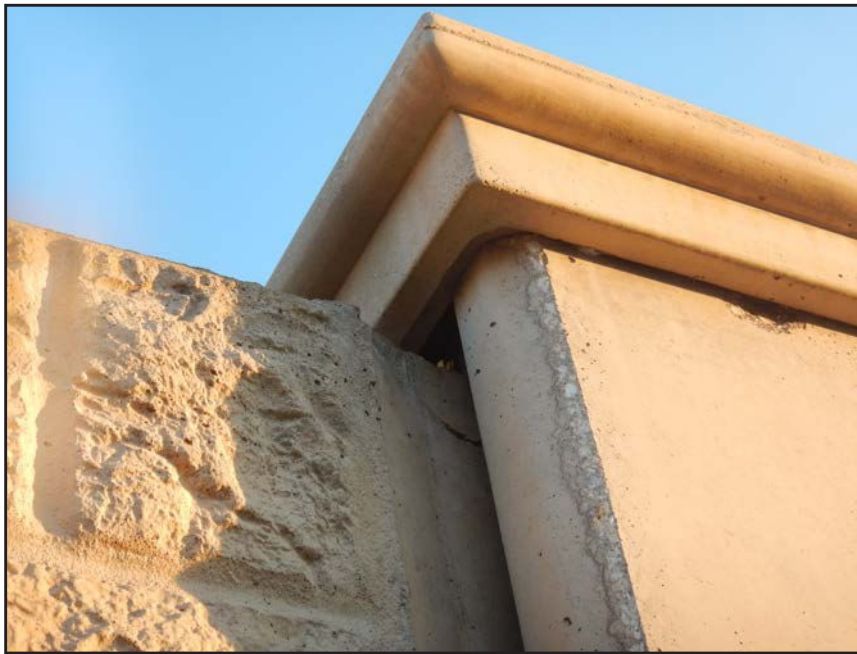
NO. 377 - COLUMN 47SS -
CRACKED AND FAILED
TONGUE OF A PRECAST WALL
PANEL IN A PRECAST COLUMN

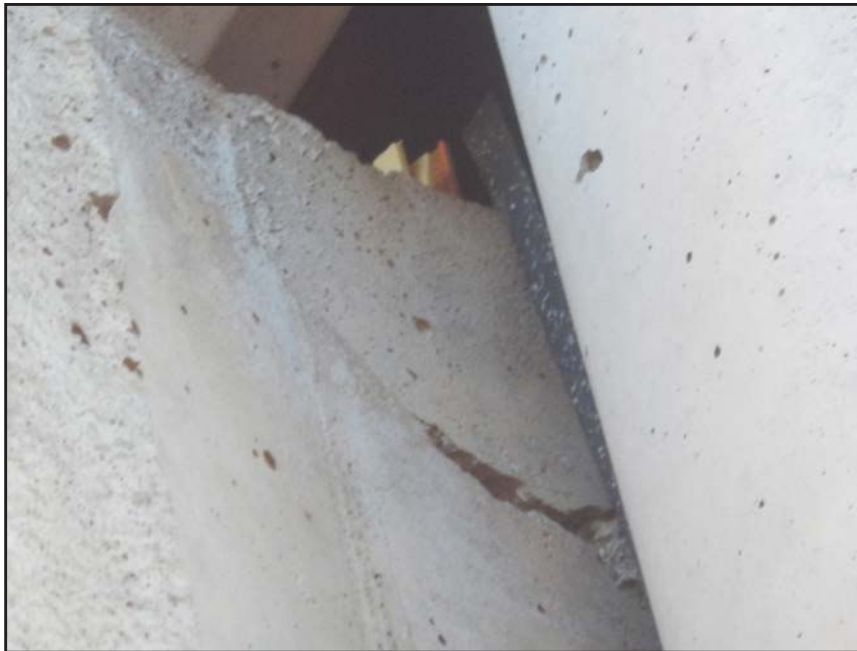
NO. 378 - COLUMN 59SS -
CRACKED AND FAILED
TONGUE OF A PRECAST WALL
PANEL IN A PRECAST COLUMN

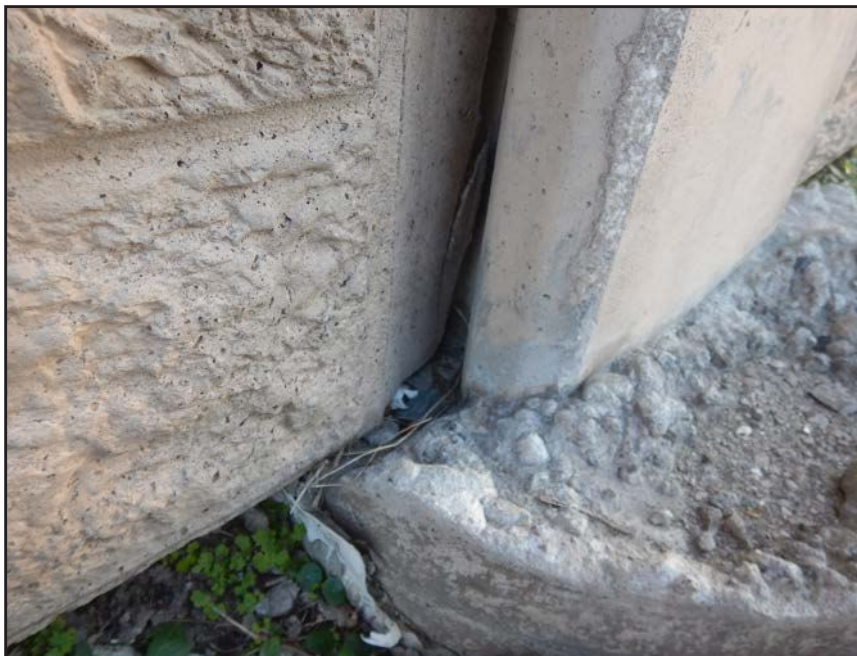
NO. 379 - COLUMN 59SS -
CRACKED AND FAILED
TONGUE OF A PRECAST WALL
PANEL IN A PRECAST COLUMN

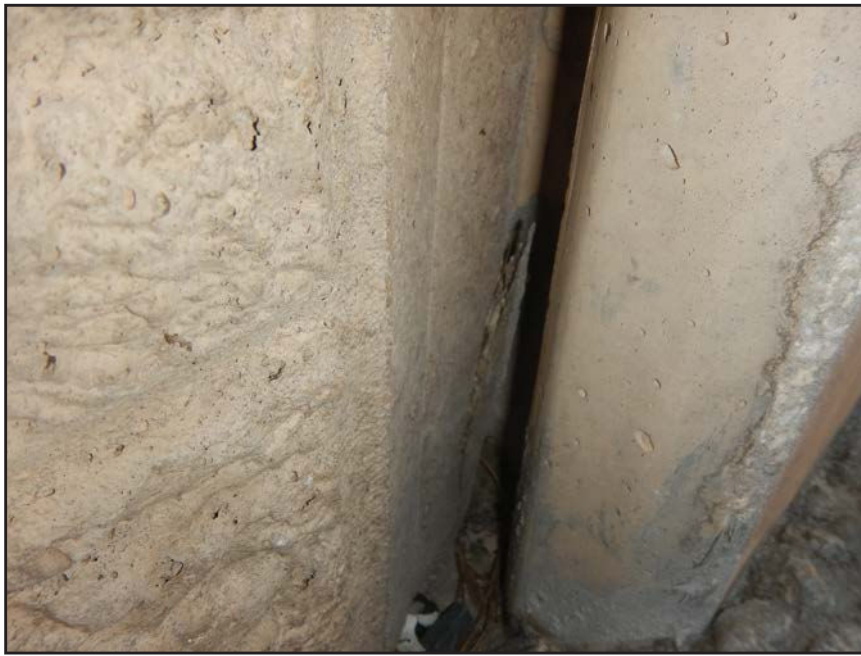
NO. 380 - COLUMN 59SS -
CRACKED AND FAILED
TONGUE OF A PRECAST WALL
PANEL IN A PRECAST COLUMN

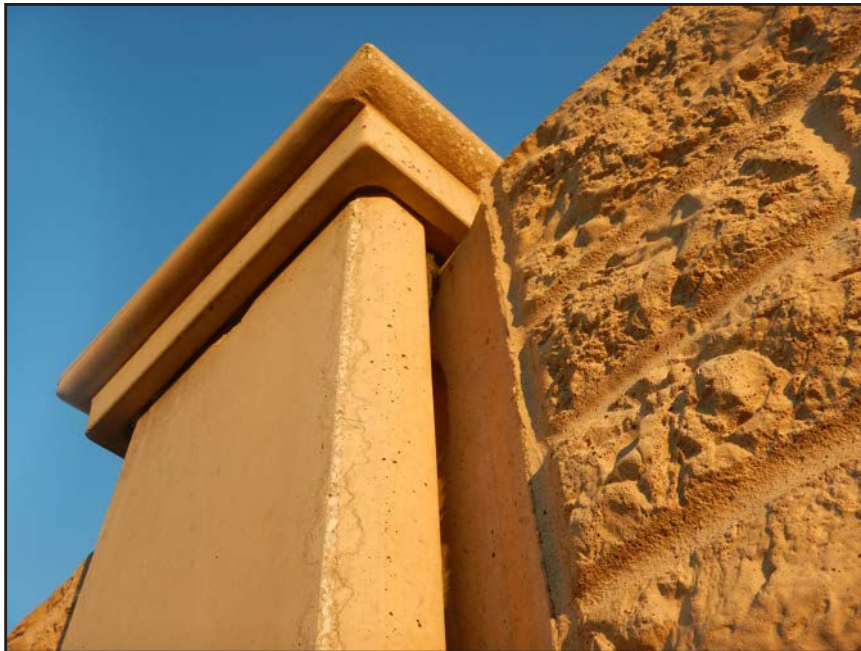
NO. 381 - COLUMN 59SS -
CRACKED AND FAILED
TONGUE OF A PRECAST WALL
PANEL IN A PRECAST COLUMN

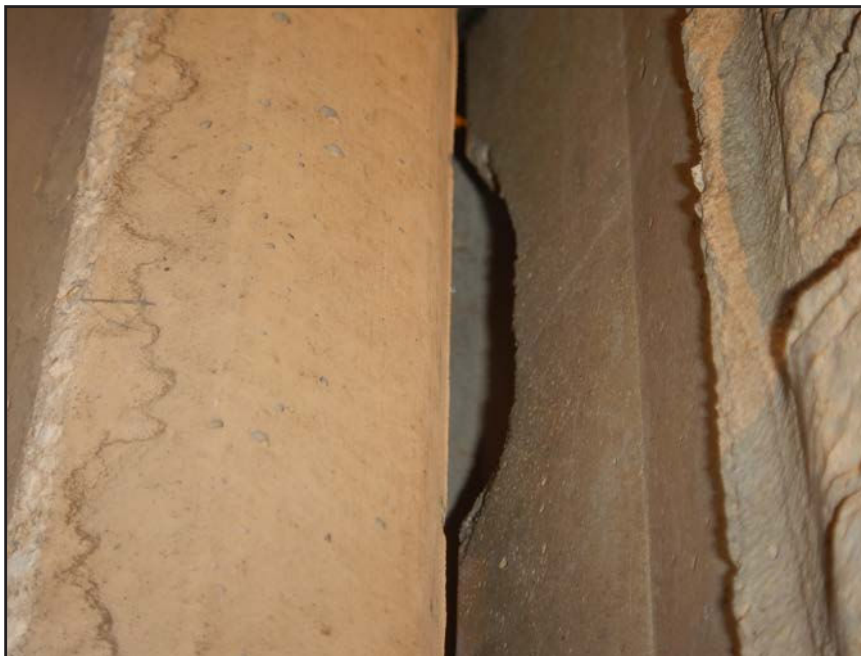
NO. 382 - COLUMN 59SS -
CRACKED AND FAILED
TONGUE OF A PRECAST WALL
PANEL IN A PRECAST COLUMN

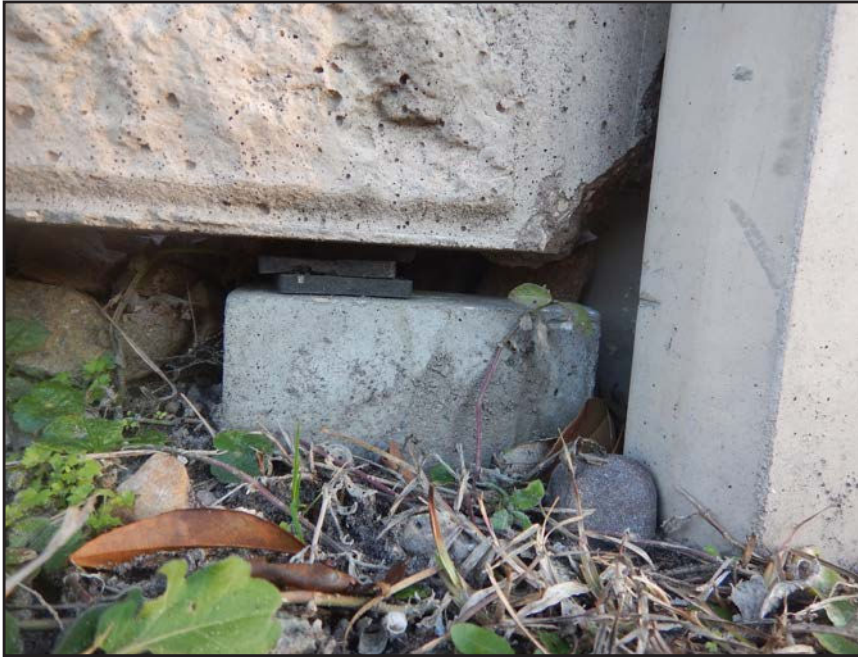
NO. 383 - COLUMN 59SS -
CRACKED AND FAILED
TONGUE OF A PRECAST WALL
PANEL IN A PRECAST COLUMN

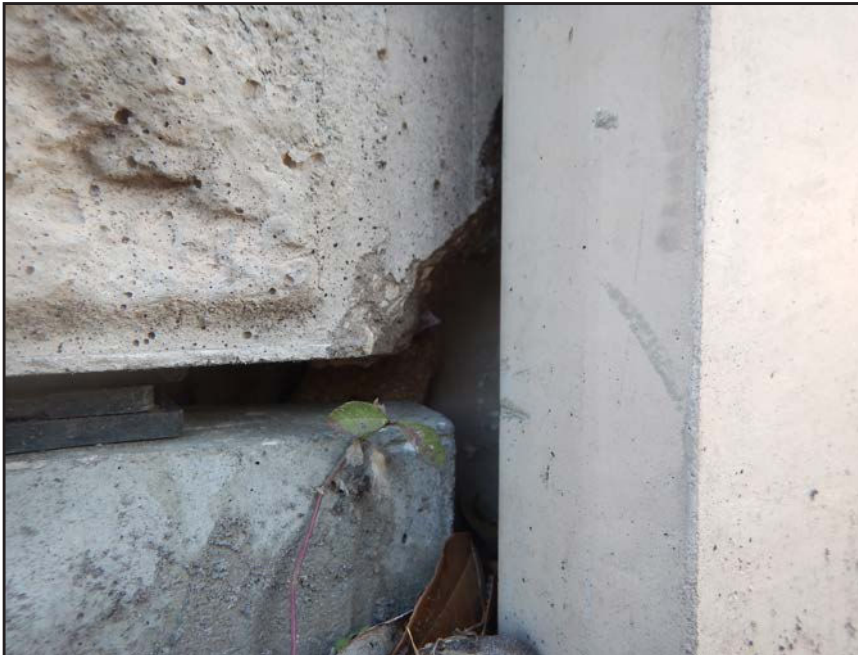
NO. 384 - COLUMN 60SS -
CRACKED AND FAILED
TONGUE OF A PRECAST WALL
PANEL IN A PRECAST COLUMN

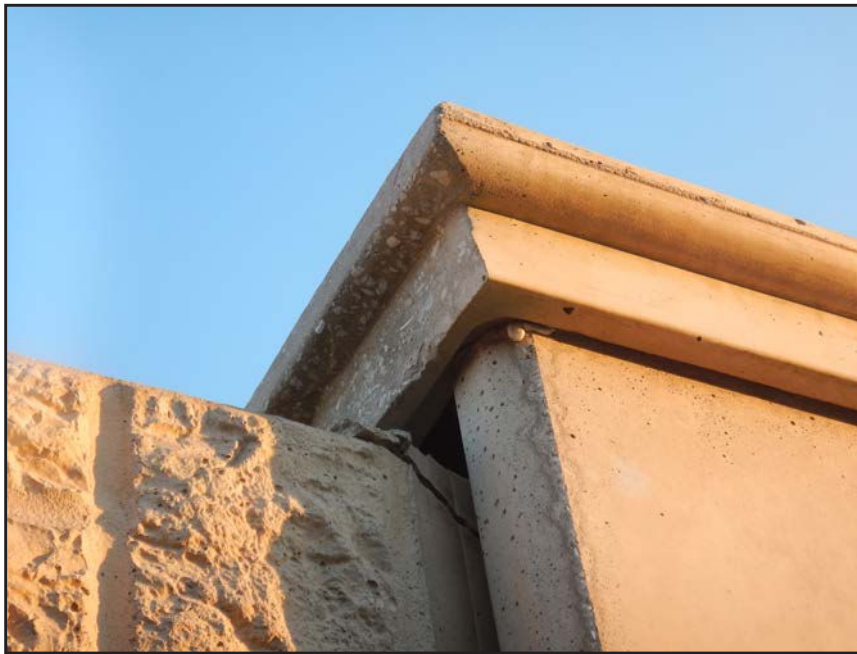
NO. 385 - COLUMN 60SS -
CRACKED AND FAILED
TONGUE OF A PRECAST WALL
PANEL IN A PRECAST COLUMN

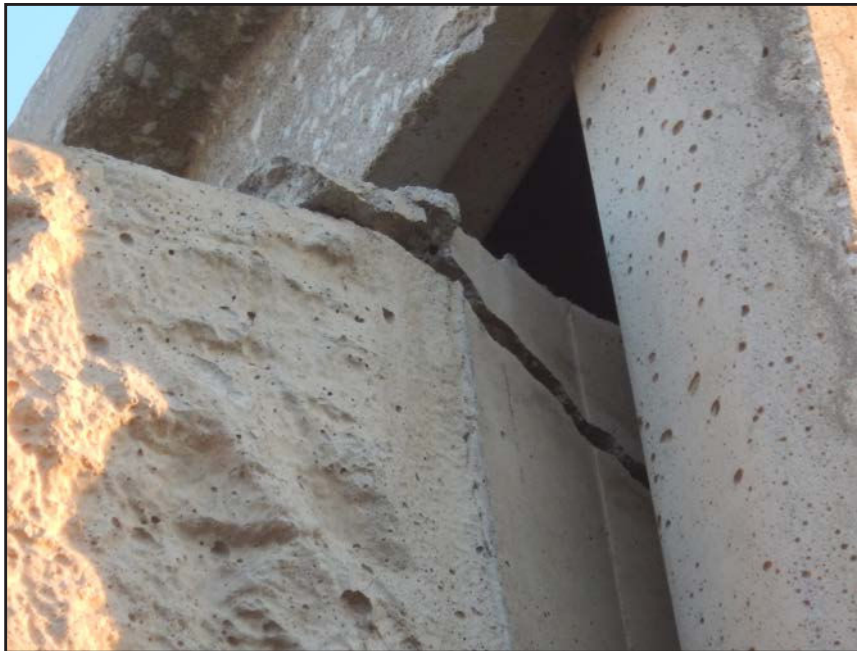
NO. 386 - COLUMN 62SS -
CRACKED AND FAILED
TONGUE OF A PRECAST WALL
PANEL IN A PRECAST COLUMN

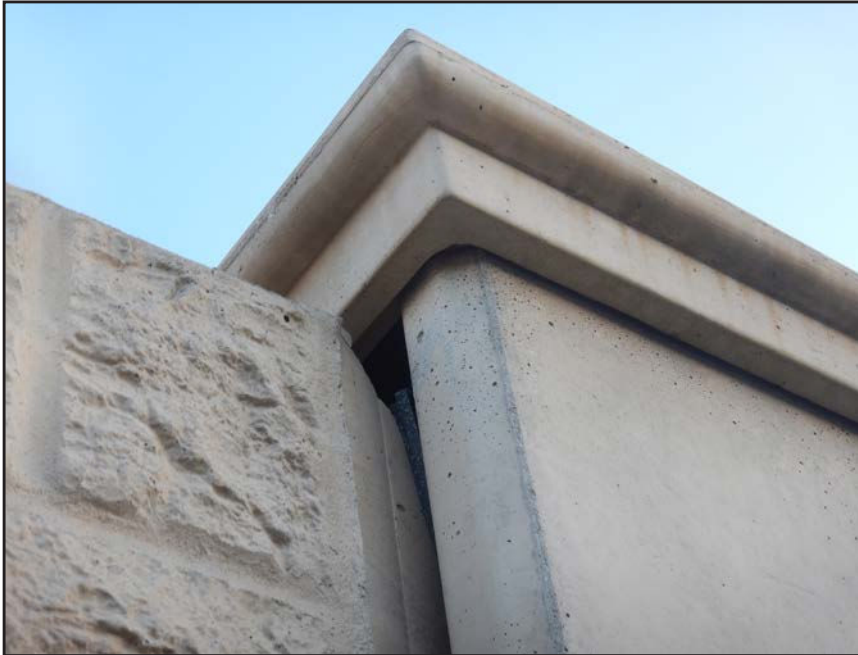
NO. 388 - COLUMN 63SS -
CRACKED AND FAILED
TONGUE OF A PRECAST WALL
PANEL IN A PRECAST COLUMN

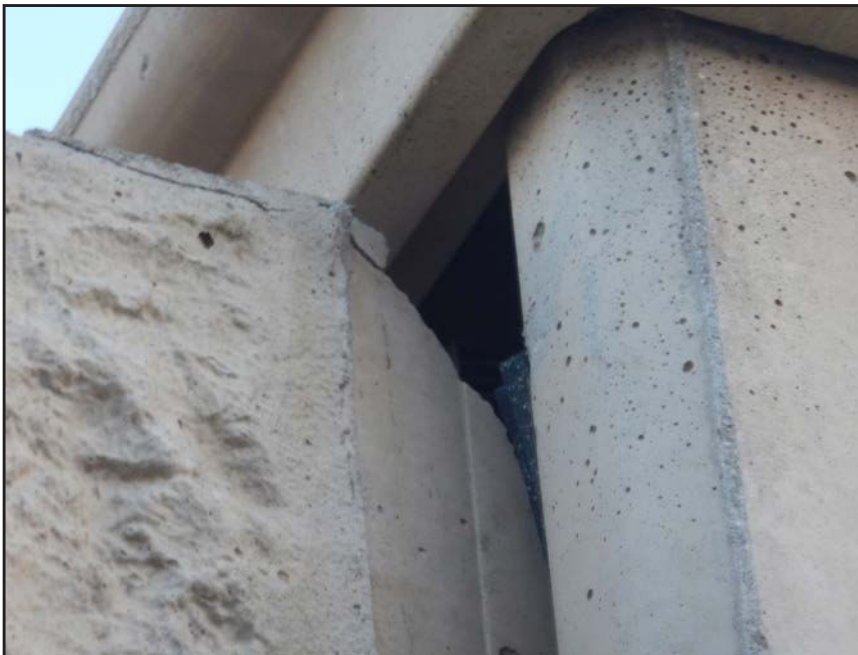
NO. 389 - COLUMN 65SS -
CRACKED AND FAILED
TONGUE OF A PRECAST WALL
PANEL IN A PRECAST COLUMN

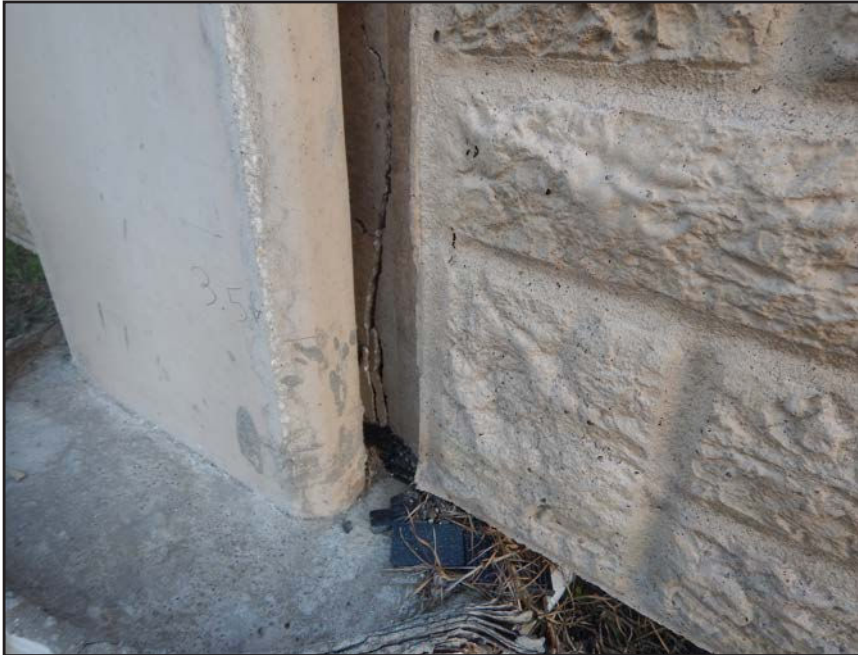
NO. 390 - COLUMN 65SS -
CRACKED AND FAILED
TONGUE OF A PRECAST WALL
PANEL IN A PRECAST COLUMN

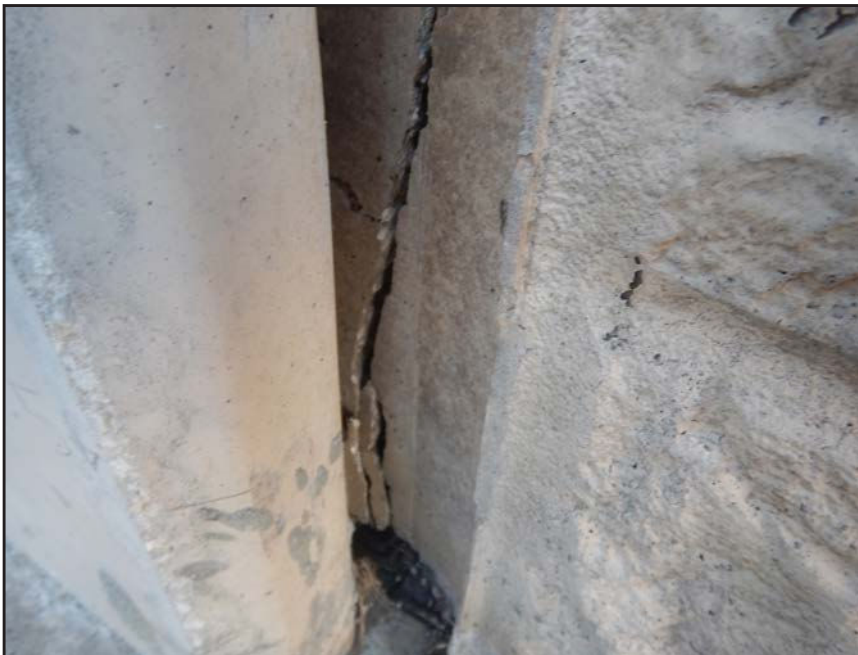
NO. 391 - COLUMN 69SS -
CRACKED AND FAILED
TONGUE OF A PRECAST WALL
PANEL IN A PRECAST COLUMN

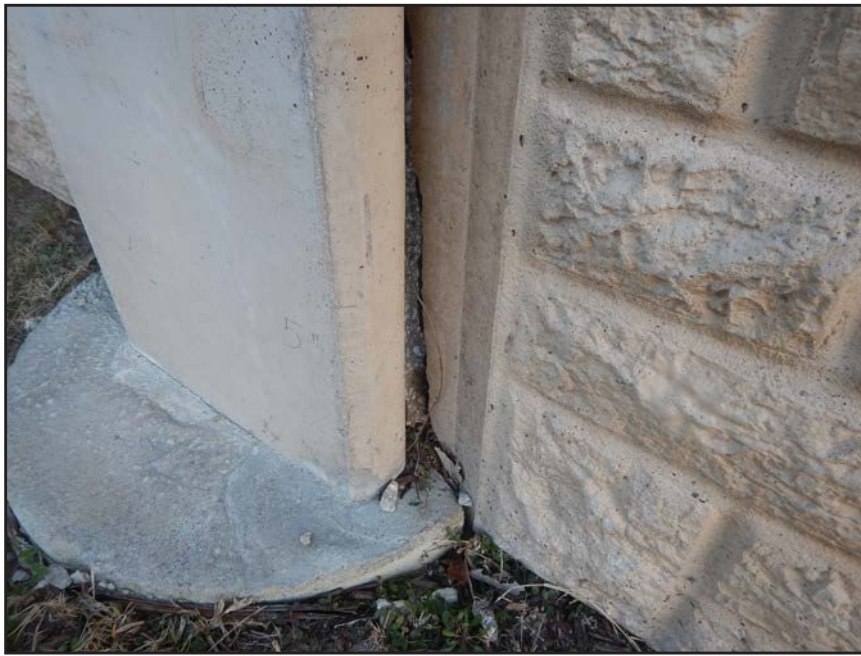
NO. 392 - COLUMN 69SS -
CRACKED AND FAILED
TONGUE OF A PRECAST WALL
PANEL IN A PRECAST COLUMN

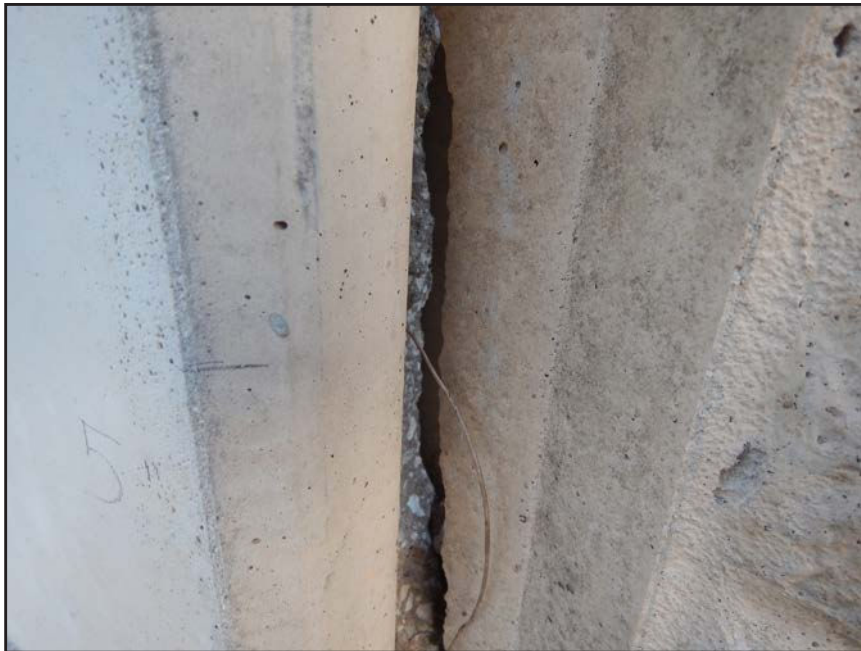
NO. 393 - COLUMN 70SS -
CRACKED AND FAILED
TONGUE OF A PRECAST WALL
PANEL IN A PRECAST COLUMN

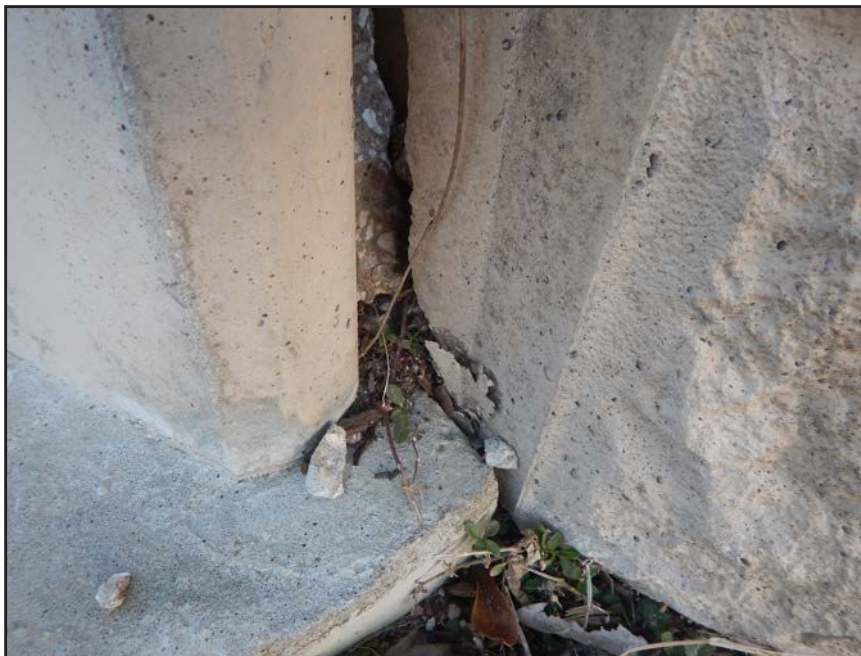
NO. 394 - COLUMN 70SS -
CRACKED AND FAILED
TONGUE OF A PRECAST WALL
PANEL IN A PRECAST COLUMN

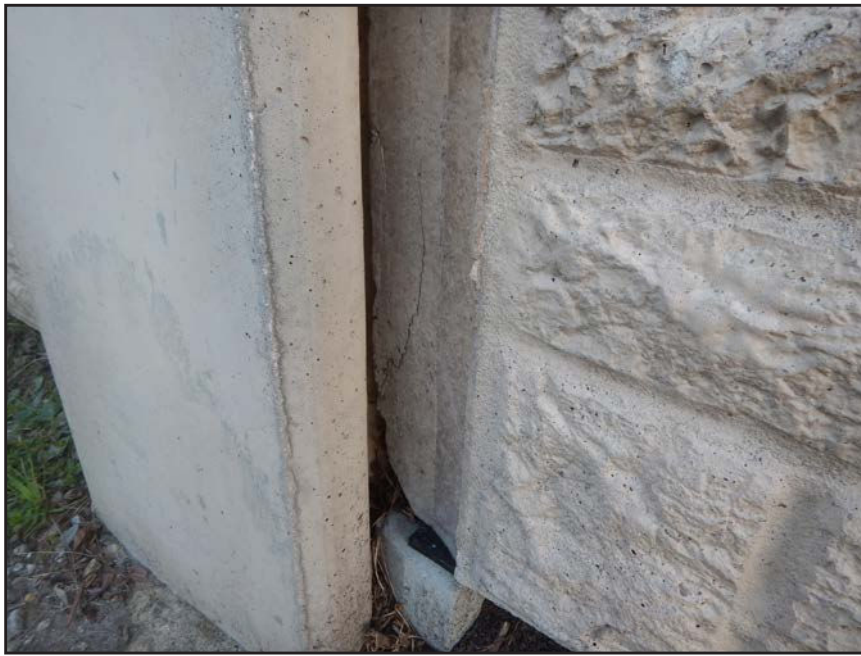
NO. 395 - COLUMN 70SS -
CRACKED AND FAILED
TONGUE OF A PRECAST WALL
PANEL IN A PRECAST COLUMN

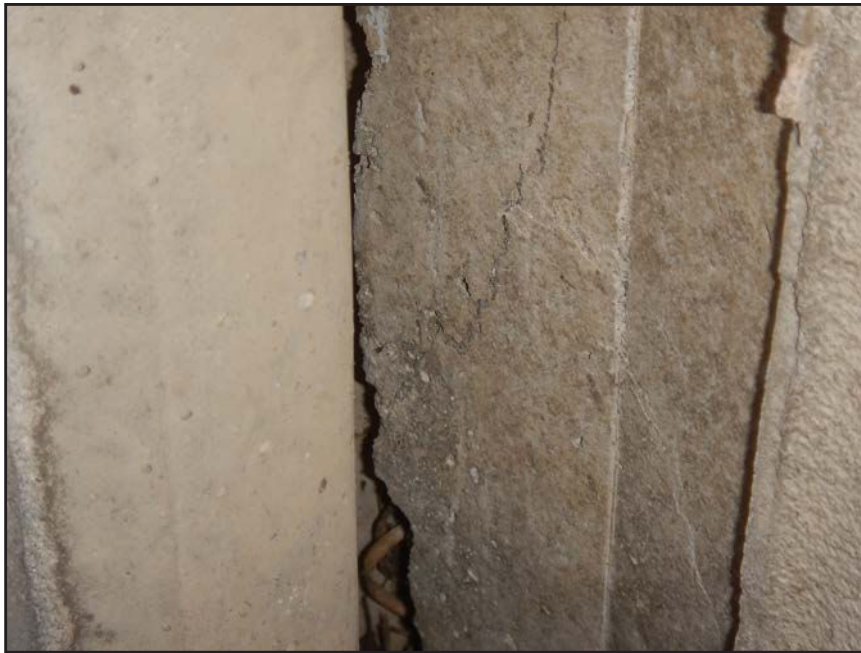
NO. 396 - COLUMN 76SS -
CRACKED AND FAILED
TONGUE OF A PRECAST WALL
PANEL IN A PRECAST COLUMN

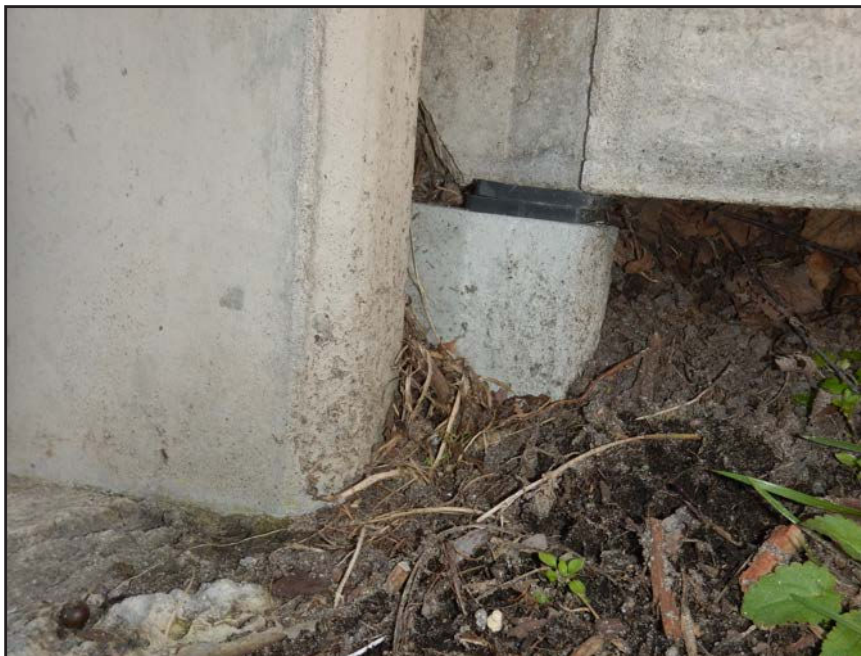
NO. 397 - COLUMN 76SS -
CRACKED AND FAILED
TONGUE OF A PRECAST WALL
PANEL IN A PRECAST COLUMN

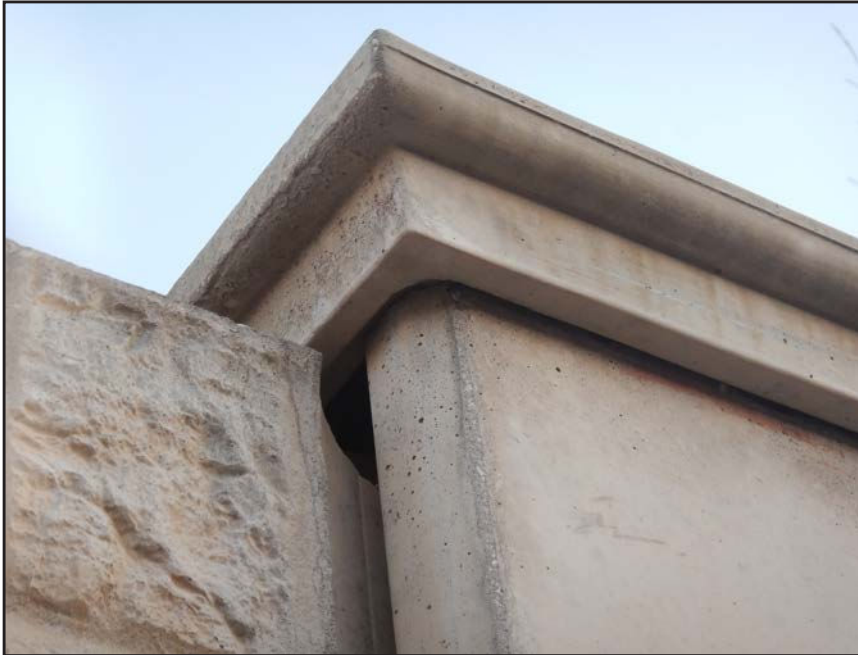
NO. 398 - COLUMN 76SS -
CRACKED AND FAILED
TONGUE OF A PRECAST WALL
PANEL IN A PRECAST COLUMN

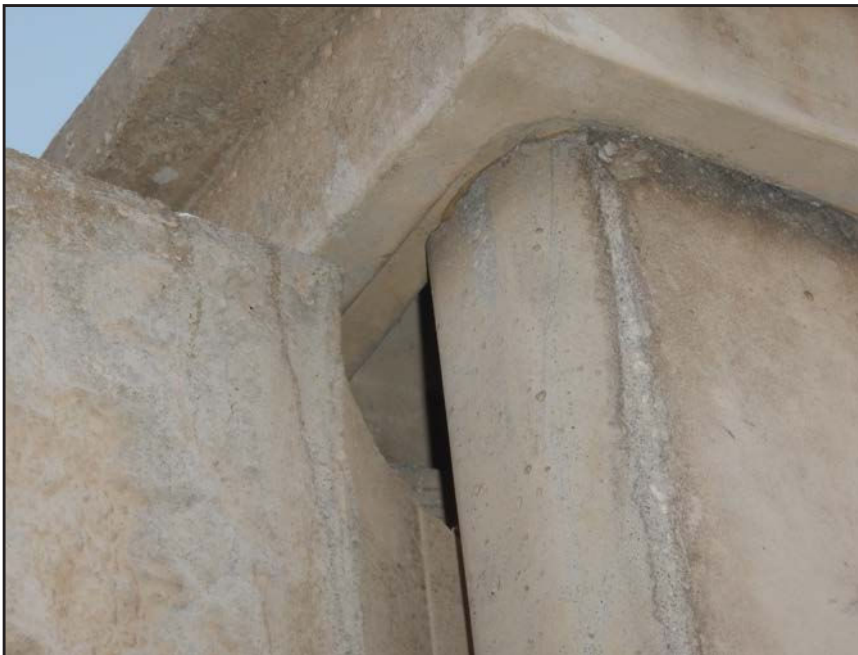
NO. 399 - COLUMN 78SS -
CRACKED AND FAILED
TONGUE OF A PRECAST WALL
PANEL IN A PRECAST COLUMN

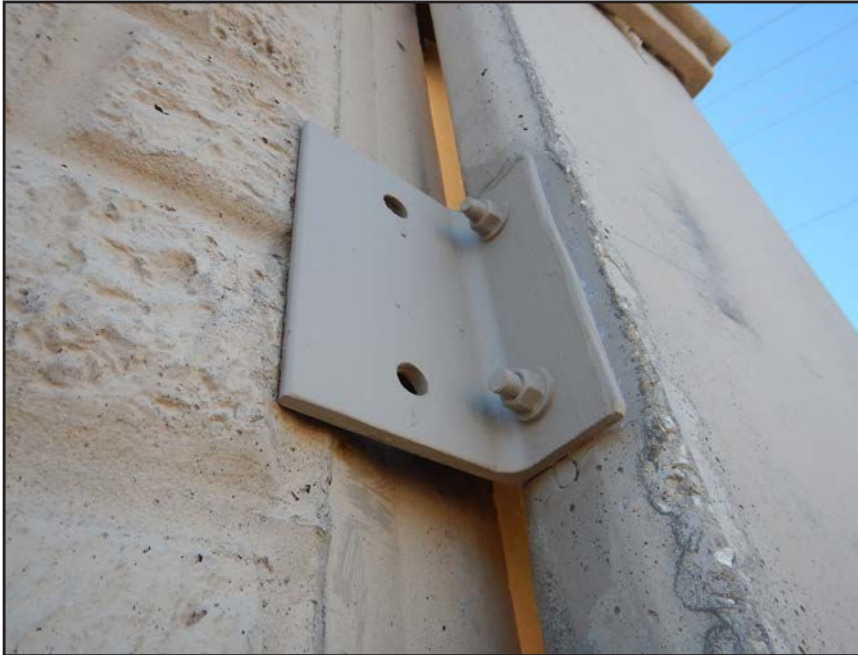
NO. 401 - COLUMN 1NE - INADEQUATE ADDED
CLIP ANGLE CONNECTION AT A DEFICIENT
WALL PANEL TO COLUMN CONNECTION

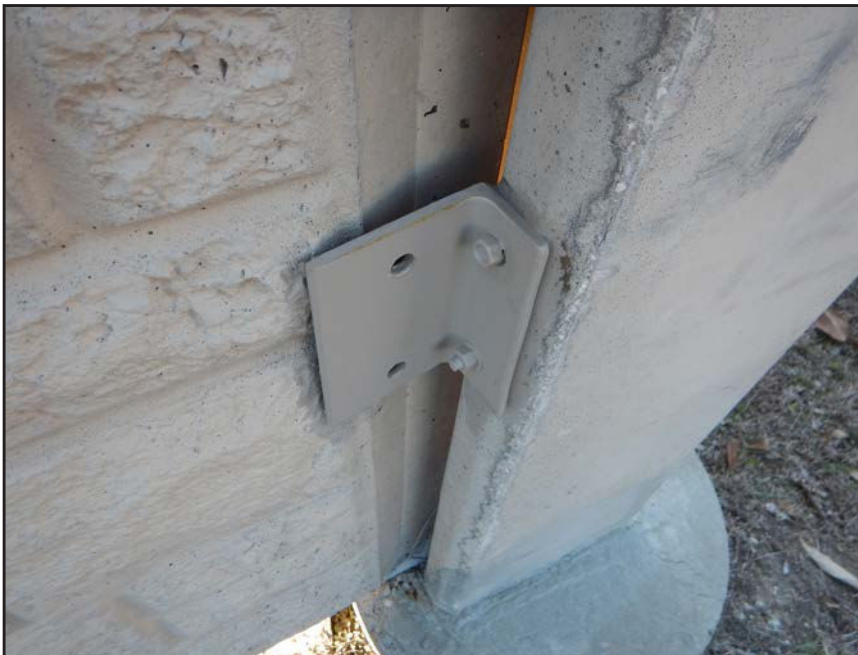
NO. 402 - COLUMN 1NE -
INADEQUATE ADDED CLIP
ANGLE CONNECTION AT A
DEFICIENT WALL PANEL TO
COLUMN CONNECTION

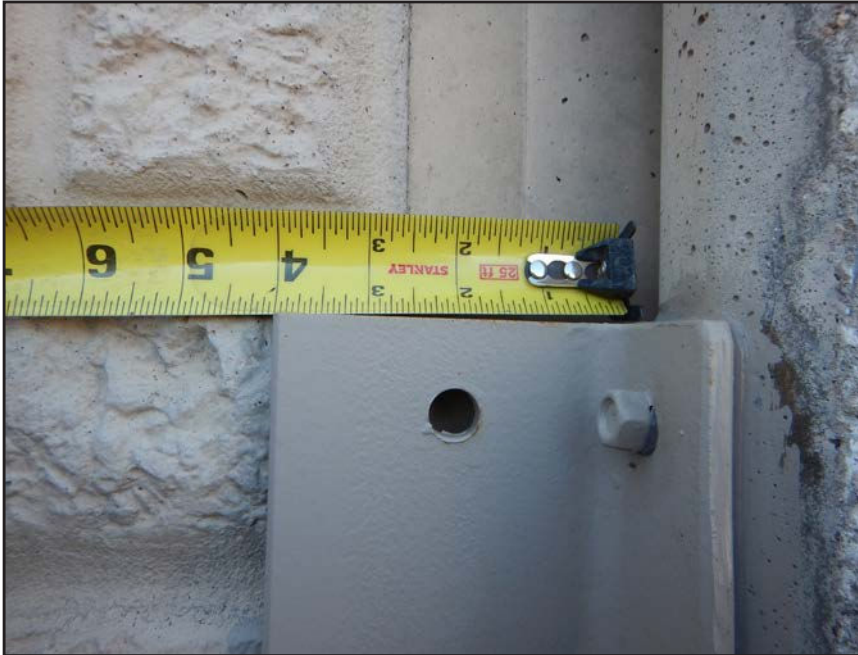
NO. 403 - COLUMN 1NE -
INADEQUATE ADDED CLIP
ANGLE CONNECTION AT A
DEFICIENT WALL PANEL TO
COLUMN CONNECTION

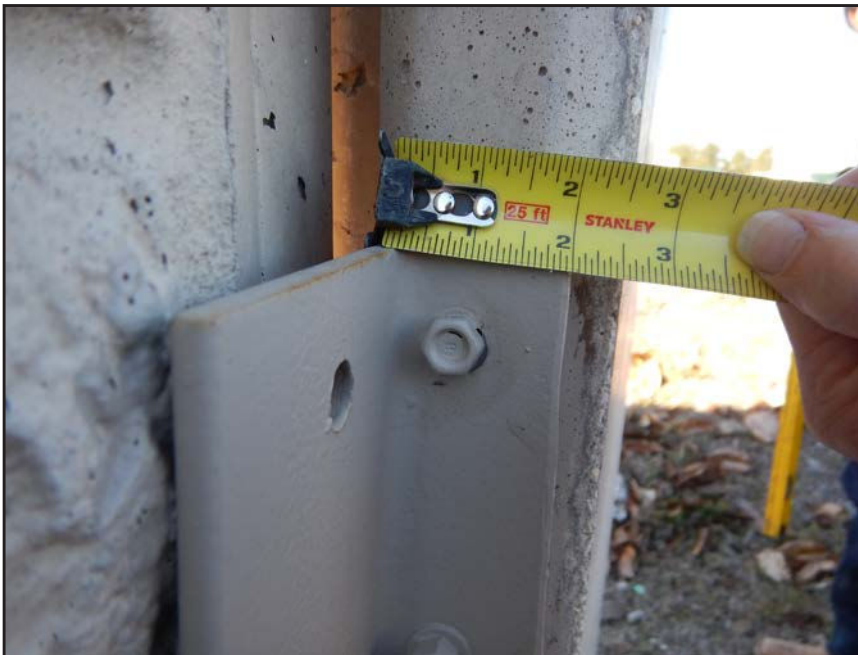
NO. 404 - COLUMN 1NE -
INADEQUATE ADDED CLIP
ANGLE CONNECTION AT A
DEFICIENT WALL PANEL TO
COLUMN CONNECTION

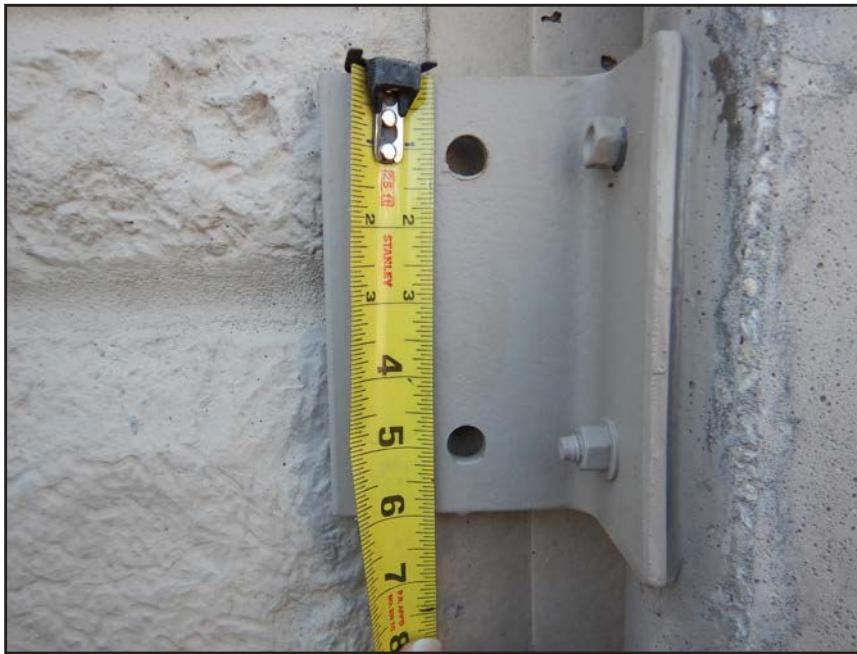
NO. 405 - COLUMN 1NE -
INADEQUATE ADDED CLIP
ANGLE CONNECTION AT A
DEFICIENT WALL PANEL TO
COLUMN CONNECTION

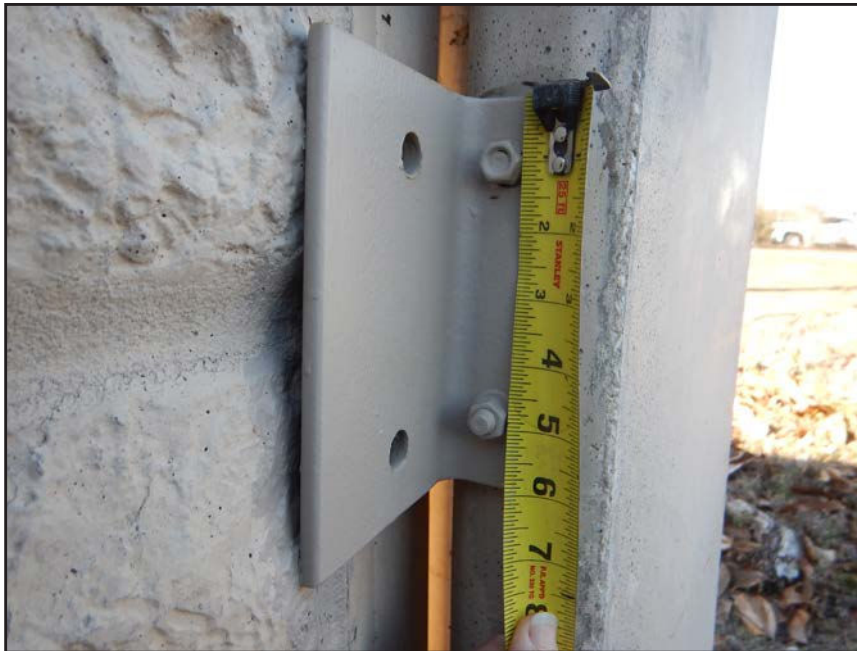
NO. 406 - COLUMN 1NE -
INADEQUATE ADDED CLIP
ANGLE CONNECTION AT A
DEFICIENT WALL PANEL TO
COLUMN CONNECTION

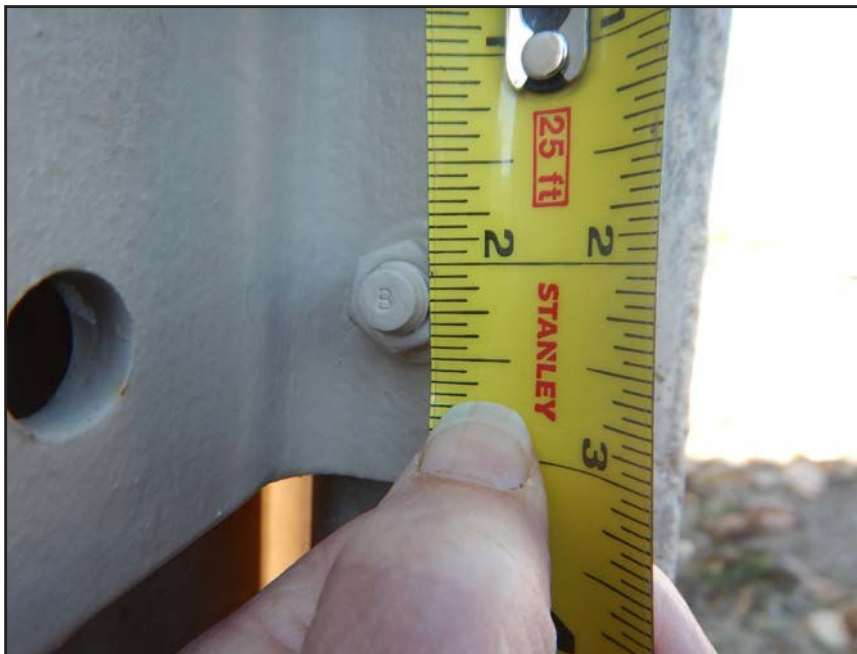
NO. 407 - COLUMN 1NE -
INADEQUATE ADDED CLIP
ANGLE CONNECTION AT A
DEFICIENT WALL PANEL TO
COLUMN CONNECTION

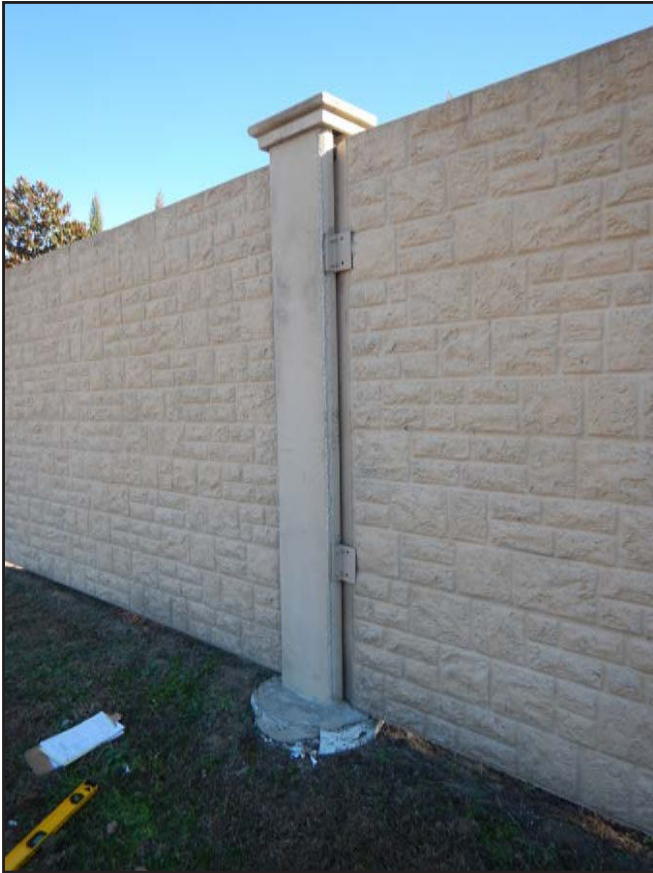
NO. 408 - COLUMN 1NE -
INADEQUATE ADDED CLIP
ANGLE CONNECTION AT A
DEFICIENT WALL PANEL TO
COLUMN CONNECTION

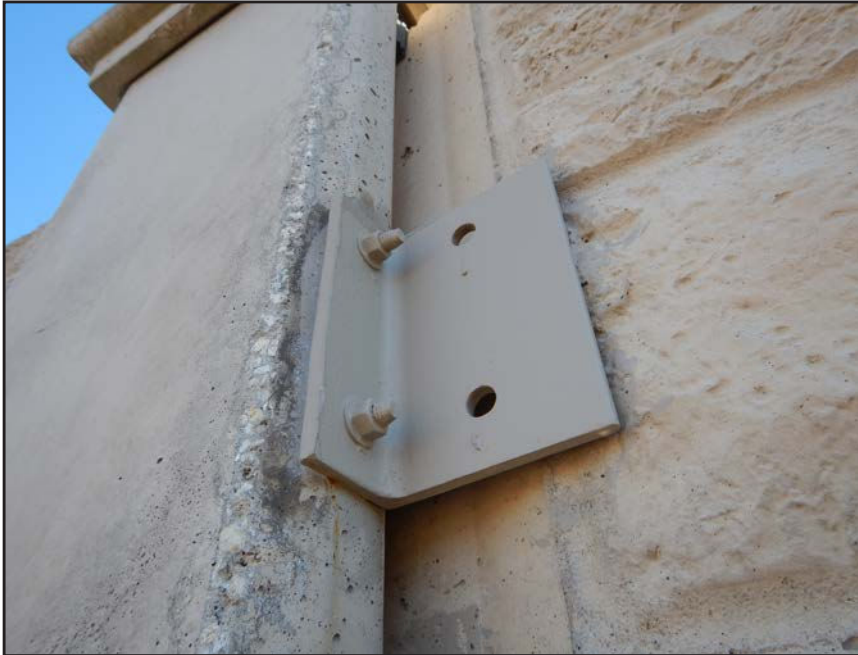
NO. 409 - COLUMN 6N - INADEQUATE ADDED
CLIP ANGLE CONNECTION AT A DEFICIENT
WALL PANEL TO COLUMN CONNECTION

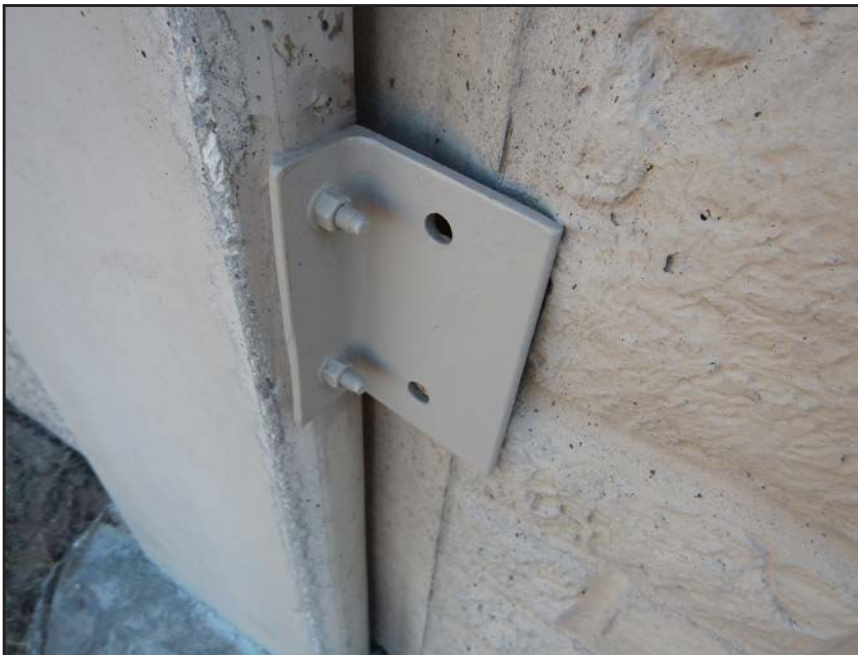
NO. 410 - COLUMN 6N -
INADEQUATE ADDED CLIP
ANGLE CONNECTION AT A
DEFICIENT WALL PANEL TO
COLUMN CONNECTION

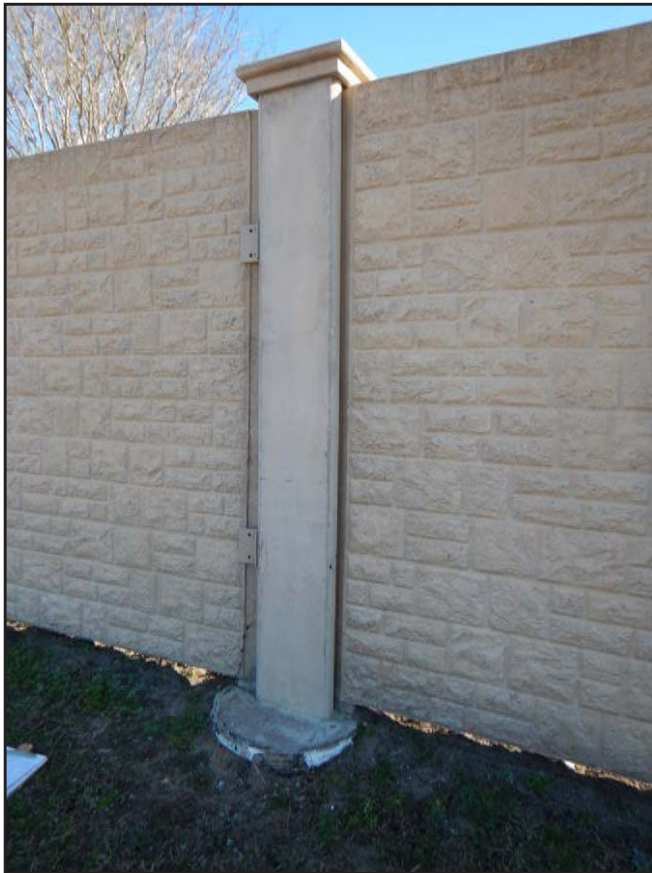
NO. 411 - COLUMN 6N -
INADEQUATE ADDED CLIP
ANGLE CONNECTION AT A
DEFICIENT WALL PANEL TO
COLUMN CONNECTION

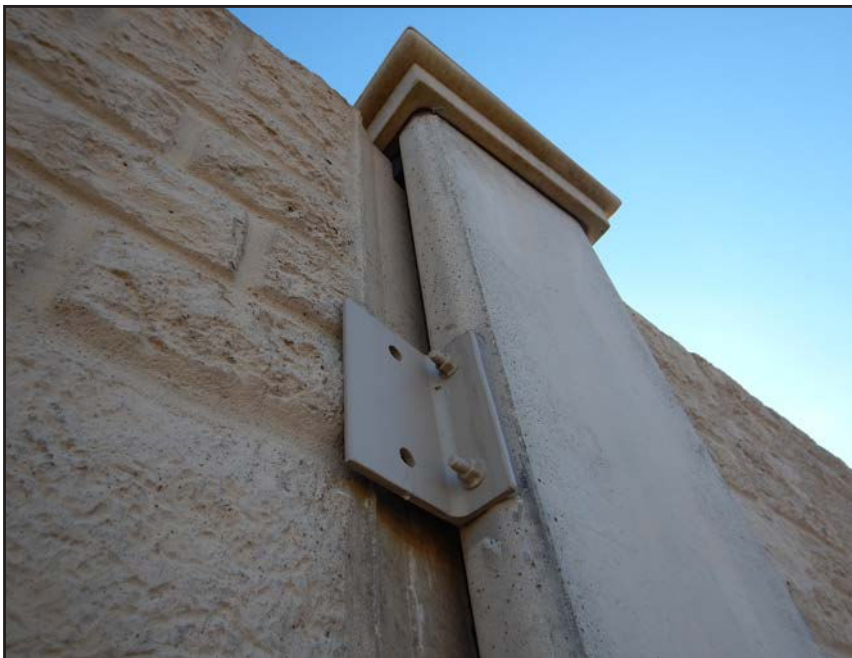
NO. 412 - COLUMN 9N - INADEQUATE ADDED CLIP ANGLE CONNECTION AT A DEFICIENT WALL PANEL TO COLUMN CONNECTION

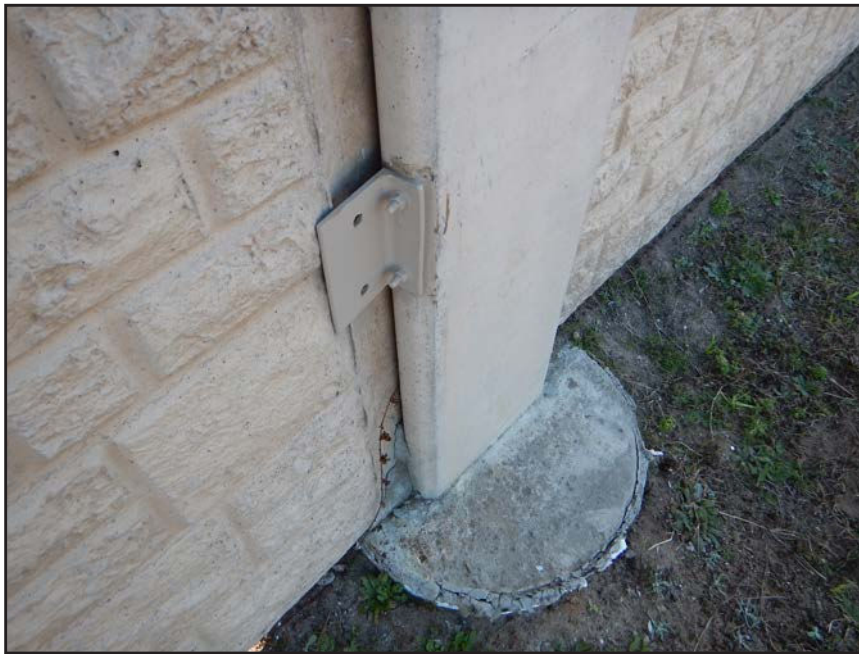
NO. 413 - COLUMN 9N - INADEQUATE ADDED CLIP ANGLE CONNECTION AT A DEFICIENT WALL PANEL TO COLUMN CONNECTION

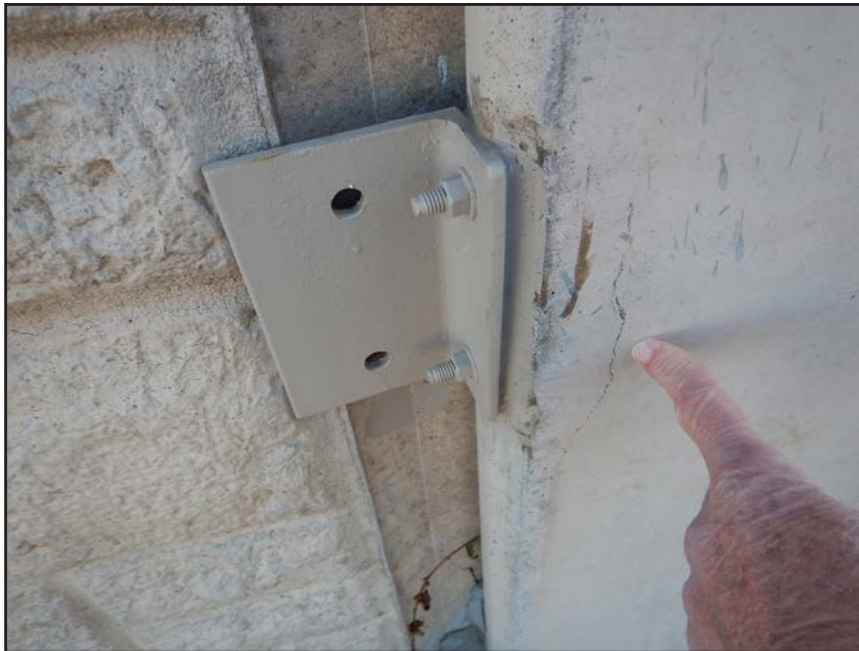
NO. 414 - COLUMN 9N -
INADEQUATE ADDED CLIP
ANGLE CONNECTION AT A
DEFICIENT WALL PANEL TO
COLUMN CONNECTION

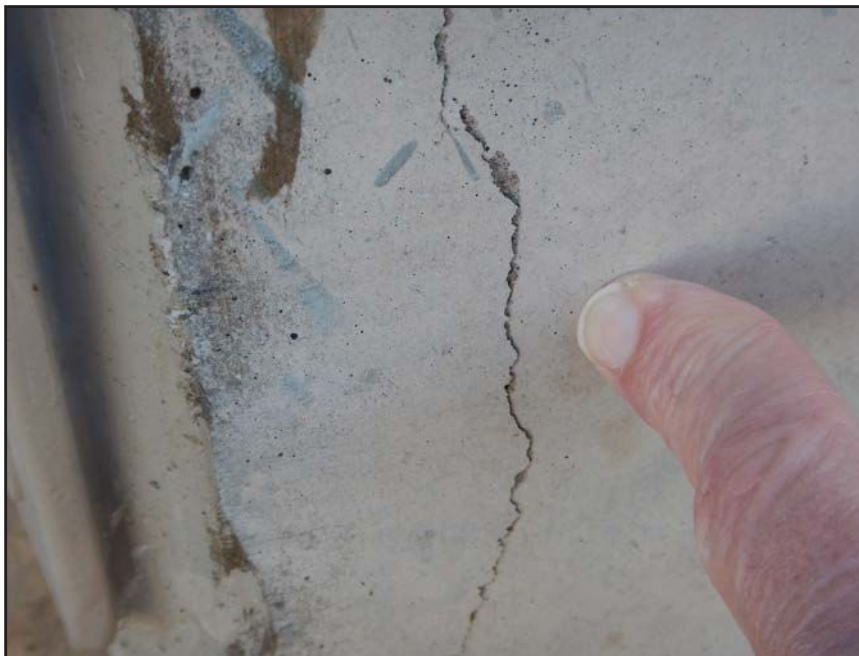
NO. 415 - COLUMN 9N -
INADEQUATE ADDED CLIP
ANGLE CONNECTION AT A
DEFICIENT WALL PANEL TO
COLUMN CONNECTION

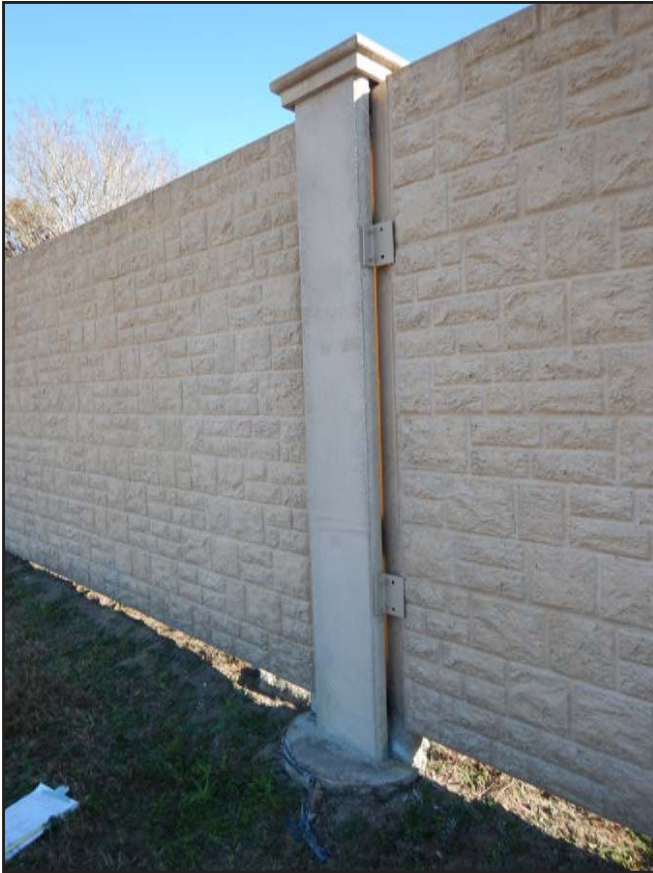
NO. 416 - COLUMN 9N -
INADEQUATE ADDED CLIP
ANGLE CONNECTION AT A
DEFICIENT WALL PANEL TO
COLUMN CONNECTION

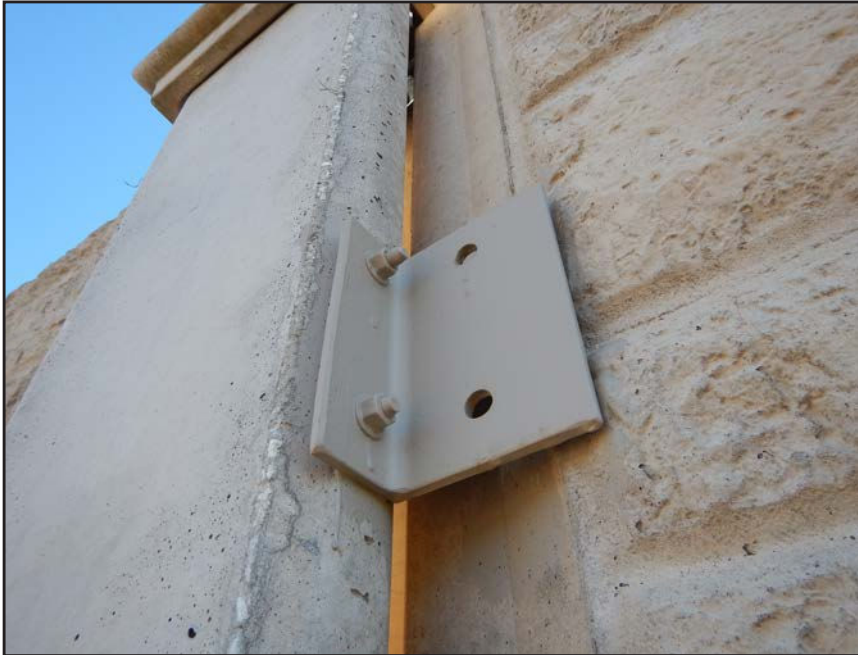
NO. 417 - COLUMN 10N - INADEQUATE ADDED
CLIP ANGLE CONNECTION AT A DEFICIENT
WALL PANEL TO COLUMN CONNECTION
