WATER TOWER ROAD SCREEN WALL INVESTIGATIONS

Water Tower Road
Longs, South Carolina

Stantec Project No. 171015900

March 31, 2025

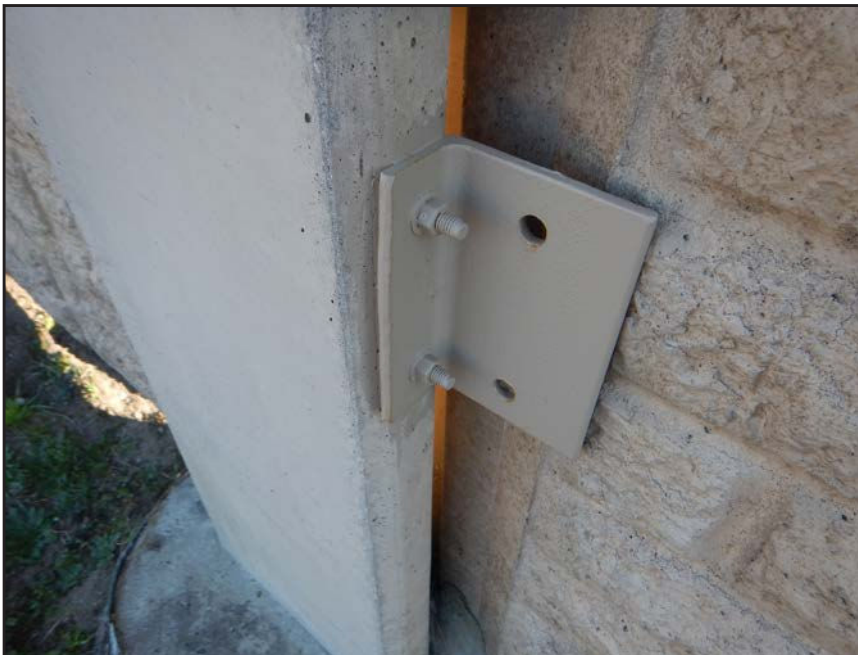
NO. 418 - COLUMN 10N -
INADEQUATE ADDED CLIP
ANGLE CONNECTION AT A
DEFICIENT WALL PANEL TO
COLUMN CONNECTION

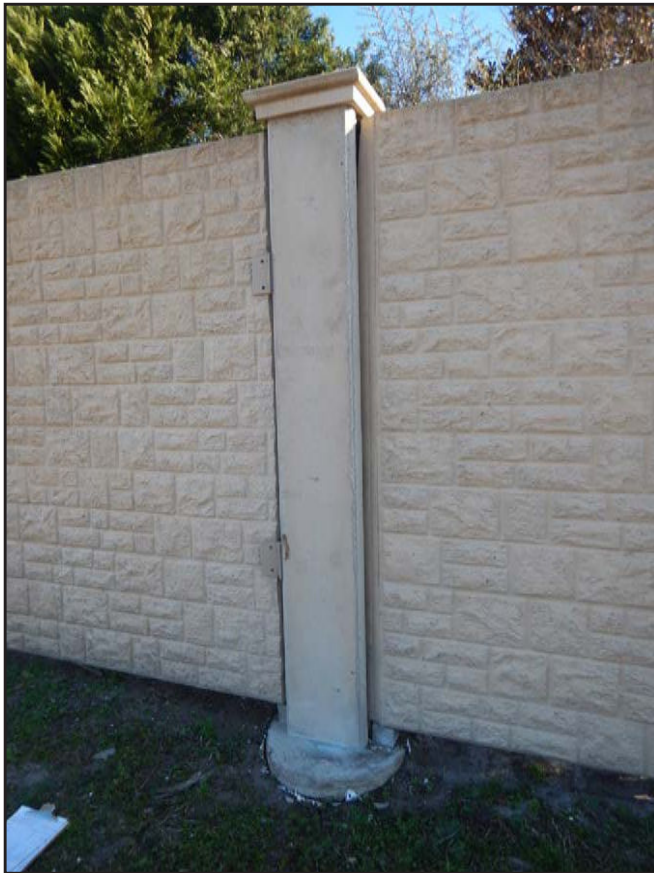
NO. 419 - COLUMN 10N -
INADEQUATE ADDED CLIP
ANGLE CONNECTION AT A
DEFICIENT WALL PANEL TO
COLUMN CONNECTION

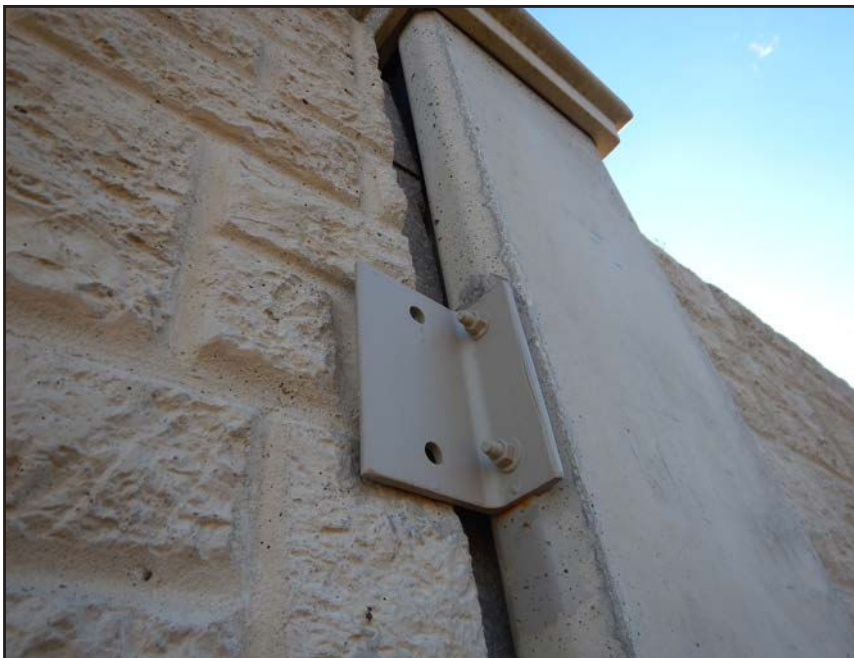
NO. 420 - COLUMN 14N - INADEQUATE ADDED CLIP ANGLE CONNECTION AT A DEFICIENT WALL PANEL TO COLUMN CONNECTION

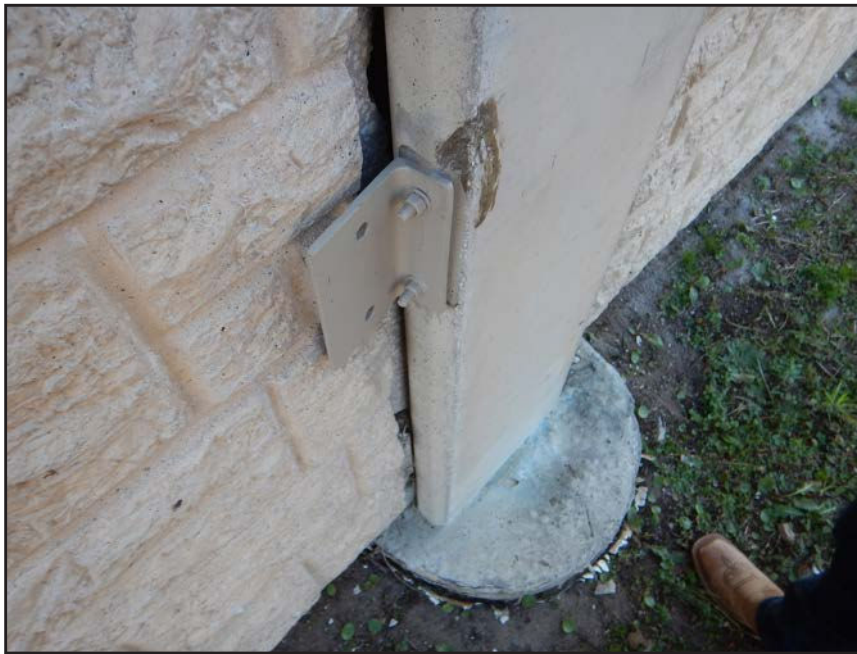
NO. 421 - COLUMN 14N - INADEQUATE ADDED CLIP ANGLE CONNECTION AT A DEFICIENT WALL PANEL TO COLUMN CONNECTION

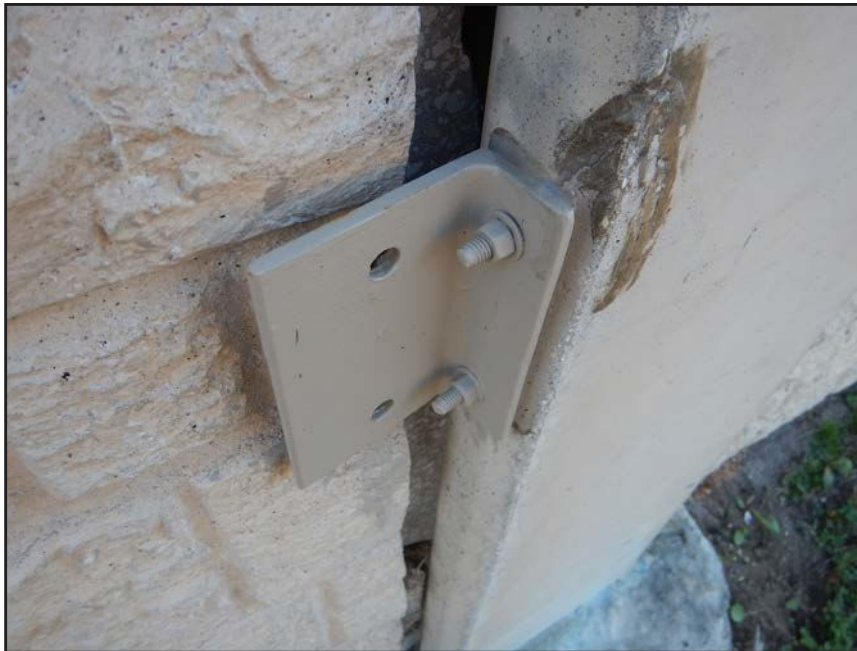
NO. 422 - COLUMN 14N -
INADEQUATE ADDED CLIP
ANGLE CONNECTION AT A
DEFICIENT WALL PANEL TO
COLUMN CONNECTION

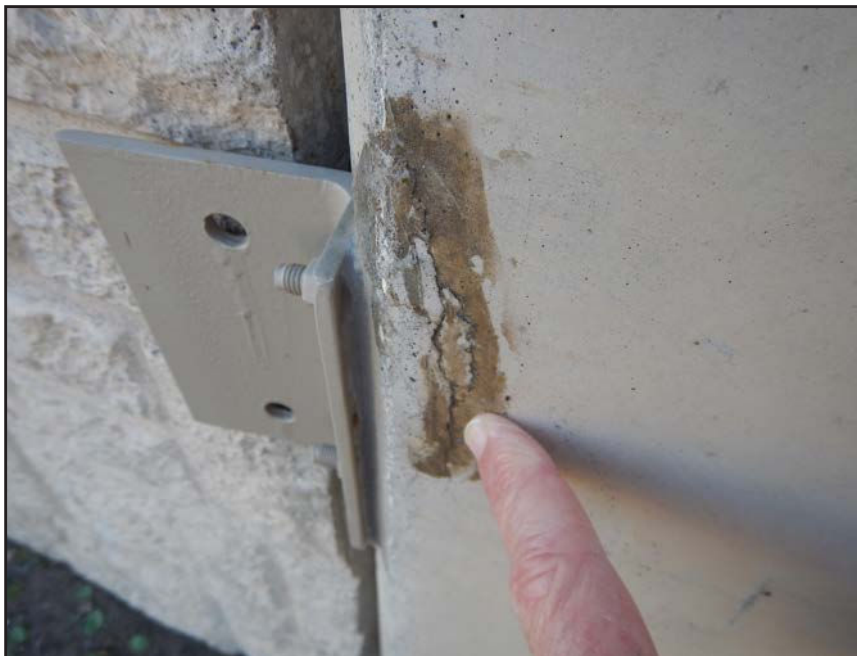
NO. 423 - COLUMN 14N -
INADEQUATE ADDED CLIP
ANGLE CONNECTION AT A
DEFICIENT WALL PANEL TO
COLUMN CONNECTION

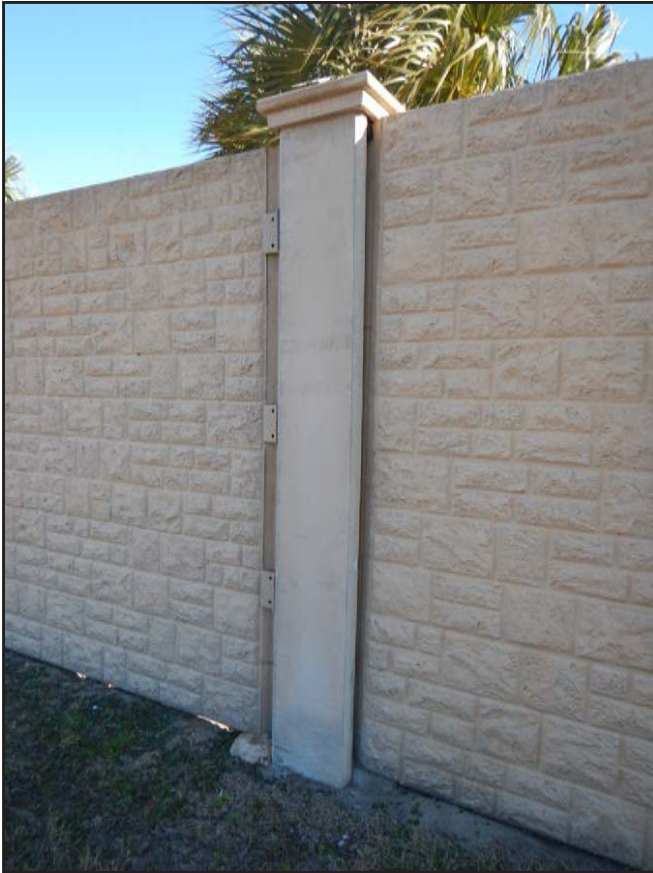
NO. 424 - COLUMN 14N -
INADEQUATE ADDED CLIP
ANGLE CONNECTION AT A
DEFICIENT WALL PANEL TO
COLUMN CONNECTION

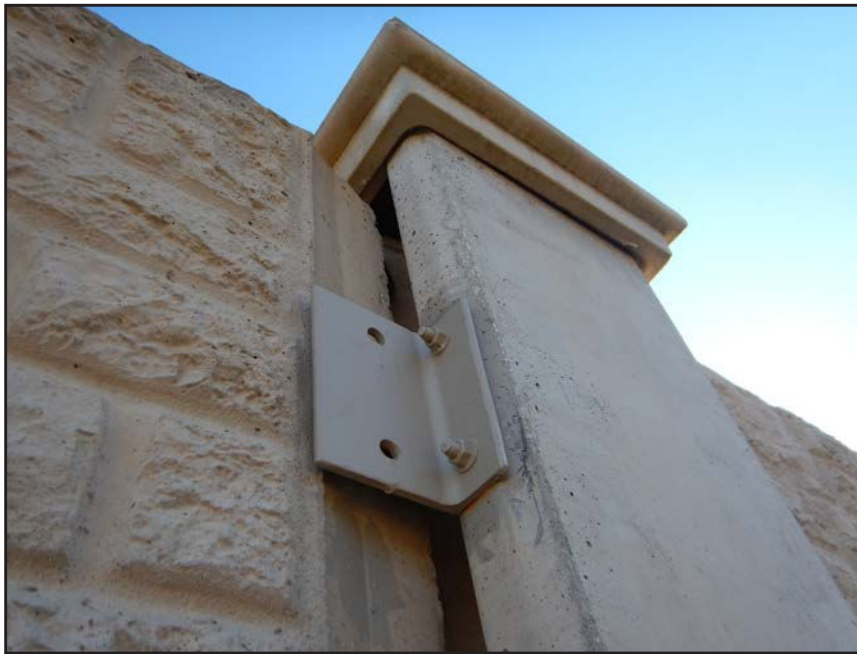
NO. 425 - COLUMN 19N - INADEQUATE ADDED
CLIP ANGLE CONNECTION AT A DEFICIENT
WALL PANEL TO COLUMN CONNECTION

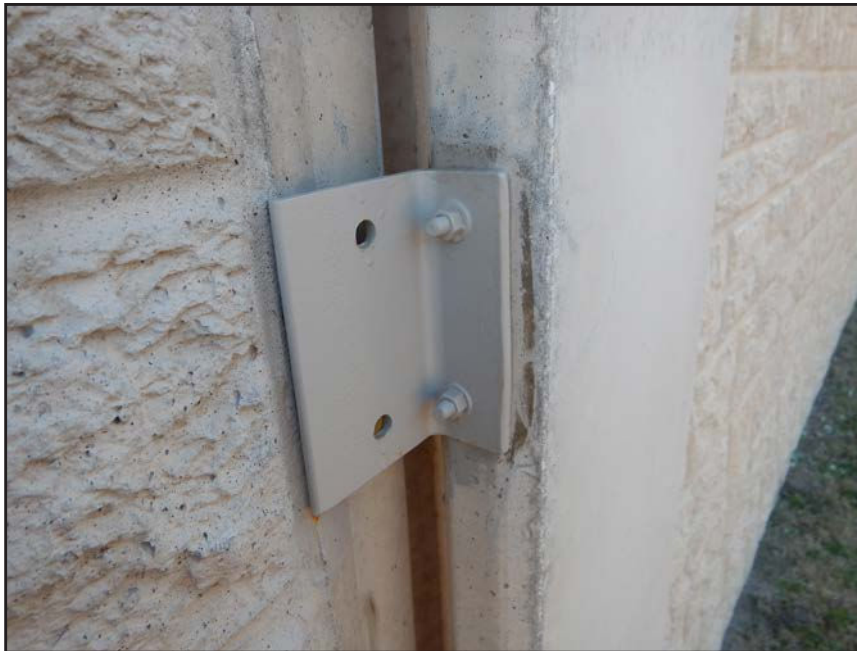
NO. 426 - COLUMN 19N -
INADEQUATE ADDED CLIP
ANGLE CONNECTION AT A
DEFICIENT WALL PANEL TO
COLUMN CONNECTION

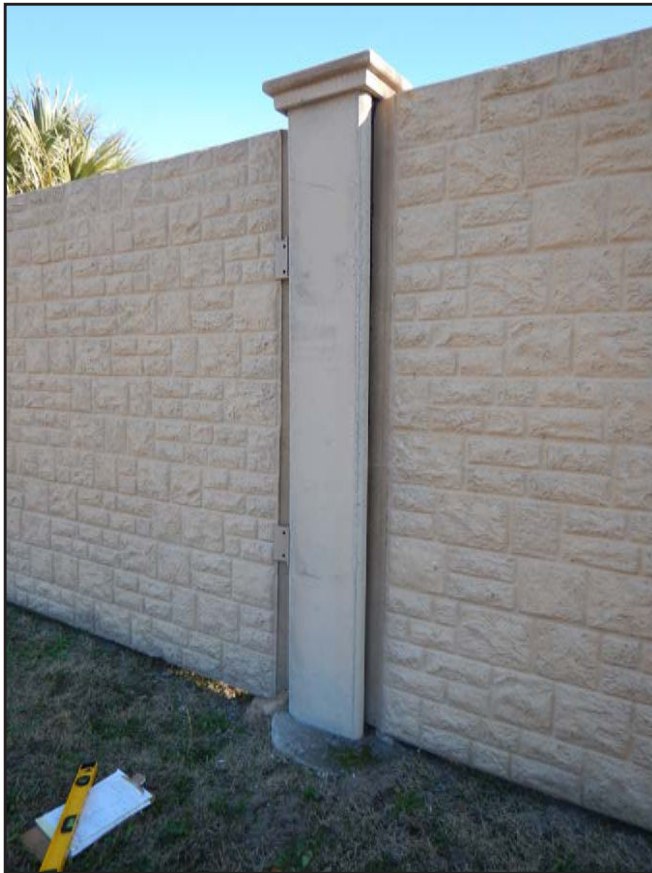
NO. 428 - COLUMN 19N -
INADEQUATE ADDED CLIP
ANGLE CONNECTION AT A
DEFICIENT WALL PANEL TO
COLUMN CONNECTION

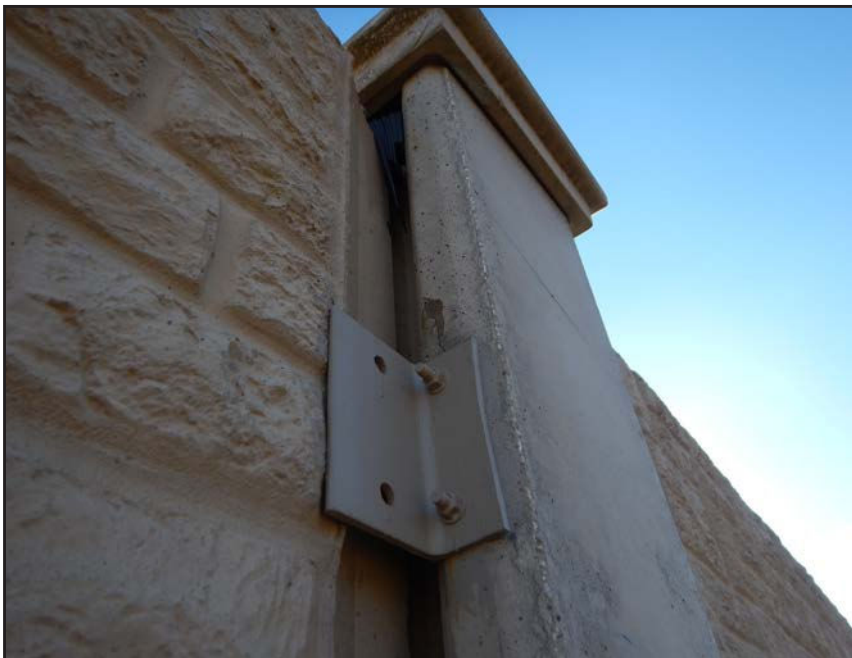
NO. 429 - COLUMN 20N - INADEQUATE ADDED CLIP ANGLE CONNECTION AT A DEFICIENT WALL PANEL TO COLUMN CONNECTION

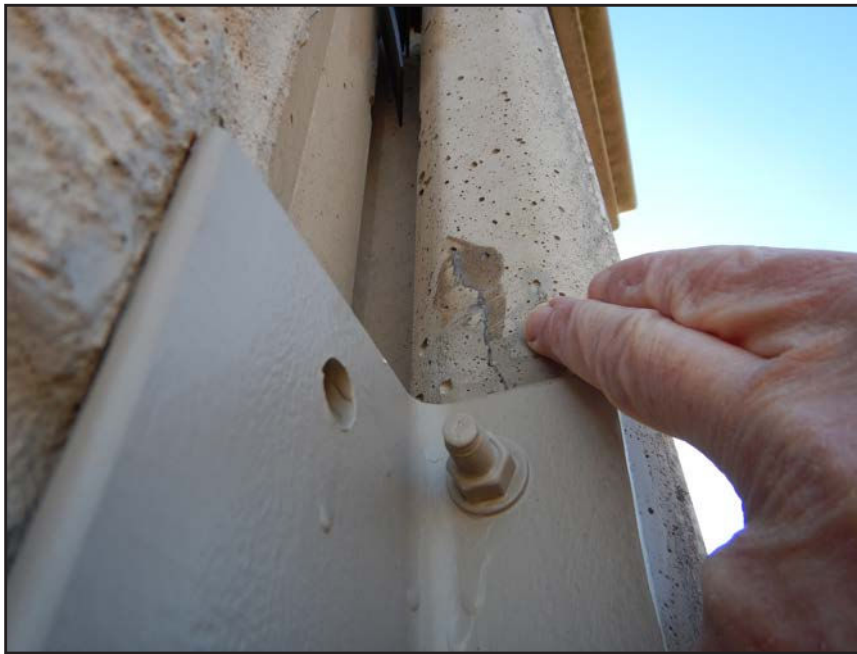
NO. 430 - COLUMN 20N - INADEQUATE ADDED CLIP ANGLE CONNECTION AT A DEFICIENT WALL PANEL TO COLUMN CONNECTION

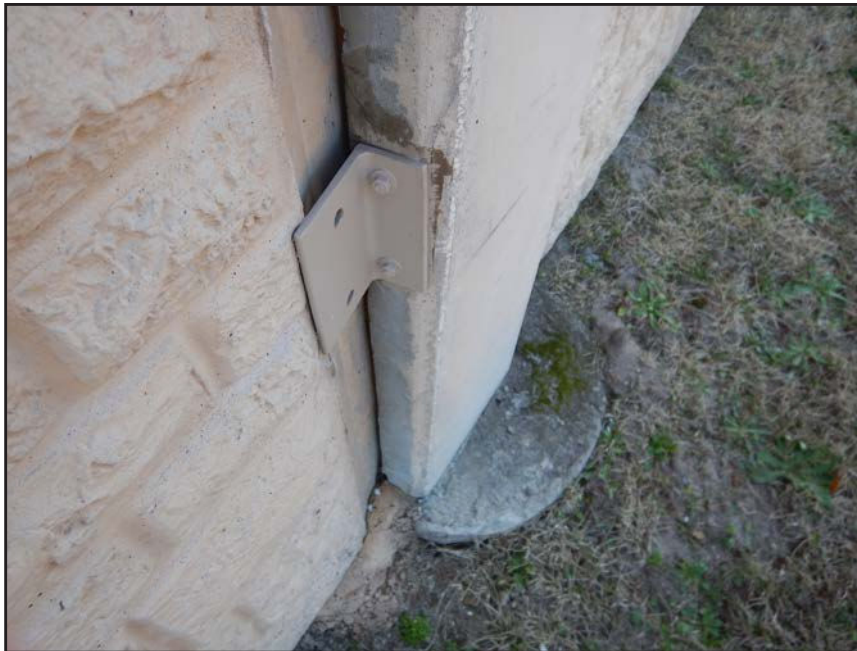
NO. 431 - COLUMN 20N -
INADEQUATE ADDED CLIP
ANGLE CONNECTION AT A
DEFICIENT WALL PANEL TO
COLUMN CONNECTION

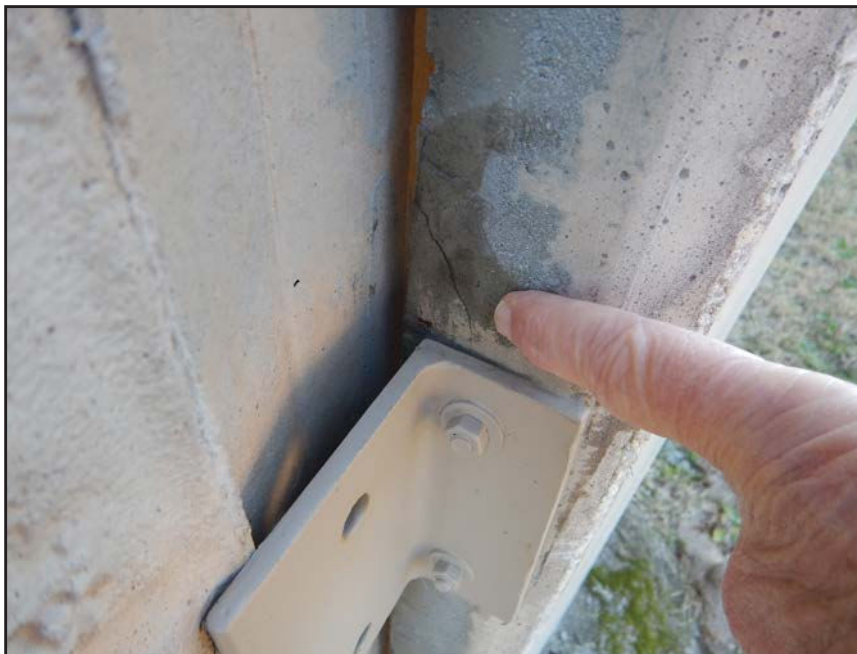
NO. 432 - COLUMN 20N -
INADEQUATE ADDED CLIP
ANGLE CONNECTION AT A
DEFICIENT WALL PANEL TO
COLUMN CONNECTION

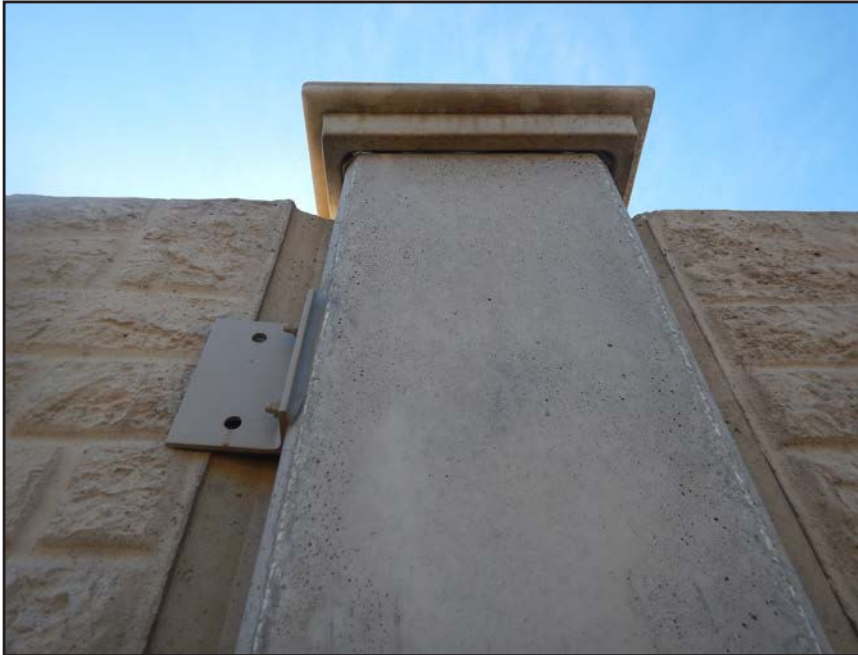
NO. 433 - COLUMN 20N -
INADEQUATE ADDED CLIP
ANGLE CONNECTION AT A
DEFICIENT WALL PANEL TO
COLUMN CONNECTION

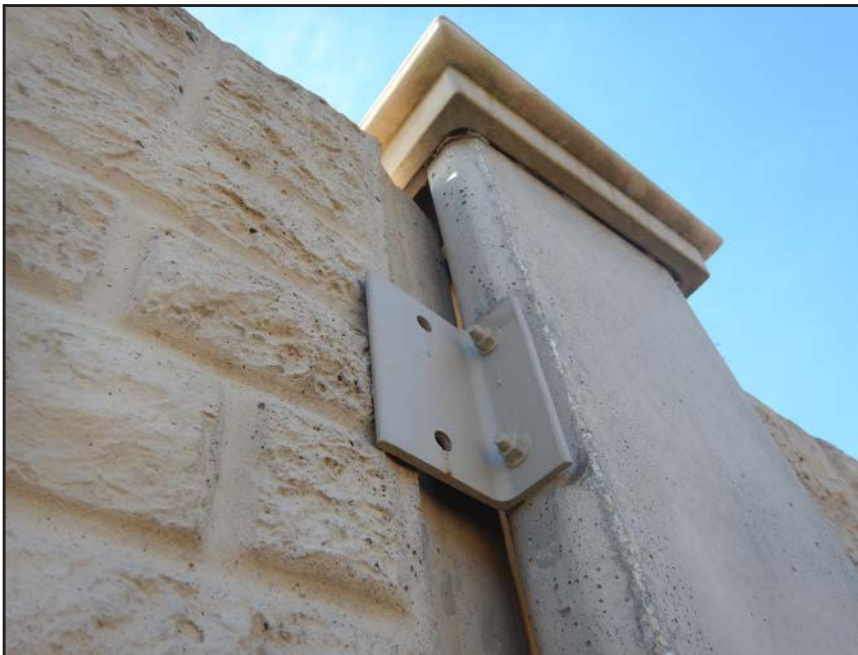
NO. 434 - COLUMN 49N -
INADEQUATE ADDED CLIP
ANGLE CONNECTION AT A
DEFICIENT WALL PANEL TO
COLUMN CONNECTION

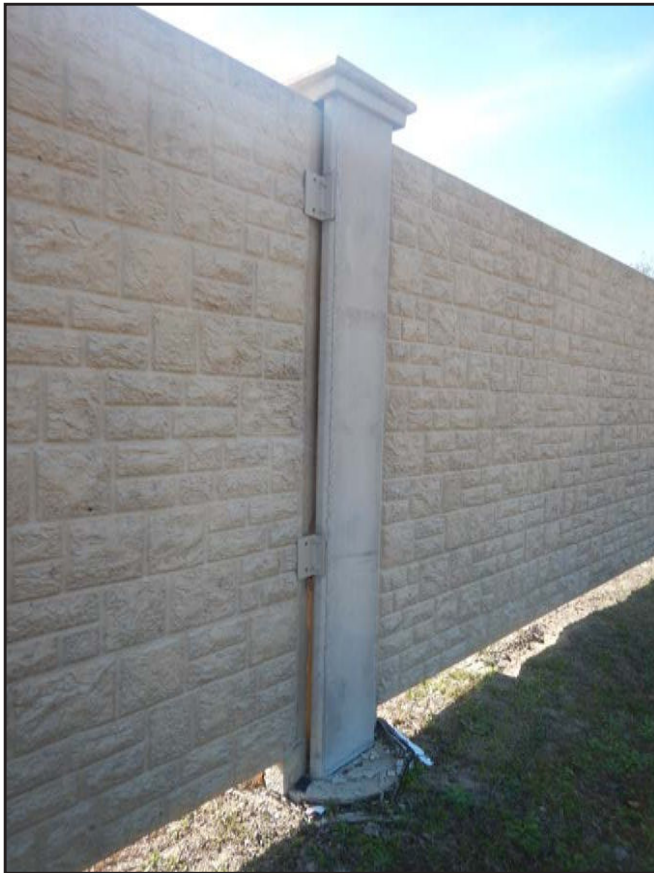
NO. 435 - COLUMN 49N -
INADEQUATE ADDED CLIP
ANGLE CONNECTION AT A
DEFICIENT WALL PANEL TO
COLUMN CONNECTION

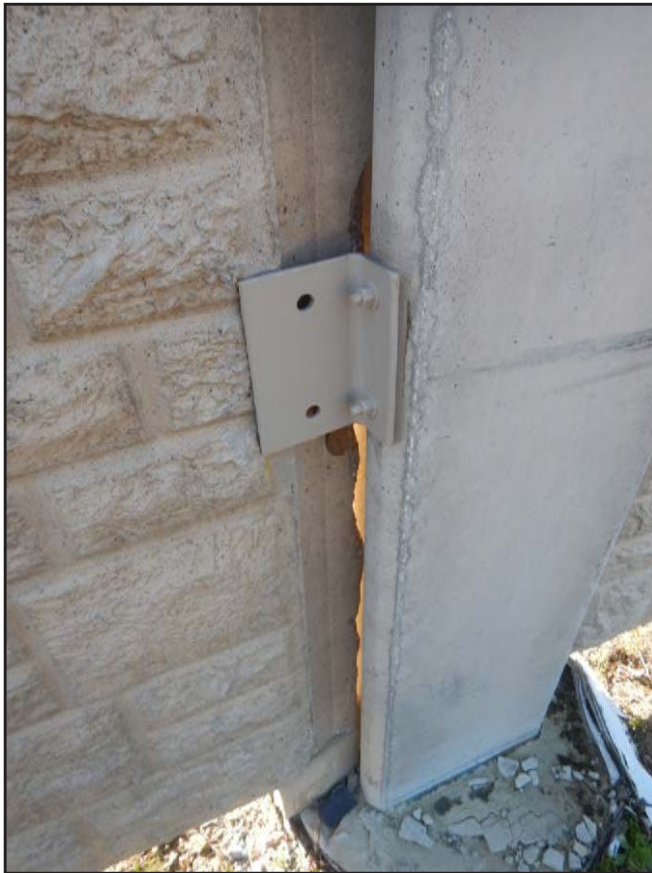
NO. 437 - COLUMN 50N - INADEQUATE ADDED CLIP ANGLE CONNECTION AT A DEFICIENT WALL PANEL TO COLUMN CONNECTION

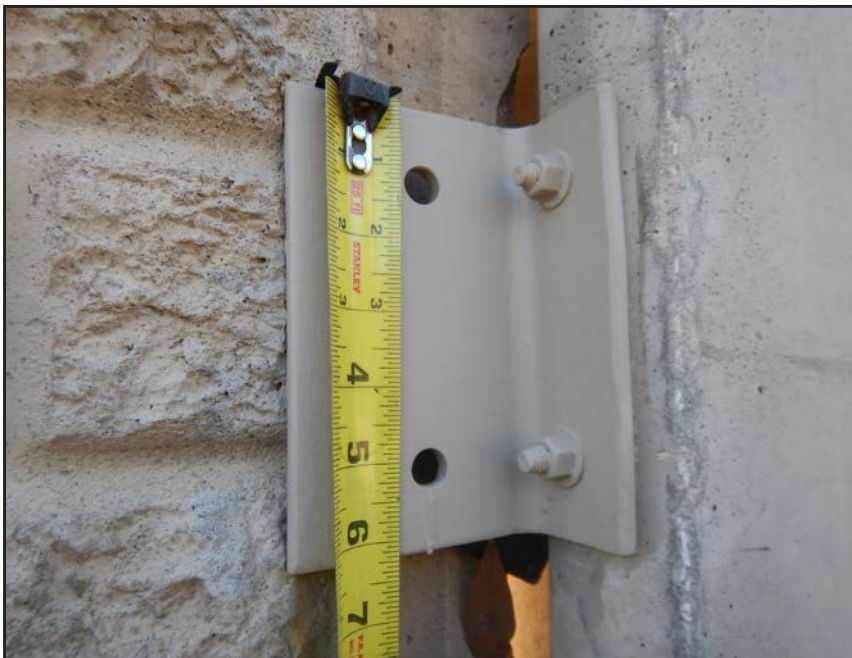
NO. 438 - COLUMN 50N - INADEQUATE ADDED CLIP ANGLE CONNECTION AT A DEFICIENT WALL PANEL TO COLUMN CONNECTION

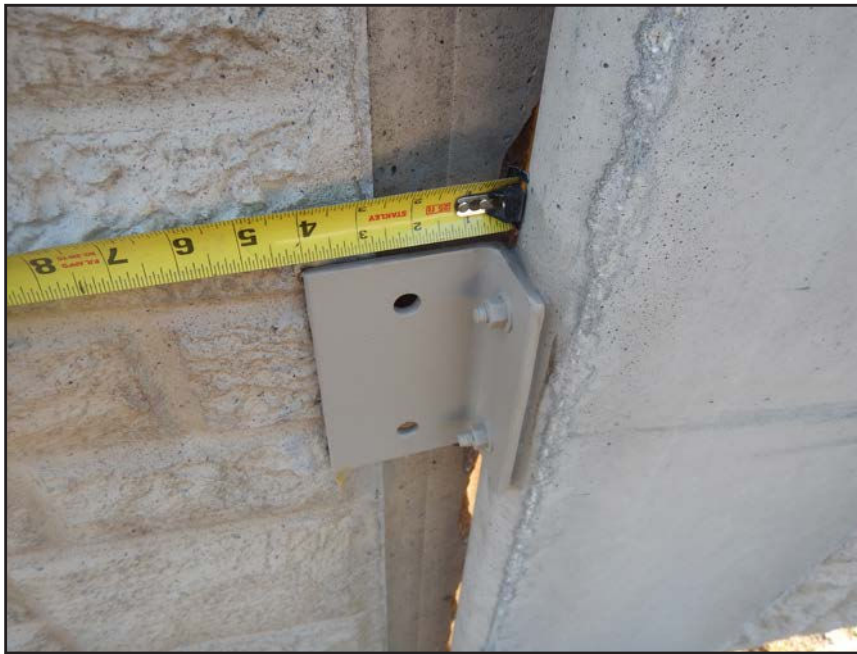
NO. 439 - COLUMN 50N - INADEQUATE ADDED CLIP ANGLE CONNECTION AT A DEFICIENT WALL PANEL TO COLUMN CONNECTION

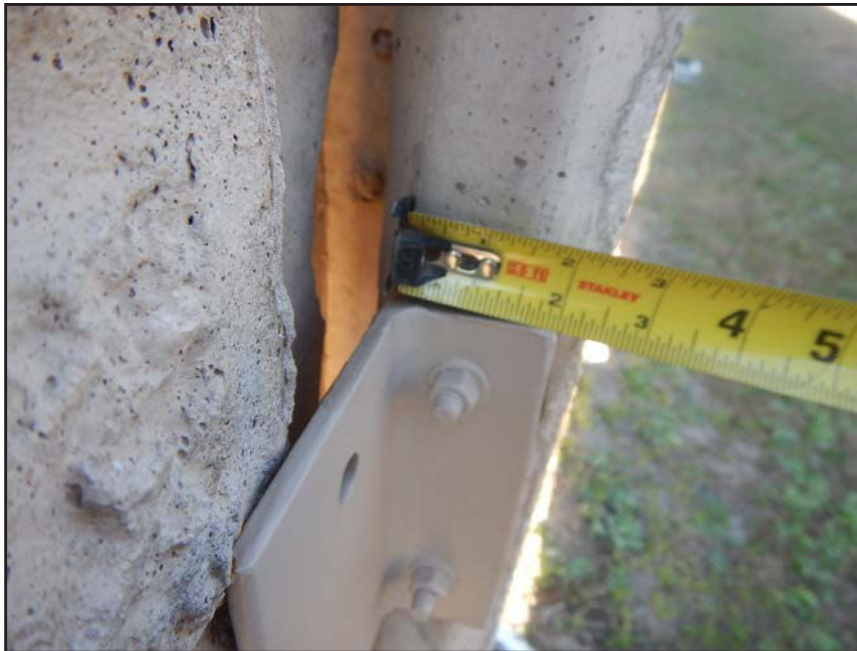
NO. 440 - COLUMN 50N -
INADEQUATE ADDED CLIP
ANGLE CONNECTION AT A
DEFICIENT WALL PANEL TO
COLUMN CONNECTION

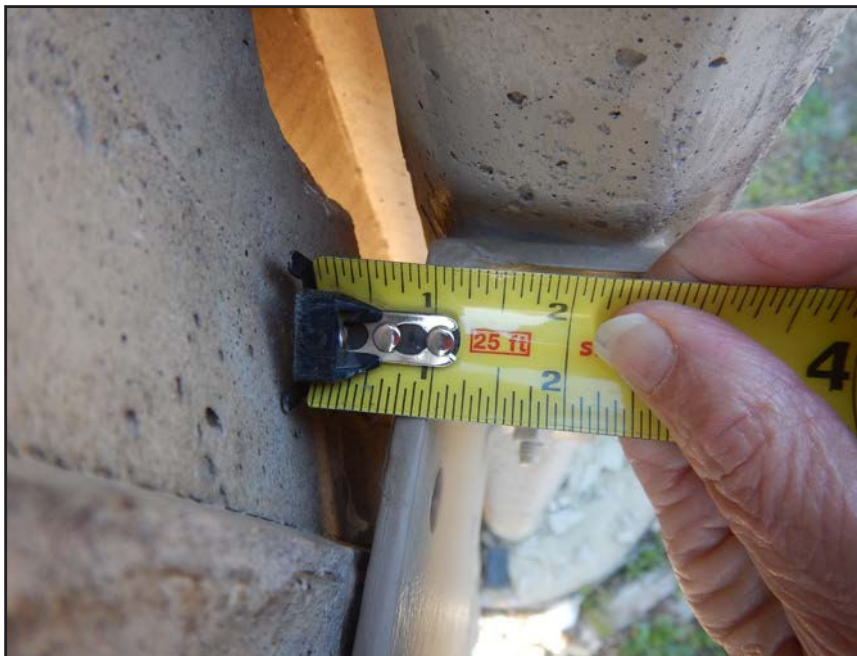
NO. 441 - COLUMN 50N -
INADEQUATE ADDED CLIP
ANGLE CONNECTION AT A
DEFICIENT WALL PANEL TO
COLUMN CONNECTION

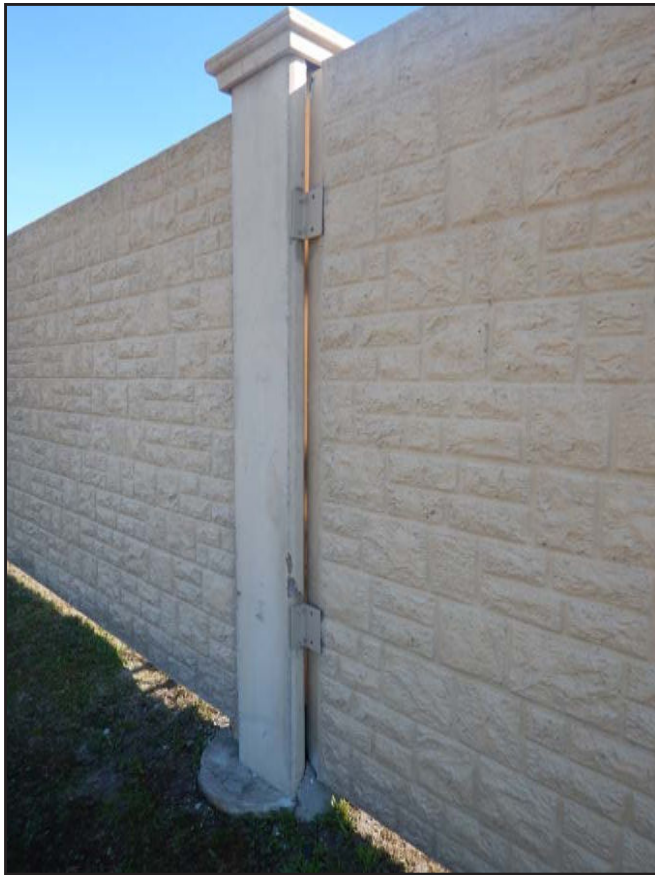
NO. 442 - COLUMN 50N -
INADEQUATE ADDED CLIP
ANGLE CONNECTION AT A
DEFICIENT WALL PANEL TO
COLUMN CONNECTION

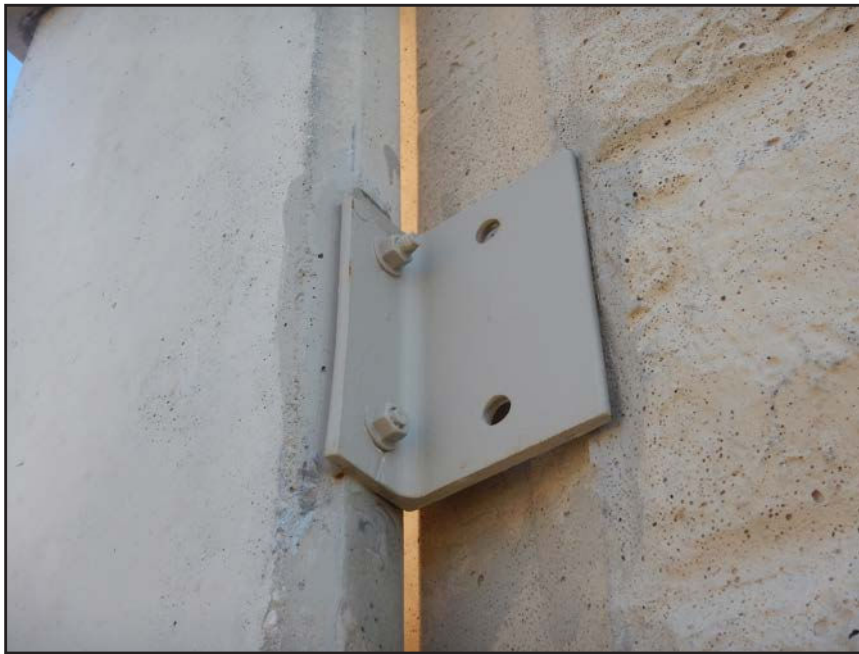
NO. 443 - COLUMN 55S - INADEQUATE ADDED
CLIP ANGLE CONNECTION AT A DEFICIENT
WALL PANEL TO COLUMN CONNECTION

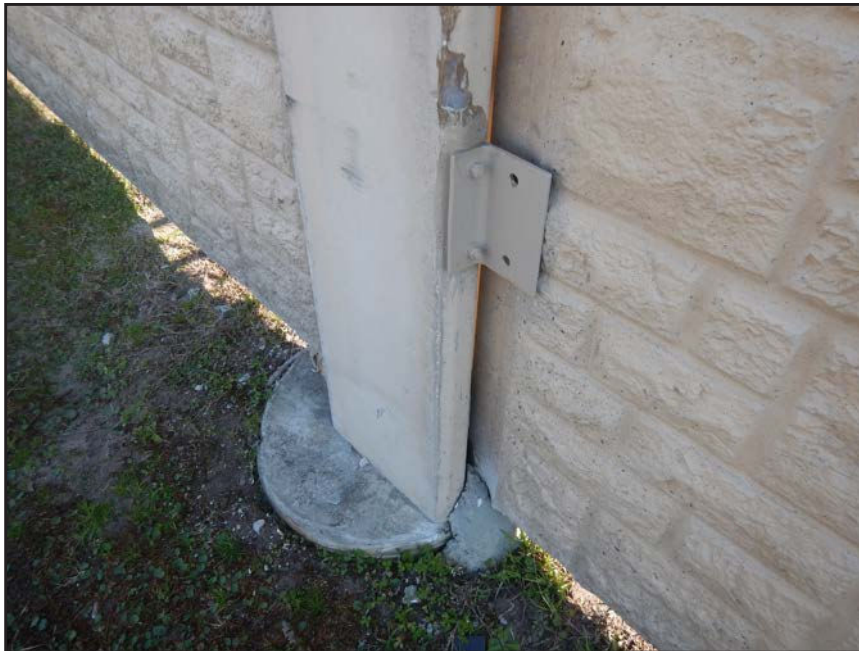
NO. 444 - COLUMN 55S -
INADEQUATE ADDED CLIP
ANGLE CONNECTION AT A
DEFICIENT WALL PANEL TO
COLUMN CONNECTION

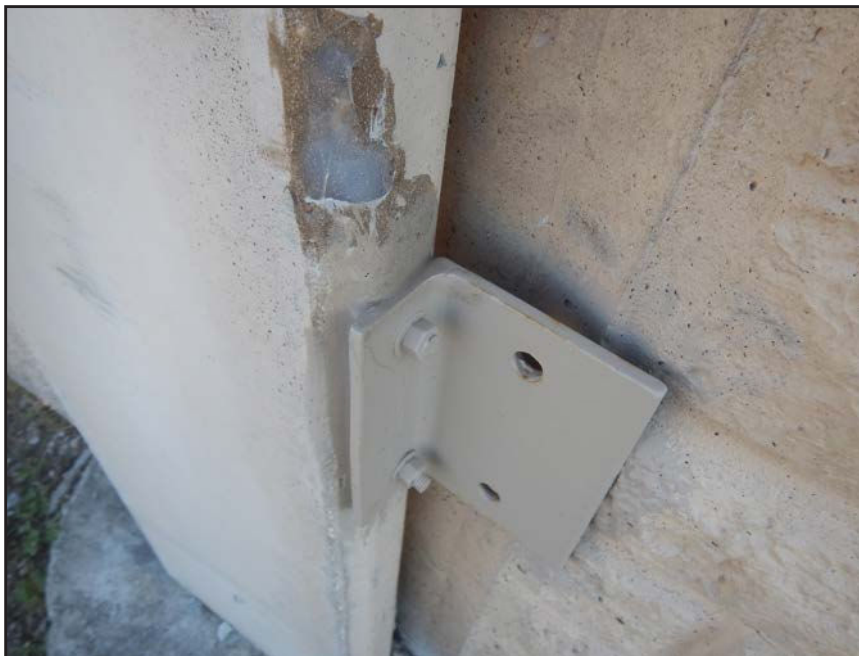
NO. 445 - COLUMN 55S -
INADEQUATE ADDED CLIP
ANGLE CONNECTION AT A
DEFICIENT WALL PANEL TO
COLUMN CONNECTION

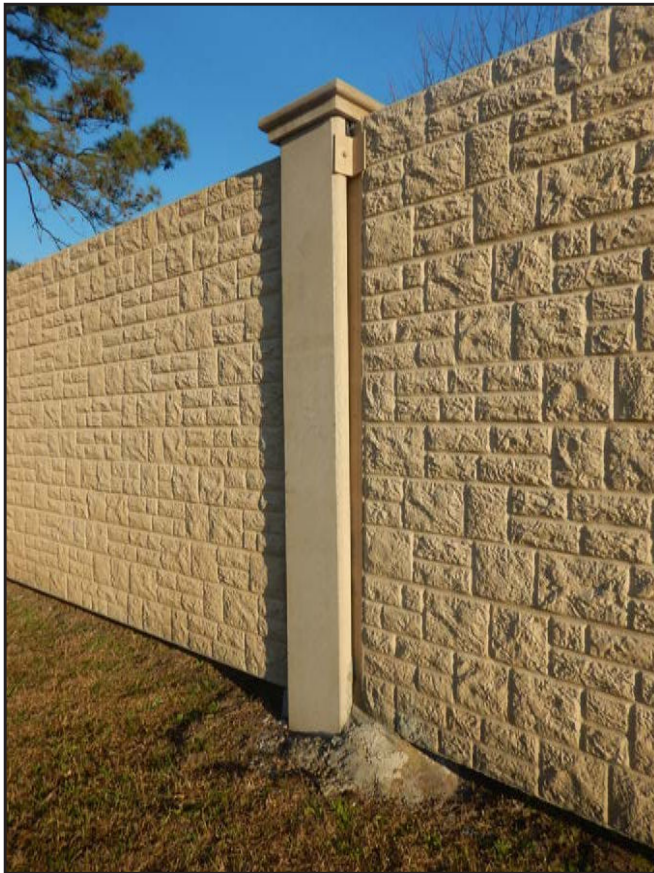
NO. 446 - COLUMN 55S -
INADEQUATE ADDED CLIP
ANGLE CONNECTION AT A
DEFICIENT WALL PANEL TO
COLUMN CONNECTION

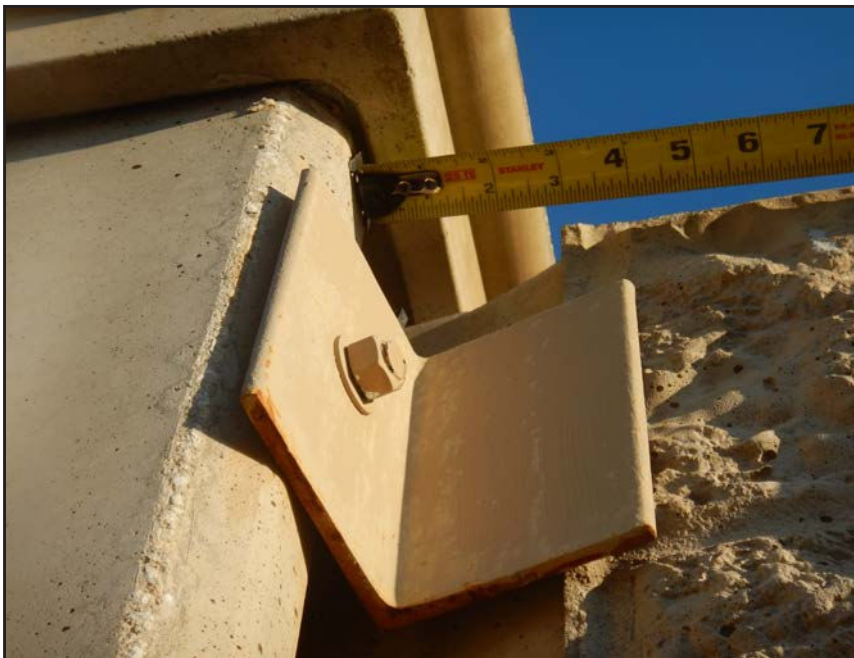
NO. 447 - COLUMN 40SS - INADEQUATE
ADDED CLIP ANGLE CONNECTION AT
A DEFICIENT WALL PANEL TO COLUMN
CONNECTION

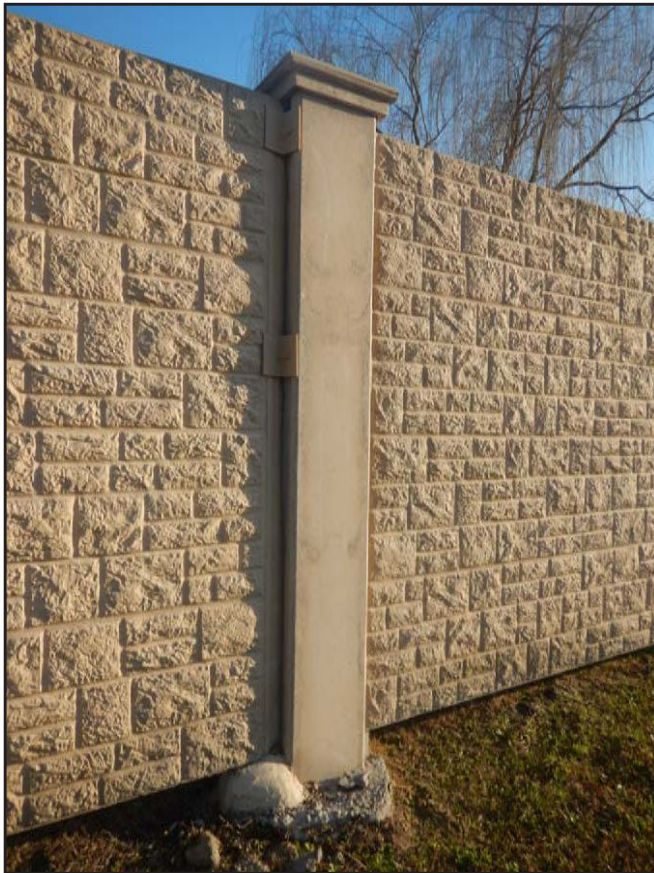
NO. 448 - COLUMN 40SS -
INADEQUATE ADDED CLIP
ANGLE CONNECTION AT A
DEFICIENT WALL PANEL TO
COLUMN CONNECTION

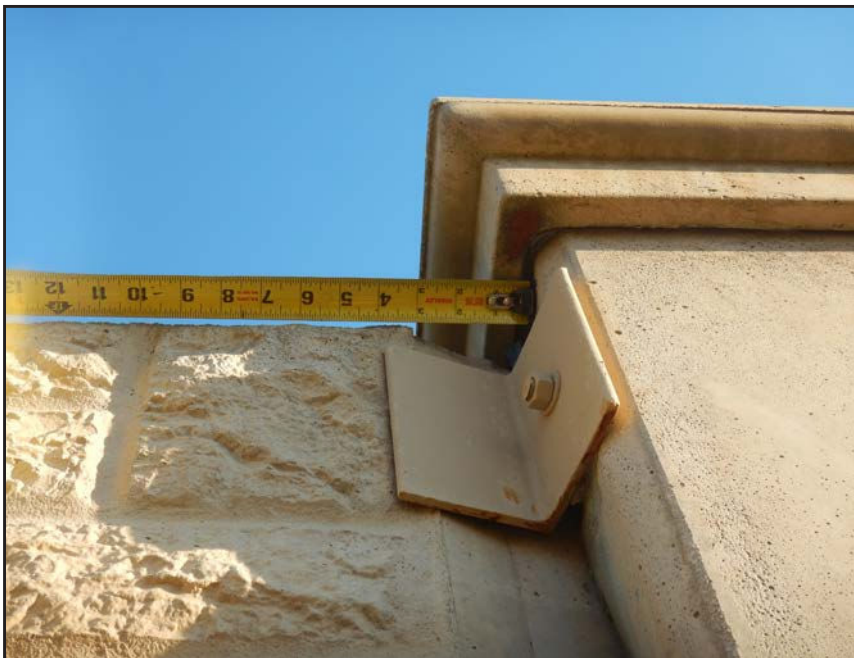
NO. 449 - COLUMN 41SS - INADEQUATE
ADDED CLIP ANGLE CONNECTION AT
A DEFICIENT WALL PANEL TO COLUMN
CONNECTION

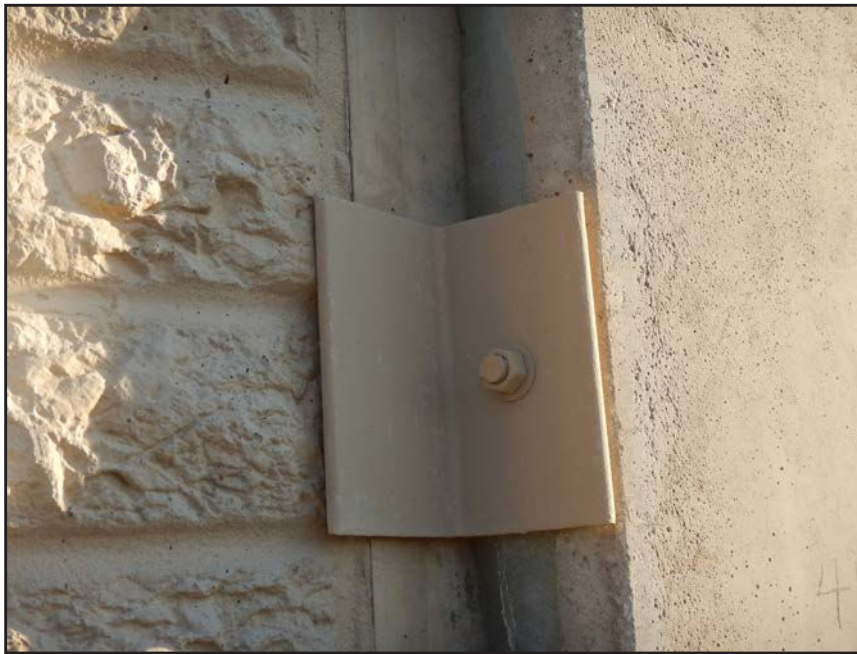
NO. 450 - COLUMN 41SS -
INADEQUATE ADDED CLIP
ANGLE CONNECTION AT A
DEFICIENT WALL PANEL TO
COLUMN CONNECTION

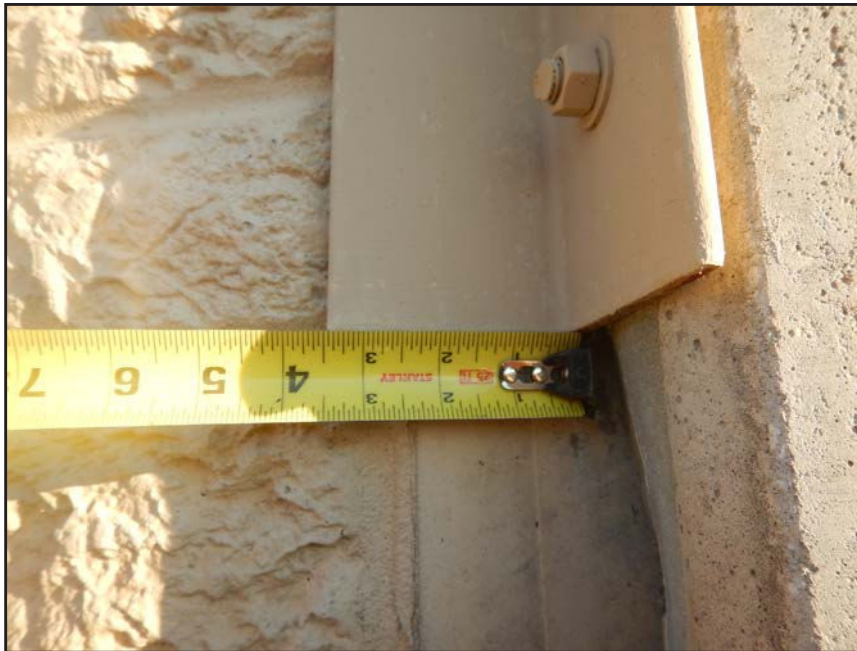
NO. 451 - COLUMN 41SS -
INADEQUATE ADDED CLIP
ANGLE CONNECTION AT A
DEFICIENT WALL PANEL TO
COLUMN CONNECTION

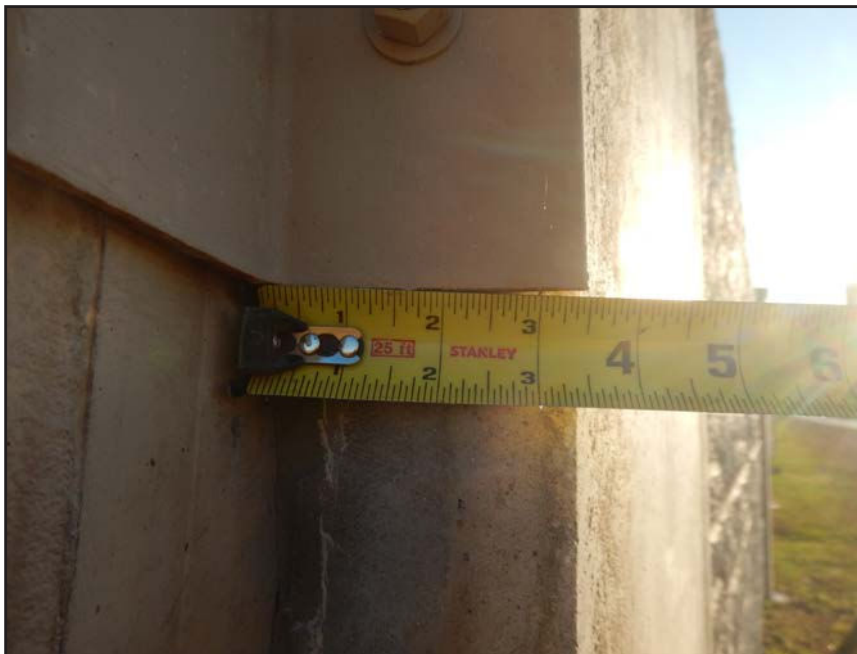
NO. 452 - COLUMN 41SS -
INADEQUATE ADDED CLIP
ANGLE CONNECTION AT A
DEFICIENT WALL PANEL TO
COLUMN CONNECTION

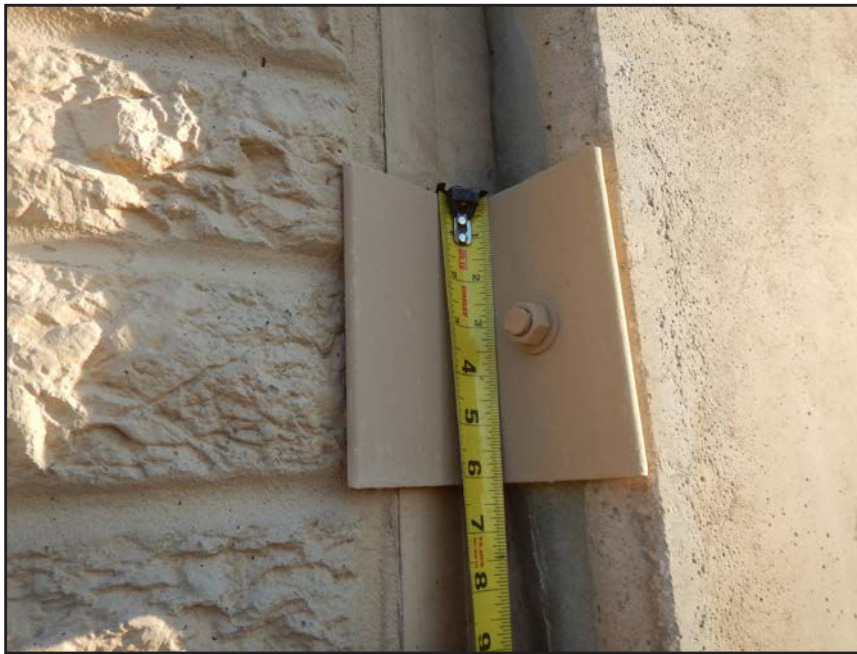
NO. 453 - COLUMN 41SS -
INADEQUATE ADDED CLIP
ANGLE CONNECTION AT A
DEFICIENT WALL PANEL TO
COLUMN CONNECTION

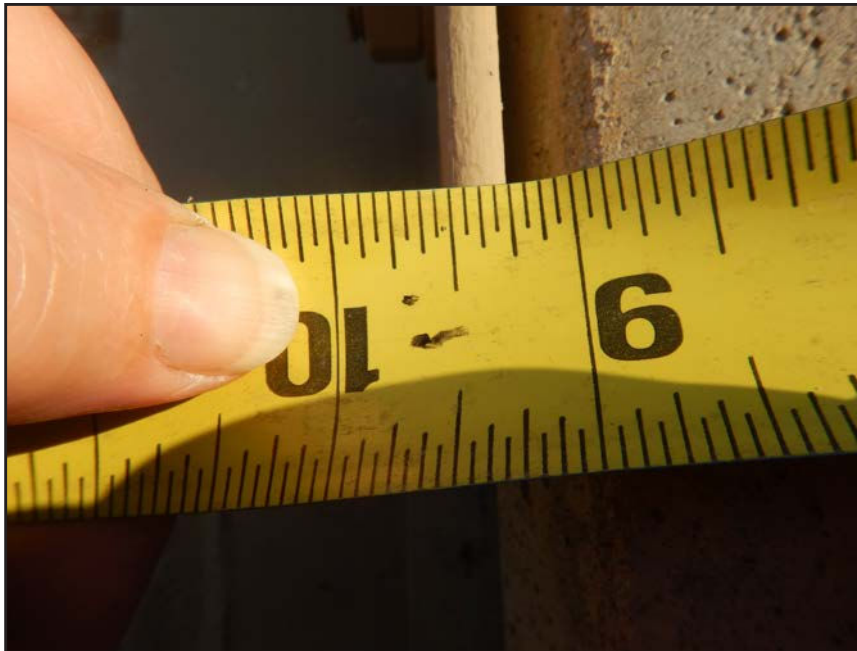
NO. 454 - COLUMN 41SS -
INADEQUATE ADDED CLIP
ANGLE CONNECTION AT A
DEFICIENT WALL PANEL TO
COLUMN CONNECTION

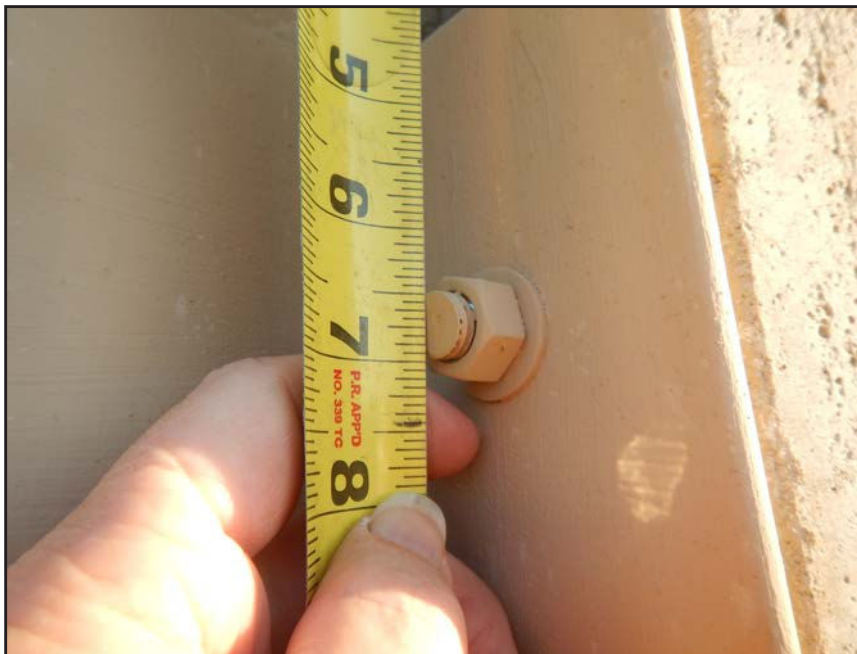
NO. 455 - COLUMN 41SS -
INADEQUATE ADDED CLIP
ANGLE CONNECTION AT A
DEFICIENT WALL PANEL TO
COLUMN CONNECTION

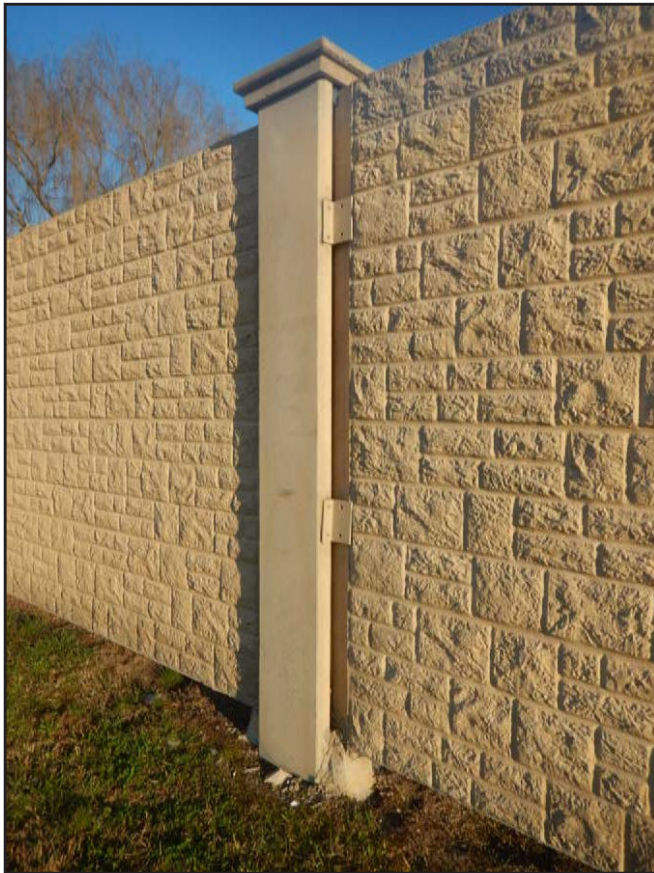
NO. 456 - COLUMN 41SS -
INADEQUATE ADDED CLIP
ANGLE CONNECTION AT A
DEFICIENT WALL PANEL TO
COLUMN CONNECTION

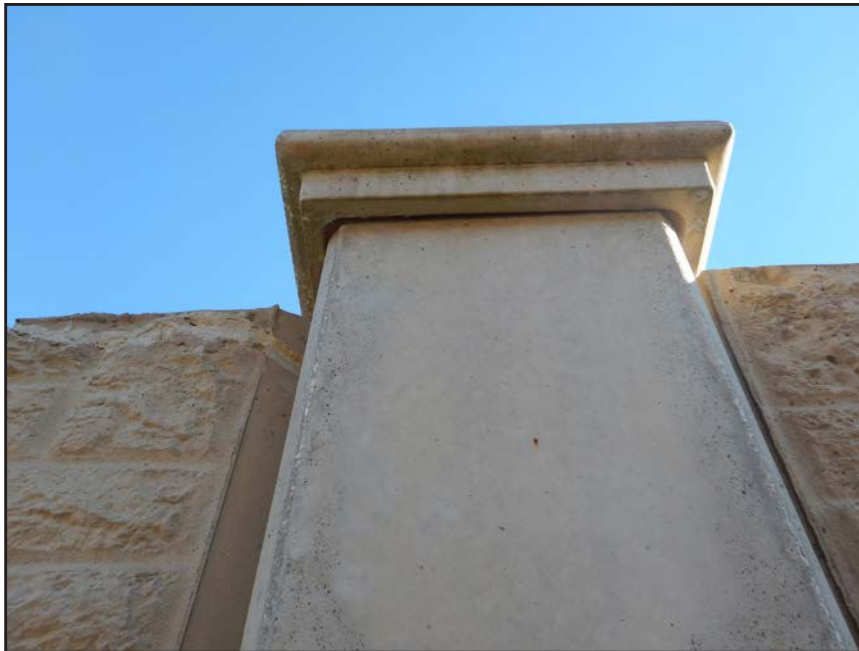
NO. 459 - COLUMN 1N -
CRACKED AND SPALLED
PRECAST CONCRETE

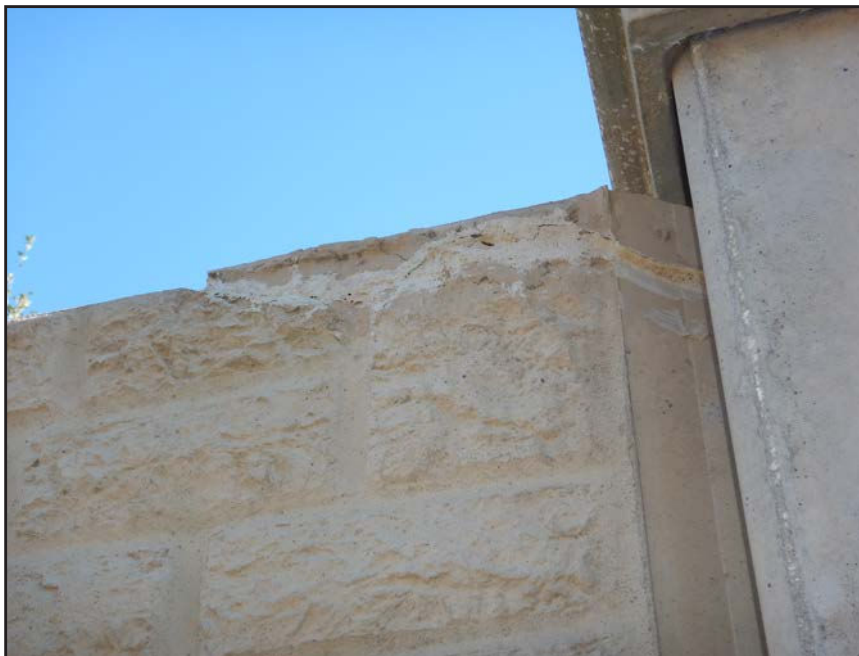
NO. 460 - COLUMN 30N -
CRACKED AND SPALLED
PRECAST CONCRETE
