WATER TOWER ROAD SCREEN WALL INVESTIGATIONS

Water Tower Road
Longs, South Carolina

Stantec Project No. 171015900

March 31, 2025

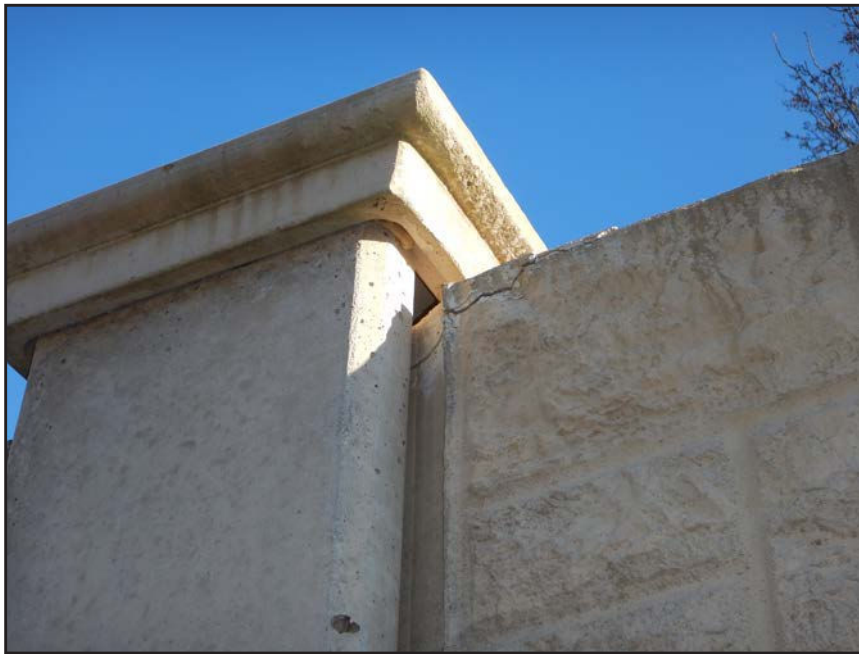
NO. 461 - COLUMN 30N -
CRACKED AND SPALLED
PRECAST CONCRETE

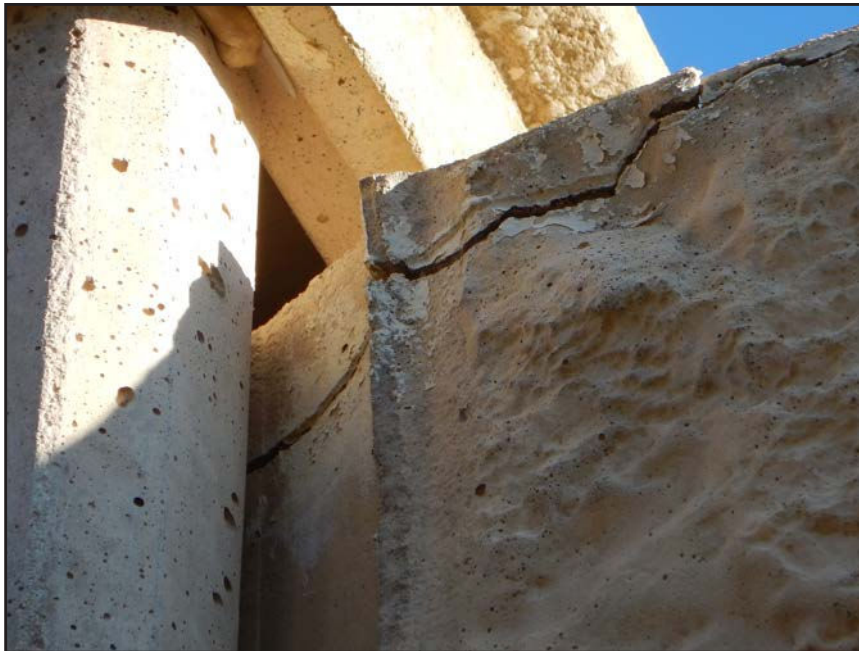
NO. 462 - COLUMN 42N -
CRACKED AND SPALLED
PRECAST CONCRETE

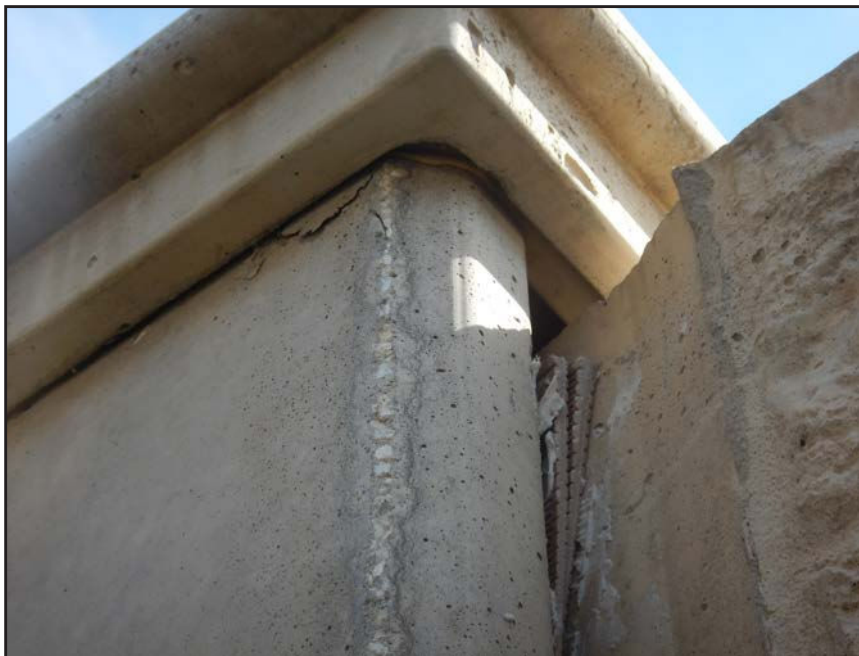
NO. 463 - COLUMN 42N -
CRACKED AND SPALLED
PRECAST CONCRETE

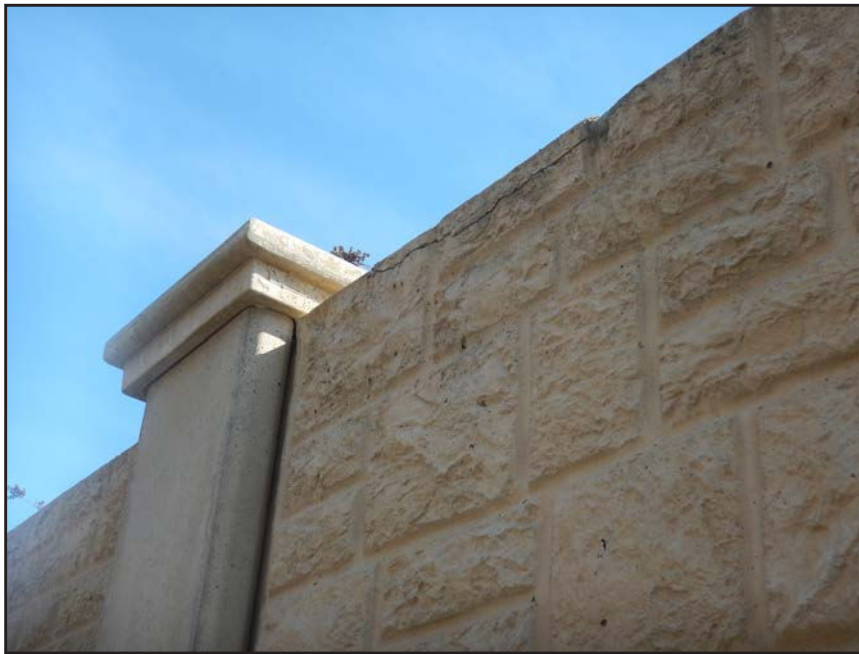
NO. 464 - COLUMN 13S -
CRACKED AND SPALLED
PRECAST CONCRETE

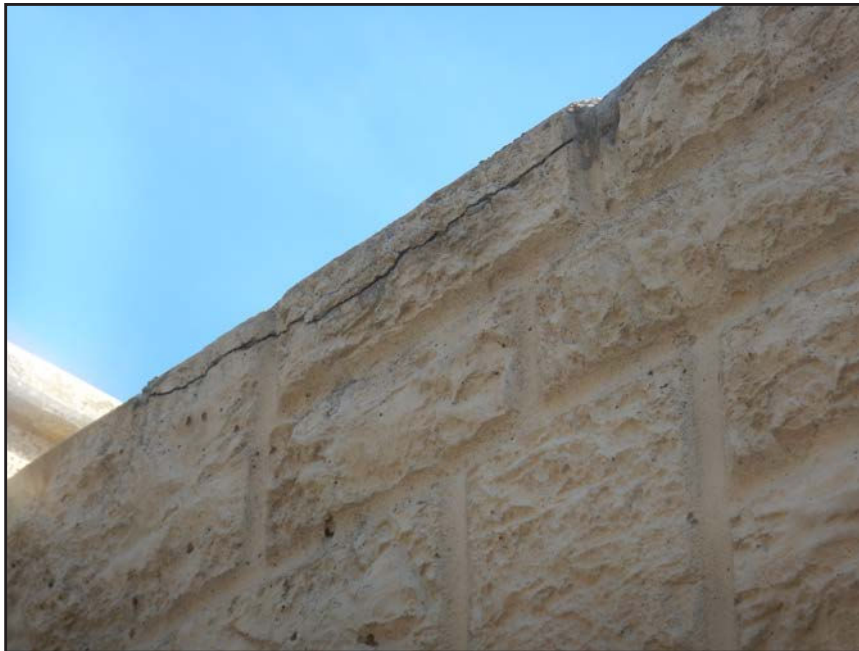
NO. 465 - COLUMN 17S -
CRACKED AND SPALLED
PRECAST CONCRETE

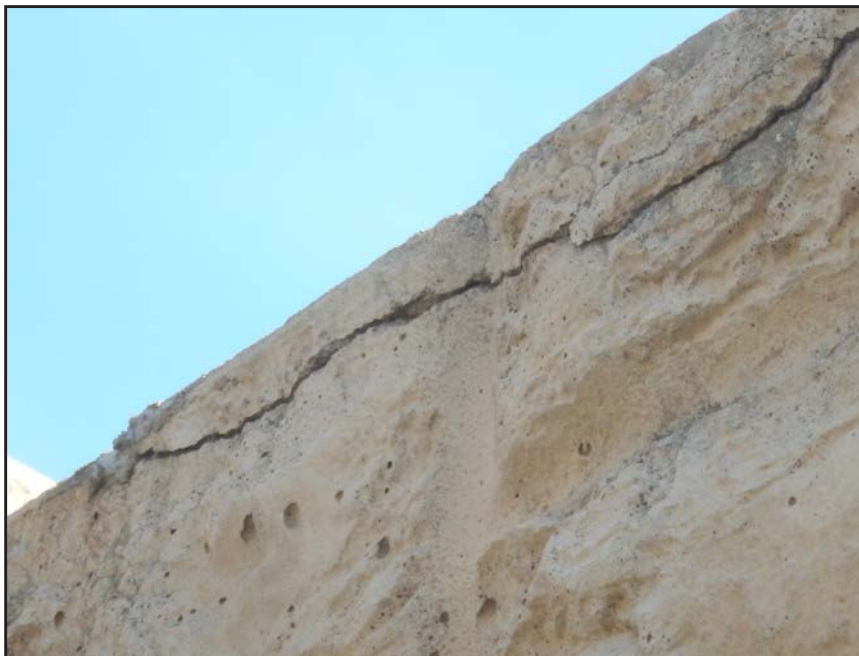
NO. 466 - COLUMN 17S -
CRACKED AND SPALLED
PRECAST CONCRETE

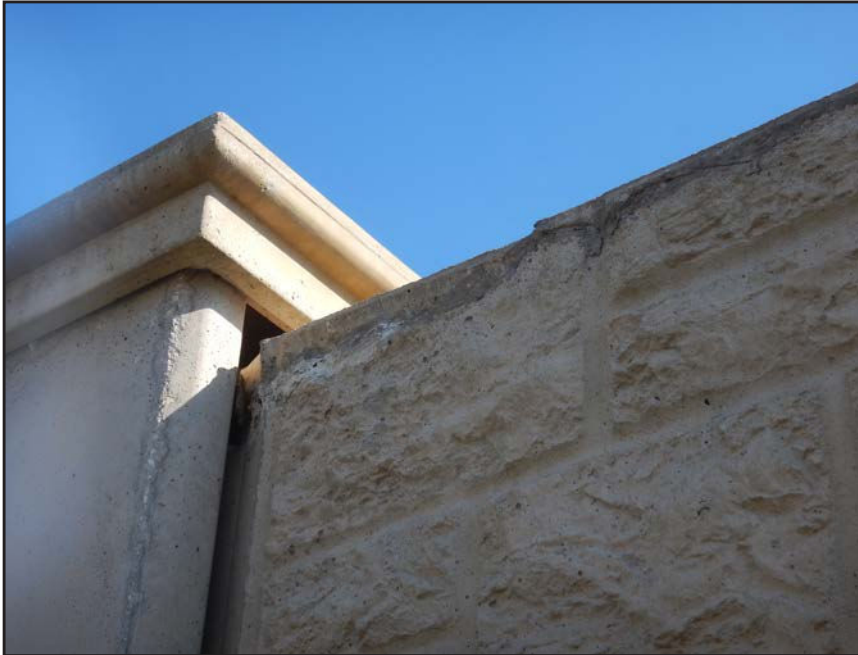
NO. 467 - COLUMN 17S -
CRACKED AND SPALLED
PRECAST CONCRETE

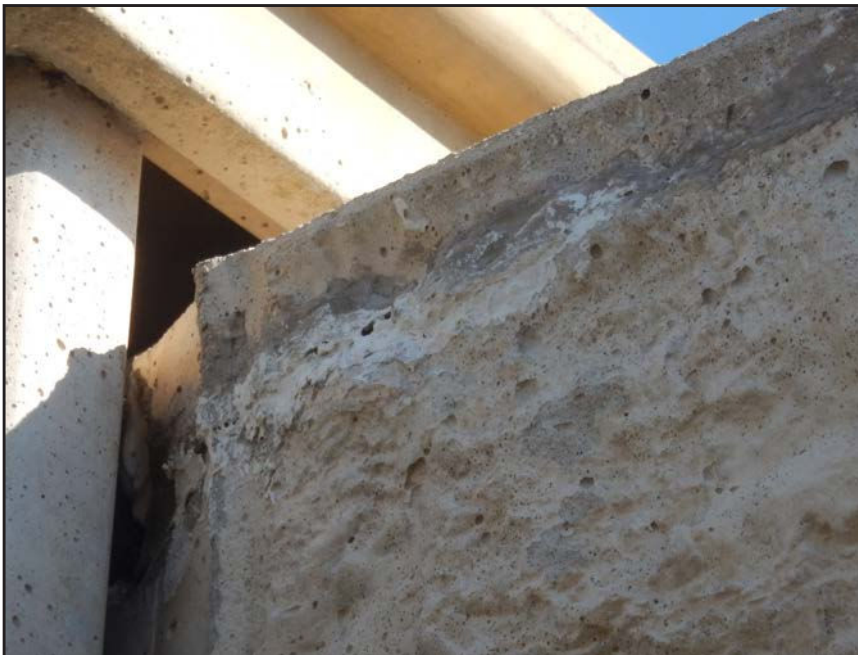
NO. 468 - COLUMN 52S -
CRACKED AND SPALLED
PRECAST CONCRETE

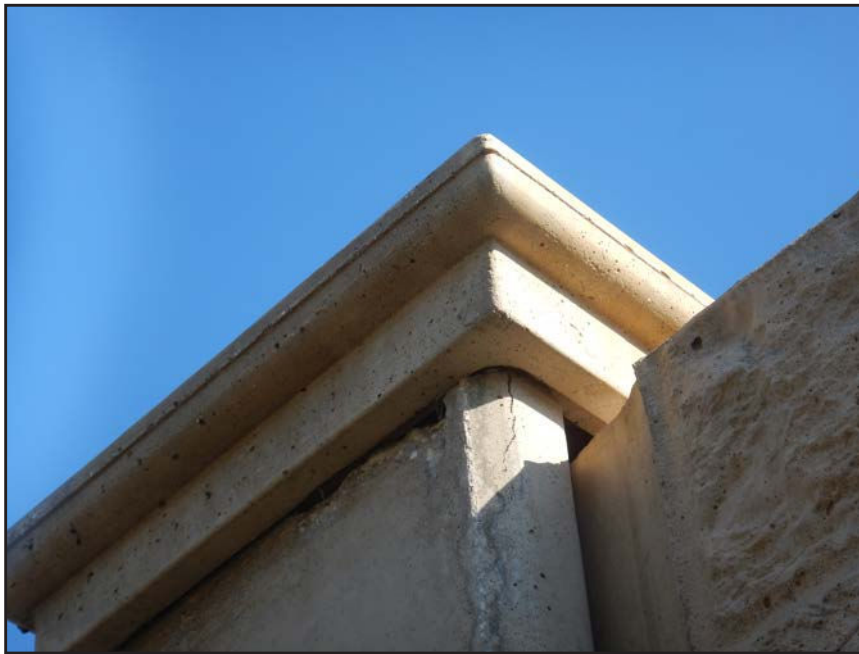
NO. 469 - COLUMN 52S -
CRACKED AND SPALLED
PRECAST CONCRETE

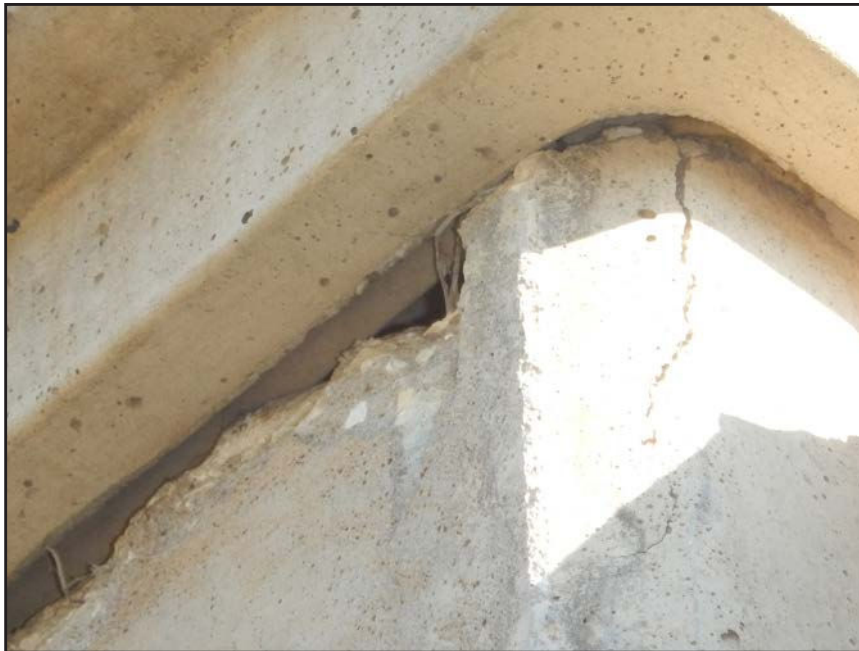
NO. 470 - COLUMN 75S -
CRACKED AND SPALLED
PRECAST CONCRETE

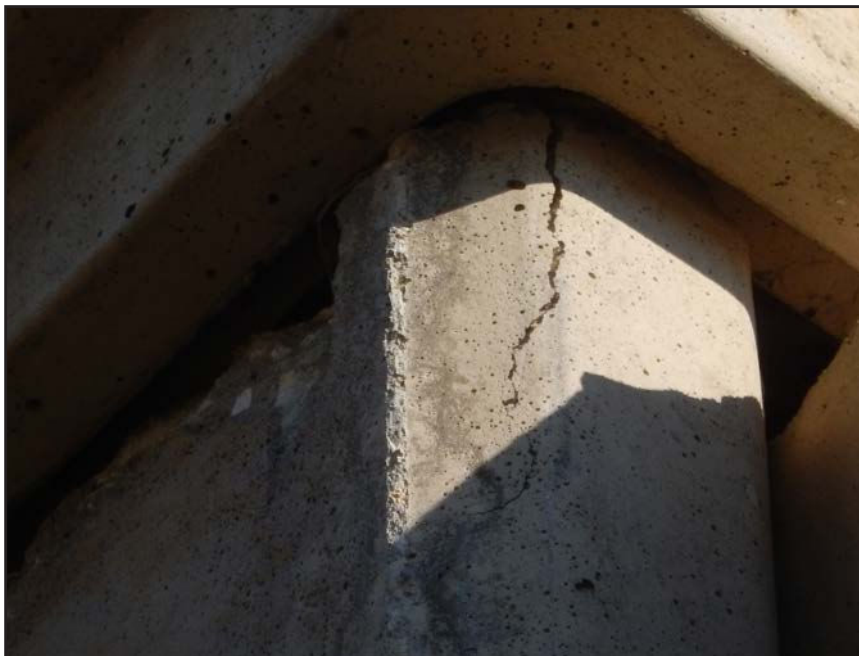
NO. 471 - COLUMN 75S -
CRACKED AND SPALLED
PRECAST CONCRETE

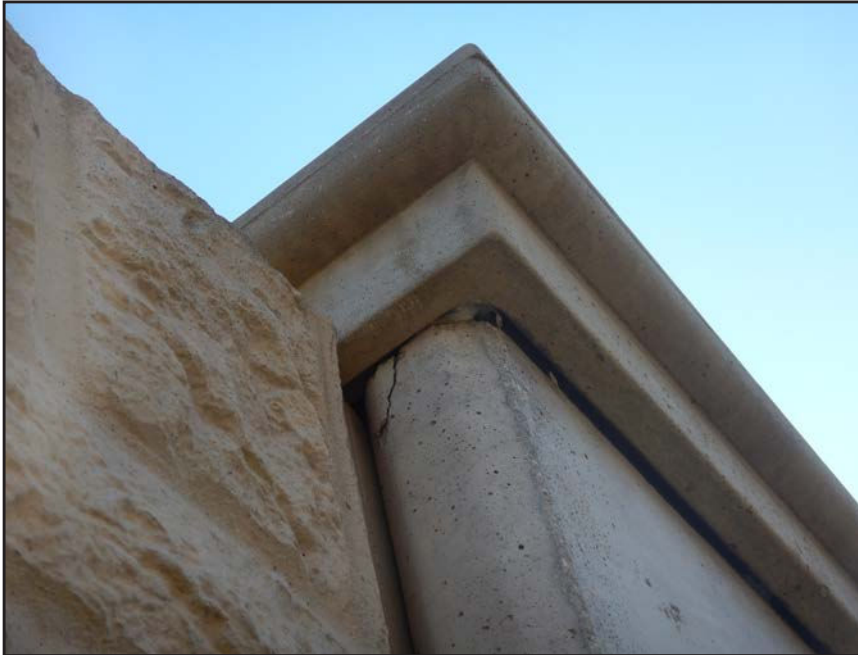
NO. 472 - COLUMN 75S -
CRACKED AND SPALLED
PRECAST CONCRETE

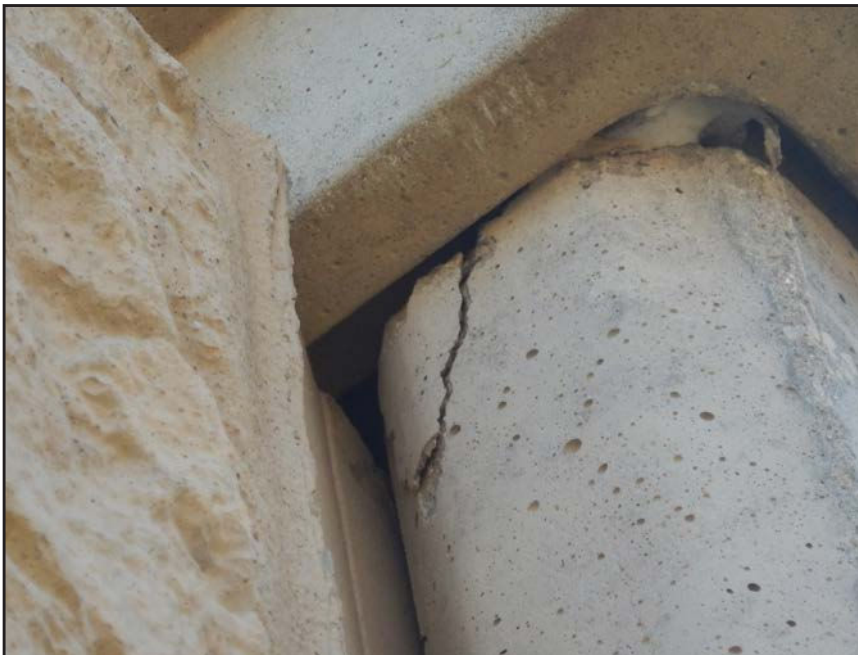
NO. 473 - COLUMN 77S -
CRACKED AND SPALLED
PRECAST CONCRETE

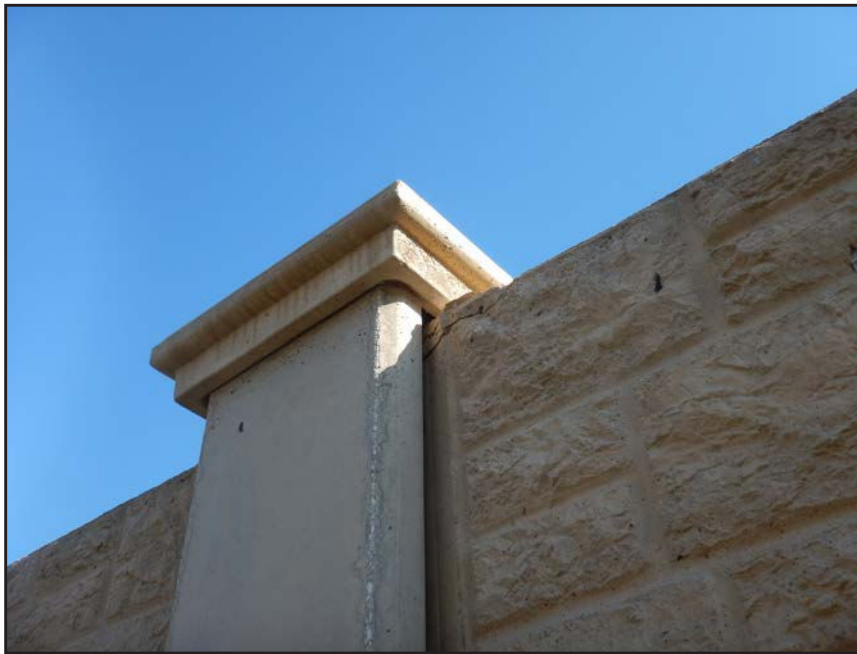
NO. 474 - COLUMN 77S -
CRACKED AND SPALLED
PRECAST CONCRETE

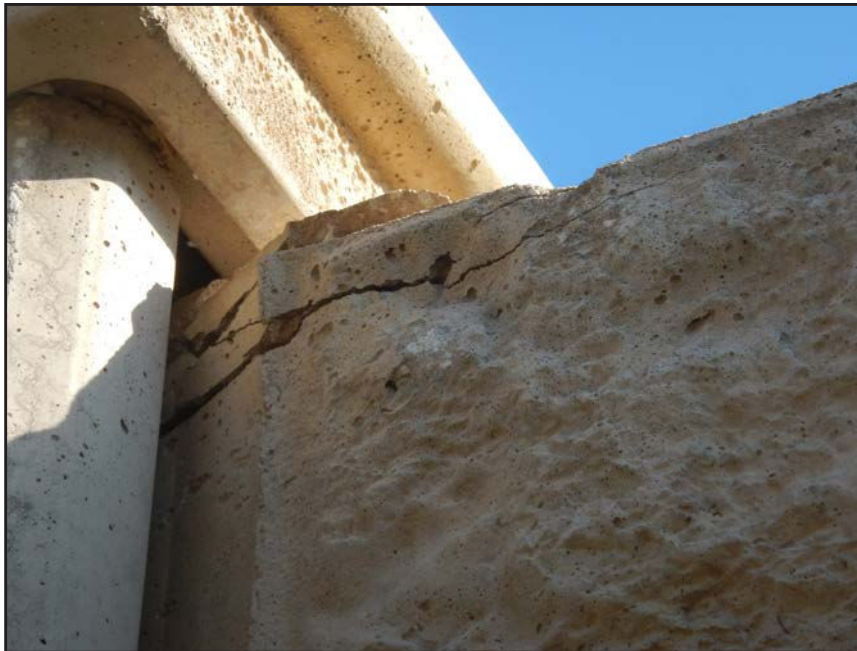
NO. 475 - COLUMN 78S -
CRACKED AND SPALLED
PRECAST CONCRETE

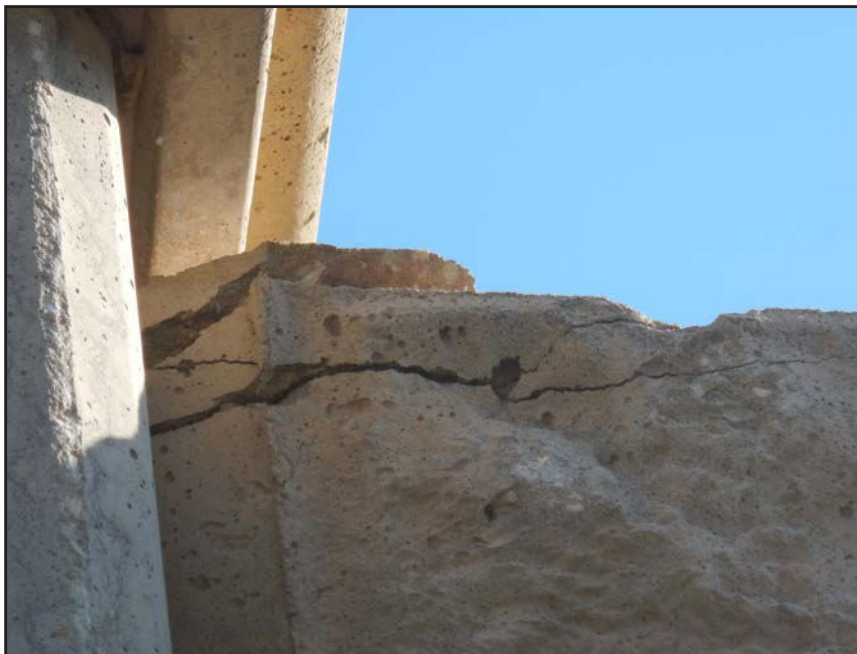
NO. 476 - COLUMN 78S -
CRACKED AND SPALLED
PRECAST CONCRETE

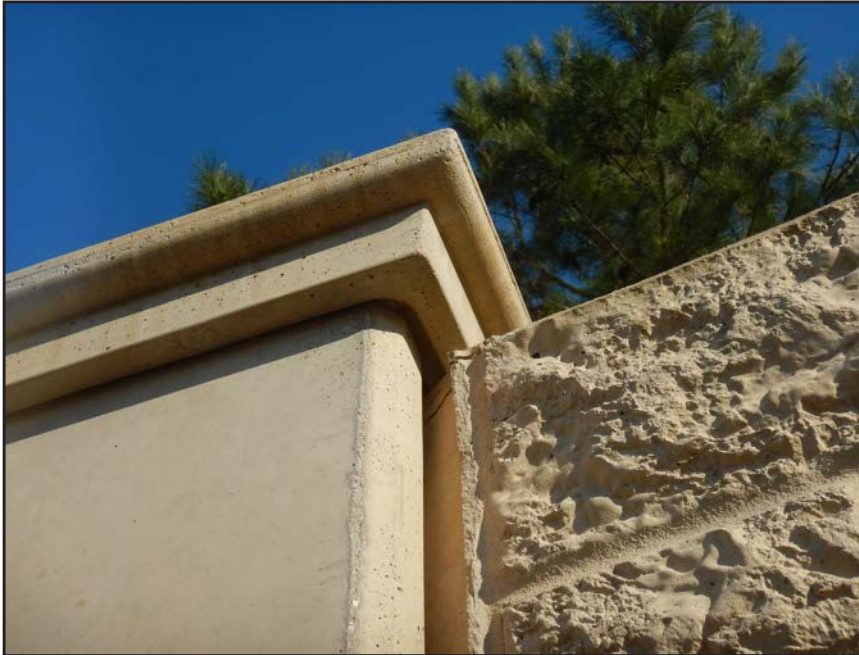
NO. 477 - COLUMN 78S -
CRACKED AND SPALLED
PRECAST CONCRETE

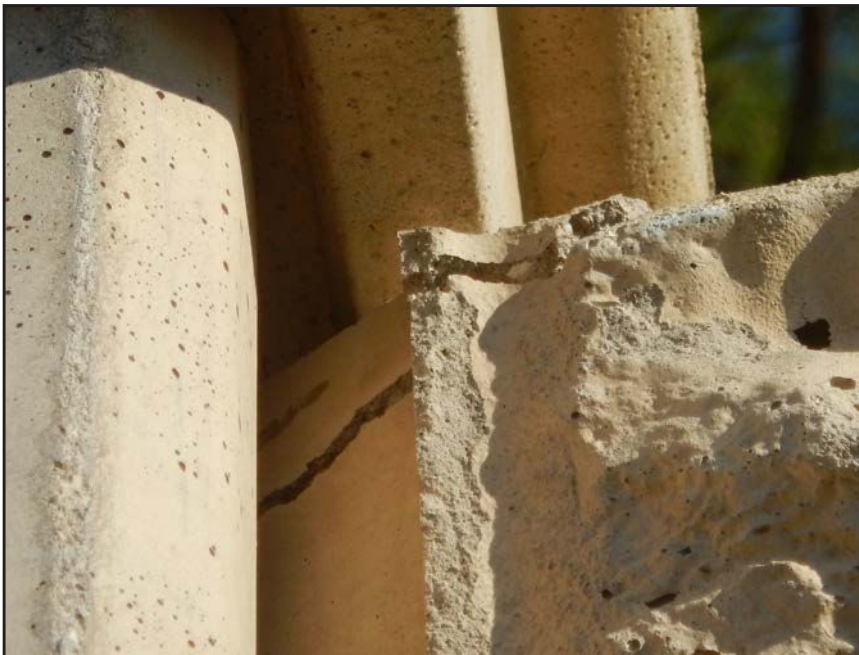
NO. 478 - COLUMN 3SS -
CRACKED AND SPALLED
PRECAST CONCRETE

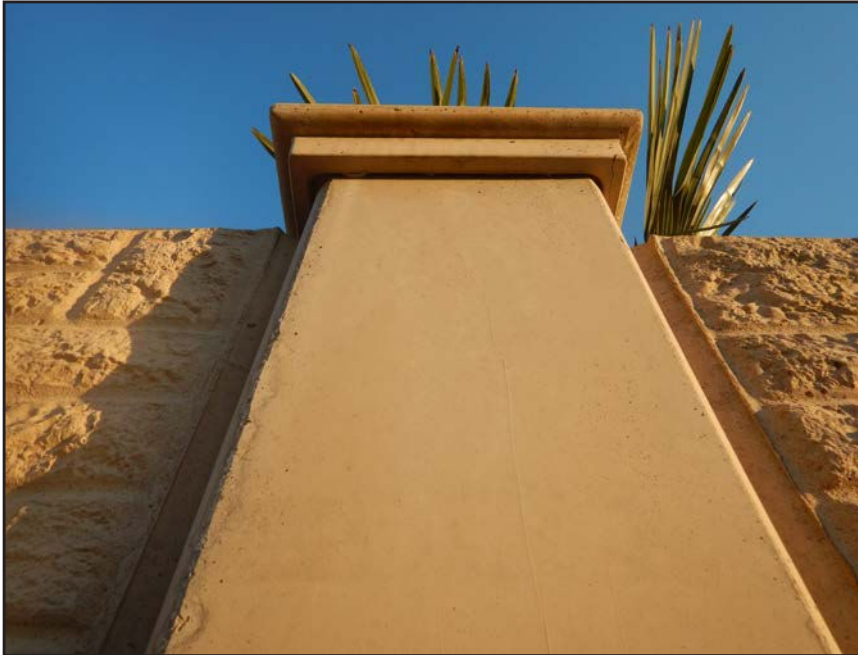
NO. 479 - COLUMN 3SS -
CRACKED AND SPALLED
PRECAST CONCRETE

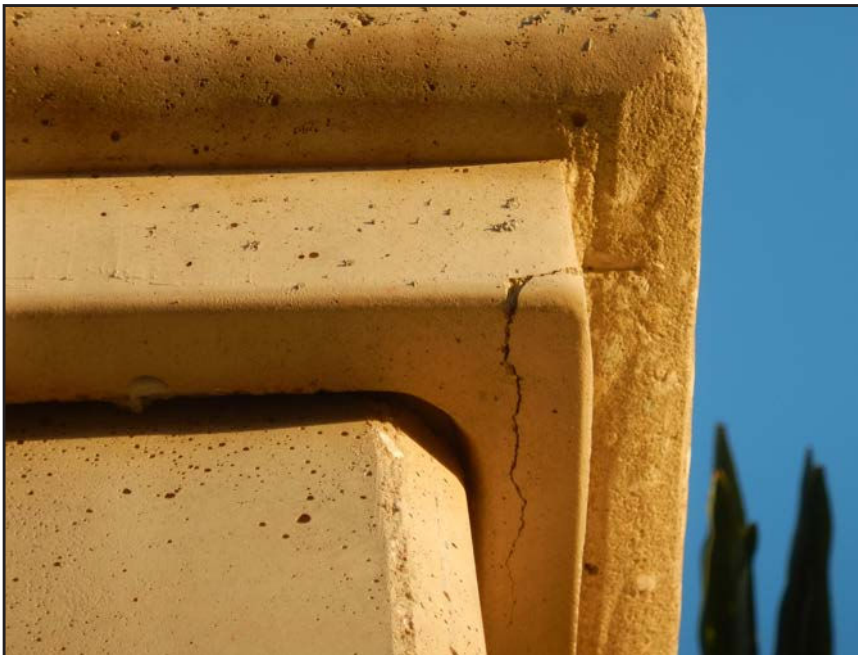
NO. 480 - COLUMN 54SS -
CRACKED AND SPALLED
PRECAST CONCRETE

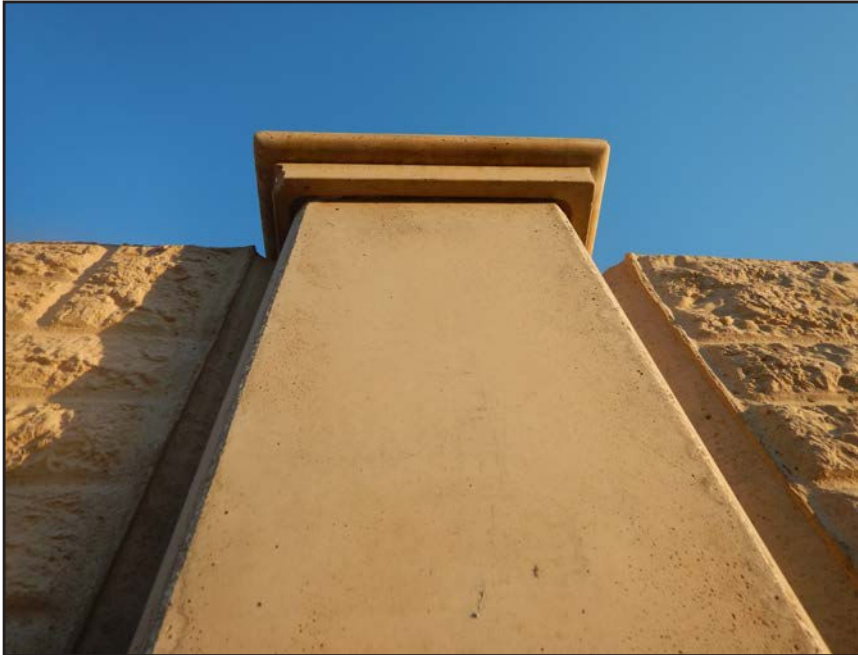
NO. 481 - COLUMN 54SS -
CRACKED AND SPALLED
PRECAST CONCRETE

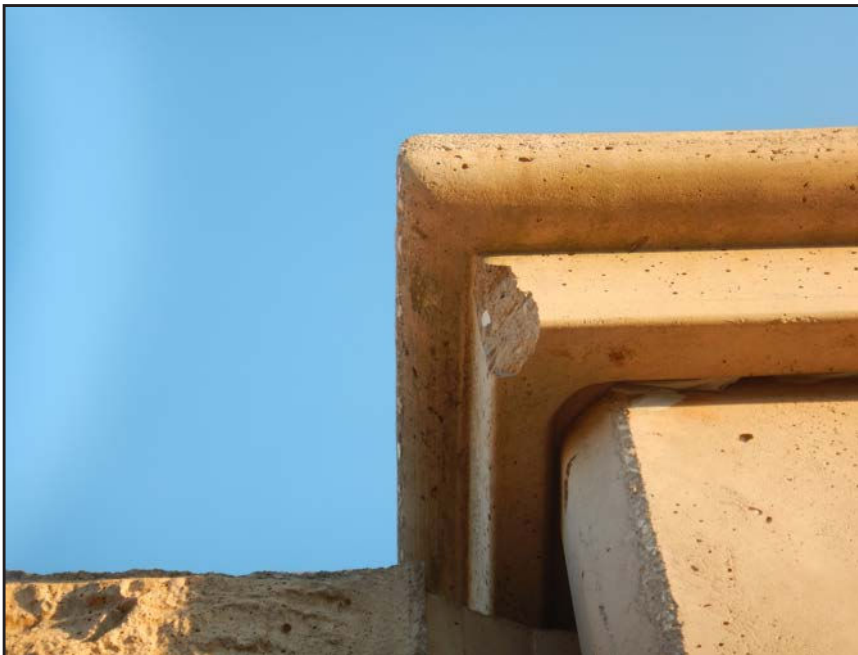
NO. 482 - COLUMN 55SS-
CRACKED AND SPALLED
PRECAST CONCRETE

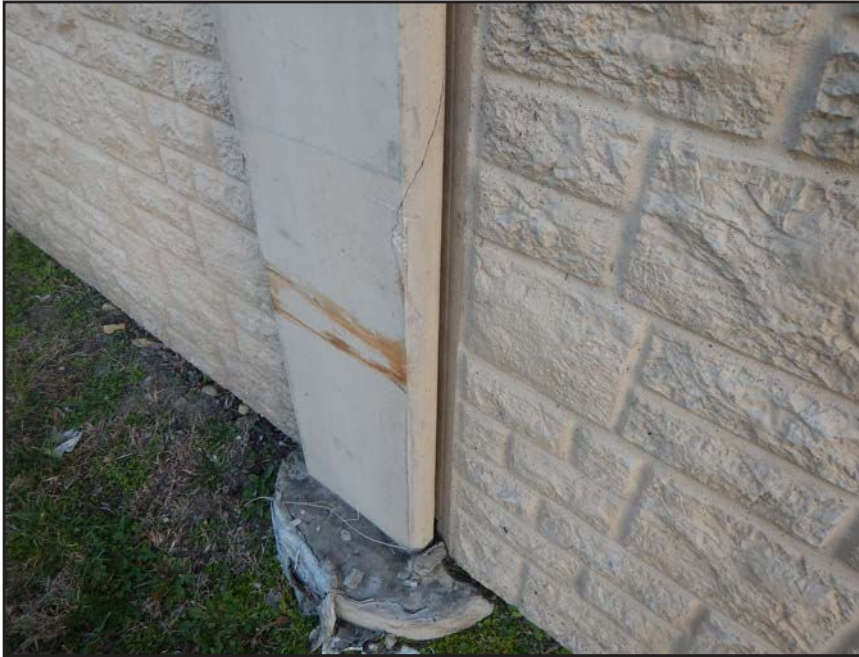
NO. 483 - COLUMN 55SS -
CRACKED AND SPALLED
PRECAST CONCRETE

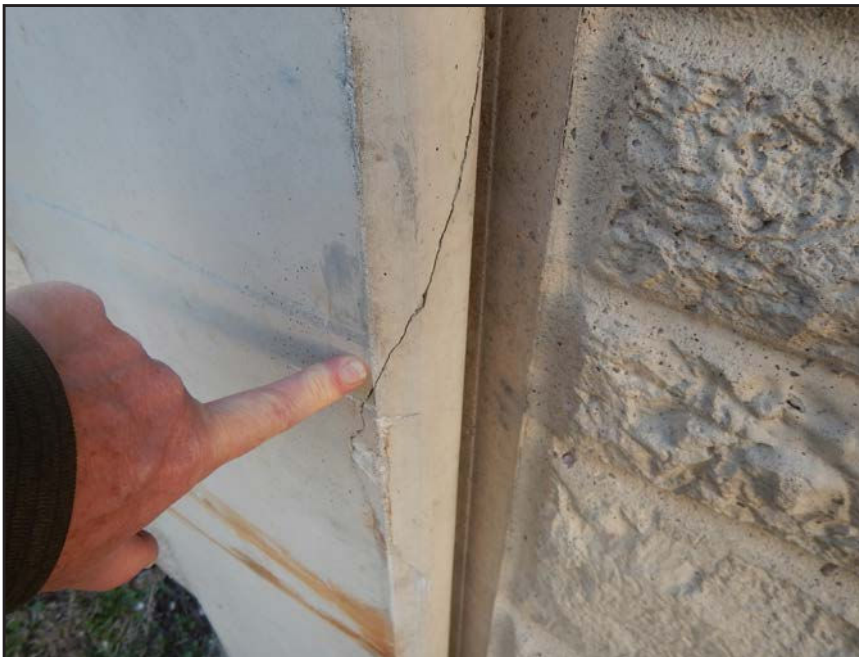
NO. 484 - COLUMN 63SS -
CRACKED AND SPALLED
PRECAST CONCRETE

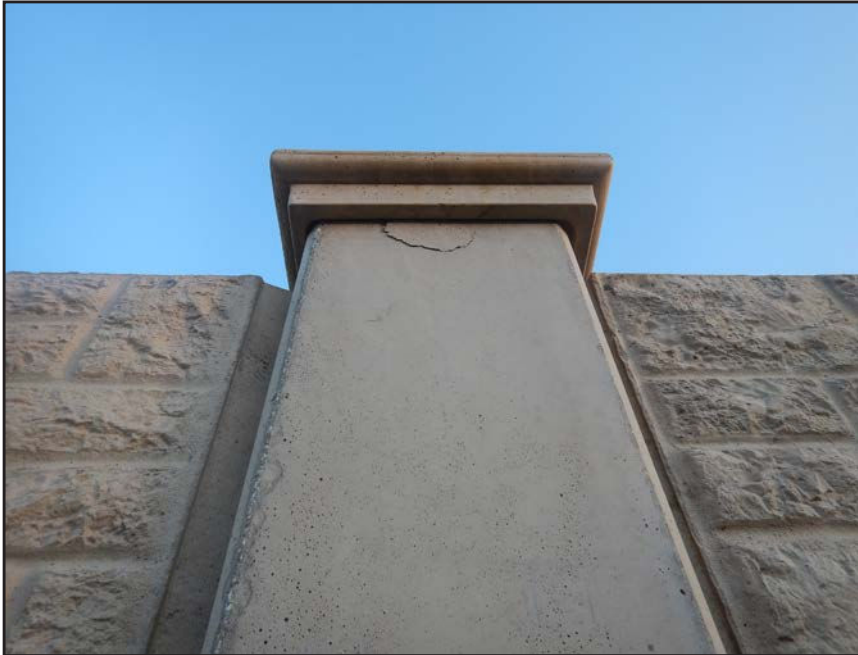
NO. 485 - COLUMN 63SS -
CRACKED AND SPALLED
PRECAST CONCRETE

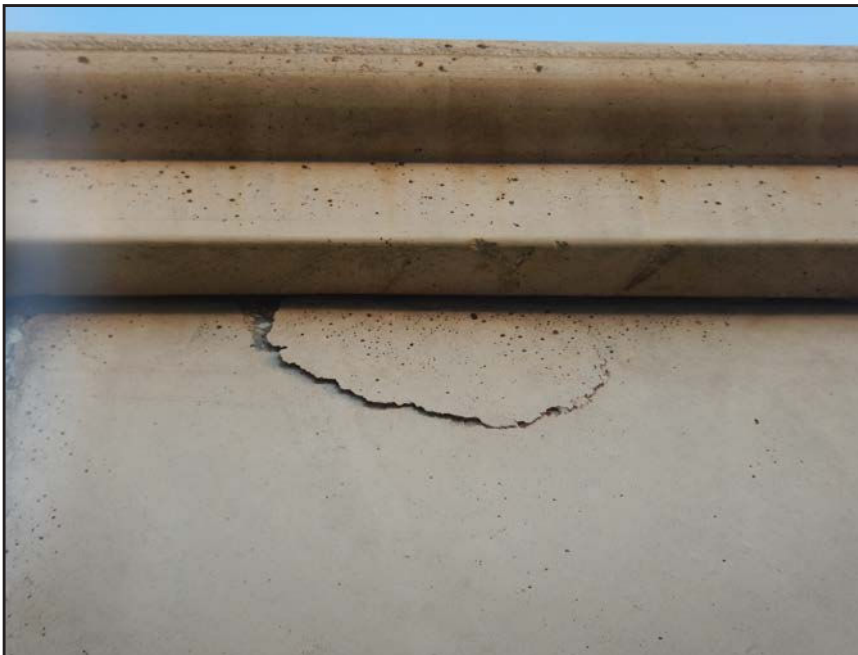
NO. 486 - COLUMN 64SS -
CRACKED AND SPALLED
PRECAST CONCRETE

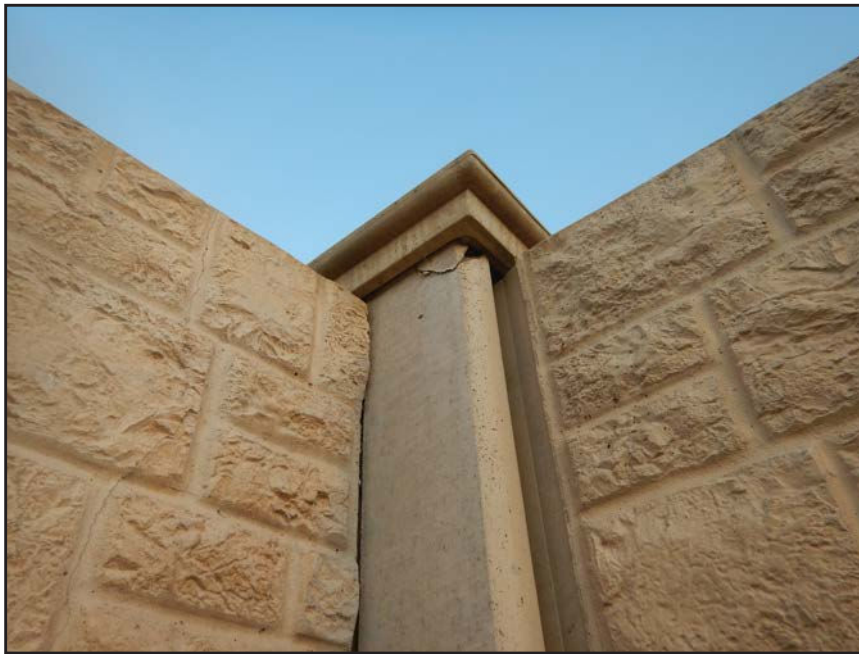
NO. 487 - COLUMN 64SS -
CRACKED AND SPALLED
PRECAST CONCRETE

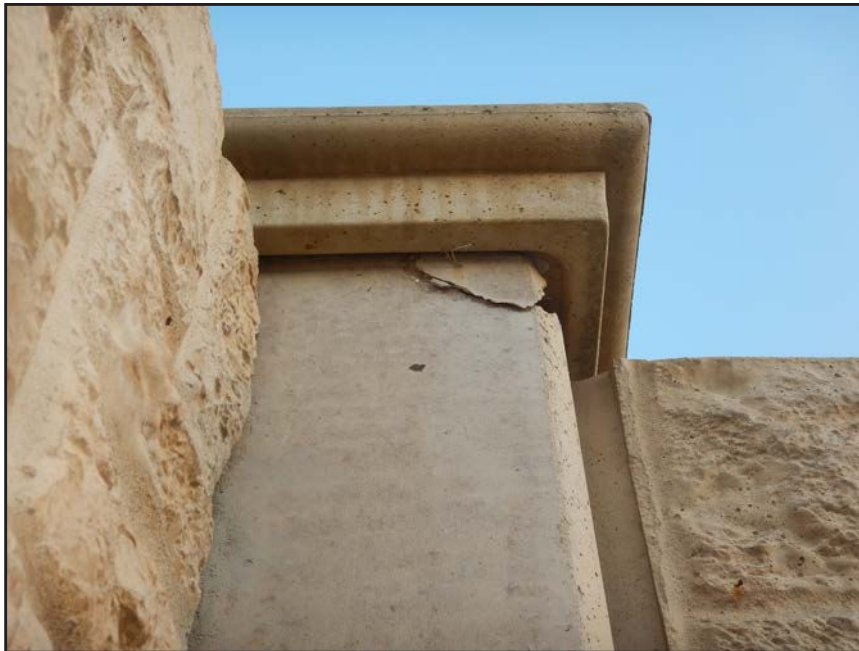
NO. 488 - COLUMN 68SS
(BACK) - CRACKED AND
SPALLED PRECAST CONCRETE

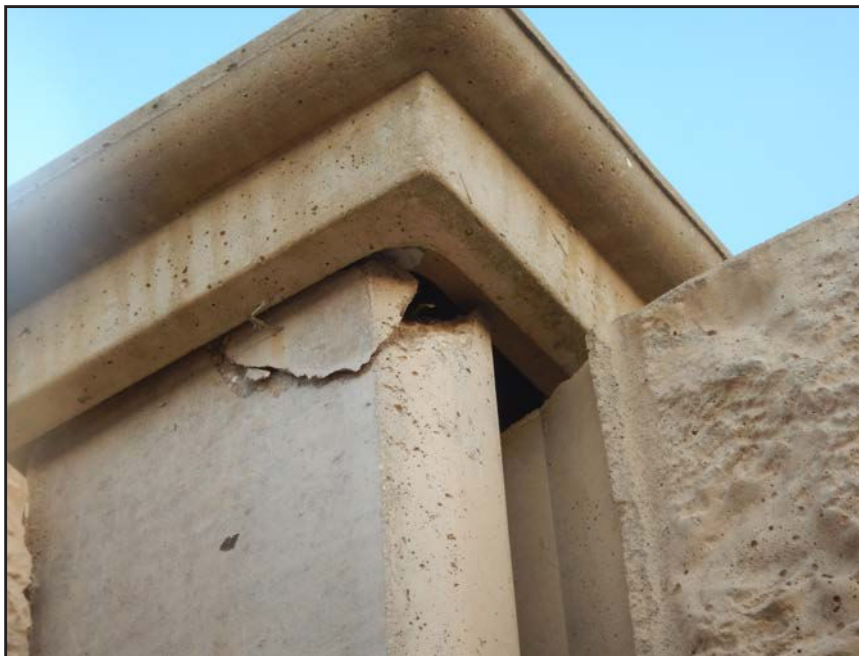
NO. 489 - COLUMN 68SS
(BACK) - CRACKED AND
SPALLED PRECAST CONCRETE

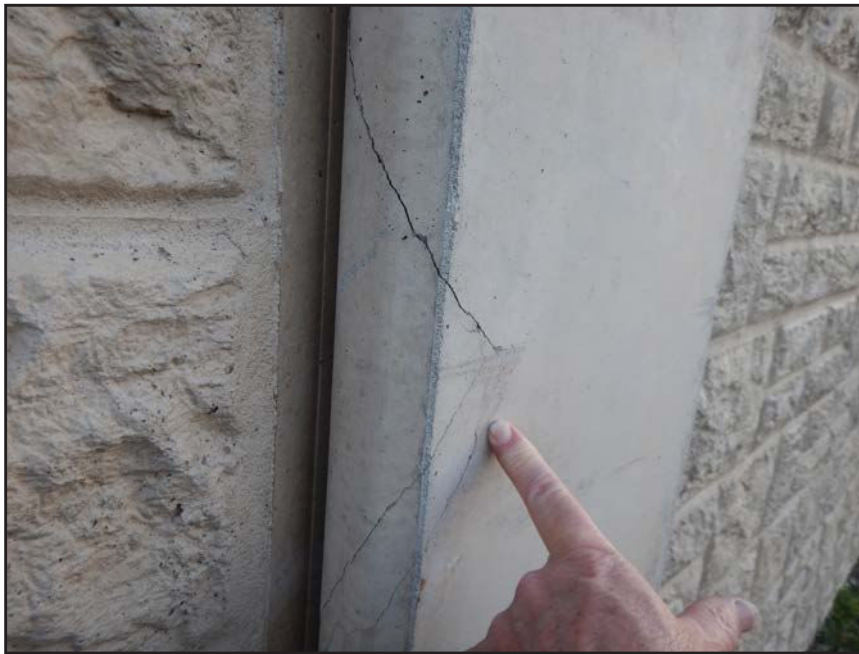
NO. 490 - COLUMN 68SS
(BACK) - CRACKED AND
SPALLED PRECAST CONCRETE

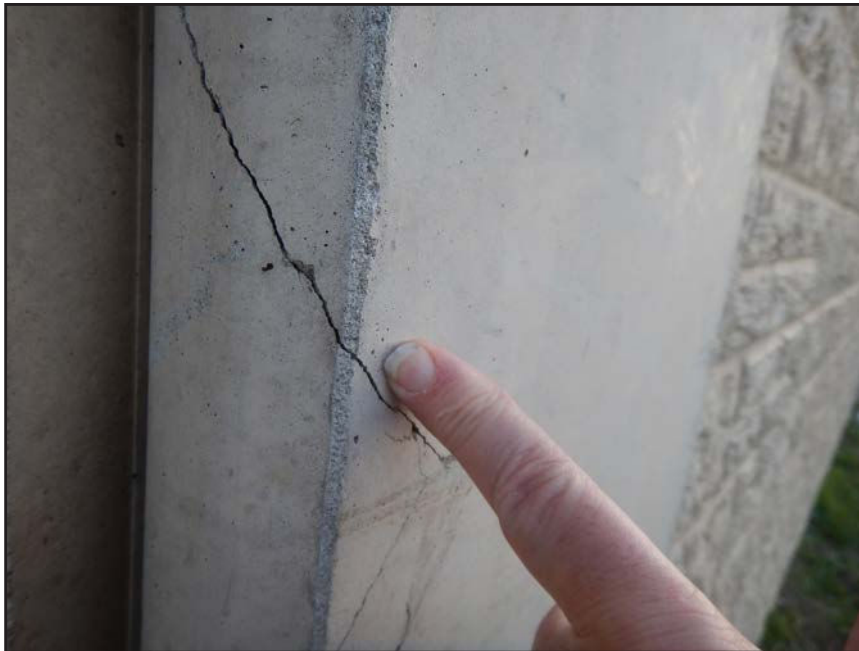
NO. 491 - COLUMN 70SS -
CRACKED AND SPALLED
PRECAST CONCRETE

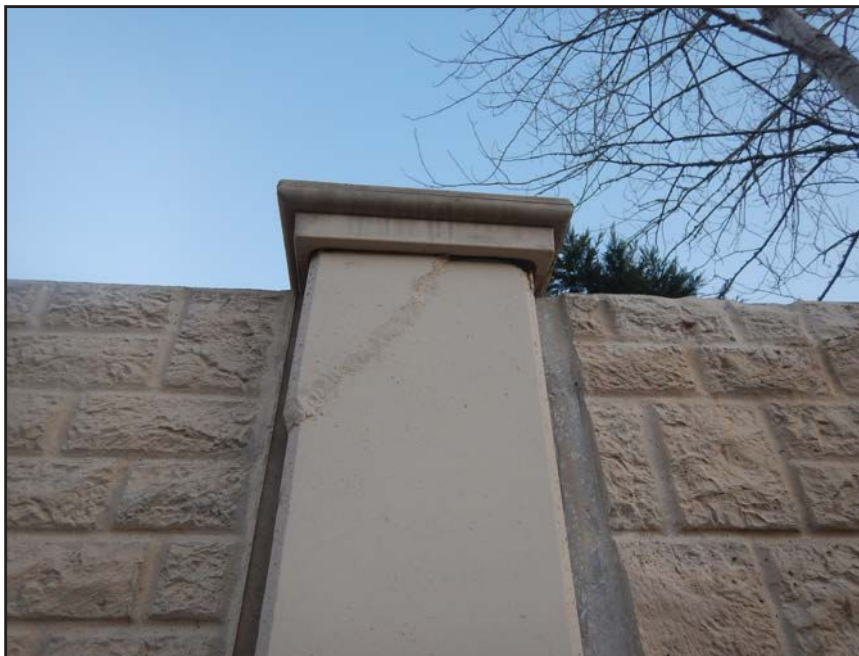
NO. 492 - COLUMN 70SS -
CRACKED AND SPALLED
PRECAST CONCRETE

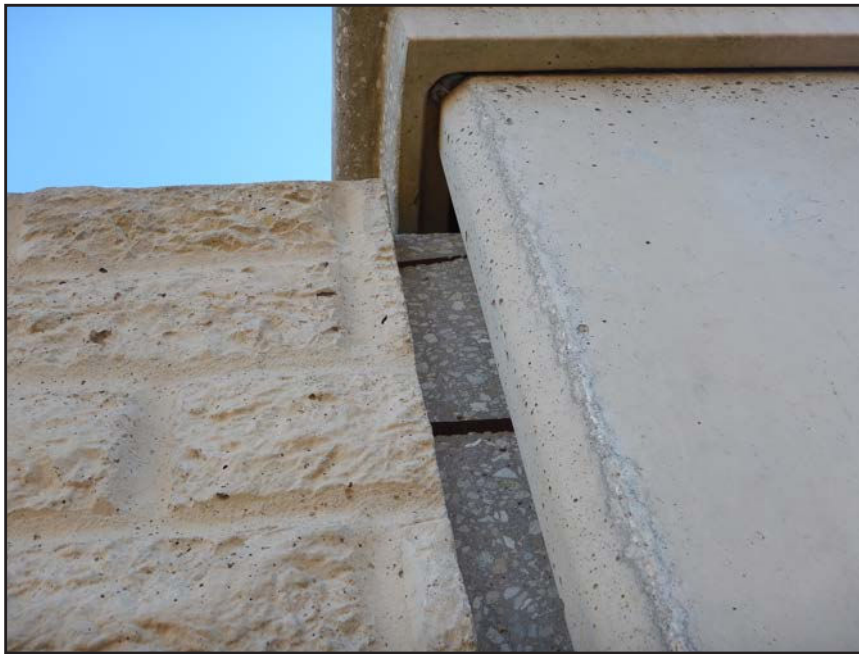
NO. 493 - COLUMN 79SS -
CRACKED AND SPALLED
PRECAST CONCRETE

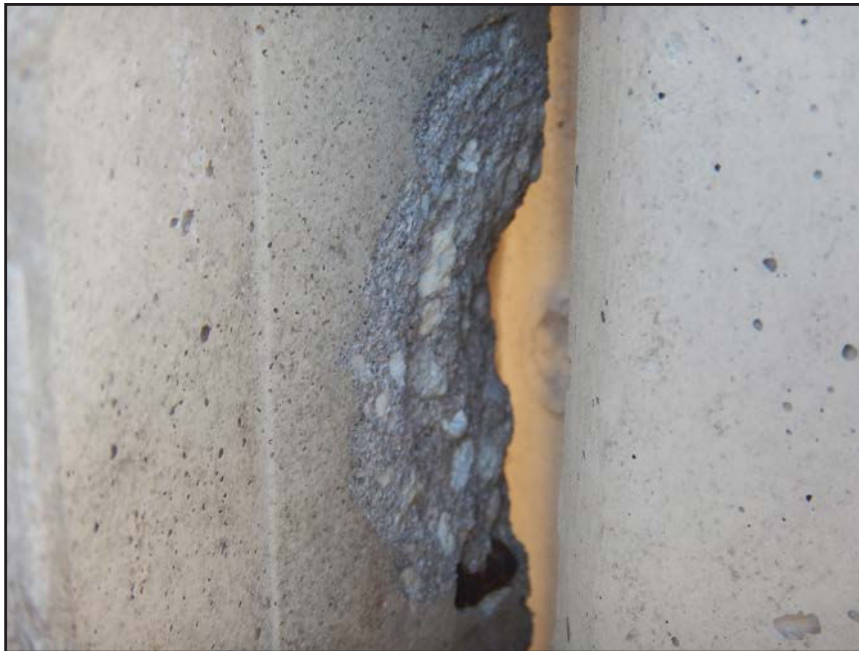
NO. 494 - COLUMN 14N -
EXPOSED REINFORCING STEEL
WITH INADEQUATE CONCRETE
COVER

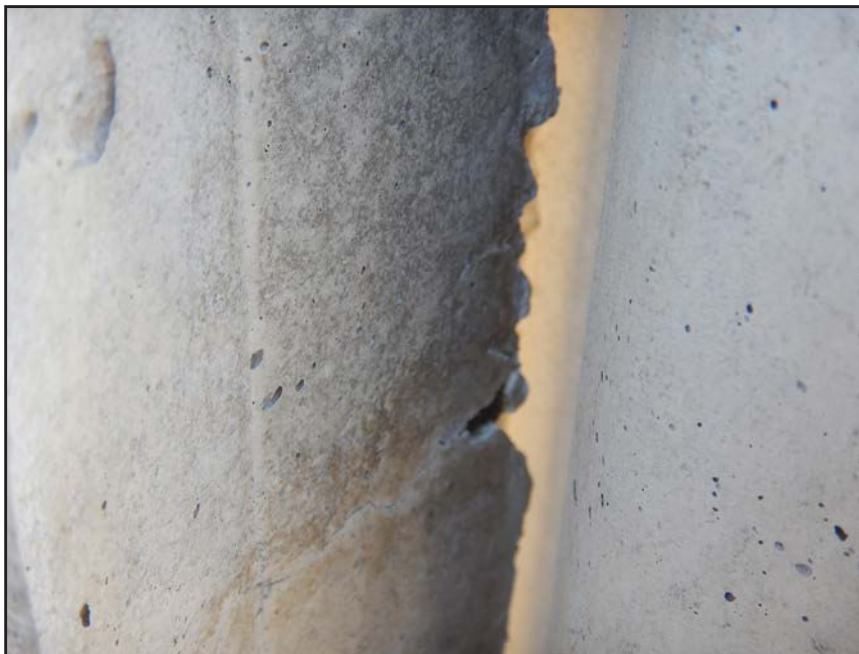
NO. 495 - COLUMN 56N -
EXPOSED REINFORCING STEEL
WITH INADEQUATE CONCRETE
COVER

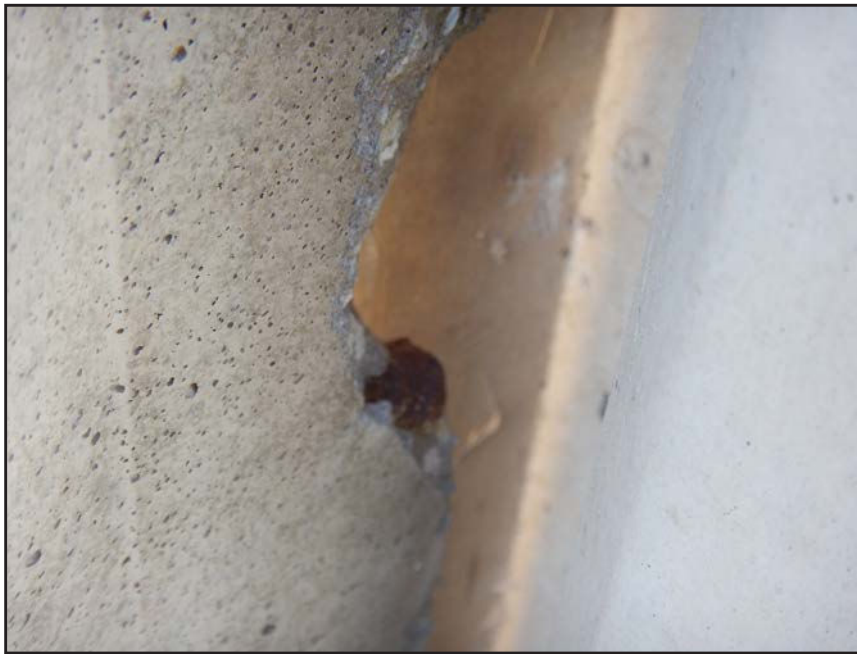
NO. 496 - COLUMN 56N -
EXPOSED REINFORCING STEEL
WITH INADEQUATE CONCRETE
COVER

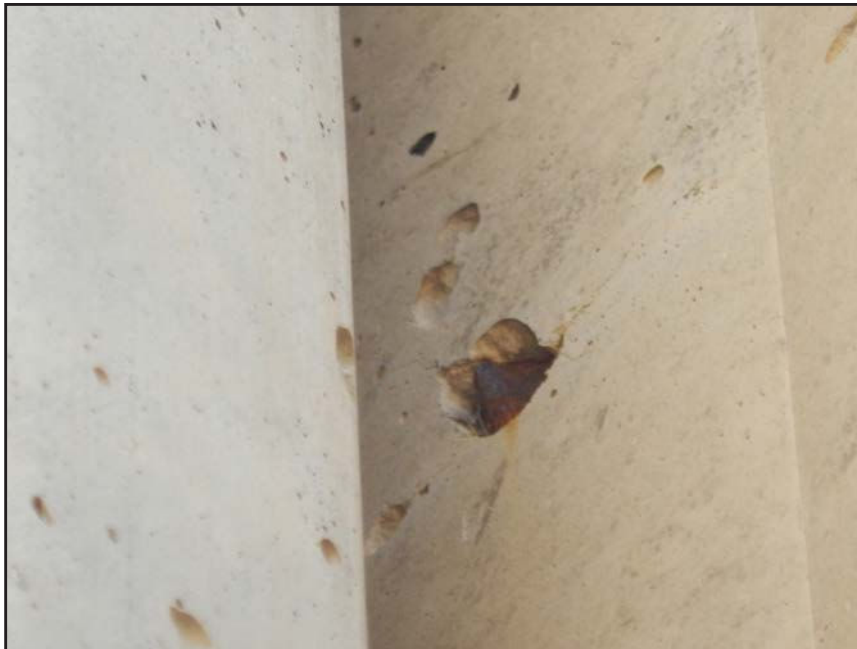
NO. 497 - COLUMN 11NM -
EXPOSED REINFORCING STEEL
WITH INADEQUATE CONCRETE
COVER

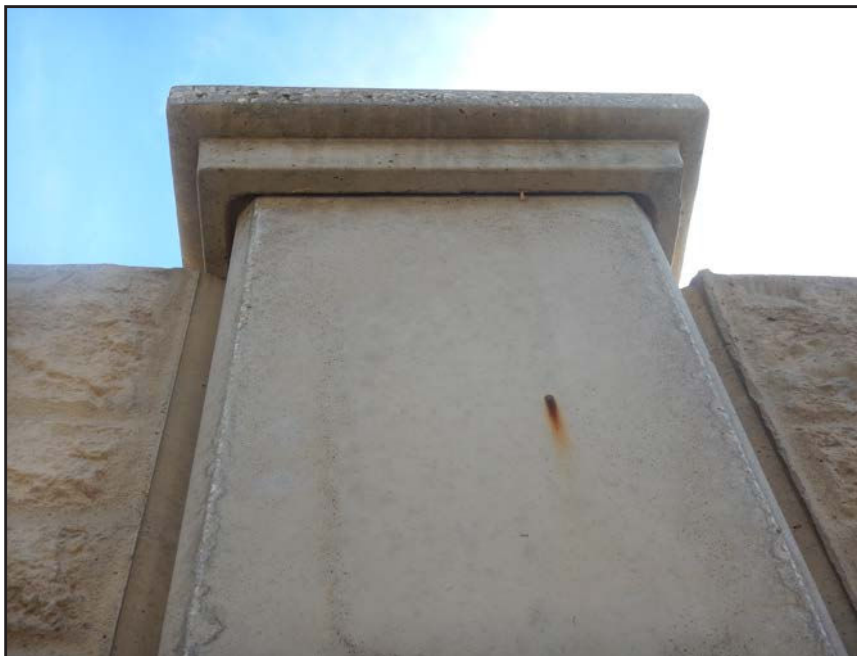
NO. 498 - COLUMN 16SM -
EXPOSED REINFORCING STEEL
WITH INADEQUATE CONCRETE
COVER

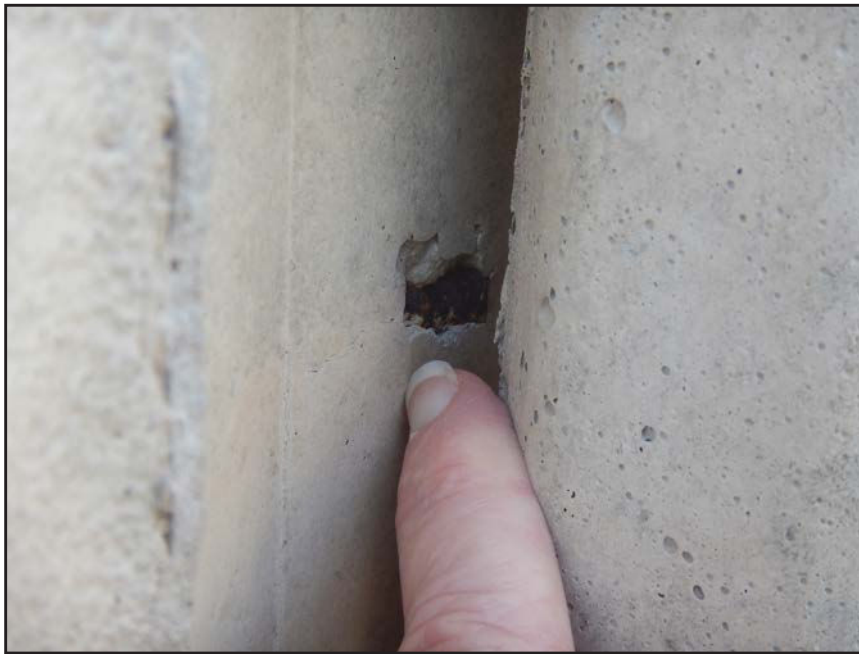
NO. 499 - COLUMN 6S -
EXPOSED REINFORCING STEEL
WITH INADEQUATE CONCRETE
COVER

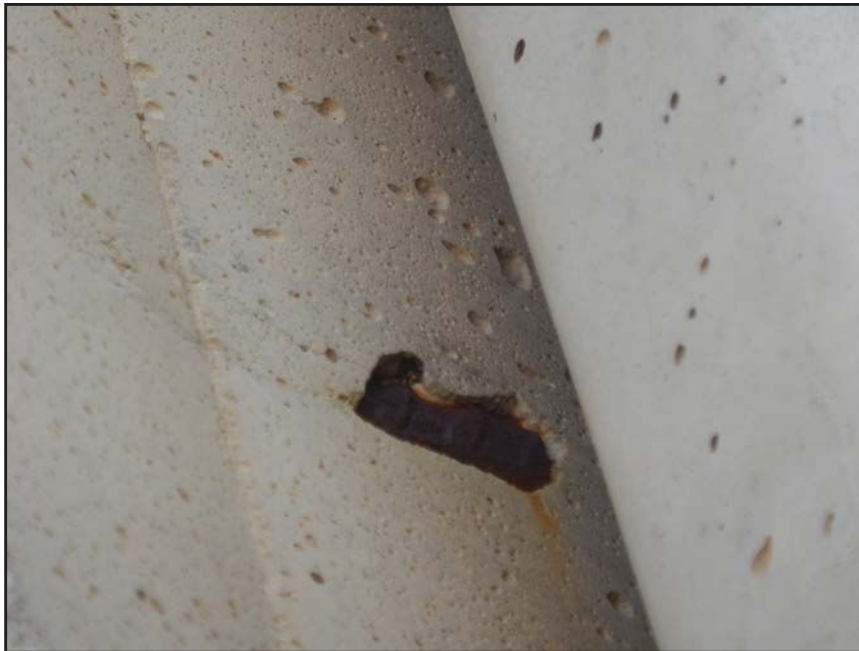
NO. 500 - COLUMN 12S -
EXPOSED REINFORCING STEEL
WITH INADEQUATE CONCRETE
COVER
