WATER TOWER ROAD SCREEN WALL INVESTIGATIONS

Water Tower Road
Longs, South Carolina

Stantec Project No. 171015900

March 31, 2025

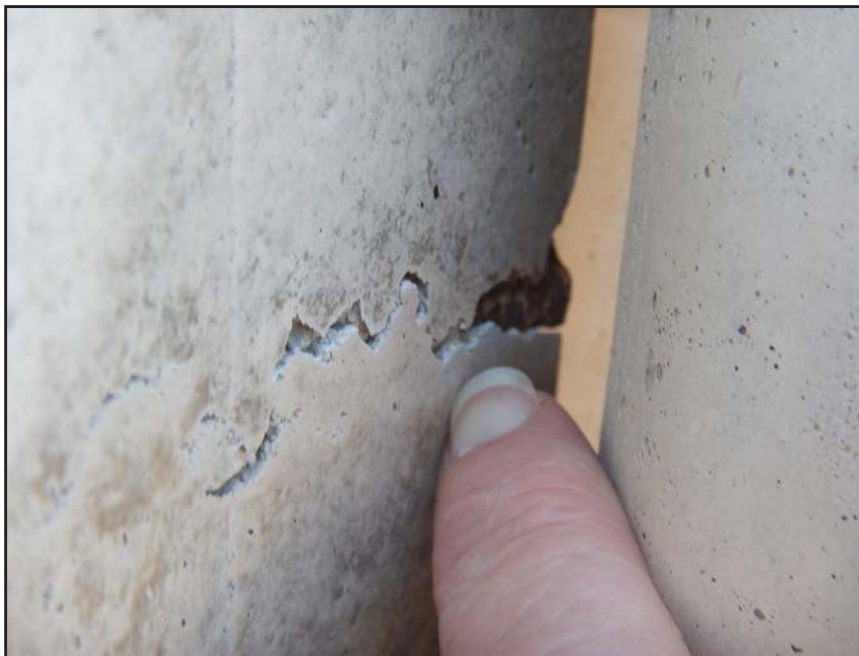
NO. 501 - COLUMN 48S -
EXPOSED REINFORCING STEEL
WITH INADEQUATE CONCRETE
COVER

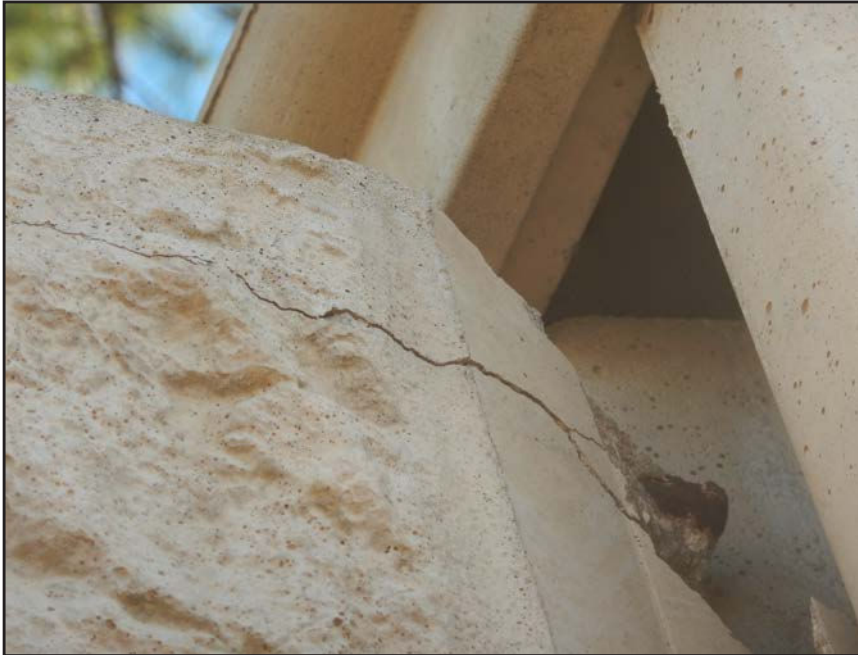
NO. 502 - COLUMN 55S -
EXPOSED REINFORCING STEEL
WITH INADEQUATE CONCRETE
COVER

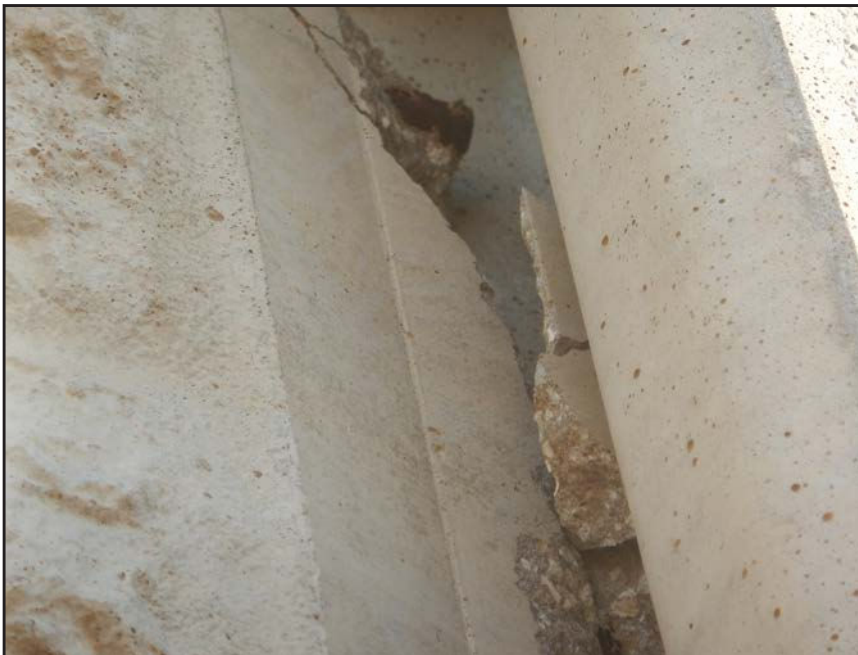
NO. 503 - COLUMN 25SS -
EXPOSED REINFORCING STEEL
WITH INADEQUATE CONCRETE
COVER

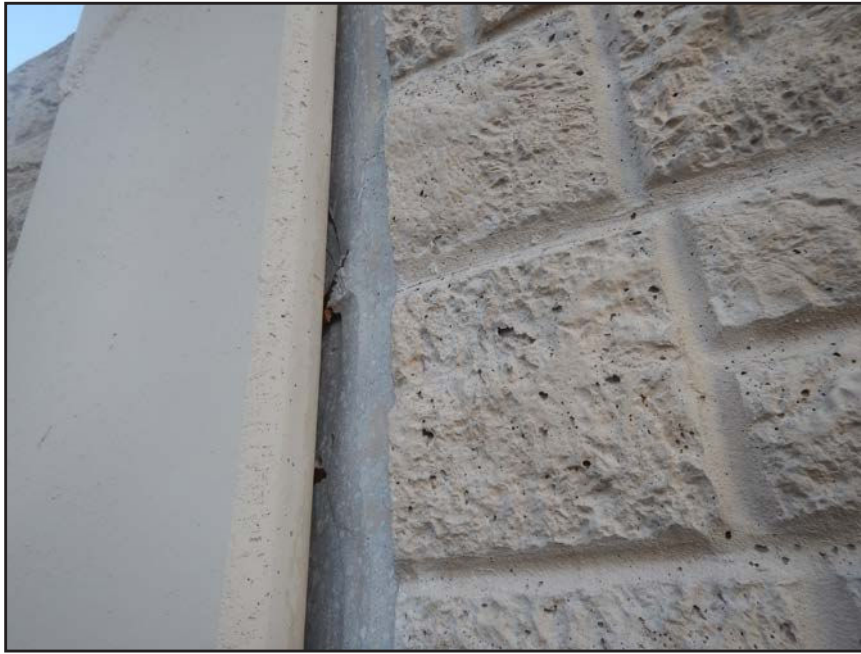
NO. 504 - COLUMN 25SS -
EXPOSED REINFORCING STEEL
WITH INADEQUATE CONCRETE
COVER

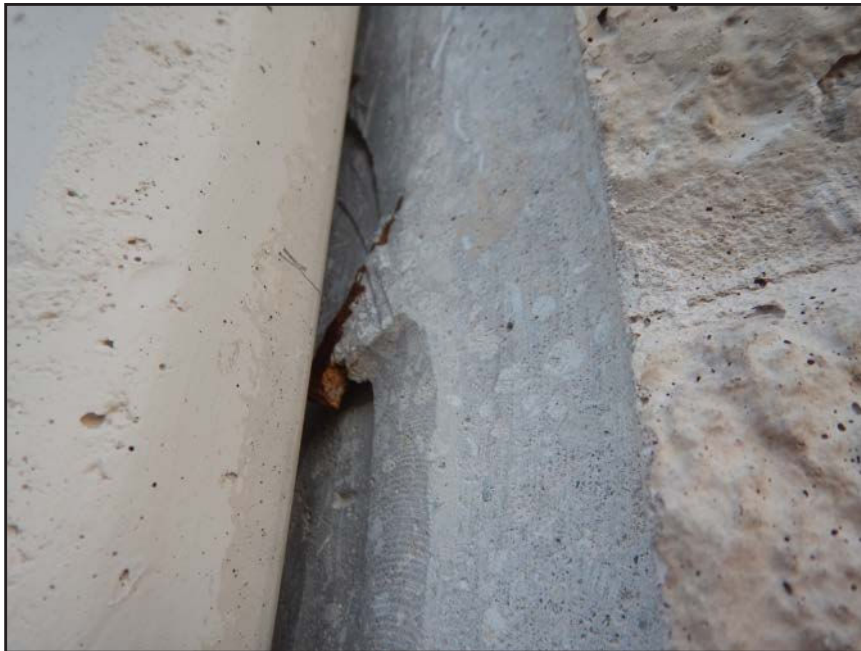
NO. 505 - COLUMN 79SS -
EXPOSED REINFORCING STEEL
WITH INADEQUATE CONCRETE
COVER

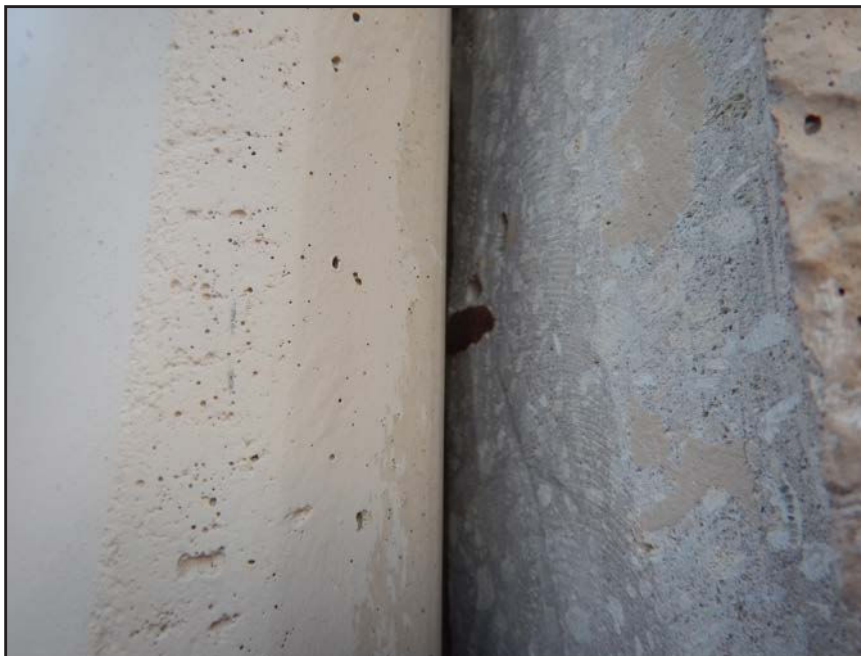
NO. 506 - COLUMN 79SS -
EXPOSED REINFORCING STEEL
WITH INADEQUATE CONCRETE
COVER
